# INDIANA DEPARTMENT OF ENVIRONMENTAL MANAGEMENT

Re: Inspection Summary Letter

**INDIANA DEPARTMENT OF ENVIRONMENTAL MANAGEMENT**  
**OFFICE OF LAND QUALITY**  
*Legitimate Use Inspection*

**EPA ID NUMBER:** Non-Notifier  
**NAME:** Indiana Shingle Recycling, LLC  
**ADDRESS:** 3725 S. Harding Street  
**CITY & COUNTY:** Indianapolis, Marion County  
**INSPECTION DATE:** August 7, 2024  
**INSPECTOR(S):** Scott Chrysler and Dan Walterman

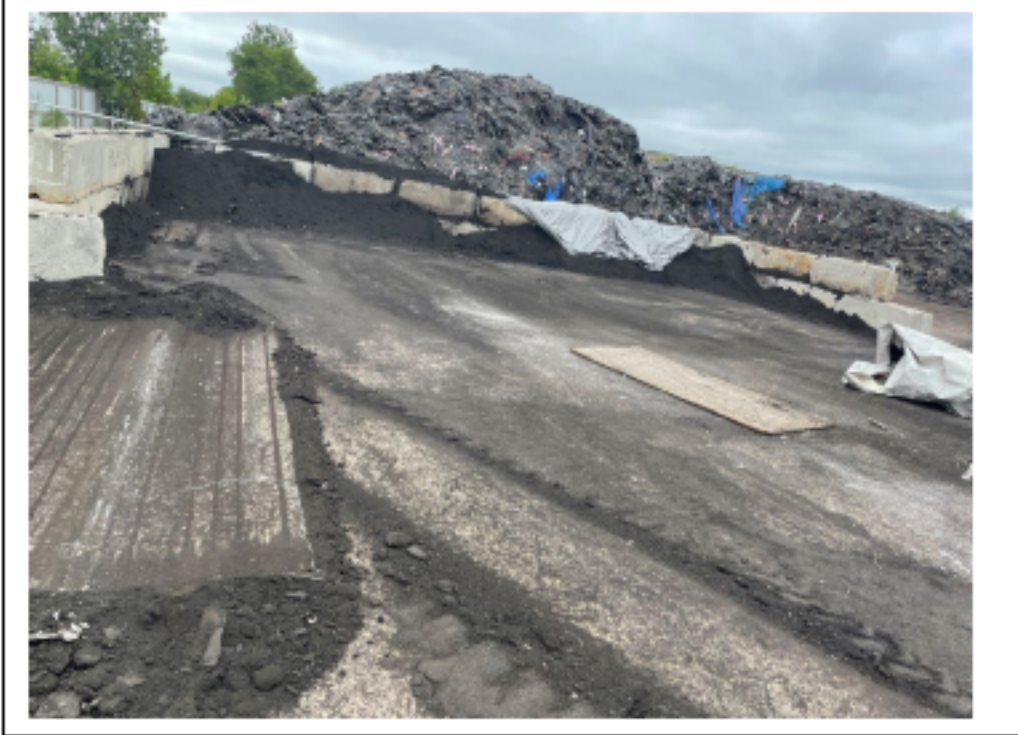
### Photo 1

IDEM staff continued the inspection along the northern edge of the property. IDEM staff observed ground shingle material staged loading (Pile A)(See attached Photo Log – Photo 1).

Location & Description: Ground material staged for loading

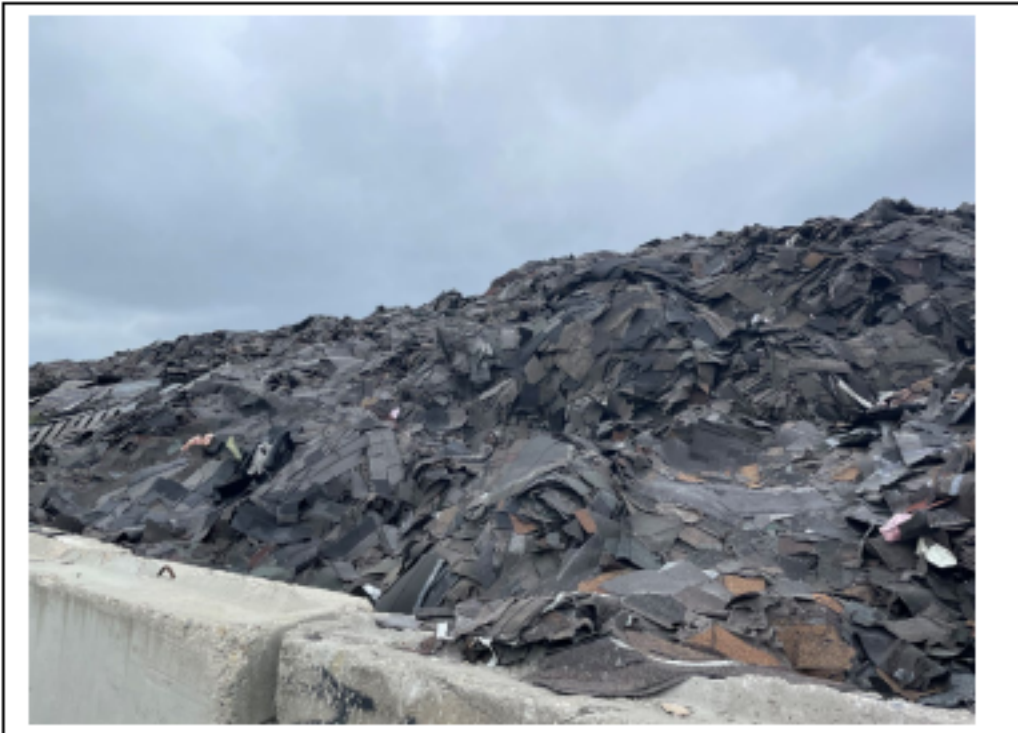
### Photo 2

IDEM staff continued along the northern edge of the property where they observed a large L-shape pile (Piles B1 and B2)(See Photo 2) IDEM staff observed that most of the pile was uncovered or covered with degraded tarp. IDEM staff noted that a large number of shingles had been removed since the last inspection.

Location & Description: Northern edge of pile B1

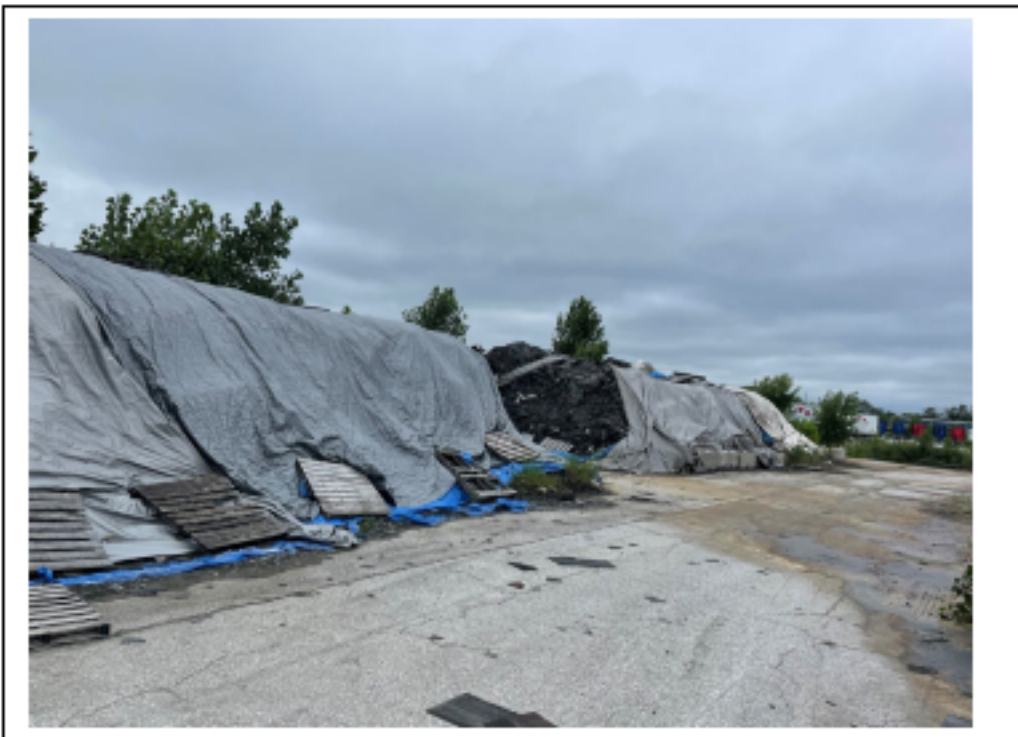
### Photo 3

IDEM staff continued the inspection along the eastern edge of the property and observed two piles (Piles C and D). Pile C was fully covered with tarps while some of the tarps covering Pile D had come off due to high winds (See Photo 3). IDEM staff advises facility staff to recover the pile as soon as possible. IDEM staff observed that

Location & Description: Piles C and D. Pile D's tarps were blown off due to high winds

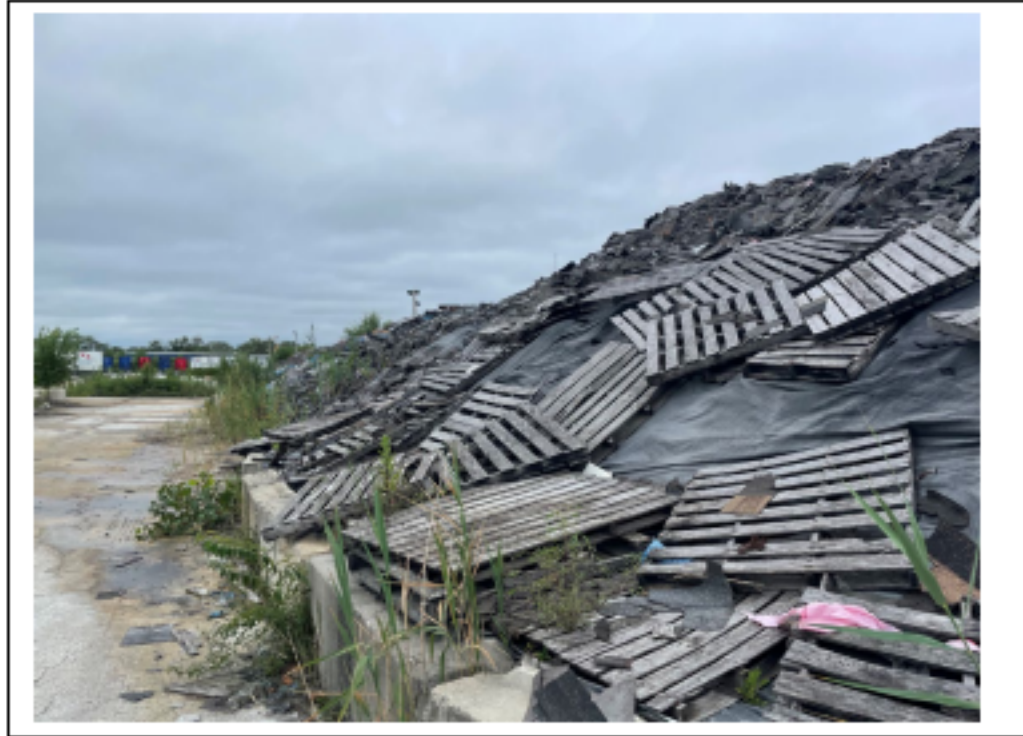
Photo 4

the piles had not changed since the previous inspection, IDEM staff also observed the eastern edge of pile B1/B2 (See photo 4).

Location & Description: Eastern edge of Pile B1/B2

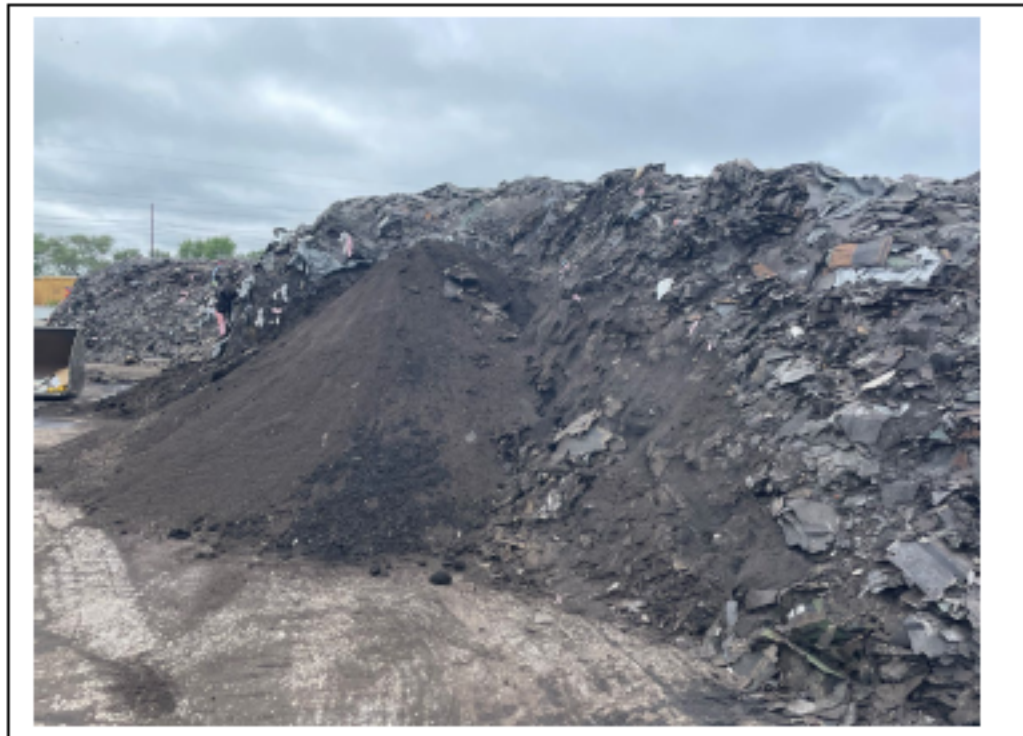
Photo 5

IDEM staff continued to the eastern side of the pole barn. IDEM staff observed the western area of Pile B1/B2. IDEM staff observed that additional shingles had been removed since the previous inspection (See Photos 5 and 6).

Location & Description: Ground material to be reground

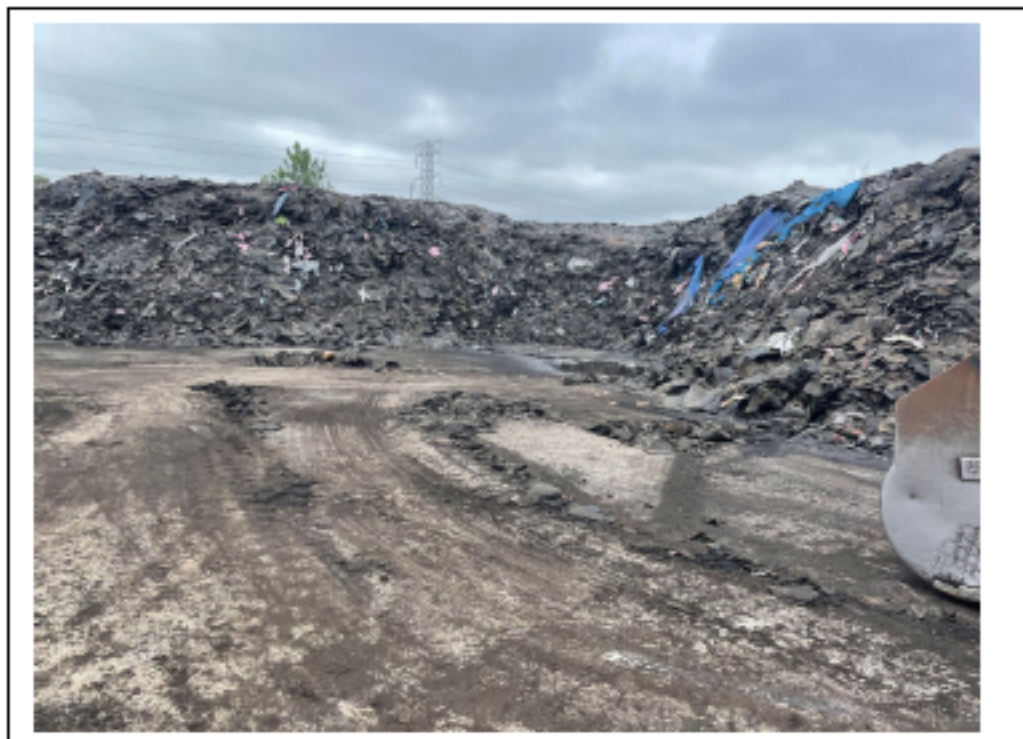
Photo 6

Location & Description: Section of Pile B1/B2 where material is being removed
