Indiana Department of Environmental Management

Re: Inspection Summary Letter
Strawtown Koteewi Park
PWSID# IN2290000
Noblesville, Hamilton County

Type of Inspection: Sanitary Survey Inspection
Primary Inspector: Lily Alexander: lalexand@idem.in.gov or 317-694-2754

Strawtown Koteewi Park - IN2290000

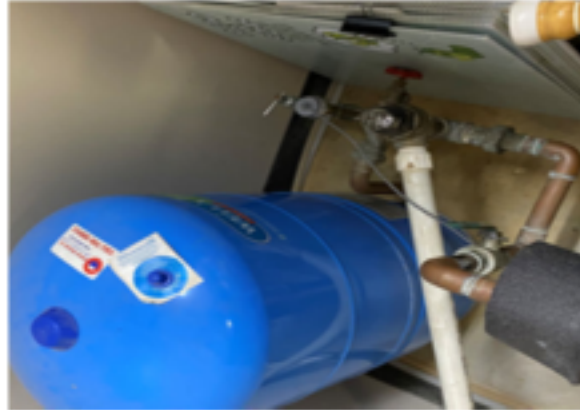
- 1 A **Minor** deficiency was identified regarding: **Inadequate source water sample tap**

The inspector noted: "Deficiency - 327 IAC 8-2.3-2(b)(6) The system is to install a smooth bore sample tap at a location prior to any storage or treatment. The tap is to be located at least eighteen (18) inches from the floor, in a location with relatively constant flow and readily accessible. The tap is to be smooth bore with no interior or exterior threads."

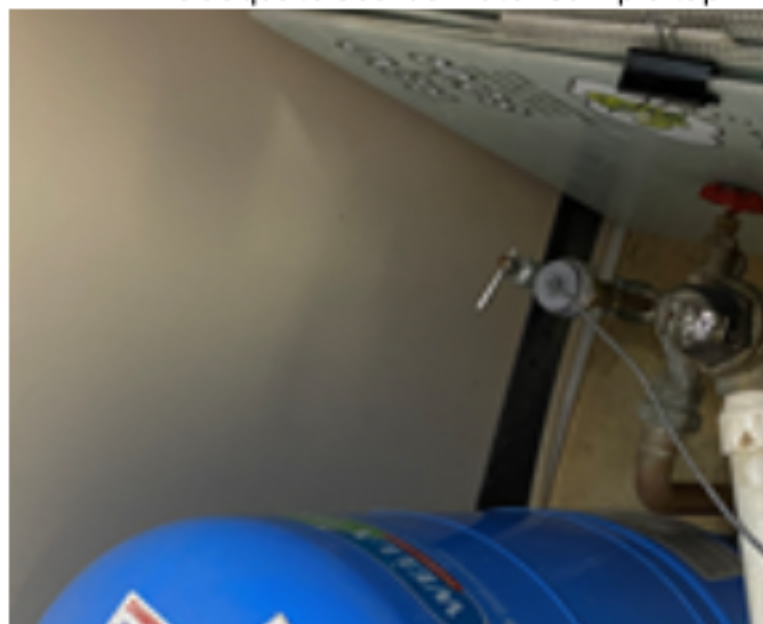
SO17

- 16 **Is there an adequate raw water sample tap for each source?**

Deficiency - 327 IAC 8-2.3-2(b)(6)

The system is to install a smooth bore sample tap at a location prior to any storage or treatment. The tap is to be located at least eighteen (18) inches from the floor, in a location with relatively constant flow and readily accessible. The tap is to be smooth bore with no interior or exterior threads.

Inadequate source water sample tap

MIN
Deficiency
