# Indiana Department of Environmental Management

Re: Inspection Summary Letter  
Sugar Grove Church, Inc.  
PWSID# IN2200091  
Goshen, Elkhart County

Type of Inspection: Sanitary Survey Inspection  
Primary Inspector: Megan Wright: MEwright@idem.IN.gov or 574-274-5778

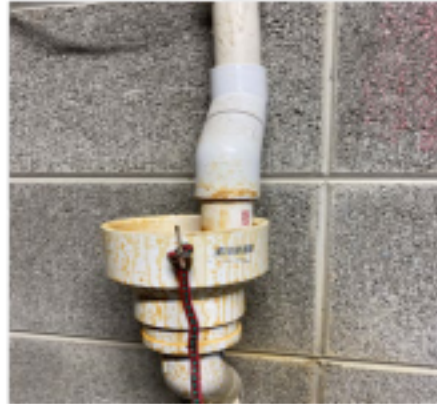
- 1 A **Significant** deficiency was identified regarding: **Cross connection(s) in the treatment process**

The inspector noted: "Deficiency - 327 IAC 8-10 System is to provide an air gap separation on the water softener discharge drain tube to the drain. A minimum of one (1) inch is to be provided. This was noted in the previous inspection and is now a significant violation."

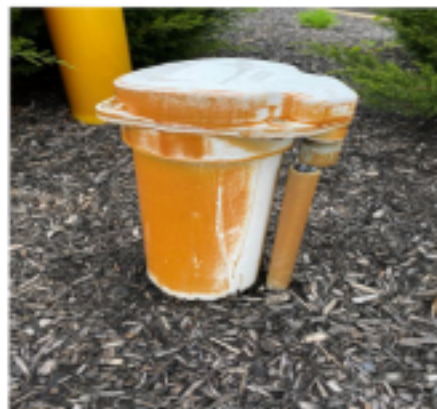
- 2 A **Minor** deficiency was identified regarding: **Well components are not maintained or operating properly**

The inspector noted: "Deficiency - 327 IAC 8-2-8.2(e)(7)(E)(ii) The electrical conduit going into the well cap is broken. This must be repaired to prevent any contamination to the well."

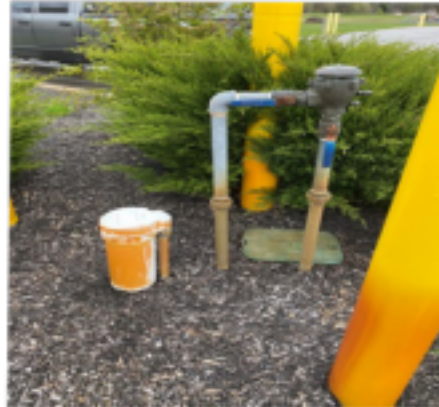
**3 A Minor deficiency was identified regarding: Inadequate source water sample tap**

The inspector noted: "Deficiency - 327 IAC 8-2.3-2(b)(6) The irrigation system comes directly off of the well. Due to this, the smooth bore sample tap must be moved to an approved sampling station outdoors to ensure that the tap is the first line off of the well."

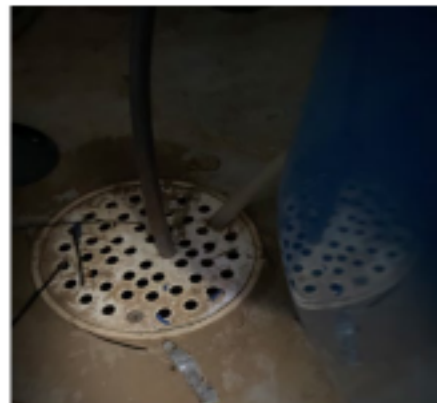
**4 A Minor deficiency was identified regarding: Cross connection(s) in the treatment process**

The inspector noted: "Deficiency - 327 IAC 8-10 System is to provide an air gap separation on the water softener discharge drain tube to the drain. A minimum of one (1) inch is to be provided."

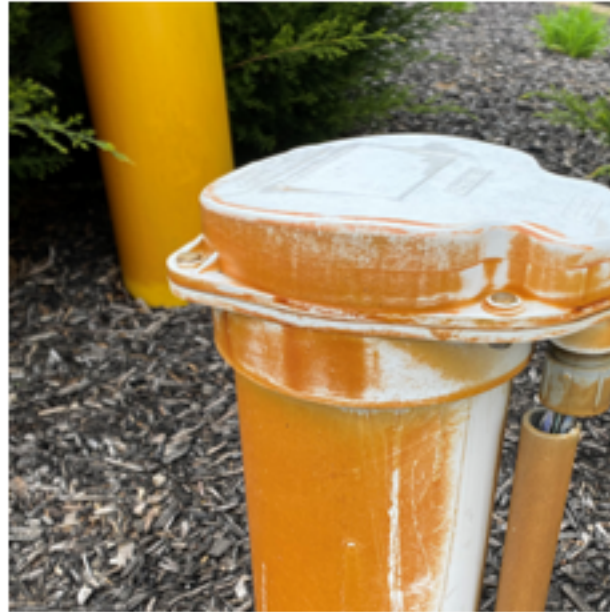
SO12

Deficiency - 327 IAC 8-2-8.2(e)(7)(E)(ii)

The electrical conduit going into the well cap is broken. This must be repaired to prevent any contamination to the well.

Well components are not maintained or operating properly

MIN  
Deficiency

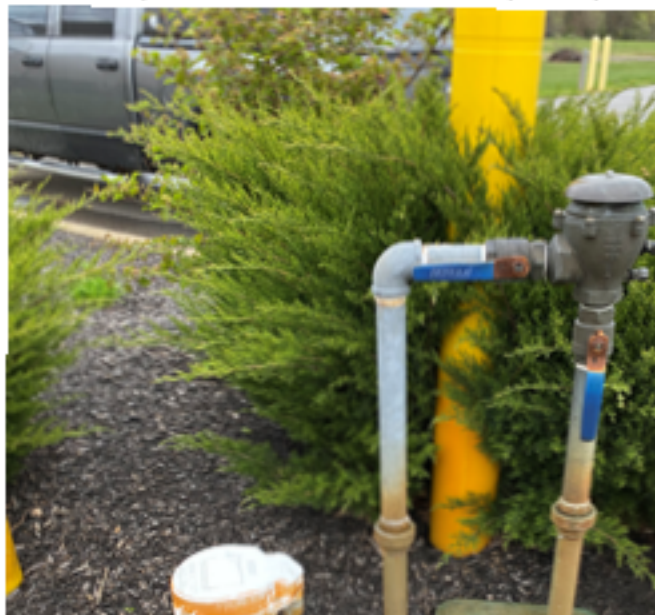
SO17

Deficiency - 327 IAC 8-2.3-2(b)(6)

The irrigation system comes directly off of the well. Due to this, the smooth bore sample tap must be moved to an approved sampling station outdoors to ensure that the tap is the first line off of the well.

Inadequate source water sample tap

MIN  
Deficiency

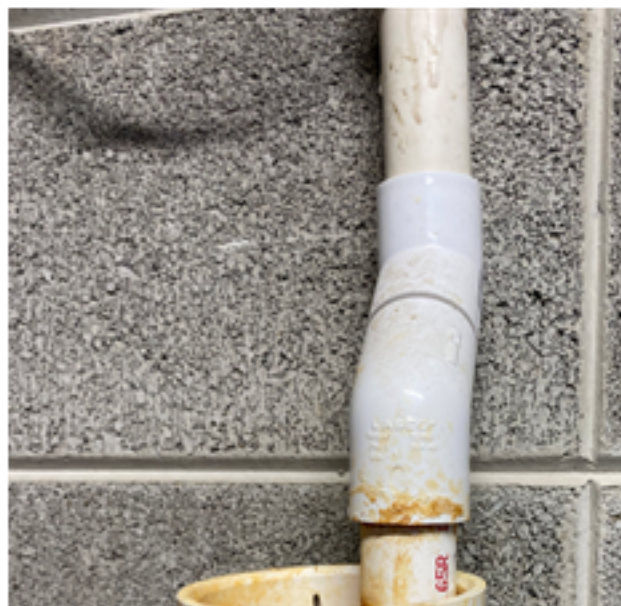
TR11

Deficiency - 327 IAC 8-10

System is to provide an air gap separation on the water softener discharge drain tube to the drain. A minimum of one (1) inch is to be provided. This was noted in the previous inspection and is now a significant violation.

Cross connection(s) in the treatment process

SIG  
Deficiency

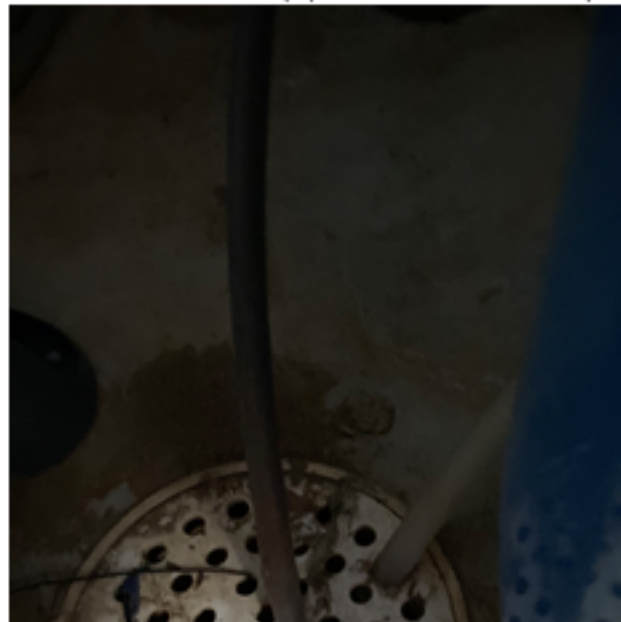
TR11

Deficiency - 327 IAC 8-10

System is to provide an air gap separation on the water softener discharge drain tube to the drain. A minimum of one (1) inch is to be provided.

Cross connection(s) in the treatment process

MIN  
Deficiency
