Indiana Department of Environmental Management

Re: Inspection Summary Letter
Dollar General #16323 - Leesburg
PWSID# IN2430251
Leesburg, Kosciusko County

Type of Inspection: Sanitary Survey Inspection
Primary Inspector: Sophia Andrews: SOandrew@idem.IN.gov or 574-274-5610

Public Water System Sanitary Survey Report

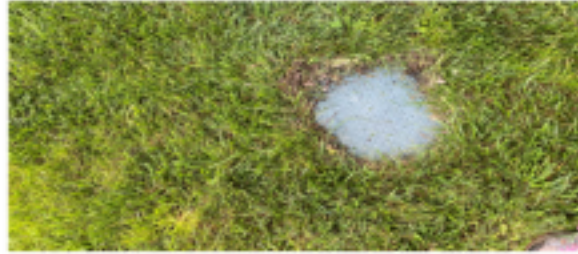
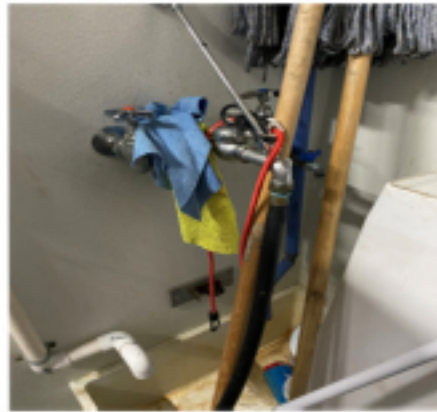
2 A **Minor** deficiency was identified regarding: **Distribution system is not free from uncontrolled cross connection**

The inspector noted: "Deficiency - 327 IAC 8-10 It cannot be determined if the irrigation system is no longer in use and has been properly abandoned or if it is still in use. A testable pressure vacuum breaker backflow preventer is not observed on the premises. The system is to either provide documentation that the irrigation system has been properly abandoned with regard to connection to the potable system or they are to ensure that a testable pressure vacuum breaker backflow preventer is present and tested immediately following installation and annually thereafter by an individual who is certified to do so in the state of Indiana. Test records are to be retained on site and made readily available during inspections by this office. Recommendation: there is a hose attached to the mop sink faucet. Although the mop sink faucet does have a built in vacuum breaker, as a best practice and to provide a second layer of protection, it is recommended that the system remove the hose when it is not in use. A sign should be posted near the mop sink to remind employees to remove the hose when it is not in use."

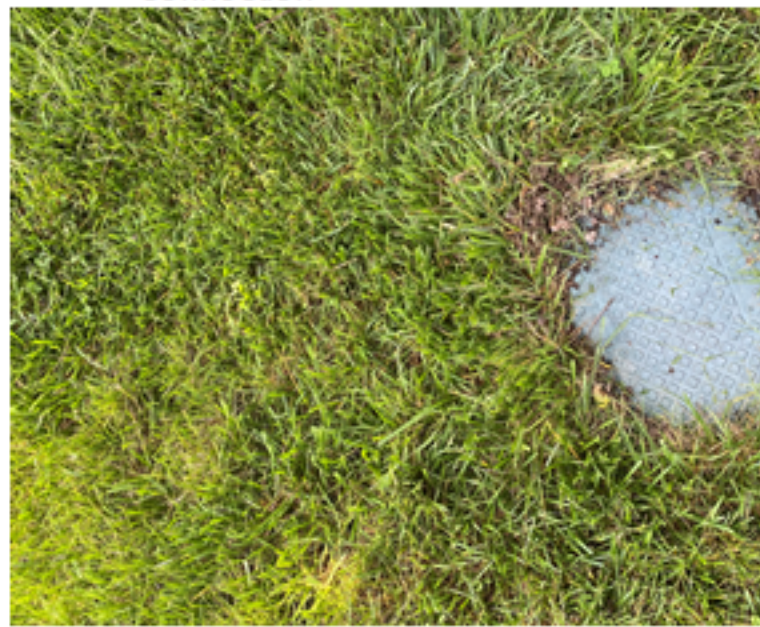
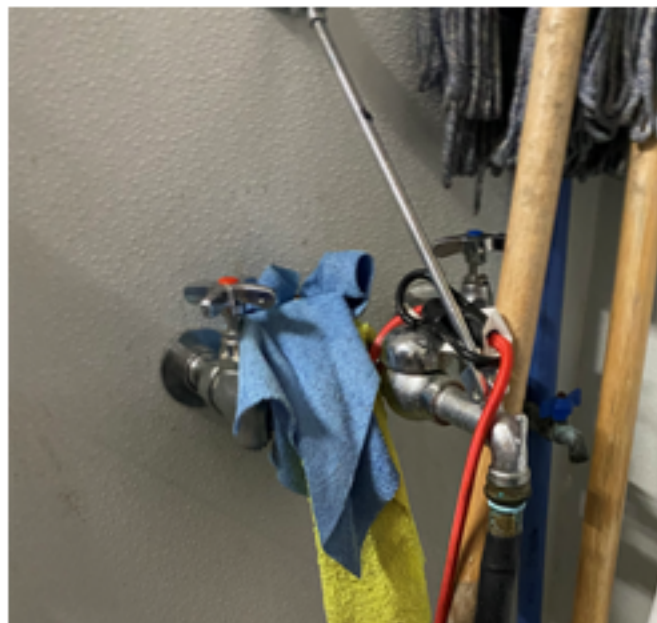
9 **Was the distribution system free from uncontrolled cross connections and are backflow prevention devices installed at all appropriate locations?**

Deficiency - 327 IAC 8-10 It cannot be determined if the irrigation system is no longer in use and has been properly abandoned or if it is still in use. A testable pressure vacuum breaker backflow preventer is not observed on the premises. The system is to either provide documentation that the irrigation system has been properly abandoned with regard to connection to the potable system or they are to ensure that a testable pressure vacuum breaker backflow preventer is present and tested immediately following installation and annually thereafter by an individual who is certified to do so in the state of Indiana. Test records are to be retained on site and made readily available during inspections by this office. Recommendation: there is a hose attached to the mop sink faucet. Although the mop sink faucet does have a built in vacuum breaker, as a best practice and to provide a second layer of protection, it is recommended that the system remove the hose when it is not in use. A sign should be posted near the mop sink to remind employees to remove the hose when it is not in use.

DS09 Distribution system is not free from uncontrolled cross connection

MIN
Deficiency
