Re: Inspection Summary Letter
Huntington First Brethren Church
PWSID# IN2350008
Huntington, Huntington County

Type of Inspection: Sanitary Survey Inspection
Primary Inspector: Darek Petro: dpetro@idem.in.gov or 317-617-9350

Huntington First Brethren Church - IN2350008

Public Water System Sanitary Survey Report

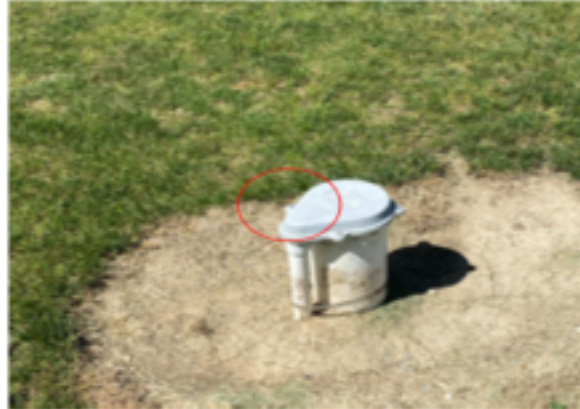
- 1 A **Minor** deficiency was identified regarding: **Top of the well is not protected**

The inspector noted: "Deficiency - 327 IAC 8-2-8.2(e)(1)(G)(iii) The system shall replace missing fastener nut on well cap."

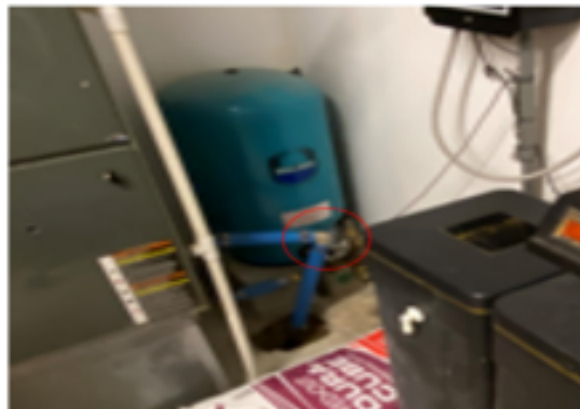
- 2 A **Minor** deficiency was identified regarding: **Inadequate source water sample tap**

The inspector noted: "Deficiency - 327 IAC 8-2.3-2(b)(6) The system is to install a smooth bore sample tap at a location prior to any storage or treatment. The tap is to be located at least eighteen (18) inches from the floor, in a location with relatively constant flow and readily accessible. The tap is to be smooth bore with no interior or exterior threads."

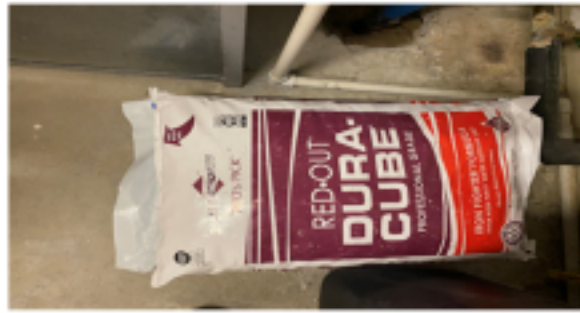
3 A Minor deficiency was identified regarding: Chemical storage is not adequate

The inspector noted: "10 States Standards 5.1.9, 5.1.10, & 5.1.11 The system shall store salt on a pallet, shelf, or other location off the floor."

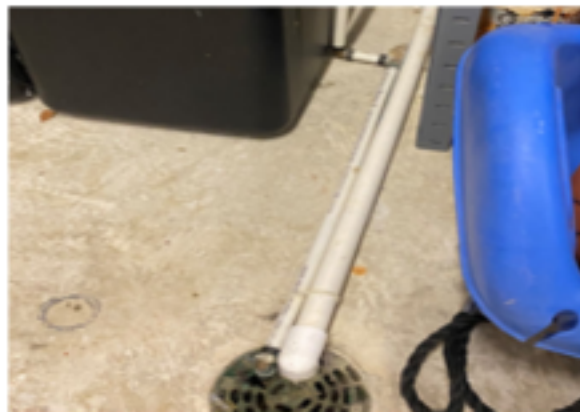
4 A Minor deficiency was identified regarding: Cross connection(s) in the treatment process

The inspector noted: "Deficiency - 327 IAC 8-10 System is to provide an air gap separation on the water softener discharge drain tube to the drain. A minimum of one (1) inch is to be provided."

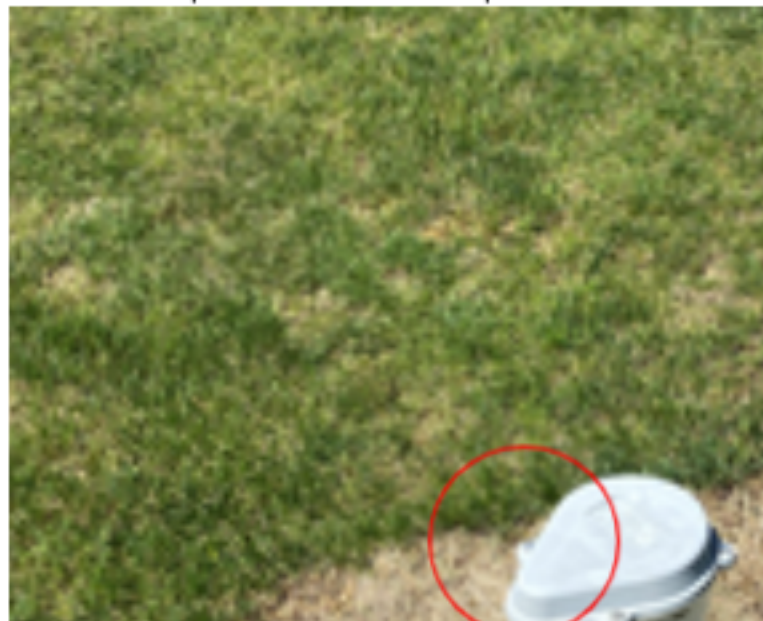
SO04

Deficiency - 327 IAC 8-2-8.2(e)(1)(G)(iii)

The system shall replace missing fastener nut on well cap.

Top of the well is not protected

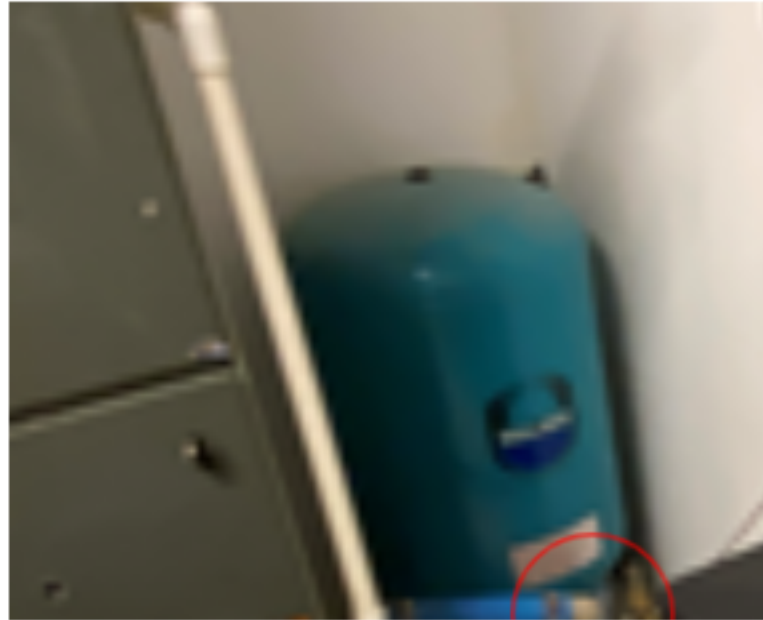
SO17

Deficiency - 327 IAC 8-2.3-2(b)(6)

The system is to install a smooth bore sample tap at a location prior to any storage or treatment. The tap is to be located at least eighteen (18) inches from the floor, in a location with relatively constant flow and readily accessible. The tap is to be smooth bore with no interior or exterior threads.

Inadequate source water sample tap

MIN
Deficiency

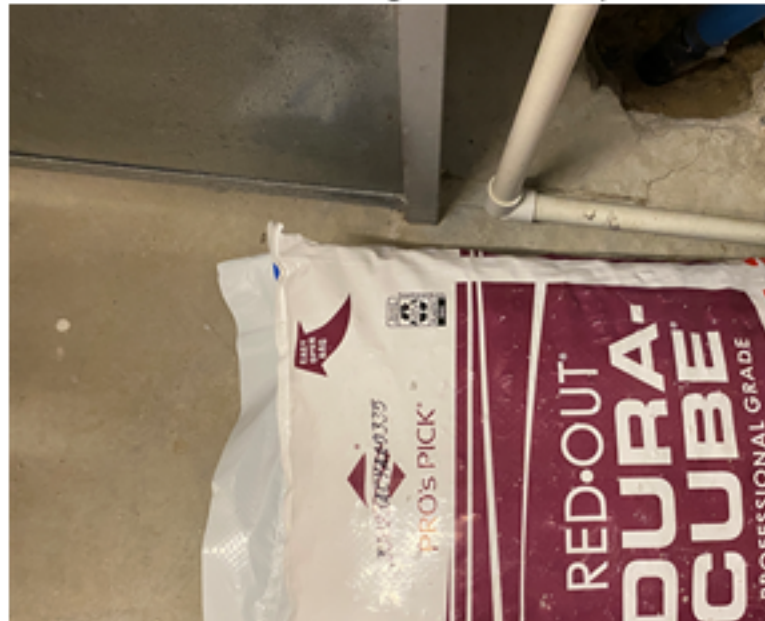
TR01

10 States Standards 5.1.9, 5.1.10, & 5.1.11

The system shall store salt on a pallet, shelf, or other location off the floor.

Chemical storage is not adequate

MIN
Deficiency

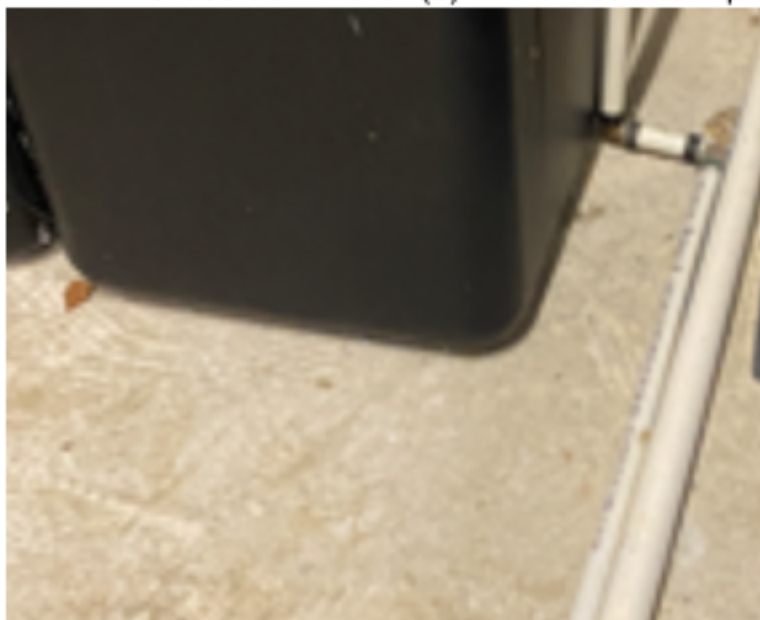
TR11

Deficiency - 327 IAC 8-10

System is to provide an air gap separation on the water softener discharge drain tube to the drain. A minimum of one (1) inch is to be provided.

Cross connection(s) in the treatment process

MIN
Deficiency
