Re: Inspection Summary Letter
Liberty Mills Church Of The Brethren
PWSID# IN2850019
Liberty Mills, Wabash County

Type of Inspection: Sanitary Survey Inspection
Primary Inspector: Darek Petro: dpetro@idem.in.gov or 317-617-9350

Public Water System Sanitary Survey Report

PWS ID: IN2850019 PWS Name: LIBERTY MILLS CHURCH OF THE BRETHREN

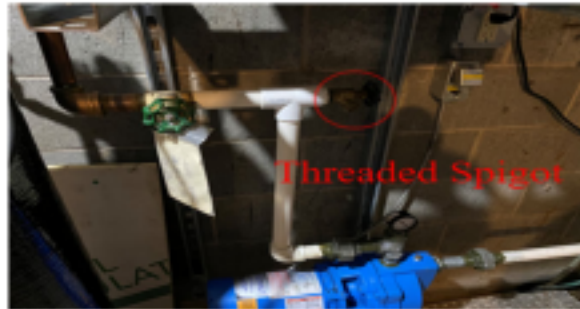
1 A Minor deficiency was identified regarding: Inadequate source water sample tap

The inspector noted: "Deficiency - 327 IAC 8-2.3-2(b)(6) The system is to install a smooth bore sample tap at a location prior to any storage or treatment. The tap is to be located at least eighteen (18) inches from the floor, in a location with relatively constant flow and readily accessible. The tap is to be smooth bore with no interior or exterior threads."

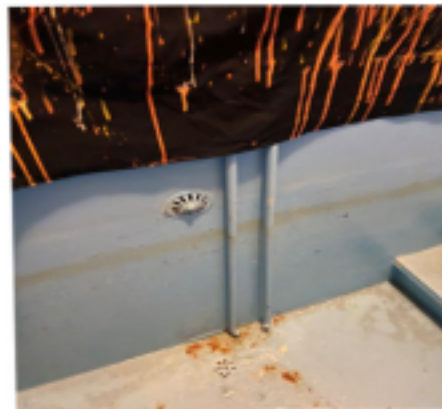
2 A Minor deficiency was identified regarding: Distribution system is not free from uncontrolled cross connection

The inspector noted: "Deficiency - 327 IAC 8-10 Baptistry fill piping shall be raised at least 1 inch above max fill line."

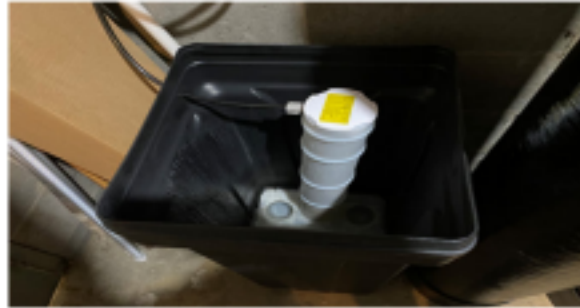
3 A **Minor** deficiency was identified regarding: **All additives are not NSF/ANSI approved**

The inspector noted: "Deficiency - 327 IAC 8-1-2(b) The system shall ensure brine tank is filled with NSF Certified softener salt. Documentation of certification shall be provided to IDEM."

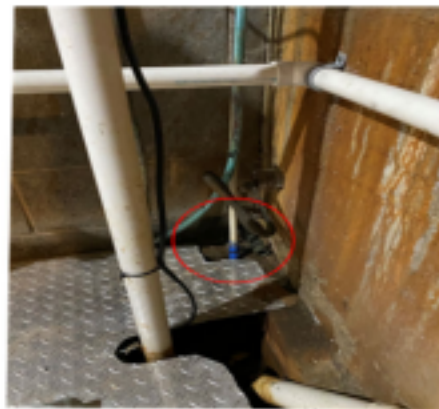
4 A **Minor** deficiency was identified regarding: **Cross connection(s) in the treatment process**

The inspector noted: "Deficiency - 327 IAC 8-10 System is to provide an air gap separation on the water softener discharge drain tube to the drain. A minimum of one (1) inch is to be provided."

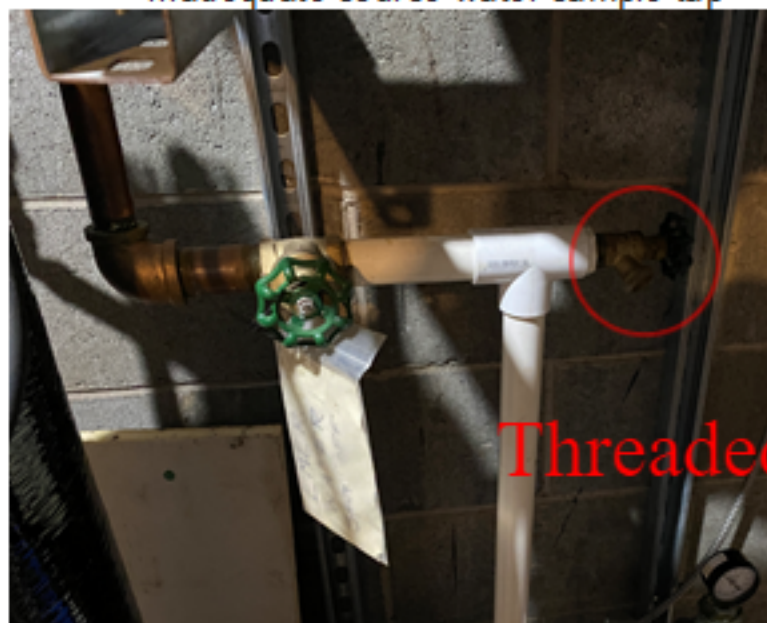
SO17

16 Is there an adequate raw water sample tap for each source?

Deficiency - 327 IAC 8-2.3-2(b)(6)

The system is to install a smooth bore sample tap at a location prior to any storage or treatment. The tap is to be located at least eighteen (18) inches from the floor, in a location with relatively constant flow and readily accessible. The tap is to be smooth bore with no interior or exterior threads.

Inadequate source water sample tap

MIN Deficiency

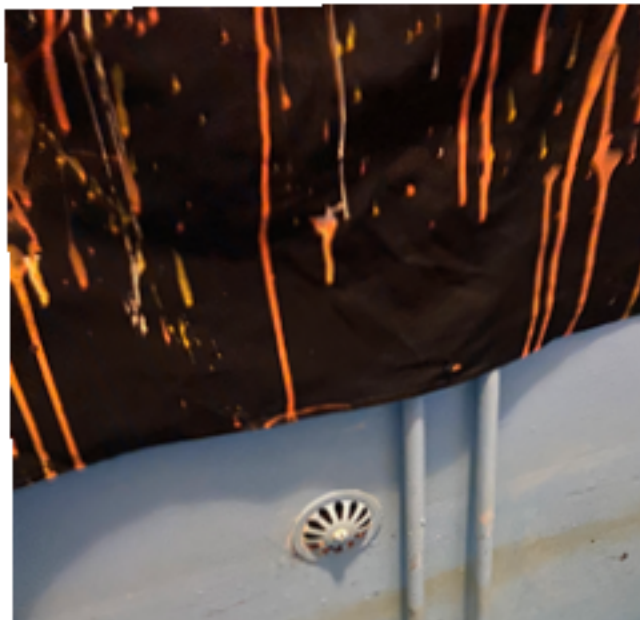
DS09

9 Was the distribution system free from uncontrolled cross connections and are backflow prevention devices installed at all appropriate locations?

Deficiency - 327 IAC 8-10

Baptistry fill piping shall be raised at least 1 inch above max fill line.

Distribution system is not free from uncontrolled cross connection

MIN
Deficiency

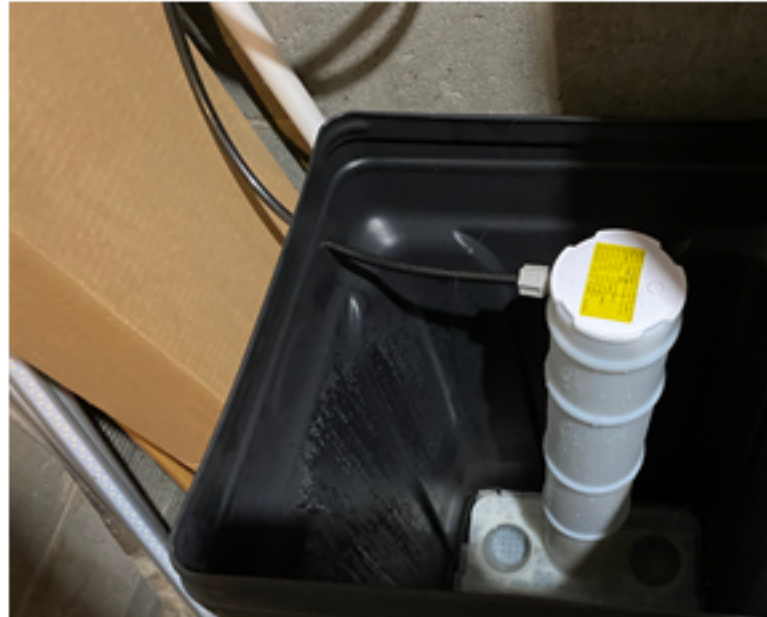
10 Do all the chemical additives used in the treatment process have ANS/N SF approval?

Deficiency - 327 IAC 8-1-2(b)
The system shall ensure brine tank is filled with NSF Certified softener salt.
Documentation of certification shall be provided to IDEM.
TR10 All additives are not NSF/ANSI approved

MIN
Deficiency

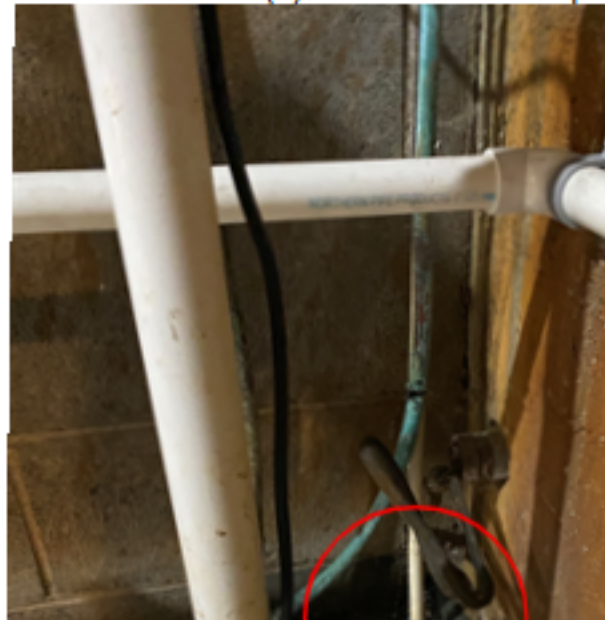
11 Was the treatment process free from uncontrolled cross connections and are backflow prevention devices installed at all appropriate locations?

Deficiency - 327 IAC 8-10
System is to provide an air gap separation on the water softener discharge drain tube to the drain. A minimum of one (1) inch is to be provided.
TR11 Cross connection(s) in the treatment process

MIN
Deficiency
