# Indiana Department of Environmental Management

Re: Inspection Summary Letter  
Dollar General #15686 - Angola  
PWSID# IN2760069  
Angola, Steuben County

## Public Water System Sanitary Survey Report

PWS ID: IN2760069    PWS Name: DOLLAR GENERAL #15686 - ANGOLA

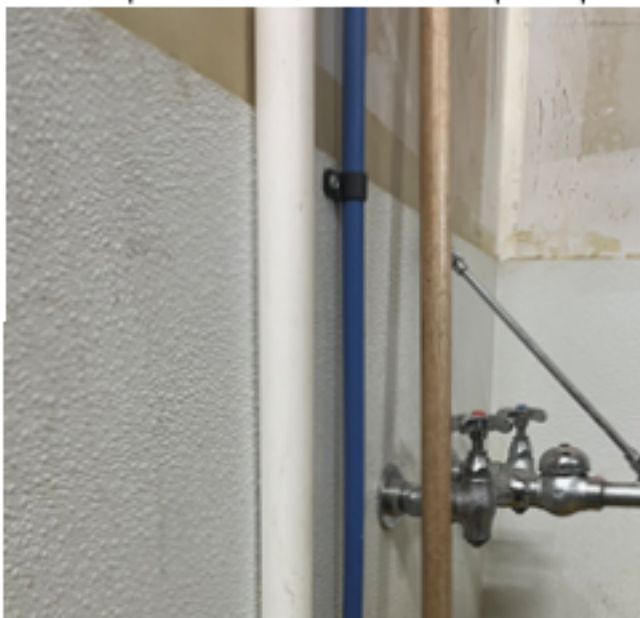
SO17

Since the storage tank could not be located at the time of inspection, it is not possible to determine whether the Source Sample Tap is properly located prior to storage (not under the influence of water from the storage tank). The system is to provide documentation as to the location of the storage tank so that IDEM can verify that the Source Sample Tap is properly located prior to any storage.

Inadequate source water sample tap

MIN  
Deficiency
