Indiana Department of Environmental Management

Re: Inspection Summary Letter
Dollar General - Knox South US 35
PWSID# IN2750046
Knox, Starke County

Type of Inspection: Sanitary Survey Inspection
Primary Inspector: Sara Benkert: SBenkert@idem.IN.gov or 765-577-0020

Public Water System Sanitary Survey Report

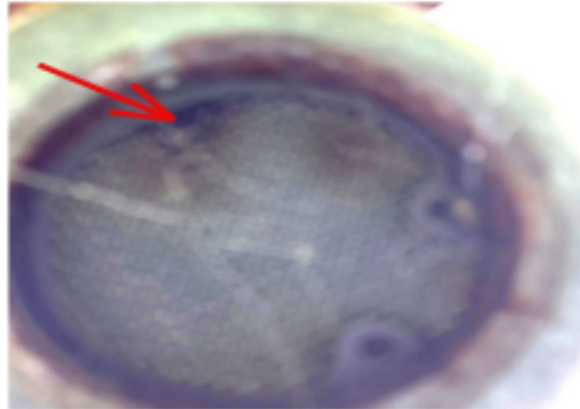
- 1 A **Minor** deficiency was identified regarding: **Well vent not screened or properly constructed**

The inspector noted: "Deficiency - 327 IAC 8-2-8.2(e)(1)(G)(iii) The well casing vent screen is to be repaired or replaced with a 24 mesh screen."

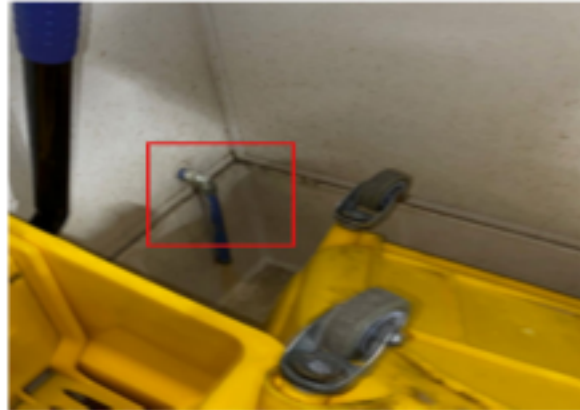
3 A **Minor** deficiency was identified regarding: **Cross connection(s) in the treatment process**

The inspector noted: "Deficiency - 327 IAC 8-10 An air gap is needed between the Water Treatment Equipment Regeneration discharge line and the Sanitary Drain. A minimum of one (1) inch is to be provided."

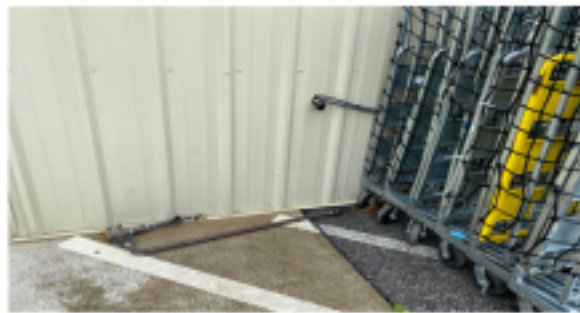
4 A **Minor** deficiency was identified regarding: **Cross connection control devices are not properly installed, tested, or inspection**

The inspector noted: "If the Irrigation System is to be reconnected, it must be tested by a licensed backflow inspector and annually thereafter."

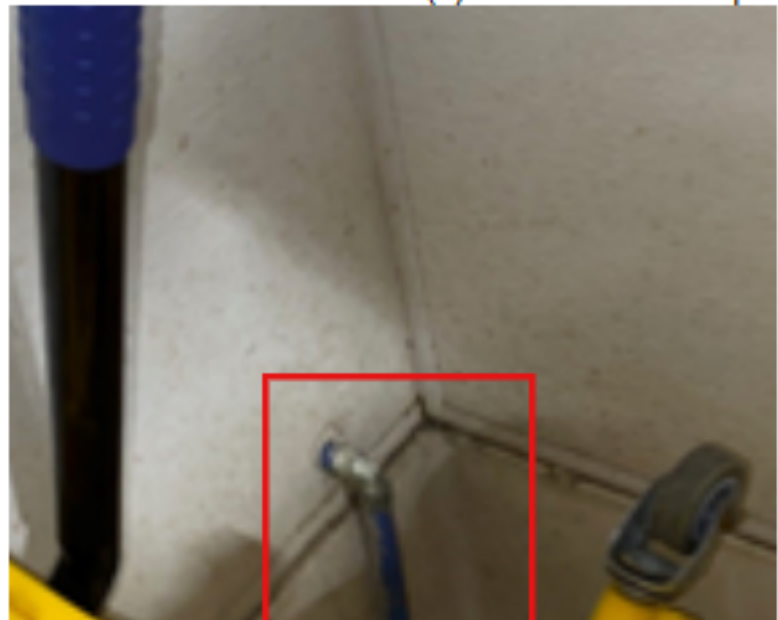
- 11 Was the treatment process free from uncontrolled cross connections and are backflow prevention devices installed at all appropriate locations?

- Deficiency - 327 IAC 8-10
 - An air gap is needed between the Water Treatment Equipment Regeneration discharge line and the Sanitary Drain. A minimum of one (1) inch is to be provided.
 - TR11 Cross connection(s) in the treatment process

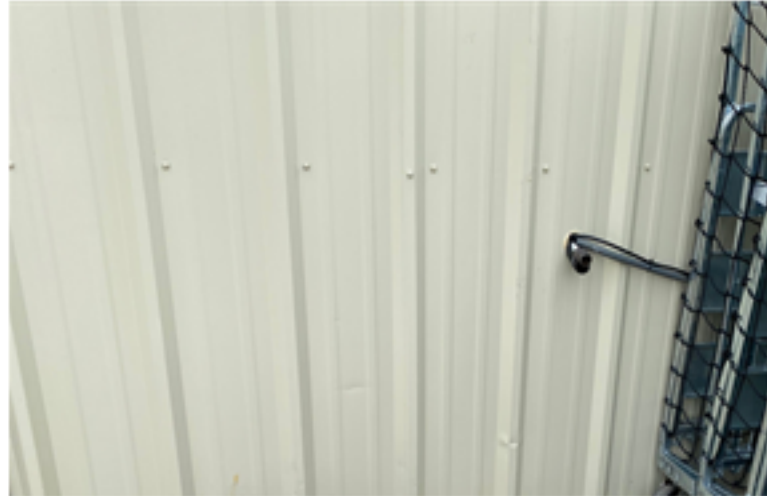
- 8 **Is the installation, testing, and inspection of cross connection control devices conducted in accordance to 327 IAC 8-10?**
 If the Irrigation System is to be reconnected, it must be tested by a licensed backflow inspector and annually thereafter.
 DS08 Cross connection control devices are not properly installed, tested, or inspection

MIN
Deficiency
