Re: Inspection Summary Letter
Mcdonald's Restaurant
PWSID# IN2710921
Granger, St. Joseph County

Type of Inspection: Sanitary Survey Inspection
Primary Inspector: Kali Young: or (574) 229-7502

Public Water System Sanitary Survey Report

PWS ID: IN2710921 PWS Name: MCDONALDS RESTAURANT

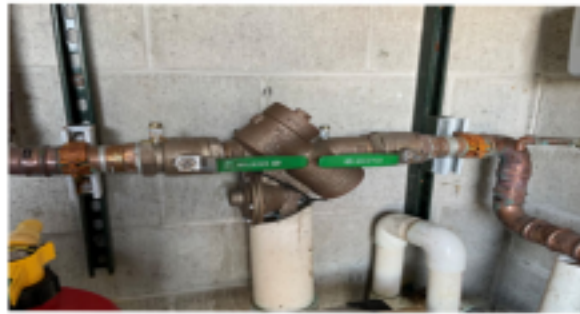
- 1 A **Minor** deficiency was identified regarding: **Cross connection control devices are not properly installed, tested, or inspection**

The inspector noted: "Deficiency - 327 IAC 8-10 The RPZ backflow preventer on the irrigation line does not have a hang tag with the most recent date of testing. The system is to have the unit tested on an annual basis and submit a photo of the hang tag to IDEM."

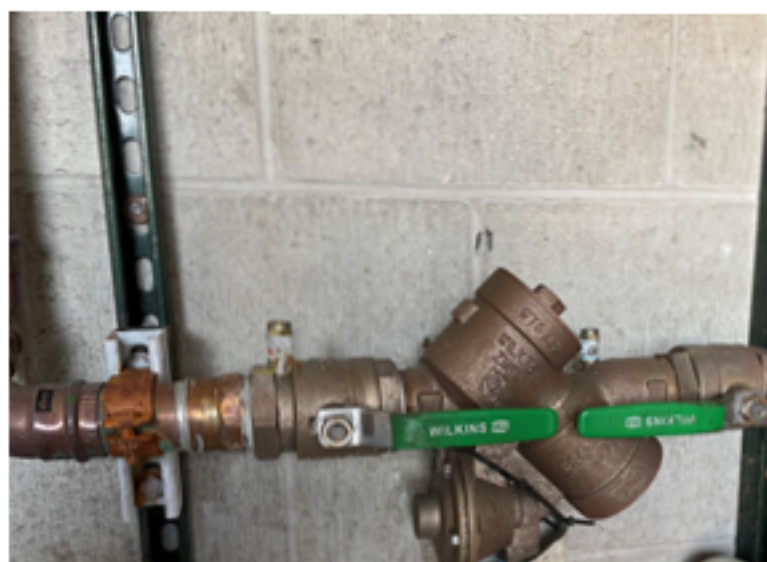
| 8 | <p>Is the installation, testing, and inspection of cross connection control devices conducted in accordance to 327 IAC 8-10?</p> <p>Deficiency - 327 IAC 8-10

The RPZ backflow preventer on the irrigation line does not have a hang tag with the most recent date of testing. The system is to have the unit tested on an annual basis and submit a photo of the hang tag to IDEM.</p> <p>DS08 Cross connection control devices are not properly installed, tested, or inspection</p> |

<div style="background-color: orange; padding: 2px; font-size: 0.8em; text-align: center;">MIN
Deficiency</div> |
