Re: Inspection Summary Letter
Dillman United Brethren In Christ
PWSID# IN2900020
Warren, Wells County

Type of Inspection: Sanitary Survey Inspection
Primary Inspector: Darek Petro: dpetro@idem.in.gov or 317-617-9350

Public Water System Sanitary Survey Report

PWS ID: IN2900020 PWS Name: DILLMAN UNITED BRETHREN IN CHRIST

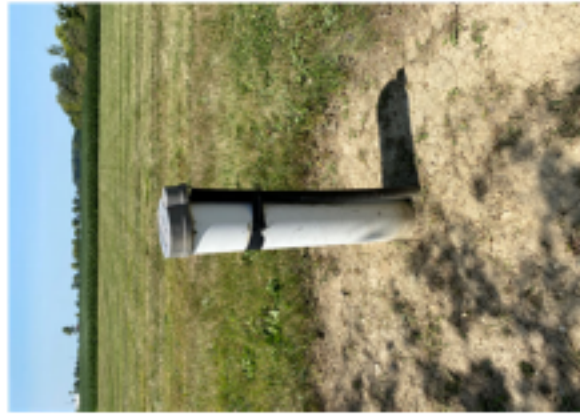
- 1 A **Minor** deficiency was identified regarding: **Top of the well is not protected**

The inspector noted: "Deficiency - 327 IAC 8-2-8.2{e}{1}{G}{iii) The system shall install well cap such that no gap exists in electrical conduit feed. System shall also install landscaping and/or impact barrier to prevent damage from lawn care equipment."

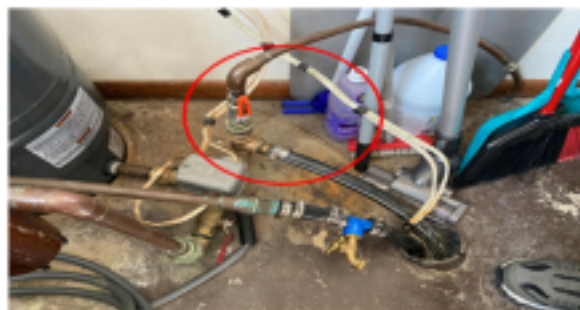
- 2 A **Minor** deficiency was identified regarding: **Inadequate source water sample tap**

The inspector noted: "Deficiency - 327 IAC 8-2.3-2{b}{6) The system is to install a smooth bore sample tap at a location prior to any branches to storage/pressure tanks and any treatment. The tap is to be located at least eighteen (18) inches from the floor, in a location with relatively constant flow and readily accessible. The tap is to be smooth bore with no interior or exterior threads."

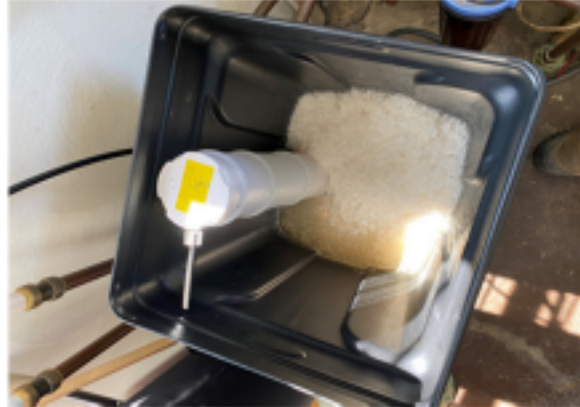
- 3 A **Minor** deficiency was identified regarding: **All additives are not NSF/ANSI approved**

The inspector noted: "Deficiency - 327 IAC 8-1-2(b) The salt used in the water softener must be NSF certified. The system must provide documentation of the water softener salt certification."

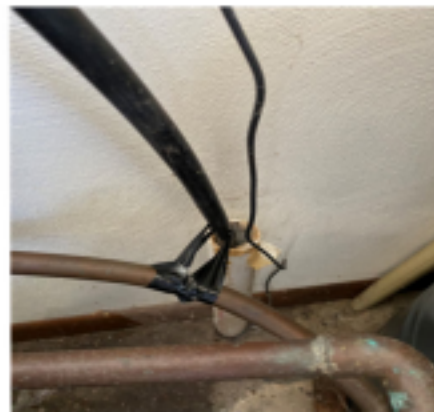
- 4 A **Minor** deficiency was identified regarding: **Cross connection(s) in the treatment process**

The inspector noted: "Deficiency - 327 IAC 8-10 System is to provide an air gap separation on the water softener discharge drain tube to the drain. A minimum of one (1) inch is to be provided."

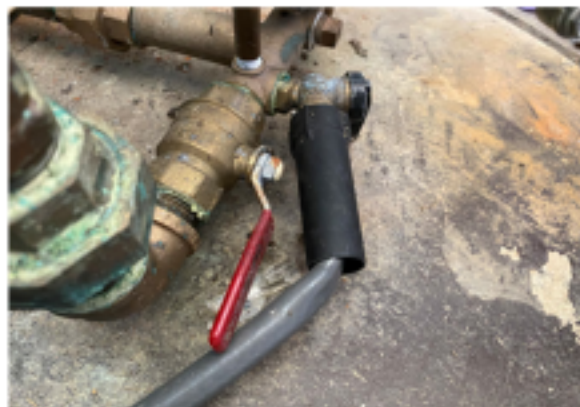
- 5 A **Minor** deficiency was identified regarding: **Distribution system is not free from uncontrolled cross connection**

The inspector noted: "Deficiency - 327 IAC 8-10 The system shall install a hose bib vacuum breaker at threaded connection in utility room."

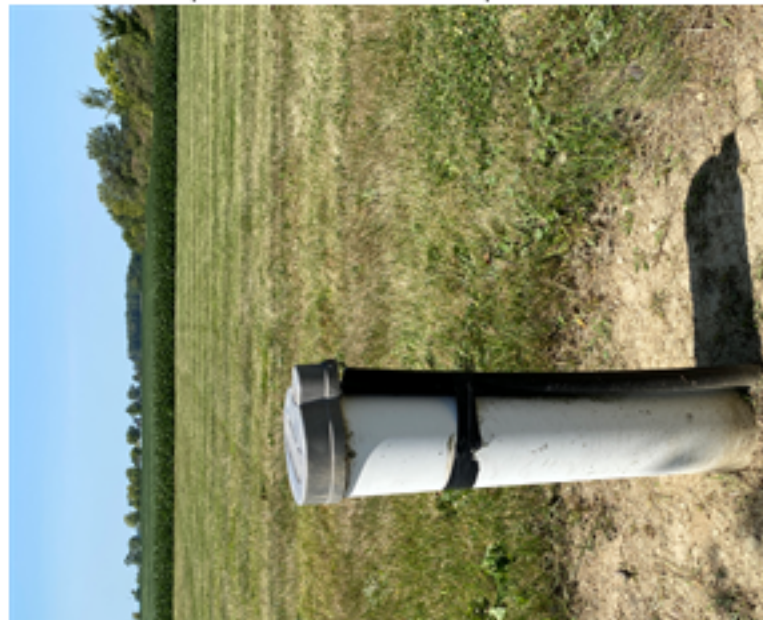
SO04

- 3 **Is the top of the well protected so that foreign matter or surface water cannot enter the well?**

Deficiency - 327 IAC 8-2-8.2(e)(1)(G)(iii)

Top of the well is not protected

The system shall install well cap such that no gap exists in electrical conduit feed. System shall also install landscaping and/or impact barrier to prevent damage from lawn care equipment.

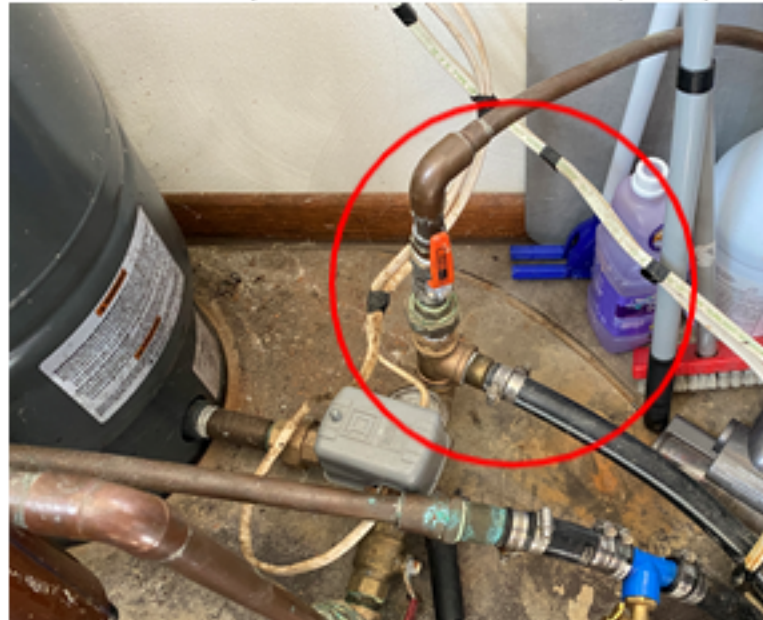
SO17

16 **Is there an adequate raw water sample tap for each source?**

Deficiency - 327 IAC 8-2.3-2(b)(6)

Inadequate source water sample tap

MIN
Deficiency

The system is to install a smooth bore sample tap at a location prior to any branches to storage/pressure tanks and any treatment. The tap is to be located at least eighteen (18) inches from the floor, in a location with relatively constant flow and readily accessible. The tap is to be smooth bore with no interior or exterior threads.

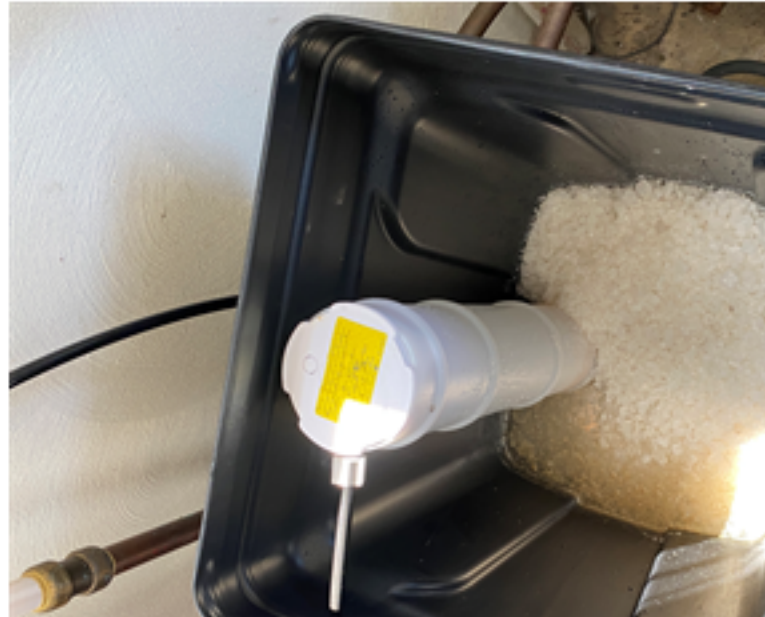
TR10

- 10 **Do all the chemical additives used in the treatment process have ANSI/NSF approval?**

Deficiency - 327 IAC 8-1-2(b)

All additives are not NSF/ANSI approved

MIN
Deficiency

The salt used in the water softener must be NSF certified. The system must provide documentation of the water softener salt certification.

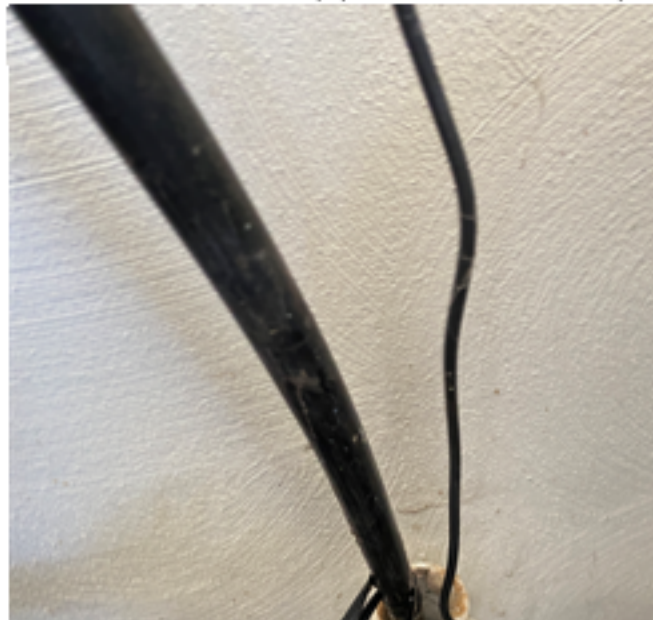
TR11

- 11 **Was the treatment process free from uncontrolled cross connections and are backflow prevention devices installed at all appropriate locations?**

Deficiency - 327 IAC 8-10

Cross connection(s) in the treatment process

MIN
Deficiency

System is to provide an air gap separation on the water softener discharge drain tube to the drain. A minimum of one (1) inch is to be provided.

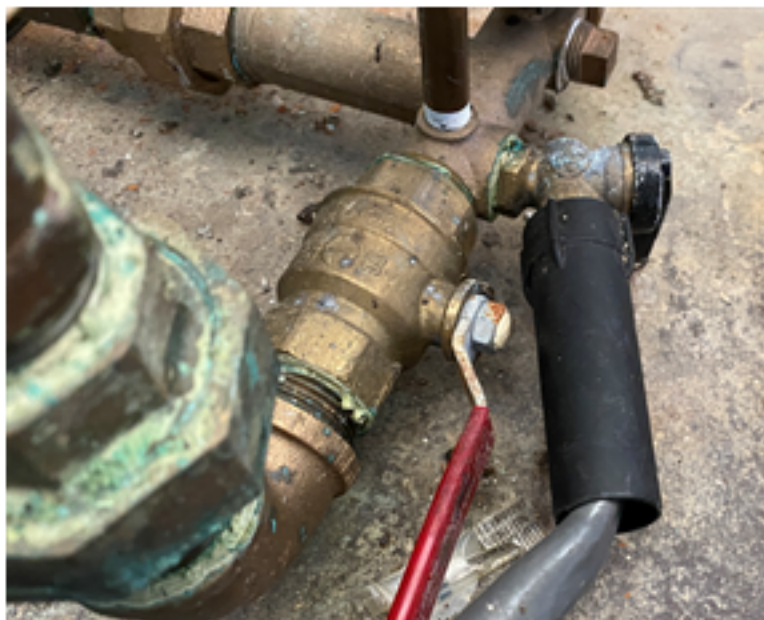
DS09

9 Was the distribution system free from uncontrolled cross connections and are backflow prevention devices installed at all appropriate locations?

Deficiency - 327 IAC 8-10

Distribution system is not free from uncontrolled cross connection

MIN
Deficiency

The system shall install a hose bib vacuum breaker at threaded connection in utility room.
