Re: Inspection Summary Letter  
Dillman United Brethren In Christ  
PWSID# IN2900020  
Warren, Wells County

Type of Inspection: Sanitary Survey Inspection  
Primary Inspector: Darek Petro: [dpetro@idem.in.gov](mailto:dpetro@idem.in.gov) or 317-617-9350

# Summary of Deficiencies Identified

## Public Water System Sanitary Survey Report

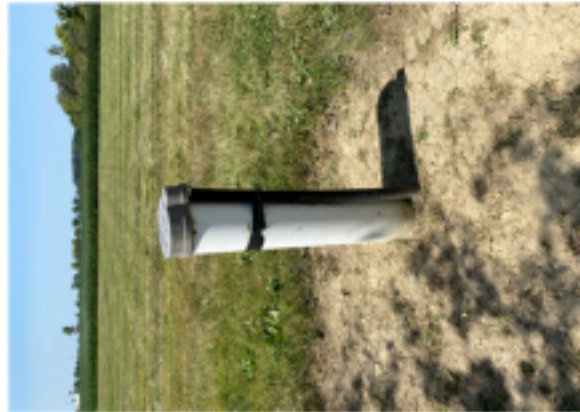
**1 A Minor deficiency was identified regarding: Top of the well is not protected**

The inspector noted: "Deficiency - 327 IAC 8-2-8.2(e)(1)(G)(iii) The system shall install well cap such that no gap exists in electrical conduit feed. System shall also install landscaping and/or impact barrier to prevent damage from lawn care equipment."

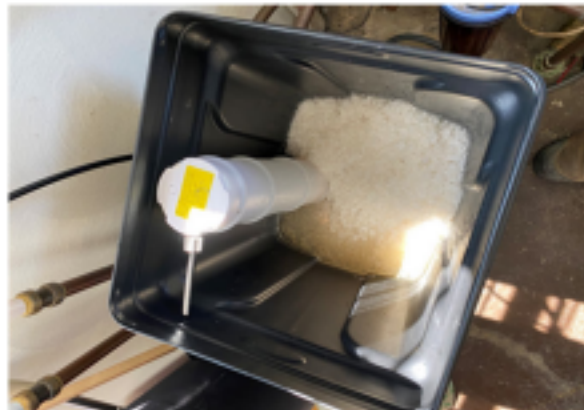
- 3 A **Minor** deficiency was identified regarding: **All additives are not NSF/ANSI approved**

The inspector noted: "Deficiency - 327 IAC 8-1-2(b) The salt used in the water softener must be NSF certified. The system must provide documentation of the water softener salt certification."

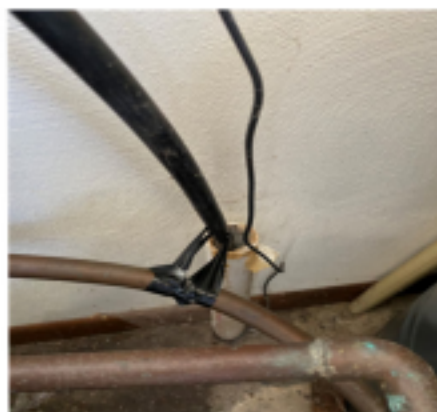
- 4 A **Minor** deficiency was identified regarding: **Cross connection(s) in the treatment process**

The inspector noted: "Deficiency - 327 IAC 8-10 System is to provide an air gap separation on the water softener discharge drain tube to the drain. A minimum of one (1) inch is to be provided."

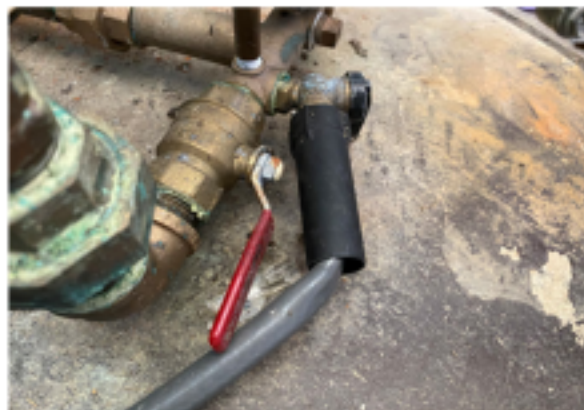
- 5 A **Minor** deficiency was identified regarding: **Distribution system is not free from uncontrolled cross connection**

The inspector noted: "Deficiency - 327 IAC 8-10 The system shall install a hose bib vacuum breaker at threaded connection in utility room."

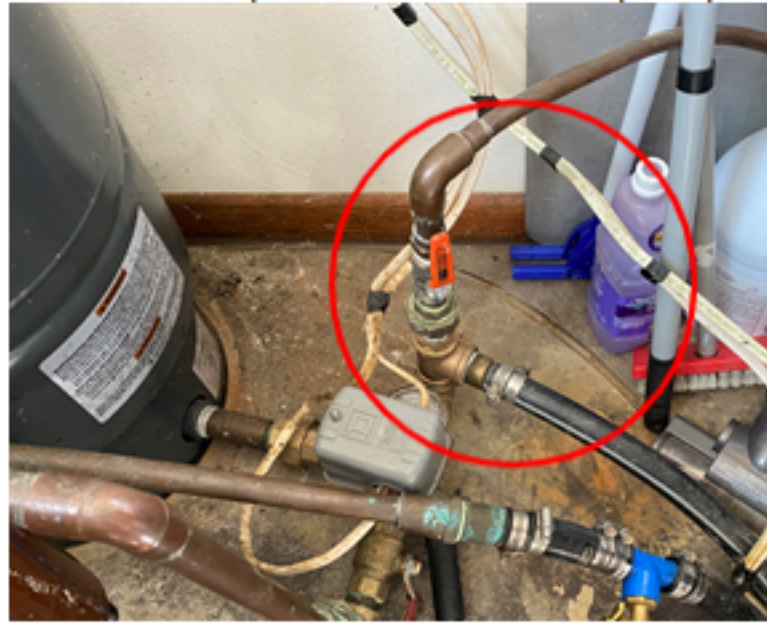
SO17

Deficiency - 327 IAC 8-2.3-2(b)(6)

Inadequate source water sample tap

MIN  
Deficiency

The system is to install a smooth bore sample tap at a location prior to any branches to storage/pressure tanks and any treatment. The tap is to be located at least eighteen (18) inches from the floor, in a location with relatively constant flow and readily accessible. The tap is to be smooth bore with no interior or exterior threads.

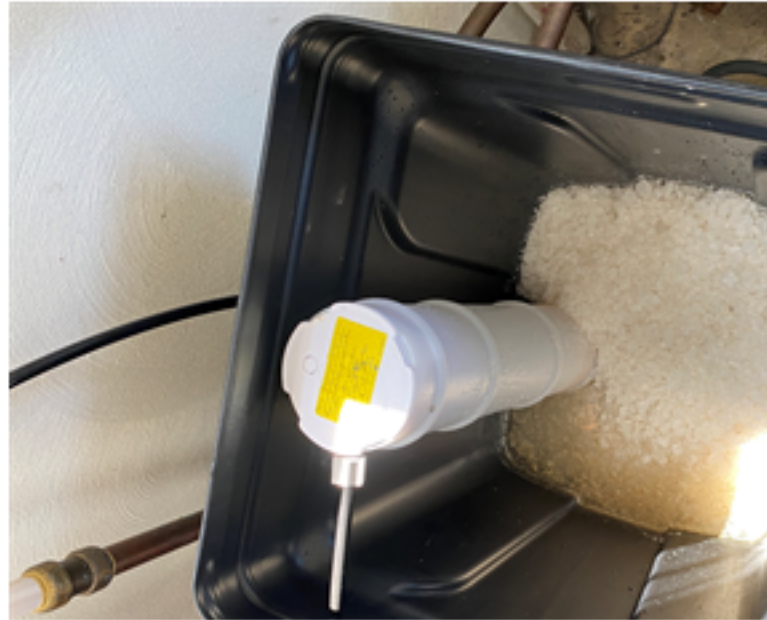
TR10

Deficiency - 327 IAC 8-1-2(b)

All additives are not NSF/ANSI approved

MIN Deficiency

The salt used in the water softener must be NSF certified. The system must provide documentation of the water softener salt certification.

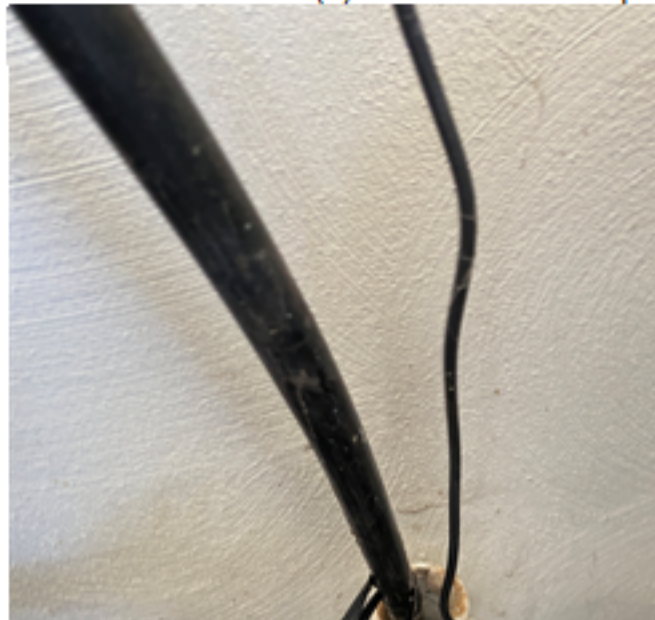
TR11

Deficiency - 327 IAC 8-10

Cross connection(s) in the treatment process

MIN Deficiency

System is to provide an air gap separation on the water softener discharge drain tube to the drain. A minimum of one (1) inch is to be provided.

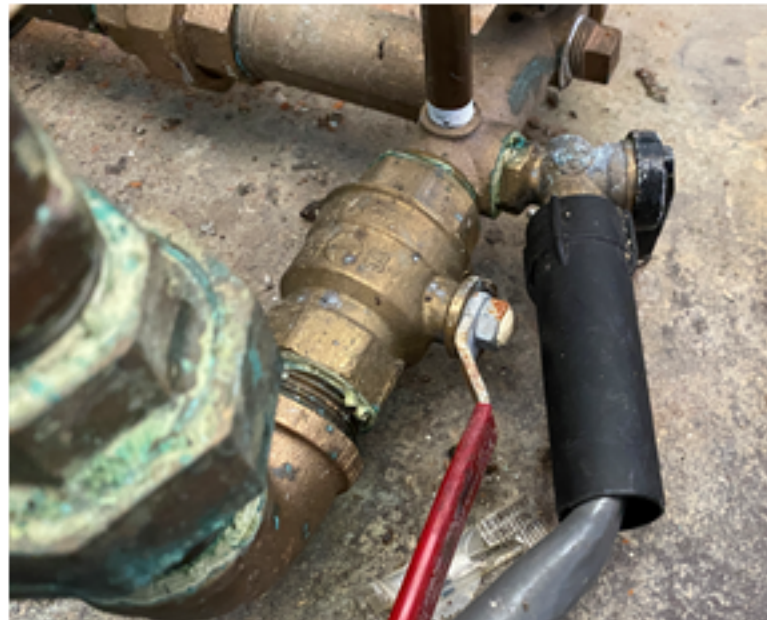
DS09

Deficiency - 327 IAC 8-10

Distribution system is not free from uncontrolled cross connection

MIN Deficiency

The system shall install a hose bib vacuum breaker at threaded connection in utility room.
