Re: Inspection Summary Letter
Ancillary Services, Inc.
PWSID# IN2460078
Michigan City, Laporte County

Type of Inspection: Sanitary Survey Inspection
Primary Inspector: Megan Wright: MEwright@idem.IN.gov or 574-274-5778

Public Water System Sanitary Survey Report

PWS ID: IN2460078 PWS Name: ANCILLARY SERVICES, INC.

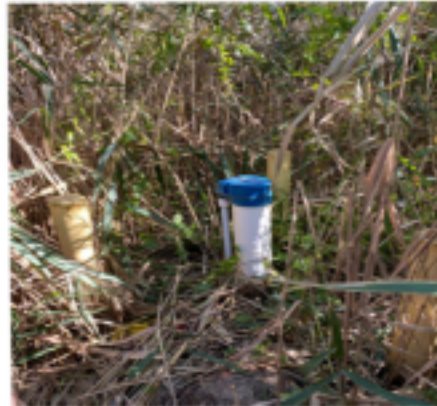
- 1 A **Minor** deficiency was identified regarding: **Top of the well is not protected**

The inspector noted: "Deficiency - 327 IAC 8-2-8.2(e)(1)(G)(iii) Area around well was overgrown with vines and other vegetation. The area immediately around the well must be kept clear of overgrown vegetation."

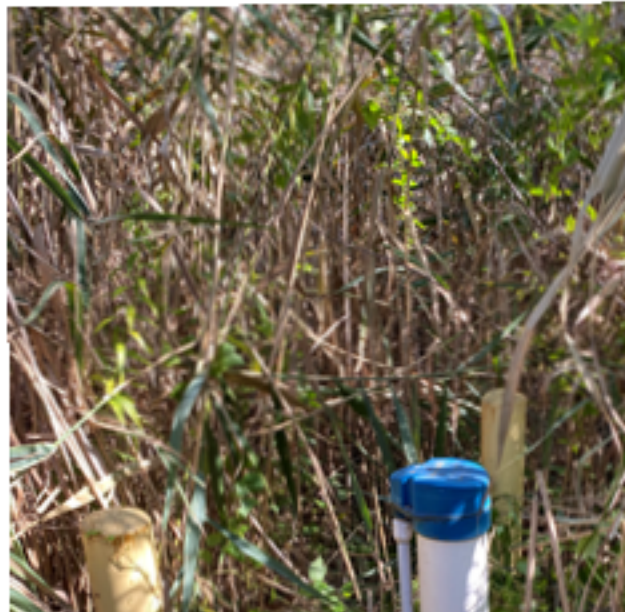
Deficiency - 327 IAC 8-2-8.2{e}{1}{G}{iii)

Area around well was overgrown with vines and other vegetation. The area immediately around the well must be kept clear of overgrown vegetation.

SO04

Top of the well is not protected

MIN Deficiency
