INDIANA DEPARTMENT OF ENVIRONMENTAL MANAGEMENT

Re: Inspection Summary Letter
Oak Wood Circle
PWSID# IN5243064
Pierceton, Kosciusko County

Type of Inspection: Sanitary Survey Inspection
Primary Inspector: Sophia Andrews: SOandrew@idem.IN.gov or 574-274-5610

Public Water System Sanitary Survey Report

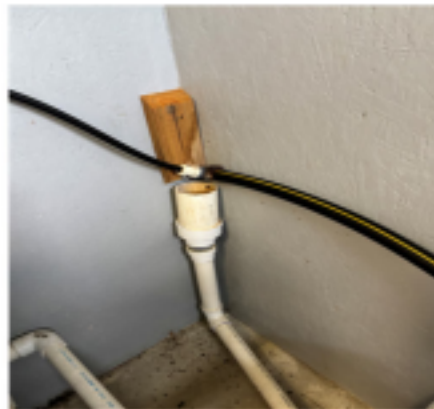
- 1 A **Significant** deficiency was identified regarding: **Cross connection(s) in the treatment process**

The inspector noted: "Deficiency - 327 IAC 8-10 The water softener brine waste line is directly plumbed to the PVC drain pipe to waste. The system is to provide an air gap between the brine waste line and the PVC drain pipe that is a minimum of one (1) inch or they are to install an air gap fitting. As this was also cited on the 2022 inspection report, it is now considered a significant deficiency."

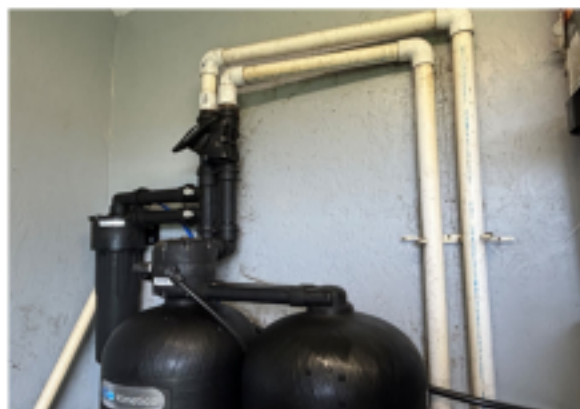
- 2 A **Significant** deficiency was identified regarding: **Sufficient operation and maintenance records are not being kept**

The inspector noted: "Deficiency - 327 IAC 8-2-8.2(e)(7)(E)(i) The system is to utilize a log system to keep track of filter change dates, as well as dates that the softener brine tank is filled and the amount of salt that is added. As this was also cited on the 2022 inspection report, it is now considered a significant deficiency."

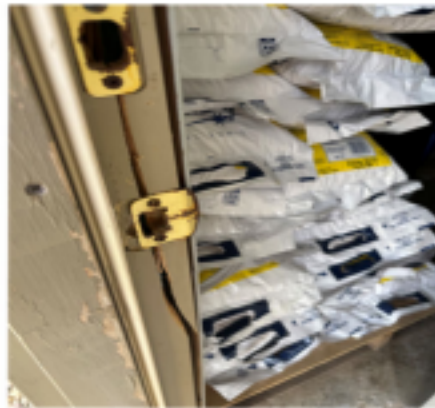
4 A **Minor** deficiency was identified regarding: **Access is not restricted to the treatment plant**

The inspector noted: "Deficiency - 327 IAC 8-2-8.2(e)(4)(F) After the inspection had concluded, it was discovered that the door jamb/casing on the wellhouse is cracked, which compromises the security of the wellhouse to intruders. The system is to repair the door jamb/casing."

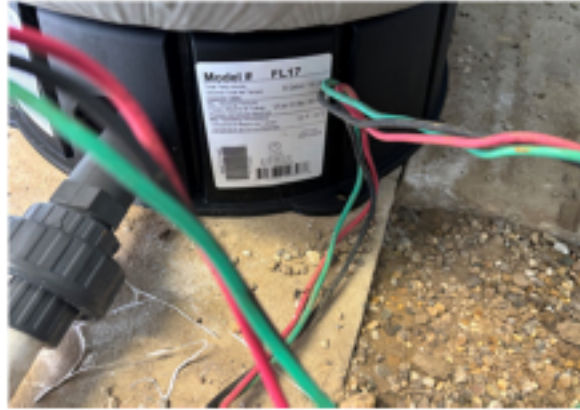
6 A Recommendation deficiency was identified regarding: **Well components are not maintained or operating properly**

The inspector noted: "A Pressure relief valve(s) is not present by the bladder tanks. The system should install a pressure relief valve(s) on the line(s) to the bladder tanks. This device would serve to relieve water and pressure within the system, allowing water to move heat away from the well pump and thus preventing potential damage to the motor, connections, and casing."

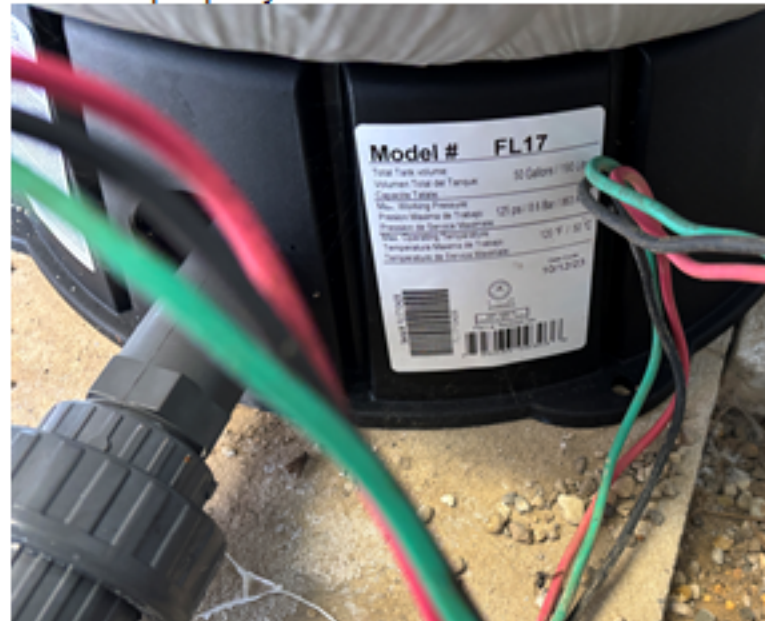
11 Are the pressure and check valves blow off valves and other well system appurtenances maintained and operating properly?

A Pressure relief valve(s) is not present by the bladder tanks. The system should install a pressure relief valve(s) on the line(s) to the bladder tanks. This device would serve to relieve water and pressure within the system, allowing water to move heat away from the well pump and thus preventing potential damage to the motor, connections, and casing.

SO12 Well components are not maintained or operating properly

REC Deficiency

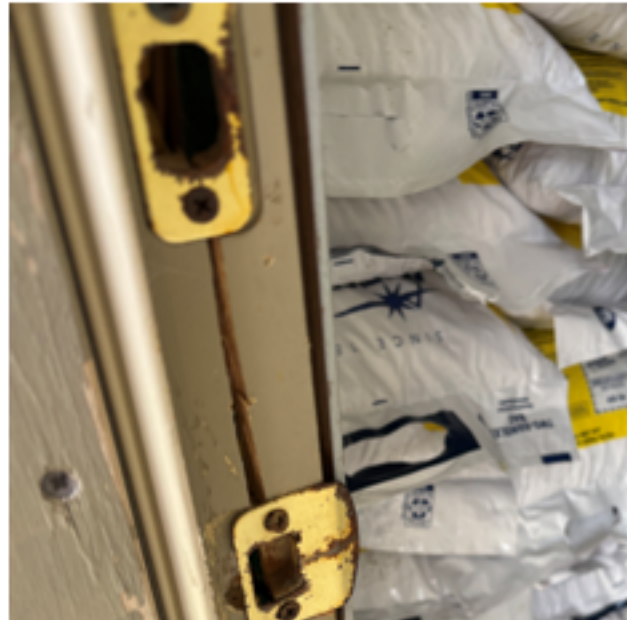
9 Is there restricted access to any unauthorized personnel from any portion of the treatment process?

Deficiency - 327 IAC 8-2-8.2(e)(4)(F) After the inspection had concluded, it was discovered that the door jamb/casing on the wellhouse is cracked, which compromises the security of the wellhouse to intruders. The system is to repair the door jamb/casing.

Access is not restricted to the treatment plant

MIN
Deficiency

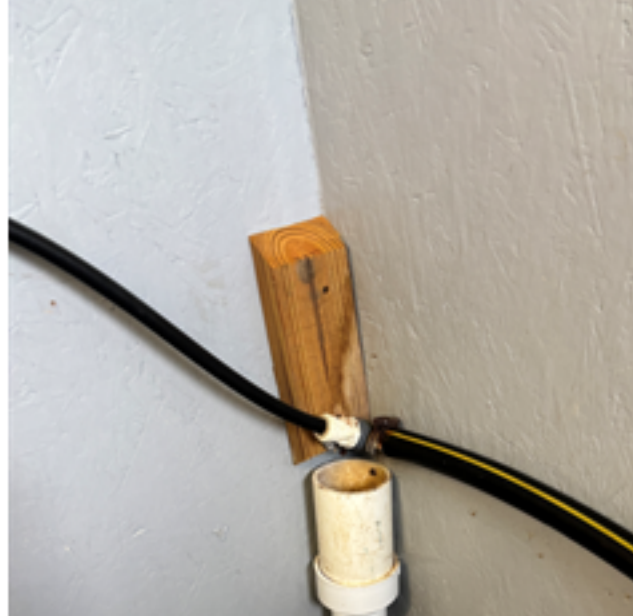
11 **Was the treatment process free from uncontrolled cross connections and are backflow prevention devices installed at all appropriate locations?**

Deficiency - 327 IAC 8-10 The water softener brine waste line is directly plumbed to the PVC drain pipe to waste. The system is to provide an air gap between the brine waste line and the PVC drain pipe that is a minimum of one (1) inch or they are to install an air gap fitting. As this was also cited on the 2022 inspection report, it is now considered a significant deficiency.

Cross connection(s) in the treatment process

SIG
Deficiency

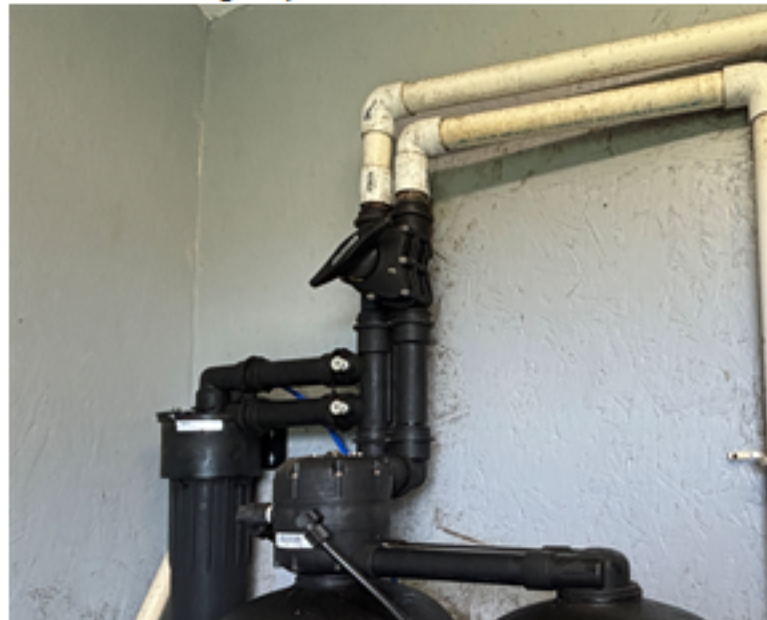
4 Are sufficient operation and maintenance records being kept?

Deficiency - 327 IAC 8-2-8.2(e)(7)(E)(i) The system is to utilize a log system to keep track of filter change dates, as well as dates that the softener brine tank is filled and the amount of salt that is added. As this was also cited on the 2022 inspection report, it is now considered a significant deficiency.

SM04 Sufficient operation and maintenance records are not being kept

SIG Deficiency
