Re: Inspection Summary Letter
Keystone Rv Company - Dutchmen Plant 815
PWSID# IN2200054
Middlebury, Elkhart County

Type of Inspection: Sanitary Survey Inspection
Primary Inspector: Megan Wright: MEwright@idem.IN.gov or 574-274-5778

Public Water System Sanitary Survey Report

PWS ID: IN2200054 PWS Name: KEYSTONE RV COMPANY - DUTCHMEN PLANT 815

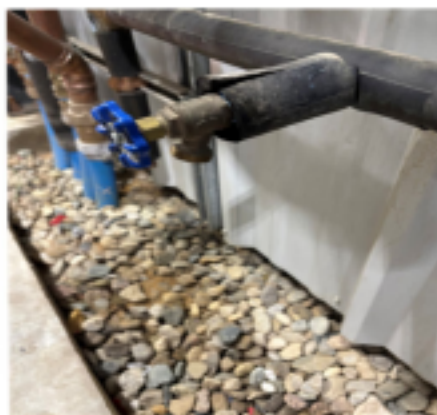
- 2 A **Minor** deficiency was identified regarding: **Inadequate source water sample tap**

The inspector noted: "Deficiency - 327 IAC 8-2.3-2(b)(6) The current source water sample tap is in the correct location, however it is a threaded tap. The system must install a smooth bore sample tap or remove the threads from the current tap."

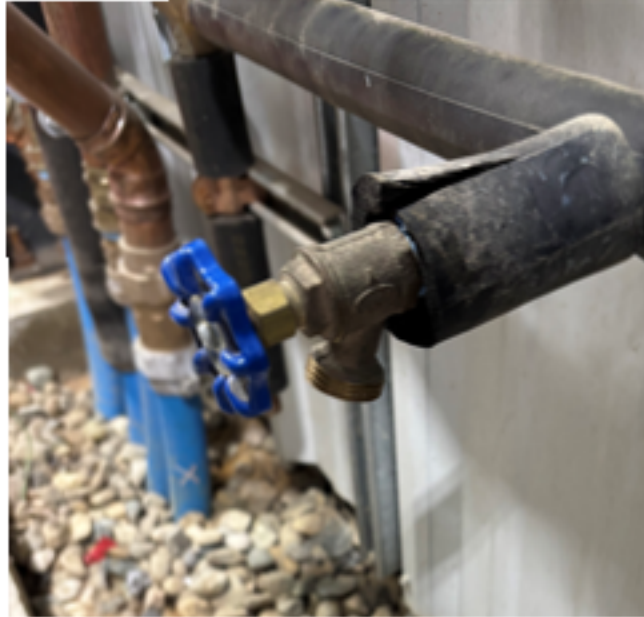
SO17

Deficiency - 327 IAC 8-2.3-2(b)(6)

The current source water sample tap is in the correct location, however it is a threaded tap. The system must install a smooth bore sample tap or remove the threads from the current tap.

Inadequate source water sample tap
