RE: Post Closure Semi-Annual Inspection Report (January 2024)
Pike County Landfill #2 (SW ID: 63-03)

Pike County Landfill II (FP 63-03)

SEMI-ANNUAL POST-CLOSURE INSPECTION REPORT

Date: 1-29-2024 (Monday)

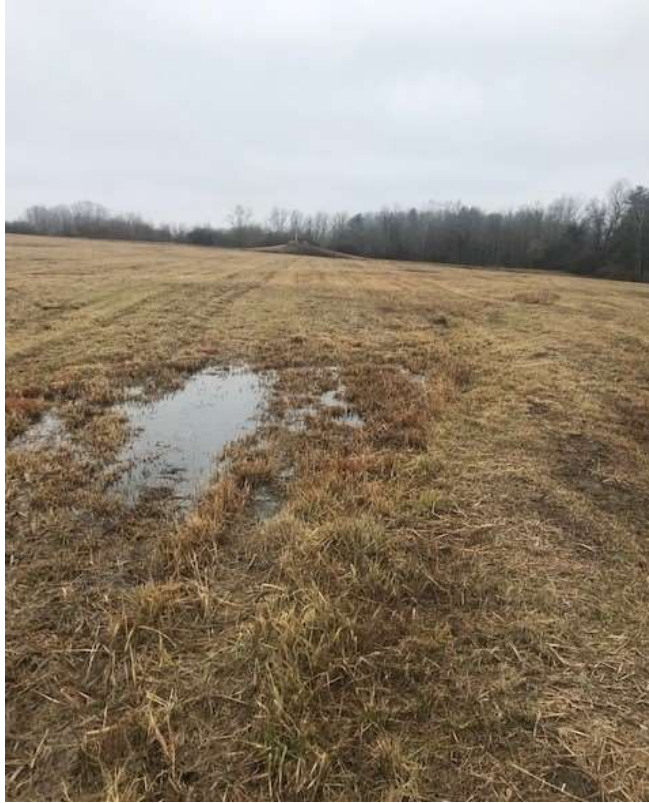
(b) Ponding (Settlement)	Minor*	Minor Along Terrace Flow Line - to be monitored and regraded as needed
(c) Animal Burrows	None Noted	
Vegetation		
(a) Bare or Stressed Areas	None Noted	None - Will reseed areas to be repaired

NOTES: * Heavy rain over weekend

7. View to South Along Landfill Lower Terrace (Minor Ponding)

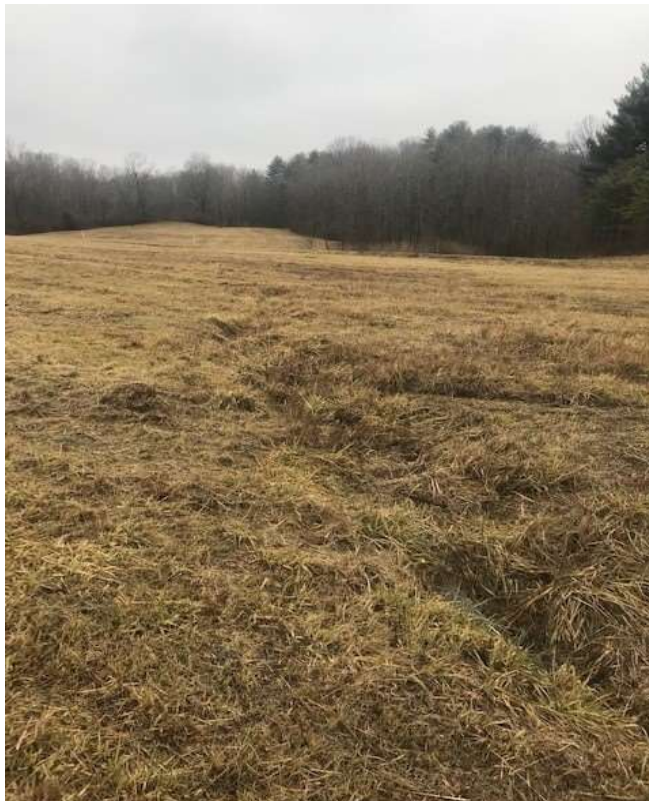
CONDITION	WORK NEEDED
Final Cover Integrity		
(a) Erosion and/or Sediment Damage	No Changes	Minor Erosion Between and along terraces scheduled for repair - currently vegetated

8. View to West - Vegetated/Stabilized Erosion Gully Between Terraces (To Be Repaired)

Landfill has scheduled erosion repairs when conditions allow

Note - LF reported repairs have been completed (May 2024) - will note condition in fall 2024 inspection
