Re: **Violation Letter**  
South Whitetail Way  
Parcel #26-12-07-301-000.604-028  
Princeton, Gibson County

Type of Inspection:	Follow-Up	<b>#112399</b>
Results of Inspection:	Violations were observed (see attached inspection report).

**REPORT OF OPEN DUMP INSPECTION**

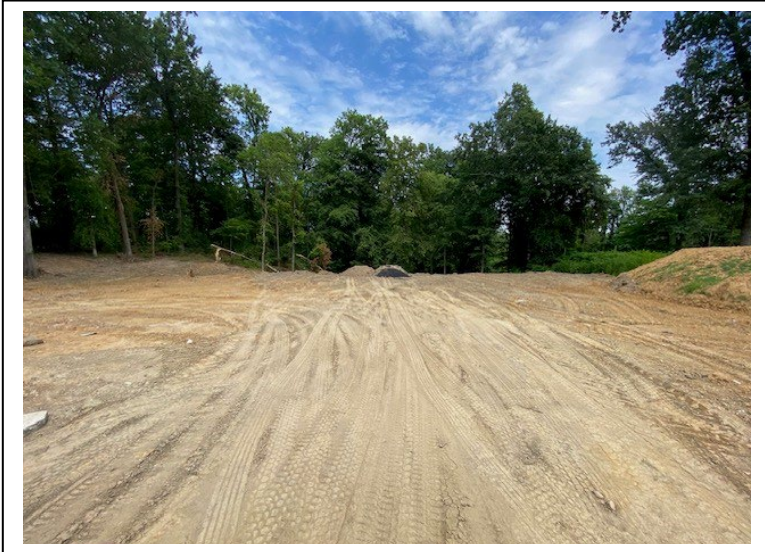
On the eastern side of the site, the large dirt pile seen previously was still present. However, no regulated waste was observed mixed in the pile (Photos 1- 2). An excavator sat on this pile as well.

Photo 1. Picture of the site. Piles of dirt seen in the center and on the left.

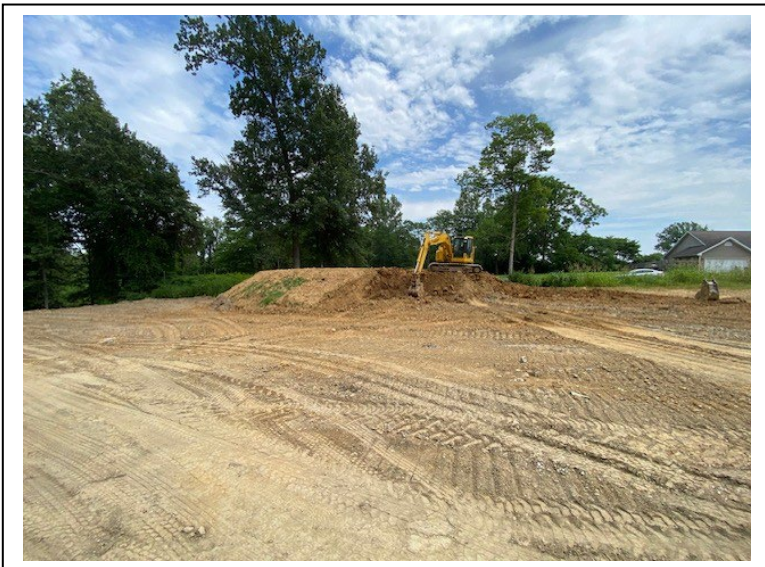
Photo 2. Pile of mixed dirt with excavator on the east side of the site.

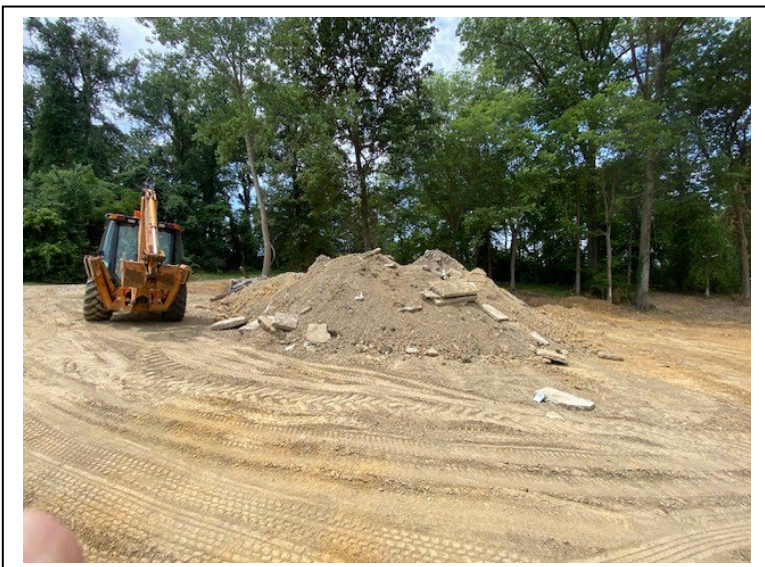
Upon arrival the inspector observed the area had changed. The dirt row that ran along the western side of the area that was filled with painted brick/ concrete debris, rebar, piping, railroad ties, and plastic culvert pieces was no longer there. A large mixed dirt pile containing broken concrete slabs, brick, and rebar was present. However, no painted concrete or brick was observed in this pile. An excavator sat next to this pile as well (Photos 3-8).

Photo 3. Mixed dirt pile and excavator on the west side of the site. Broken concrete slabs seen.

**Required Action:** It is the responsibility of the property owner to ensure that all dumping is stopped immediately and that the solid waste is removed and disposed of properly at a state approved solid waste management facility. Failure to do so will result in continued noncompliance with the Indiana rules regarding open dumping and may result in a referral to IDEM's Office of Land Enforcement. Documentation of proper disposal must be provided to the IDEM Solid Waste Compliance Inspector.

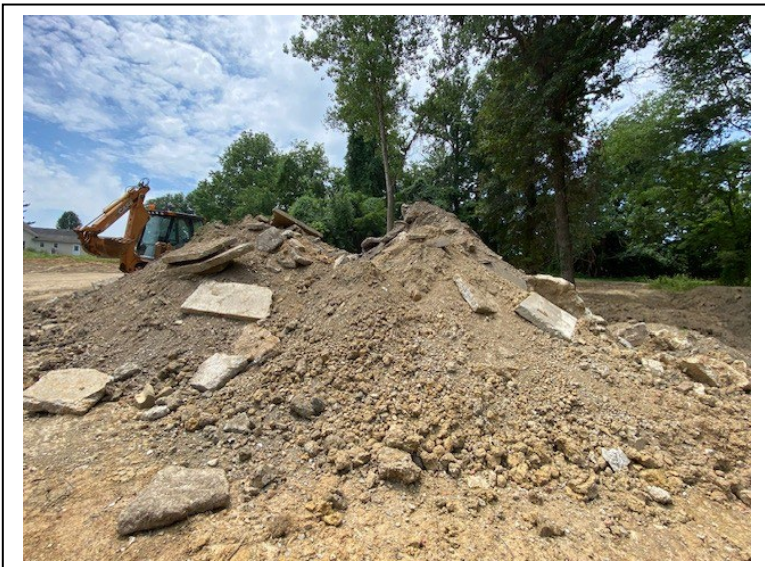
Photo 4. Closer look at the concrete pieces seen in the pile. Scrap metal sticking out at the top.

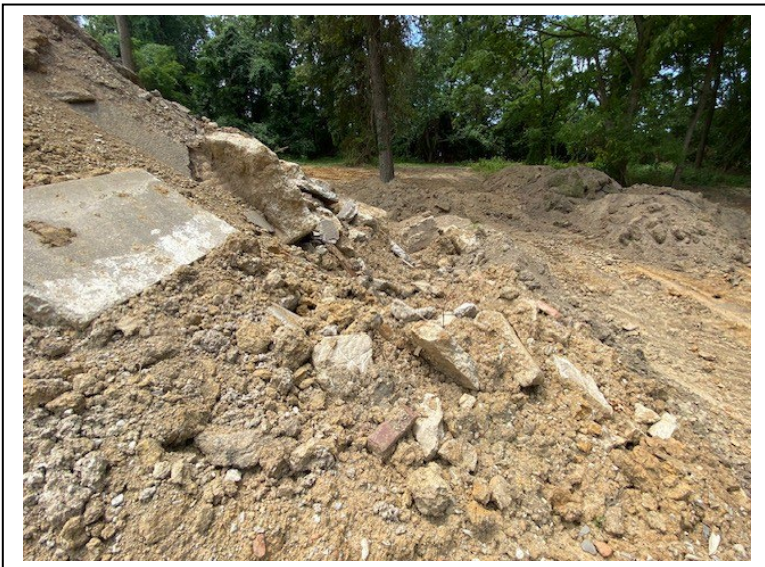
Photo 5. Picture of the base of the pile. Broken brick, concrete, and rebar seen.

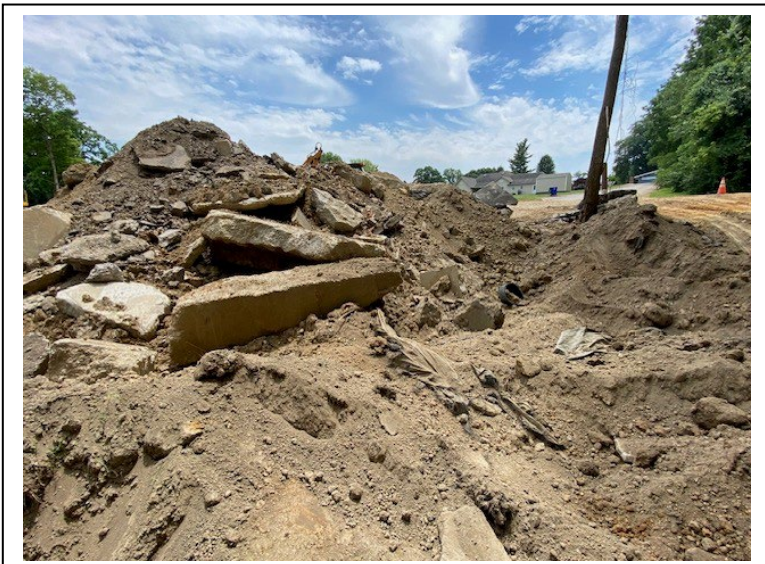
Photo 6. The backside of the pile. Plastic tarping, plastic culvert pieces, and scrap wood seen in the dirt as well.

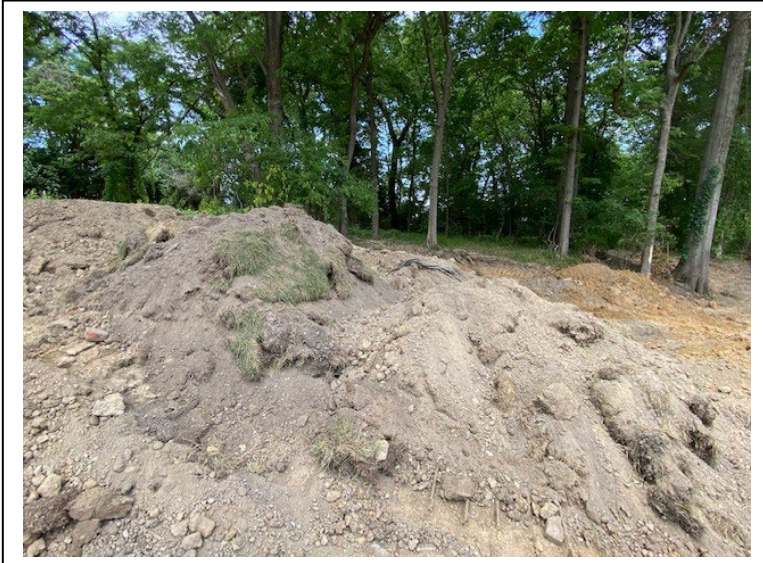
Photo 7. Dirt pile with plastic debris mixed in seen behind the previous pile.

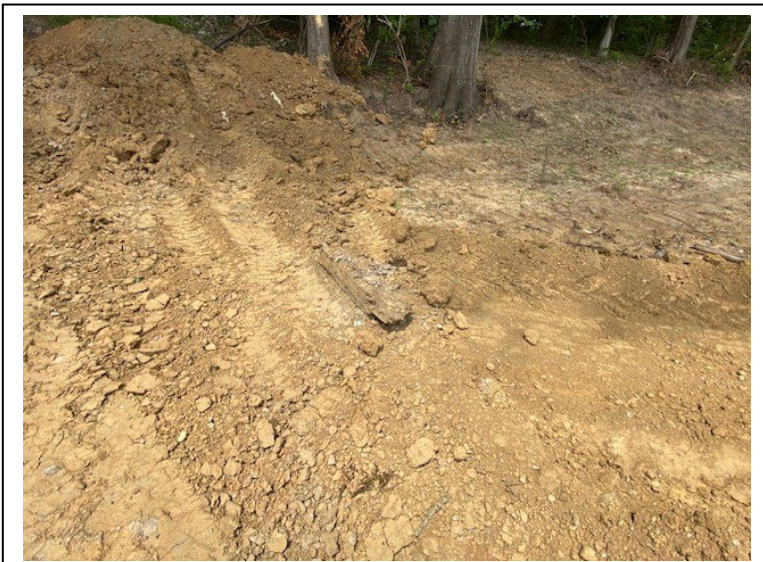
Photo 8. Piece of rail tie seen at the base of the previous dirt pile.

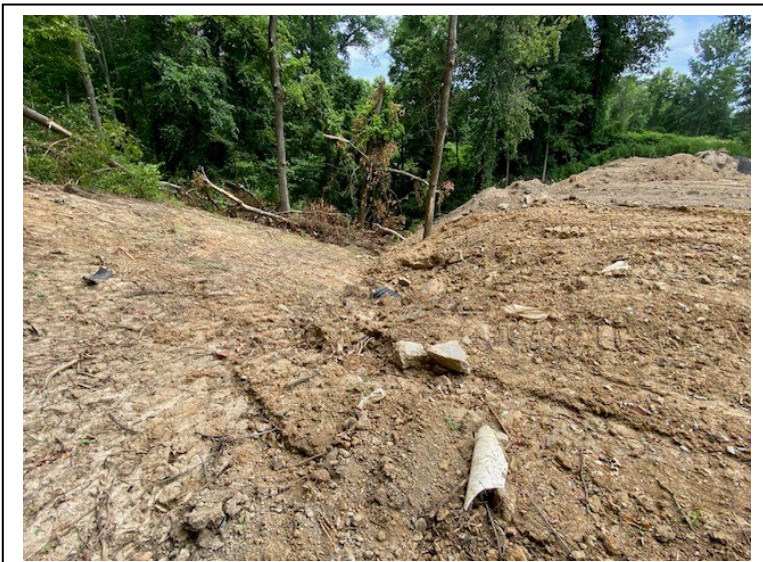
The inspector then walked down a path that was made by the excavators to see further down into the ravine. While walking down, the inspector observed plastic piping, and plastic culvert pieces in the dirt. At the bottom the inspector observed concrete slabs, cinderblocks, and scrap wood pieces. It was at this time the inspector looked over the cascading slope from all the mixed dirt that had been dumped on the site. The inspector observed black plastic tarping, scrap metals, plastic culvert pieces, and broken concrete pieces (Photos 9-13).

Photo 9. Plastic piping, culvert, metals, and pieces of concrete seen at the top of the slope next to the descending path.

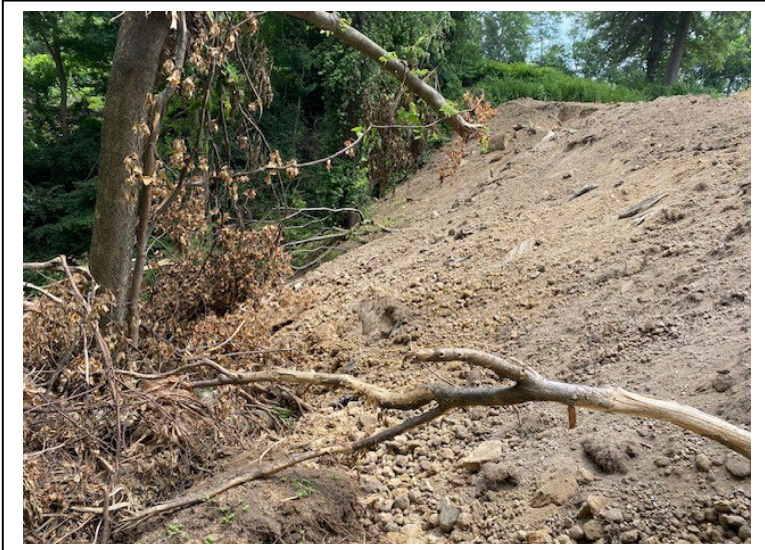
Photo 10. Picture of the slope going down into the ravine. Whole/broken cinderblocks are seen at the bottom.

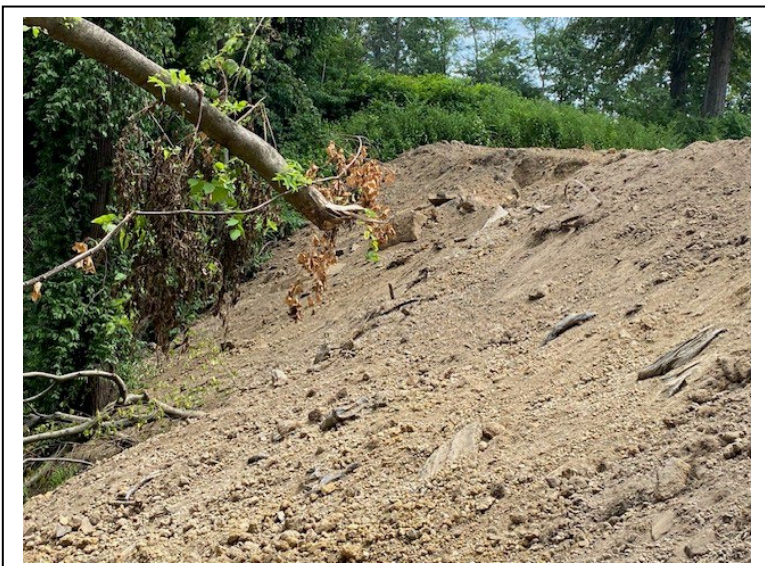
Photo 11. Closer look of the slope. Black plastic tarping pieces, scrap metals, and wood sticking out of the slope.

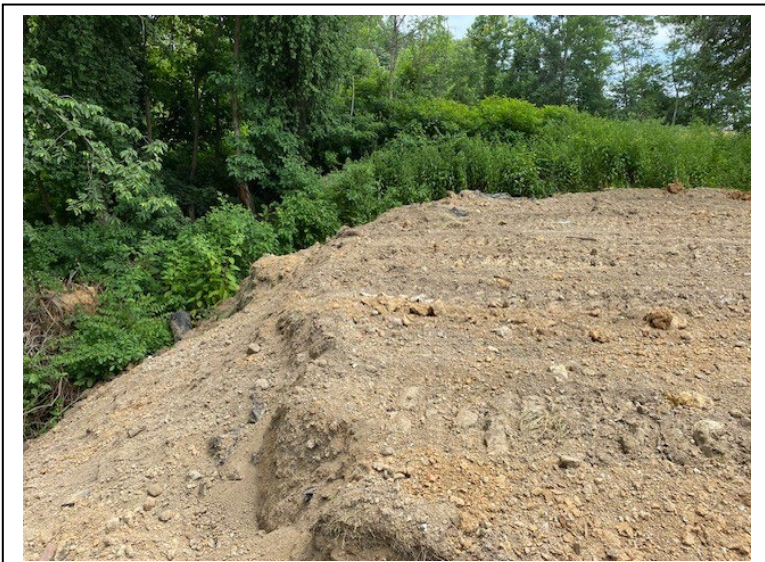
Photo 12. Top of the slope. Plastic culvert pieces, and tarping seen.

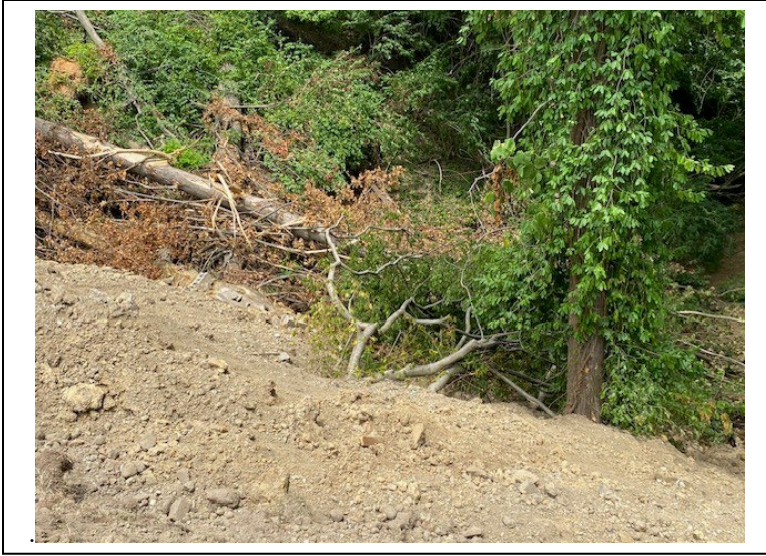
Photo 13. Another picture of the whole/broken cinderblocks at the bottom of the ravine.
