Re: Violation/Inspection Summary Letter
Solid Waste Program ID 57-UP-07

**INDIANA DEPARTMENT OF ENVIRONMENTAL
MANAGEMENT
OFFICE OF LAND QUALITY**
Follow-up Inspection

EPA ID NUMBER: Non-notifier
NAME: Garrett, LLC Monofill
ADDRESS: 200 West Ohio Street
CITY & COUNTY: Kendallville, Noble
INSPECTION DATE: June 11, 2024
INSPECTOR(S): Troy South, Kim Vedder, Michelle Lu
ALSO IN ATTENDANCE: N/A

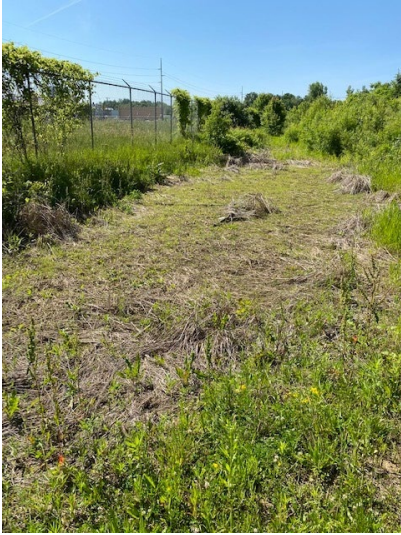
Photo 1

Location & Description: East side area has no surface water at time of inspection.

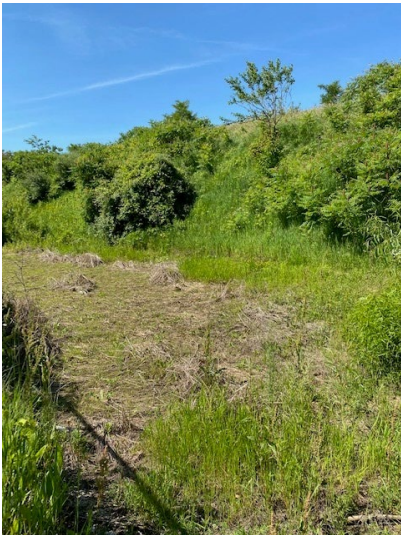
Photo 2

Location & Description: East side slope vegetation and formerly ponded low spot.

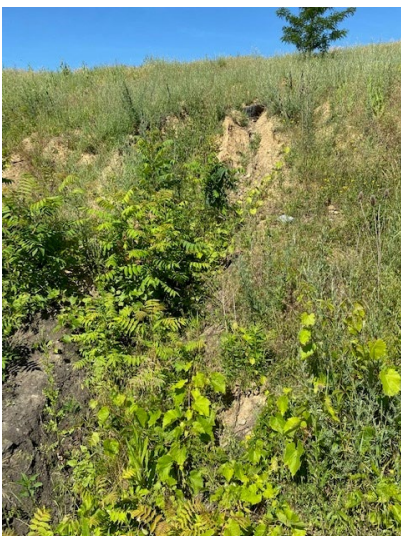
Photo 3

IDEM staff began a tour near the access road entrance located on the east side of the monofill (See Photo Log, Photo 1 through 4). Deep erosion of the soil cover, exposed foundry waste, trees, and bushes were found on the east side slope of the monofill. The silt fencing has also collapsed along the east side slope. No ponding of water was seen near the east perimeter fence during this inspection. However, liquid seeps were observed further up the access road (See Photo 5).

Location & Description: East side slope erosion with exposed foundry waste and silt fence down.

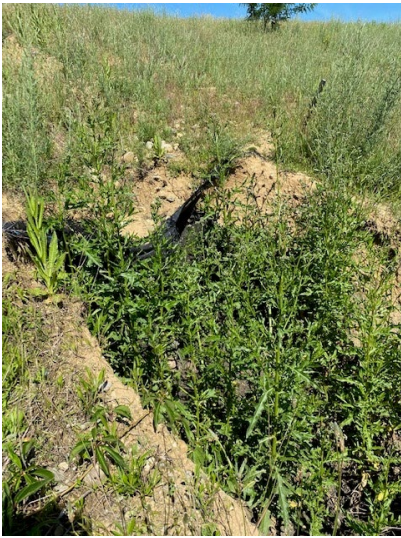
Photo 4

Location & Description: East side slope has deep erosion cut.

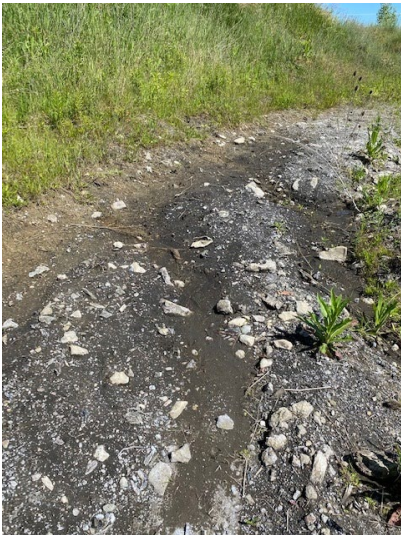
Photo 5

Status Update: *A suspected leachate seep was observed on the east access road and some standing liquid was seen at the lower northeast corner of the fill area. Erosion of side slopes cover and exposed waste were found throughout the Monofill.*

Location & Description: Areas of liquid seeps and foundry waste were observed on the access road of the east side.

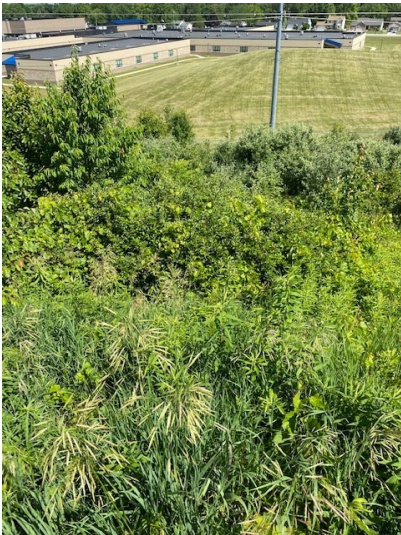
Photo 6

IDEM staff walked toward the north slope and observed trees/bushes growing and an animal burrow (See Photos 6 through 9). Staff continued to the west side slope and noted trees/bushes, collapsed silt fencing, and deep soil erosion cuts (See Photos 10 through 13). Areas of bare ground were also observed along with rocks and gravel in the soil cover of this area.

Location & Description: Trees, bushes, and vegetation on north side slope.

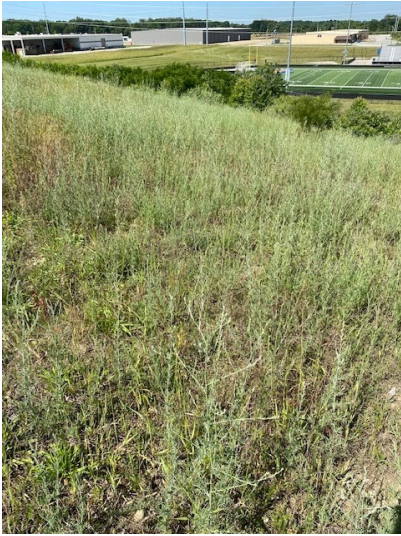
Photo 7

Location & Description: Vegetation on northwest slope.

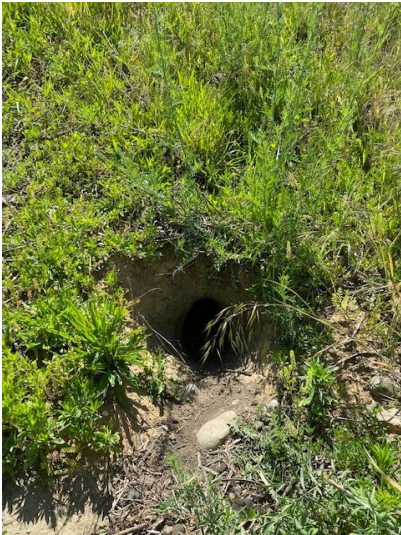
Photo 8

Location & Description: Northwest side slope animal burrow.

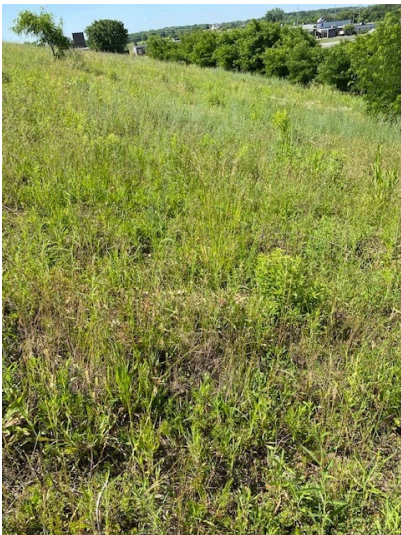
Photo 9

Location & Description: Trees, bushes, and vegetation on the west slope.

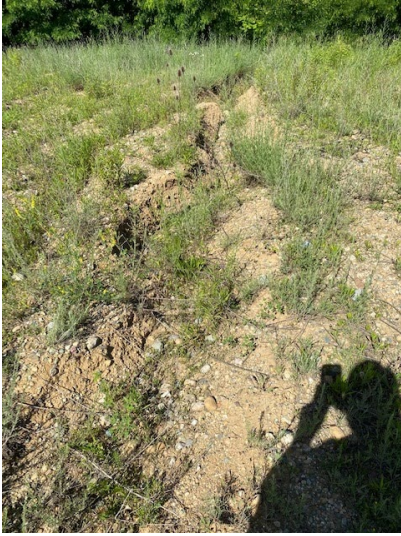
Photo 10

Location & Description: West side slope has deep cuts in the cover and bare spots. Soil contains rocks and gravel.

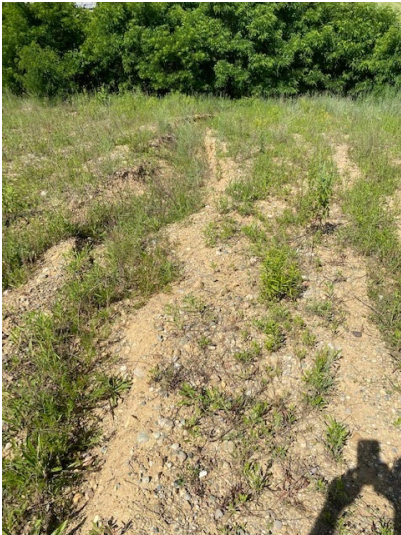
Photo 11

Location & Description: Another area of the west side slope has deep cuts in the cover and bare spots. Trees growing at bottom of slope.

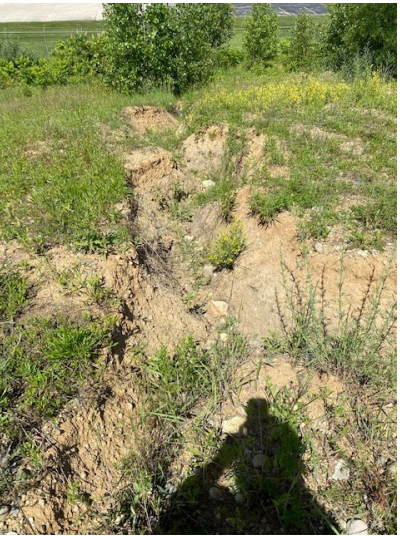
Photo 12

Location & Description: Soil erosion cut seen on southwest slope.

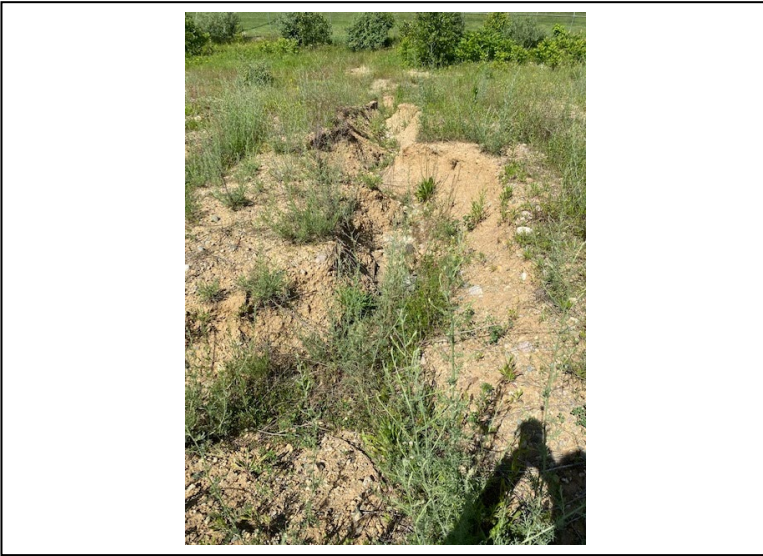
Photo 13

Location & Description: Soil erosion cut seen on southwest slope.

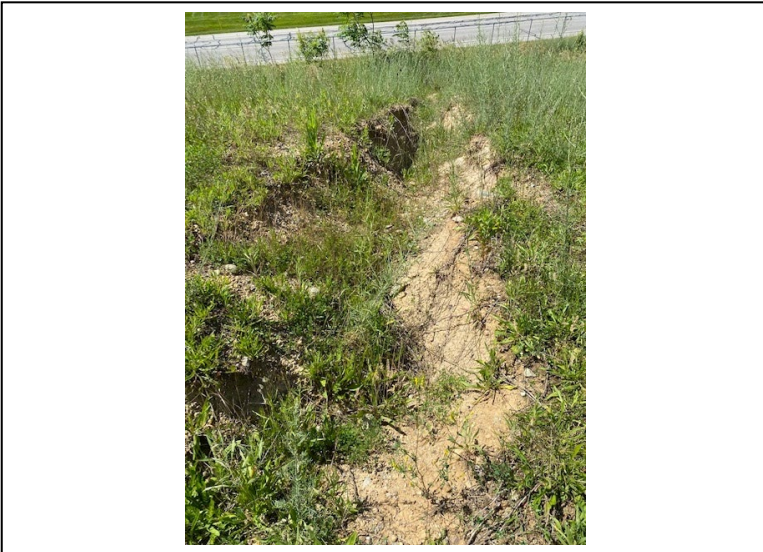
Photo 14

IDEM staff proceeded to the south end of the monofill near Ohio Street and found deep cuts in the soil cover, exposed foundry waste, trees, bushes, and silt fence not being maintained (See Photos 14 through 17). Additional erosion was found on the east side slope area (See Photo 18).

Location & Description: South side slope has deep erosion and exposed waste.

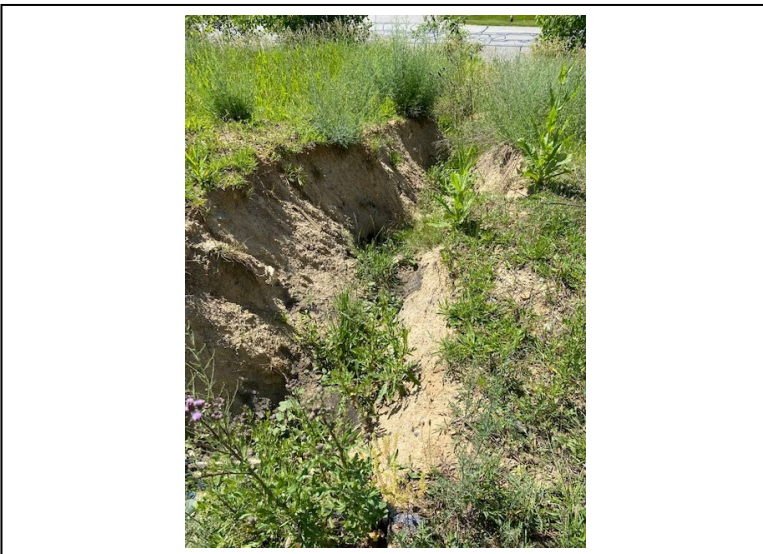
Photo 15

Location & Description: South side slope has deep erosion and exposed waste.

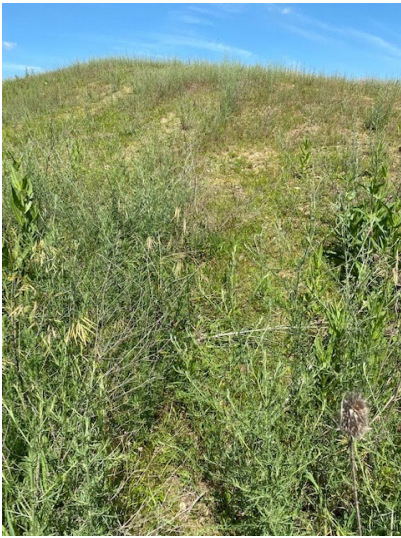
Photo 16

Location & Description: Southeast corner slope vegetated cover.

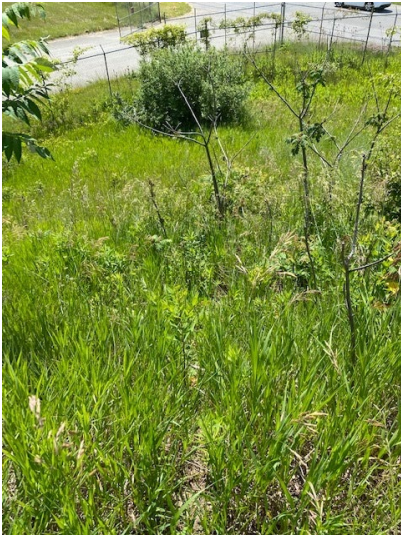
Photo 17

Location & Description: Southeast slope.

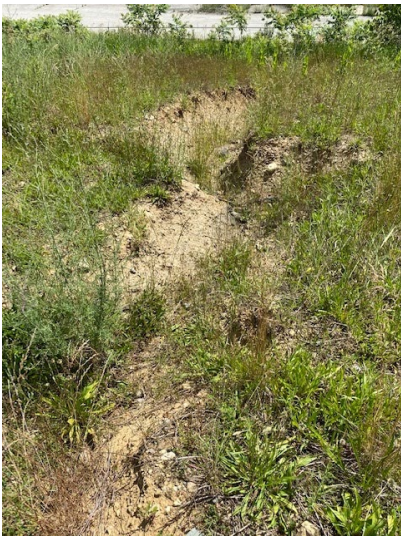
Photo 18

Location & Description: Additional soil erosion seen on east side slope.

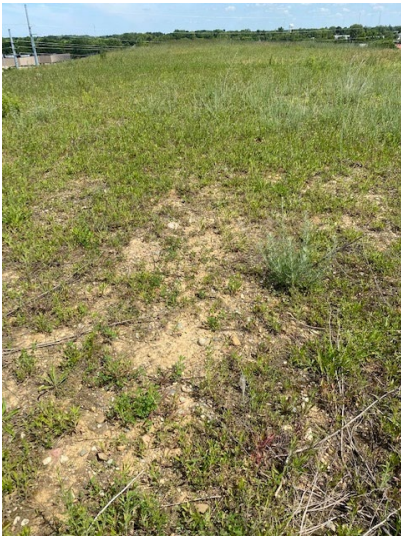
Photo 19

The inspection continued at the top elevation. The cover is composed of soil, gravel, and rocks with thinning vegetation (See Photos 19 and 20). No erosion cuts were found on top. IDEM staff walked back down the access road on the north side and observed foundry waste consisting of iron chunks and sand on the road (See Photo 21).

Location & Description: Cover on the top elevation with thinning vegetation northerly view. The soil contains rocks and gravel.

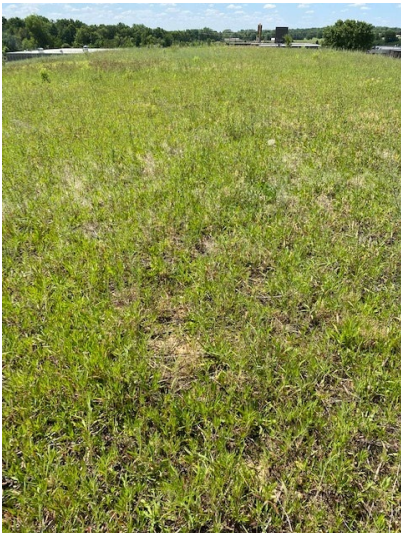
Photo 20

Location & Description: Cover on the top elevation southerly view.

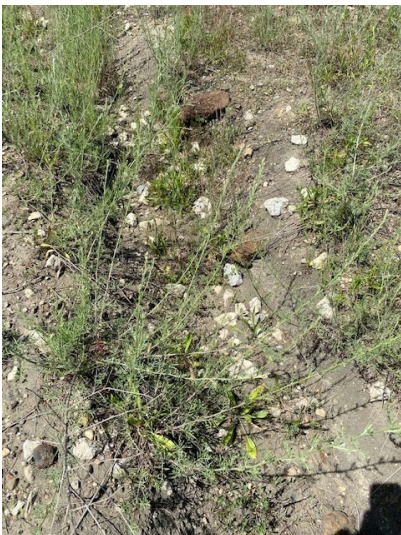
Photo 21

Location & Description: Foundry waste iron scrap, slag, and sand seen on the north access road.
