AGRICULTURE AND SOLID WASTE COMPLIANCE

State Form 47272 (R3/12-08)
INDIANA DEPARTMENT OF ENVIRONMENTAL MANAGEMENT

<u>File:</u>	<u>County:</u> Floyd	<u>Type of Report:</u> Construction		
<u>Name of Inspector:</u> Mike Sonnefeld		<u>Date of Inspection:</u> June 19, 2024	<u>Time In:</u> 9:45 am	<u>Time Out:</u> 12:15 pm
<u>Name of Facility:</u> Duke Gallagher CCR			<u>Permit:</u> 22-UP-01	
<u>Mailing Address:</u> 139 E 4 th St Cincinnati, OH 45202		<u>Location:</u> 30 Jackson St New Albany, IN 47150

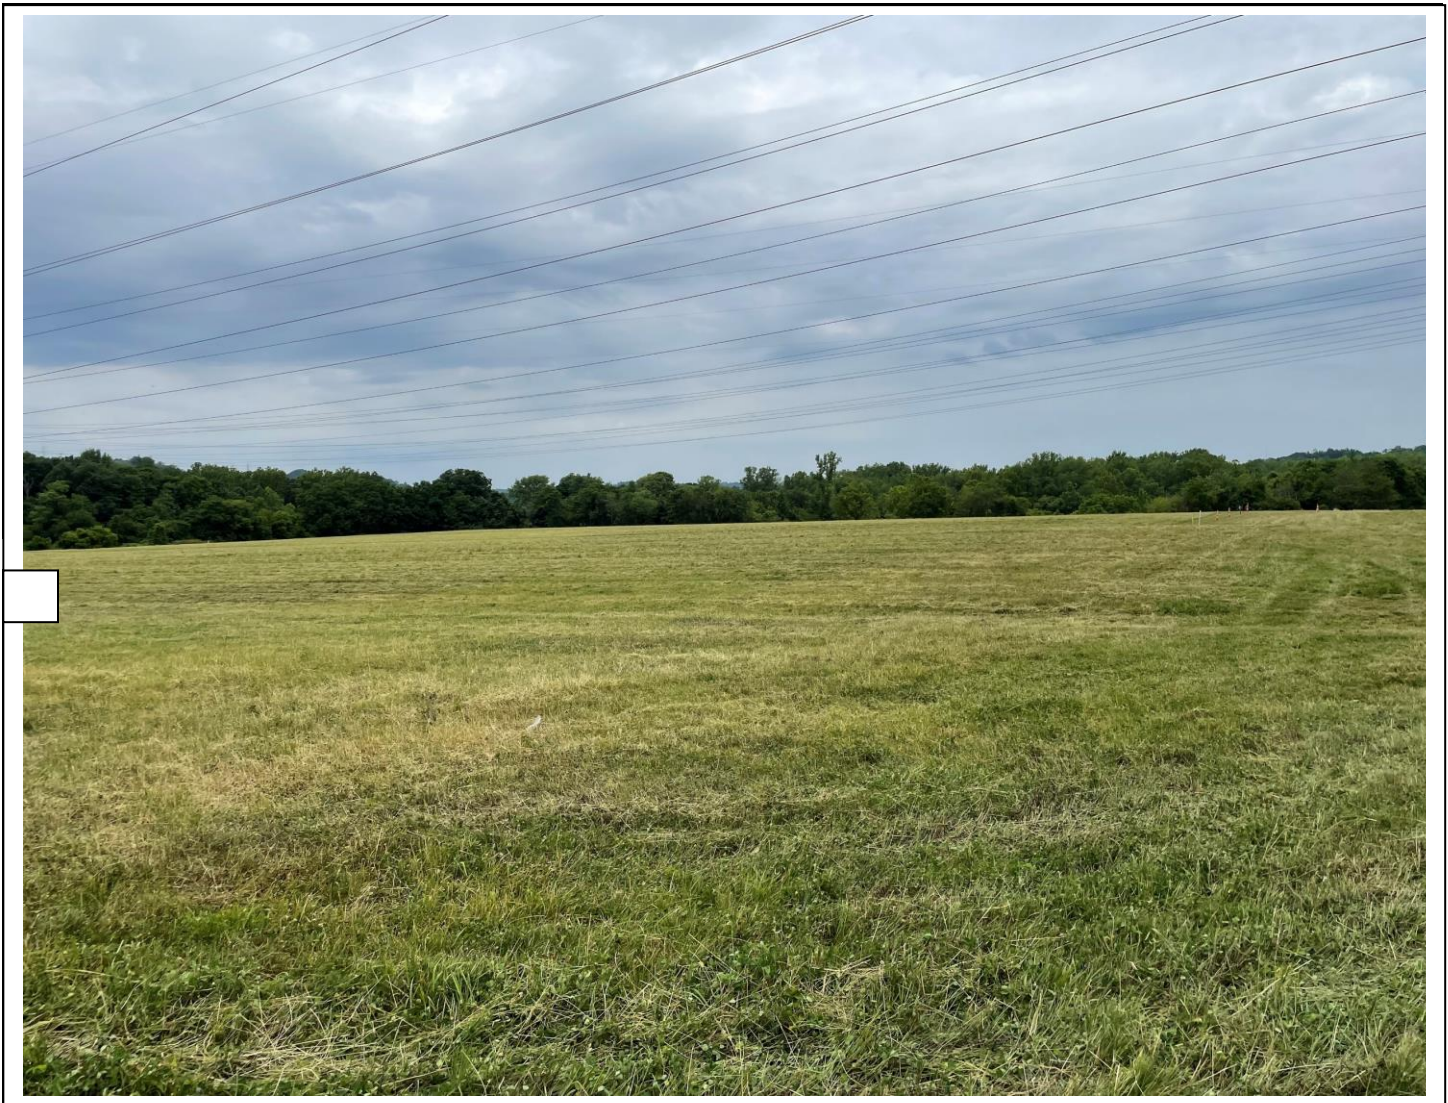
The pond was closed in place by installing a geomembrane micro drain and an 8 oz./yd² geotextile, cover soils, vegetation and toe of slope perimeter drain.

Number	1
	Description	North Ash Pond South end looking north at vegetation on the covered pond.
	Photographer	Mike Sonnefeld
	Facility Name	Gallagher CCR
	Photo Date	June 19, 2024
	Others

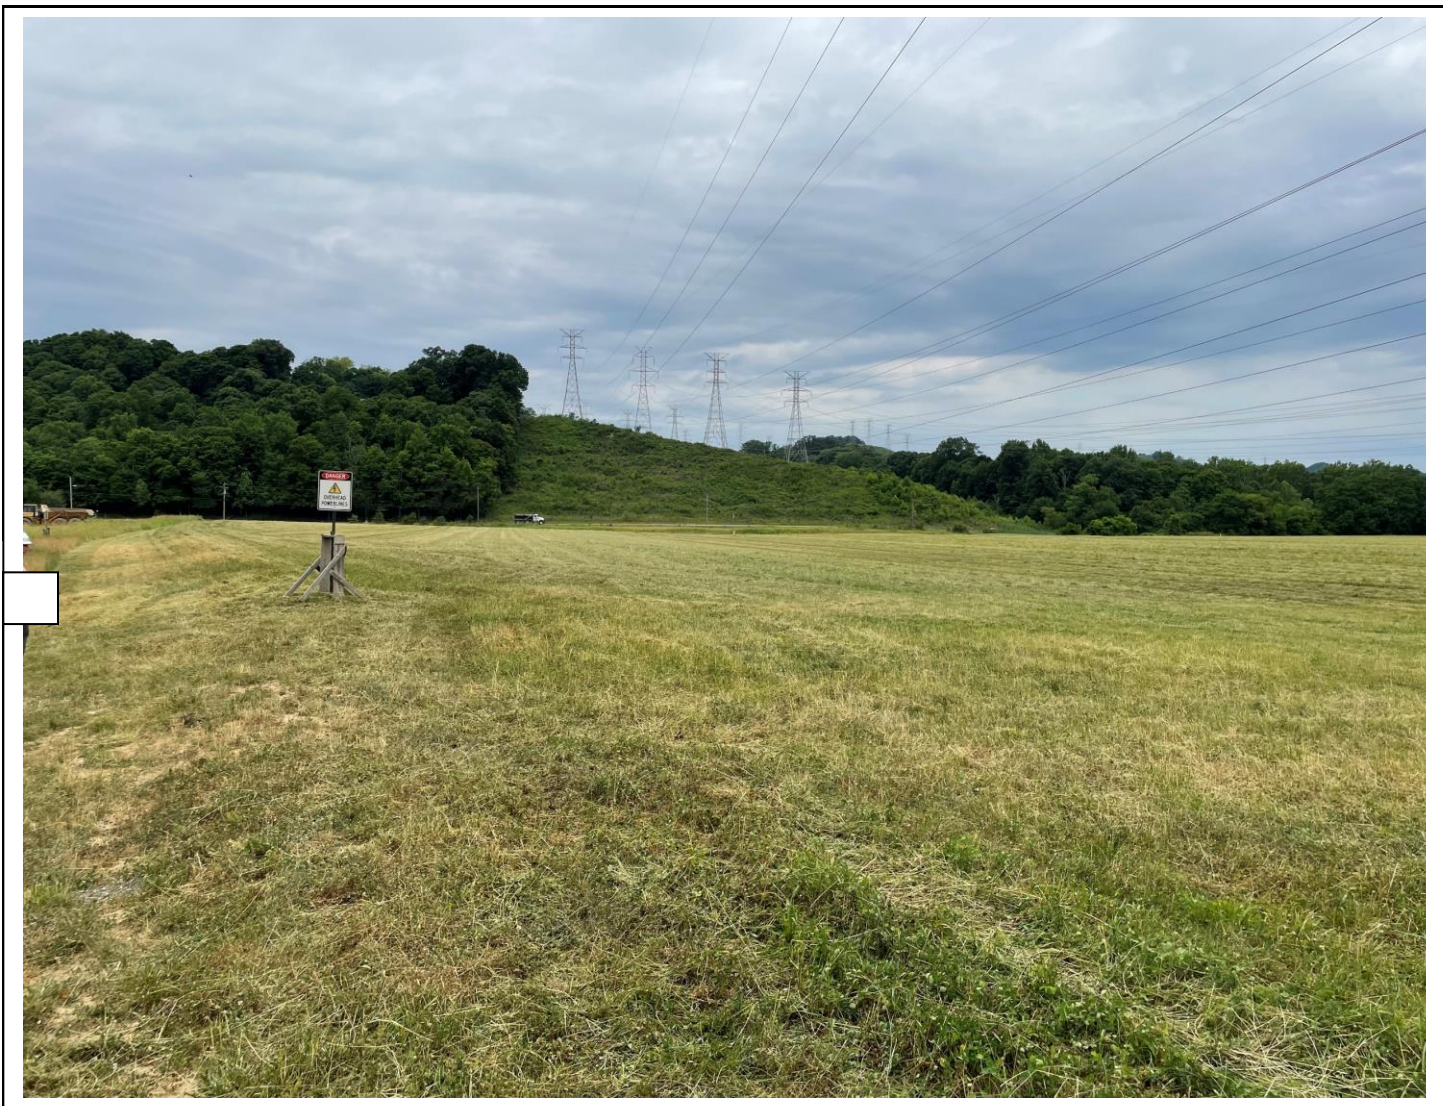
Number	2
	Description	<u>North Ash Pond</u> SE corner looking west at vegetation on the south edge of the covered pond.
	Photographer	Mike Sonnefeld
	Facility Name	Gallagher CCR
	Photo Date	June 19, 2024
	Others

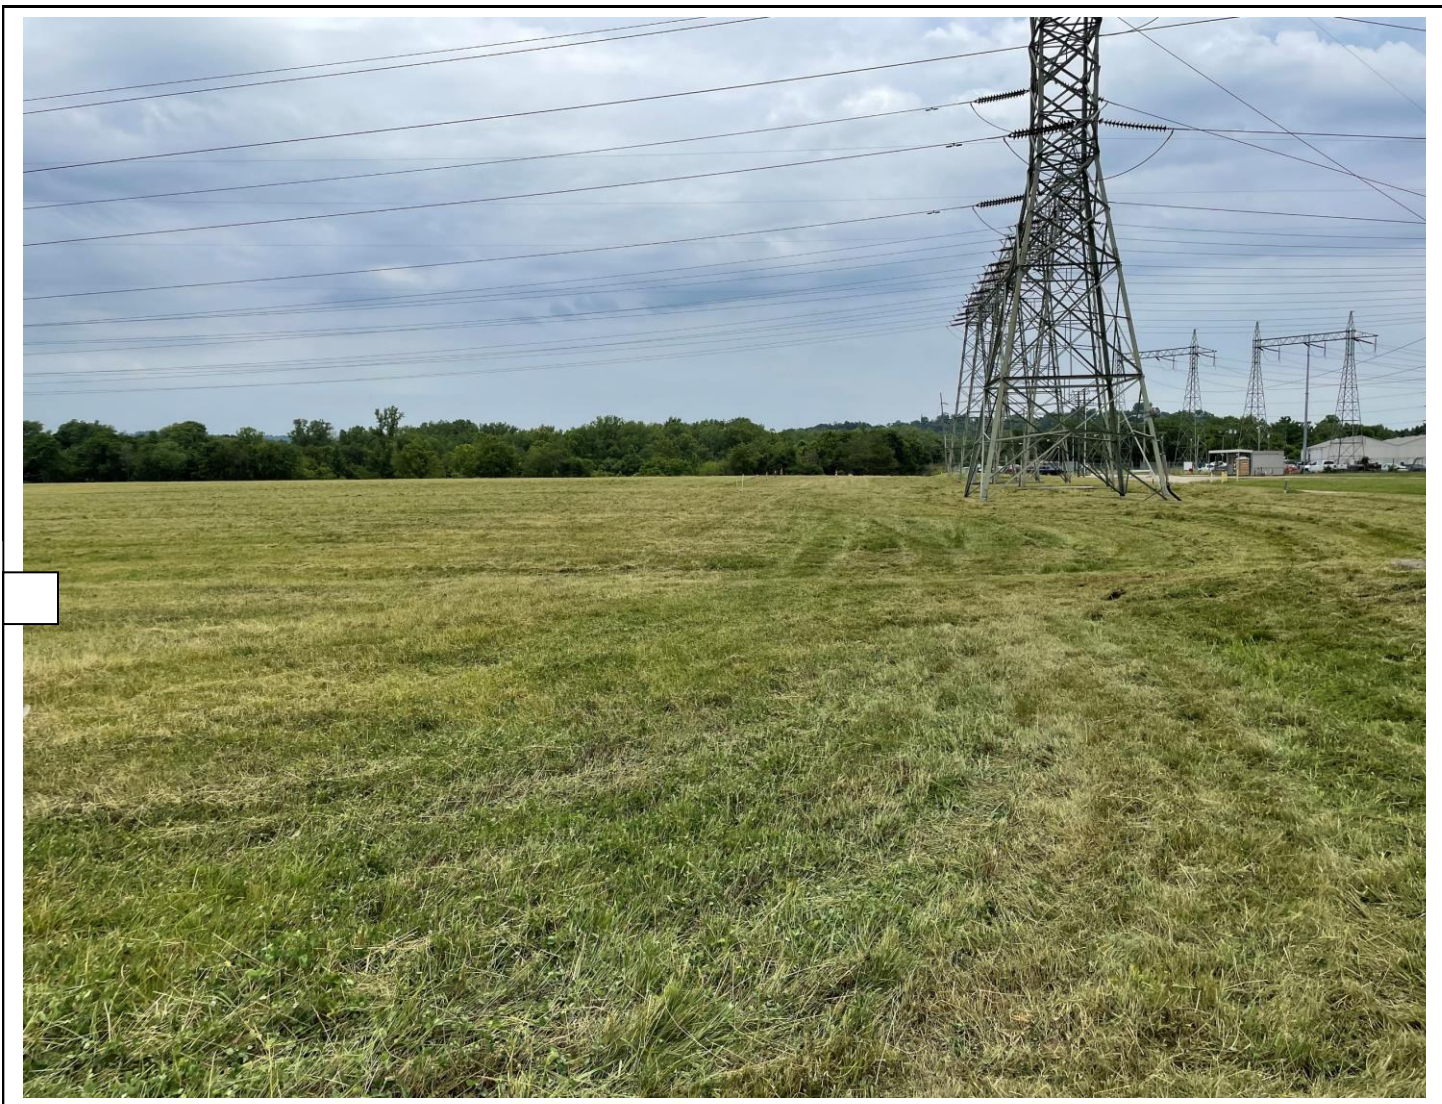
Number	3
	Description	North Ash Pond SE corner looking north at vegetation on the east edge of covered pond.
	Photographer	Mike Sonnefeld
	Facility Name	Gallagher CCR
	Photo Date	June 19, 2024
	Others

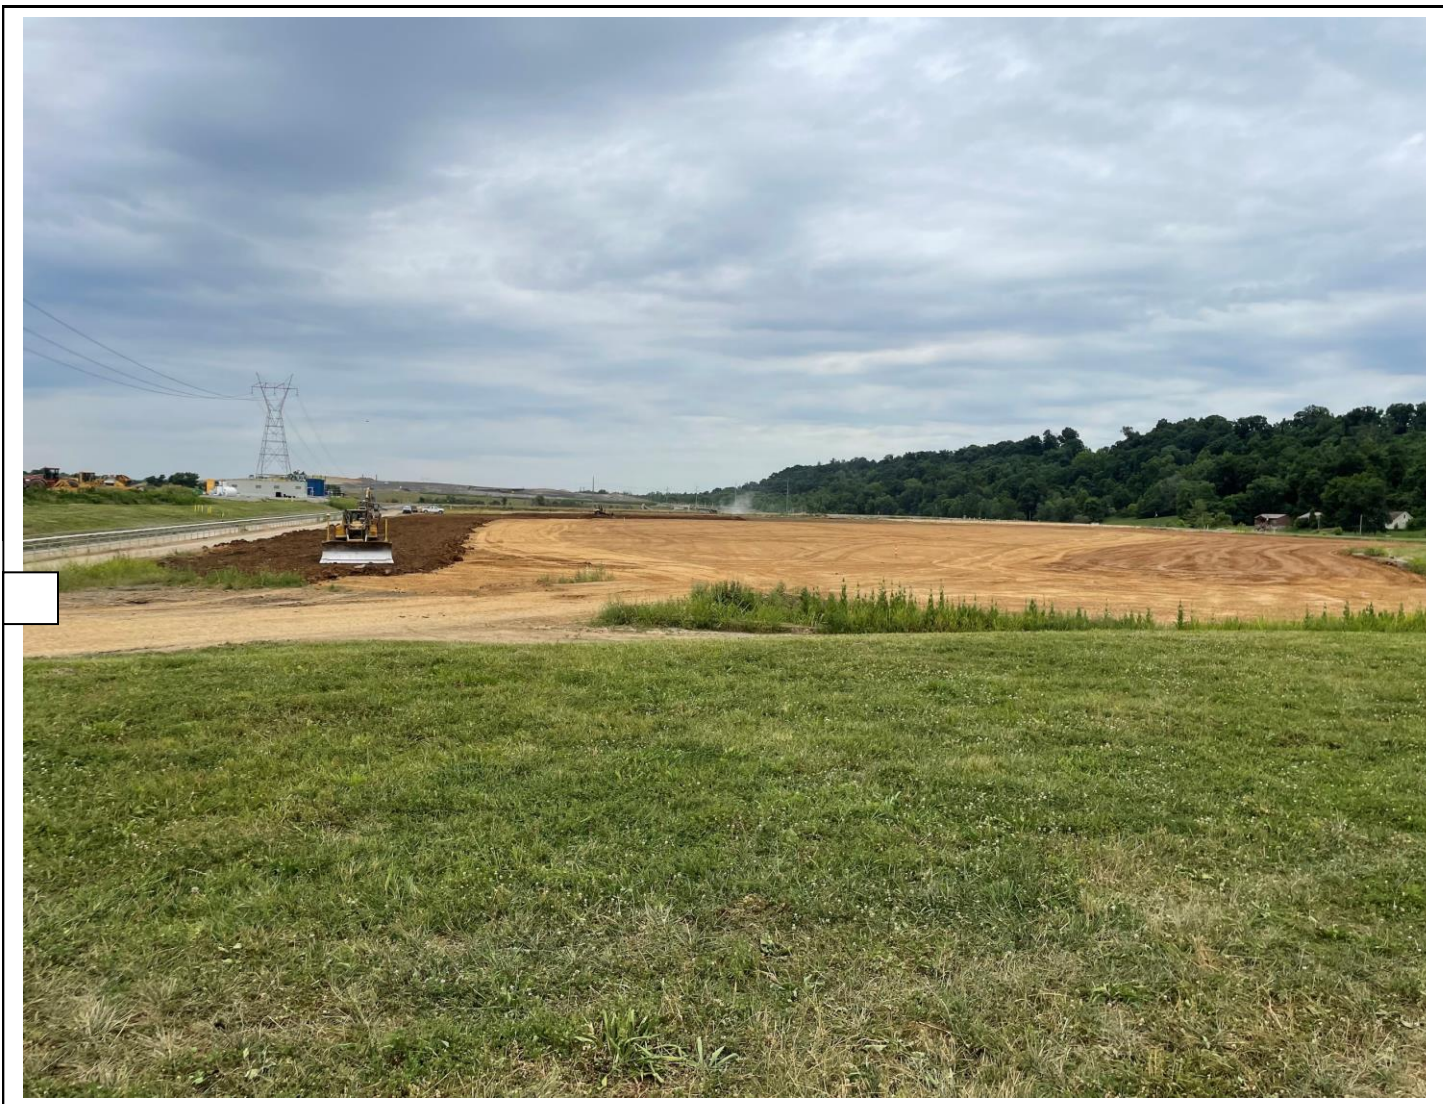
Current activities at both of these ponds include dewatering and placing soil fill.

Number	4
	Description	<u>Primary Pond</u> Standing off of the north end of pond looking south soil fill placed in the pond.
	Photographer	Mike Sonnefeld
	Facility Name	Gallagher CCR
	Photo Date	June 19, 2024
	Others

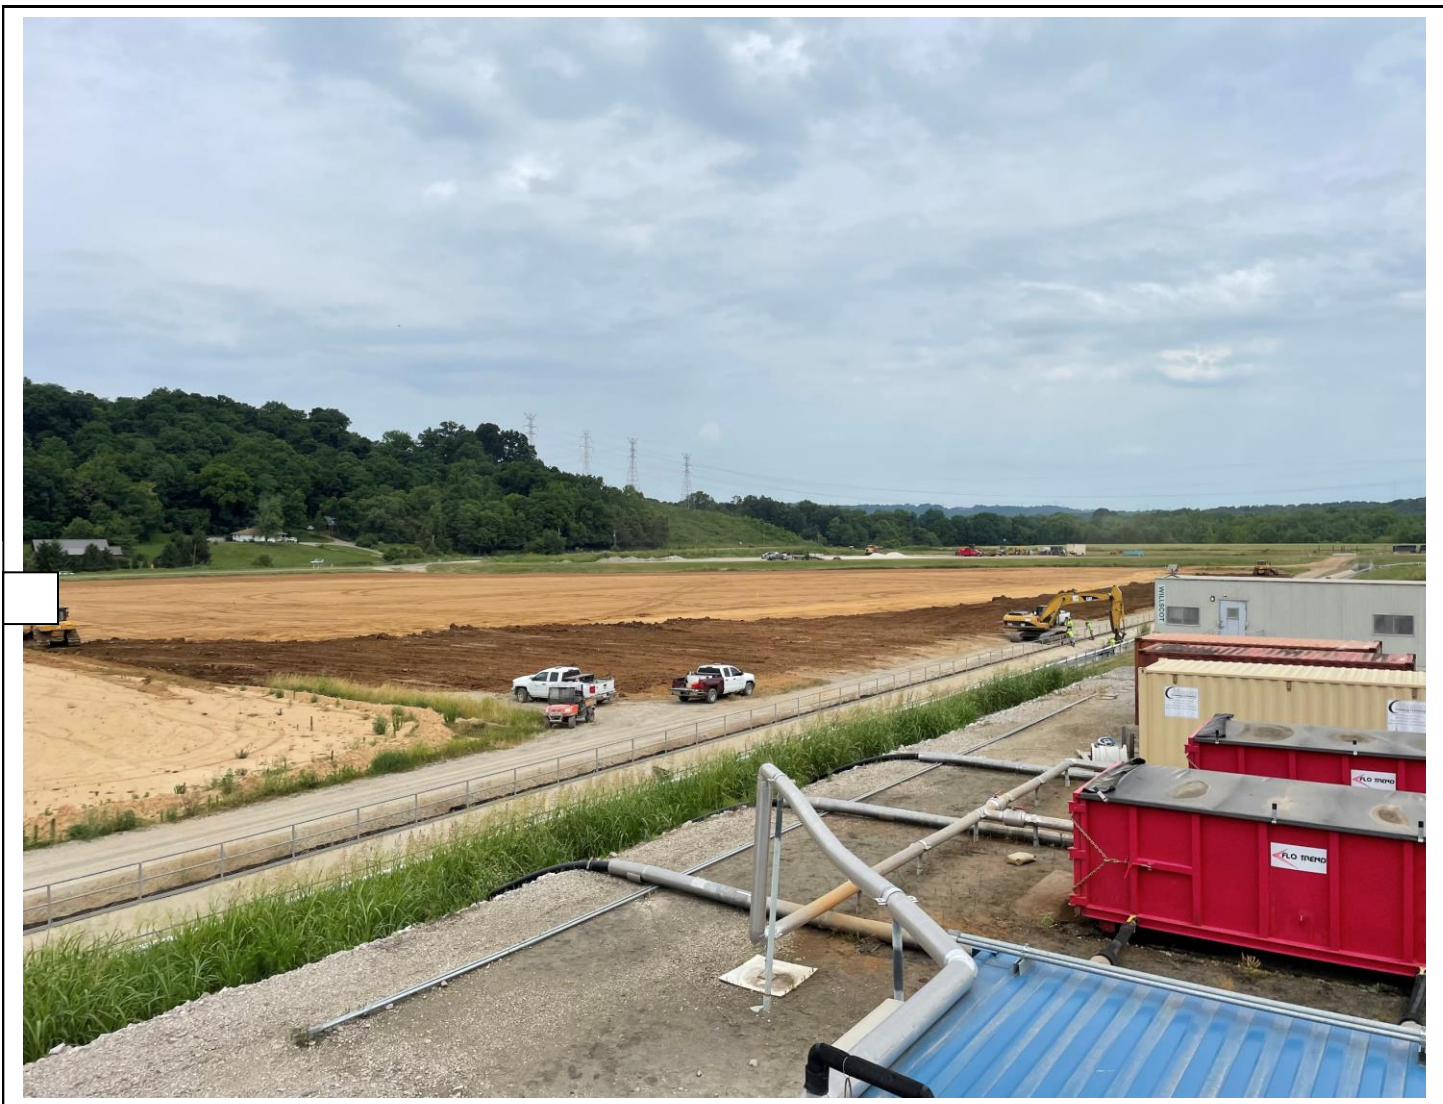
Number	5
	Description	<u>Primary Pond</u> Standing on top of the waste water treatment looking NW at soil fill placed in the pond.
	Photographer	Mike Sonnefeld
	Facility Name	Gallagher CCR
	Photo Date	June 19, 2024
	Others

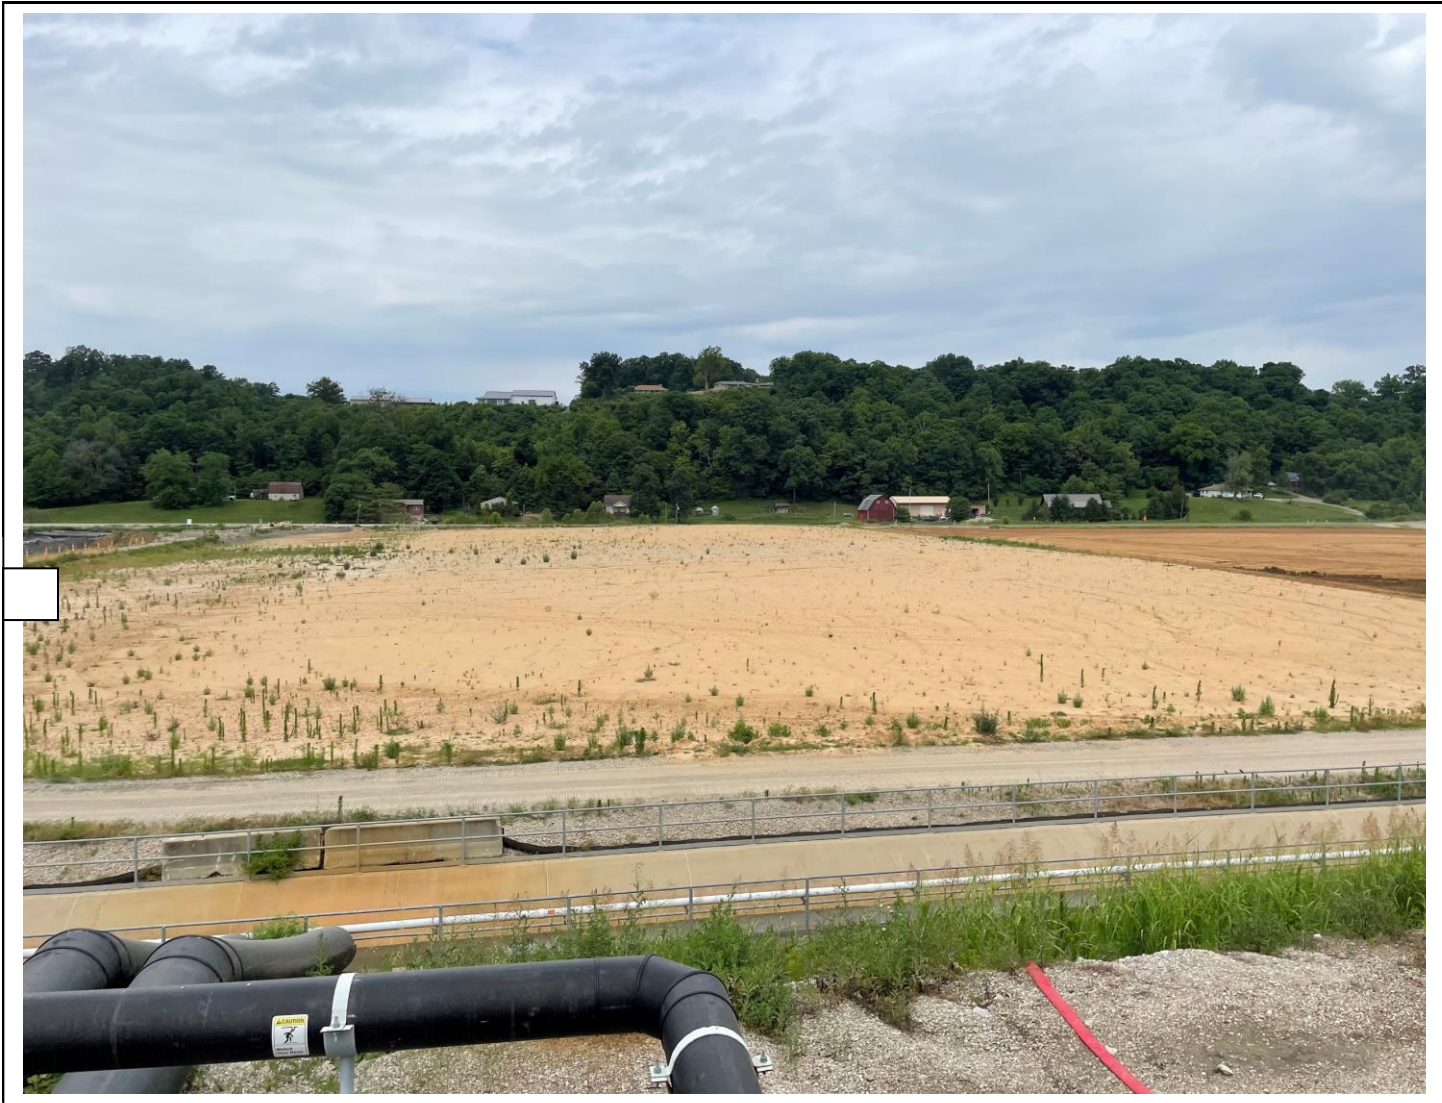
Number	6
	Description	Primary Pond Ash Fill Standing on top of the waste water treatment looking west at soil fill placed in the pond.
	Photographer	Mike Sonnefeld
	Facility Name	Gallagher CCR
	Photo Date	June 19, 2024
	Others

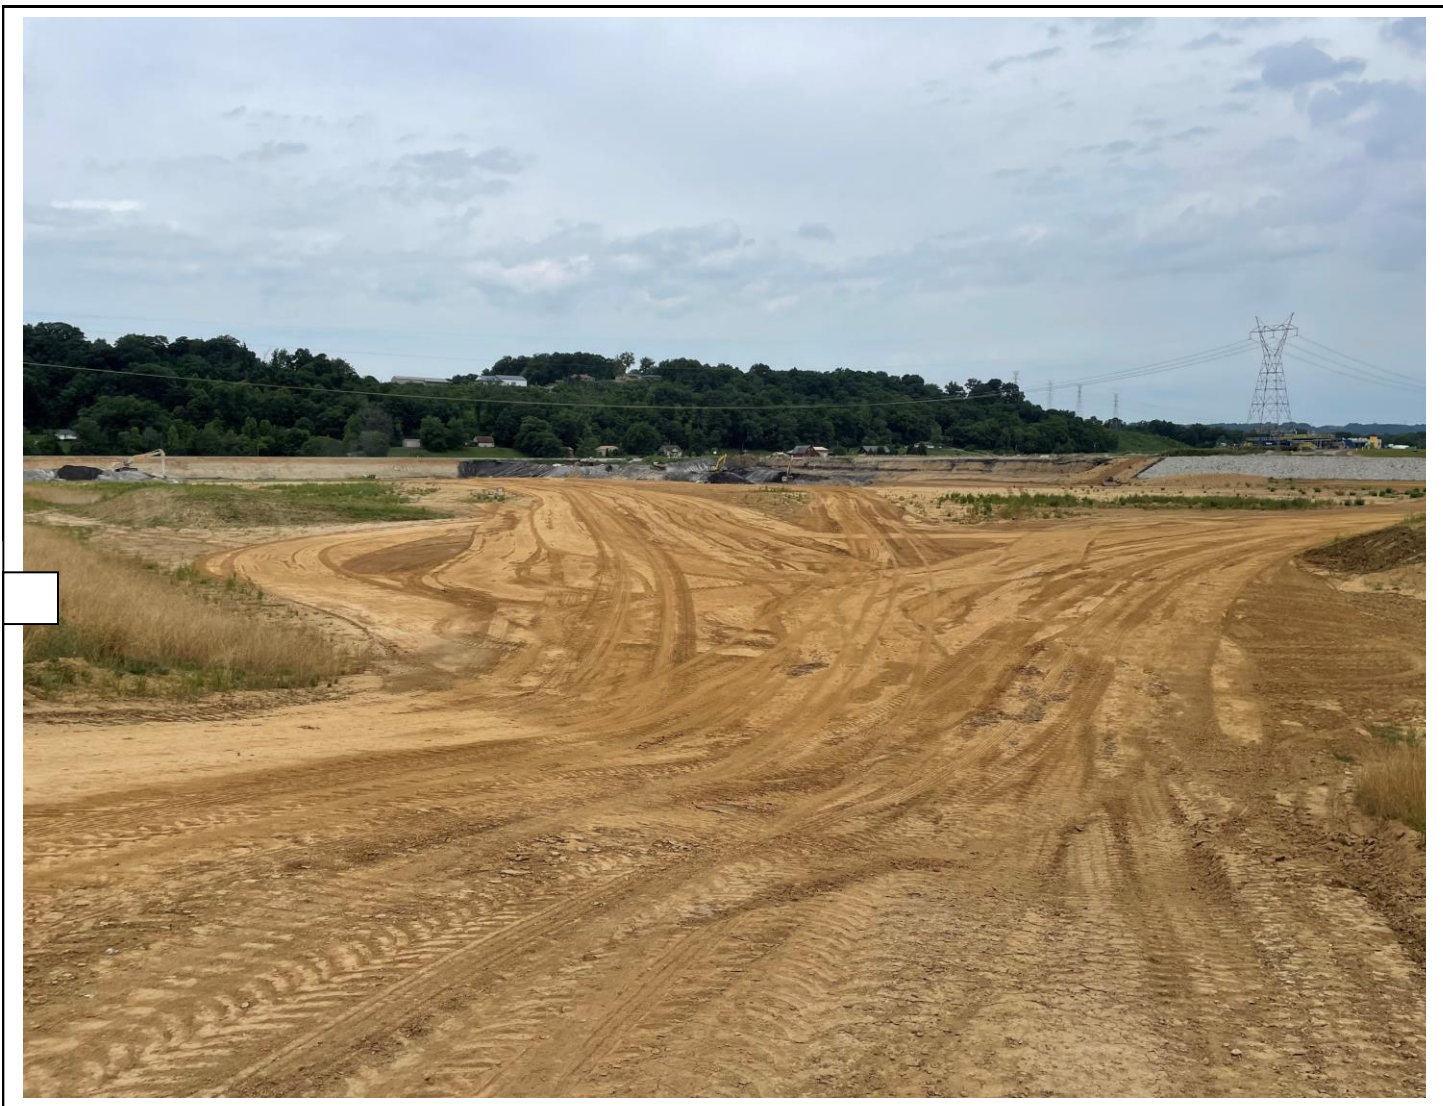
All CCR is removed, then an additional 1 ft. of in-situ soil below the CCR is removed. Next, structural fill is placed to achieve final elevation contours followed by a 1½ ft. thick layer of cohesive cover soil plus a ½ ft. thick vegetative.

Number	7
	Description	Ash Pond A Standing at the SE corner looking NW at structural fill placed in the pond after CCR removed.
	Photographer	Mike Sonnefeld
	Facility Name	Gallagher CCR
	Photo Date	June 19, 2024
	Others

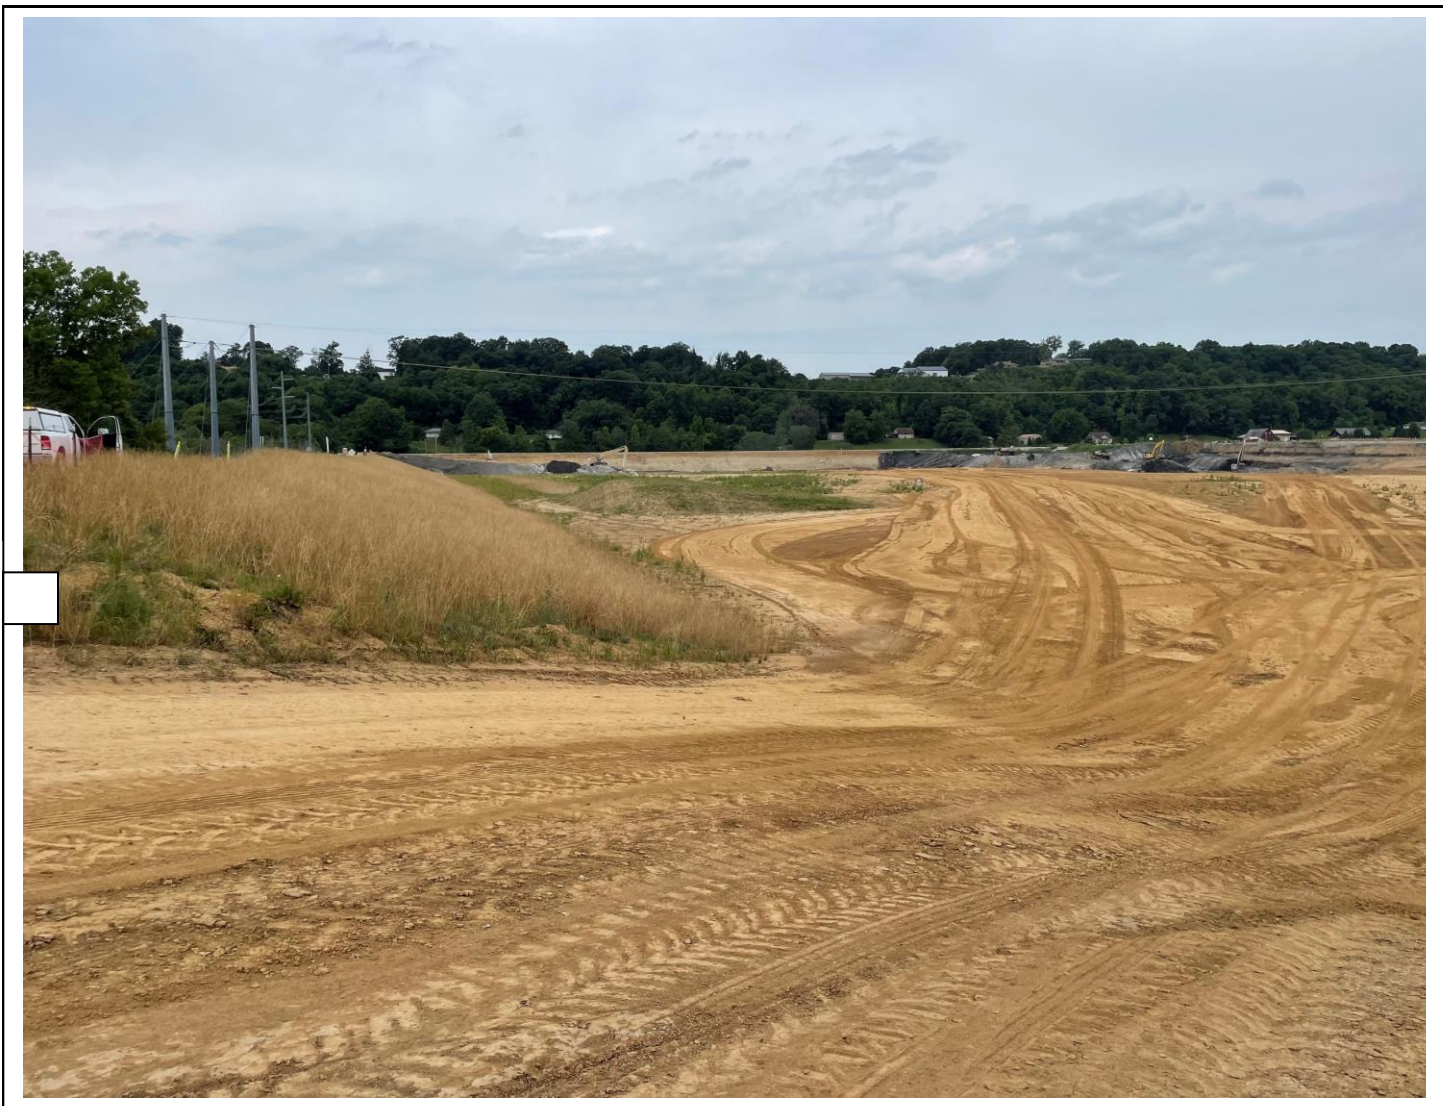
Number	8
	Description	<u>Ash Pond A</u> Standing at the SE corner looking west at structural fill placed in the pond after CCR removed.
	Photographer	Mike Sonnefeld
	Facility Name	Gallagher CCR
	Photo Date	June 19, 2024
	Others

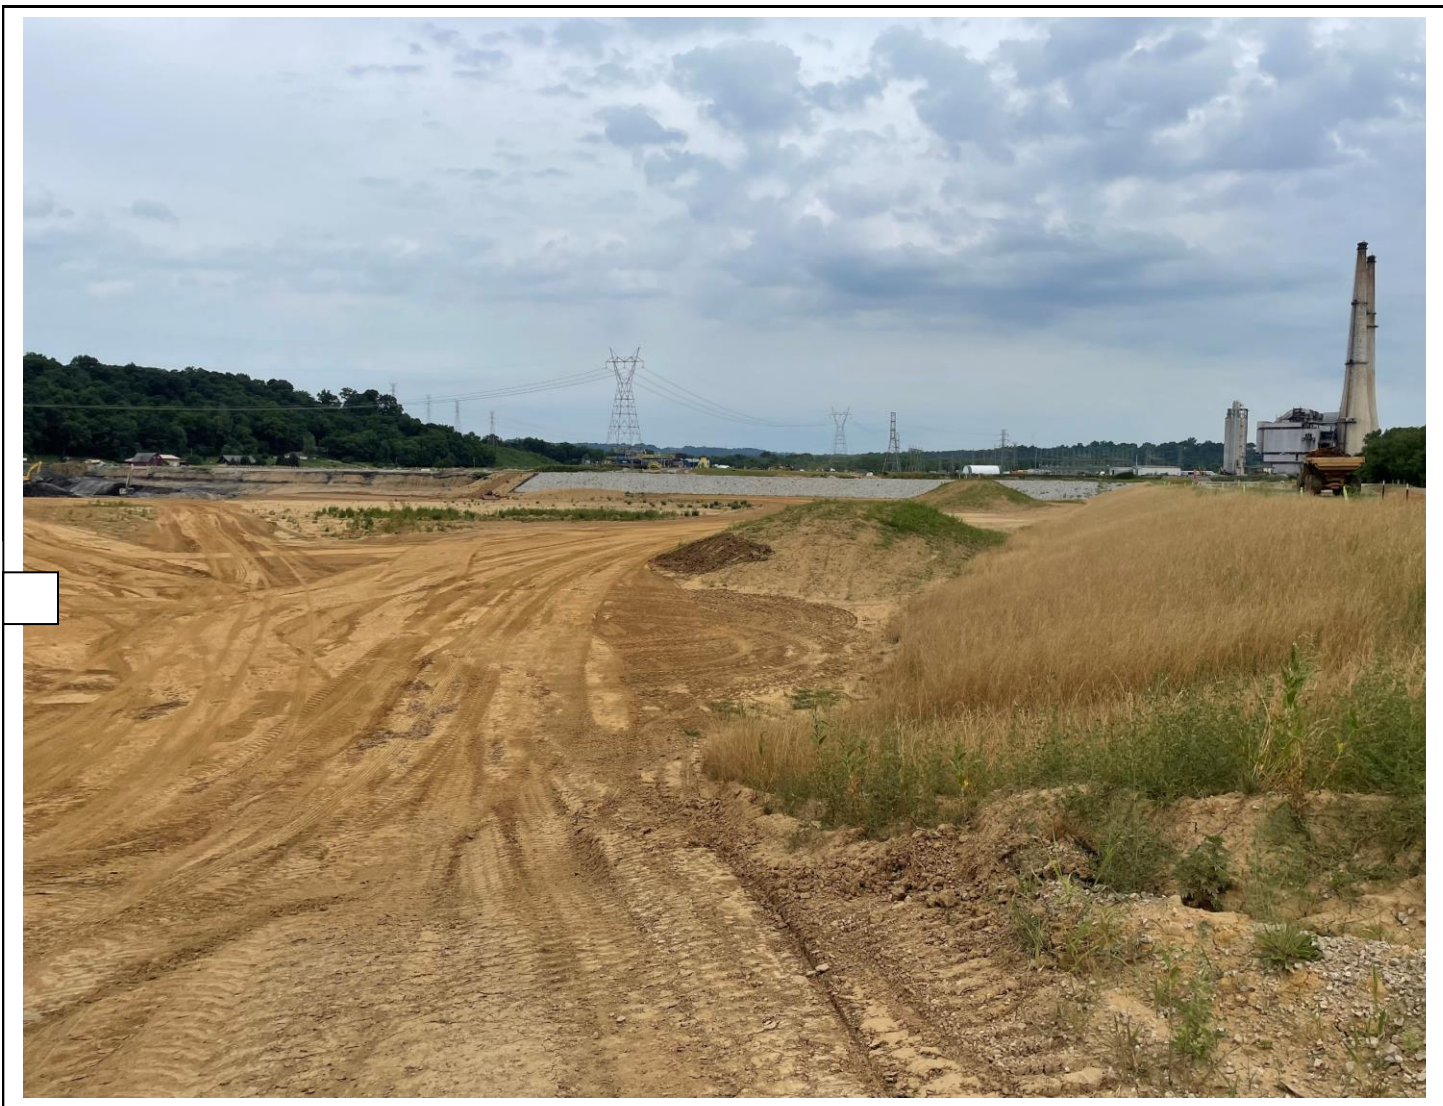
Number	9
	Description	Ash Pond A Standing at the SE corner looking north at structural fill placed in the pond placed in the pond after CCR removed.
	Photographer	Mike Sonnefeld
	Facility Name	Gallagher CCR
	Photo Date	June 19, 2024
	Others

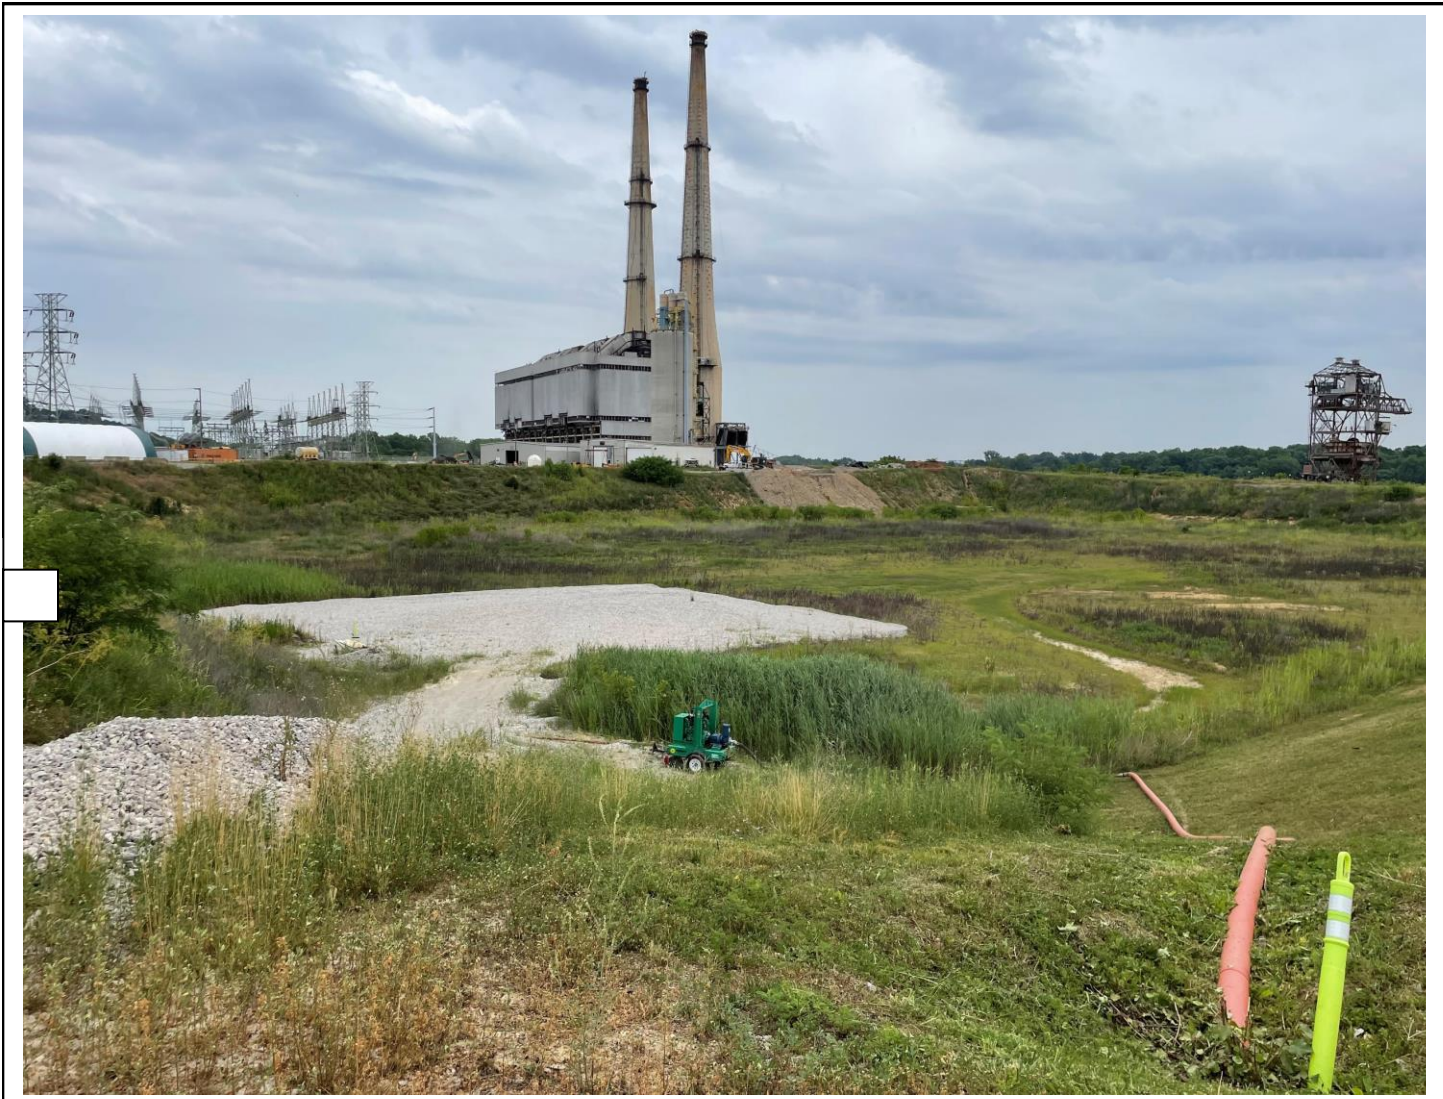
All stockpiled coal was removed (to bare ground) and visually inspected then graded for drainage. Final grading/seeding will occur after the station is removed.

Number	10
	Description	<u>Coal Pile</u> Looking NE at the excavation (from the SW corner) after coal removed.
	Photographer	Mike Sonnefeld
	Facility Name	Gallagher CCR
	Photo Date	June 19, 2024
	Others

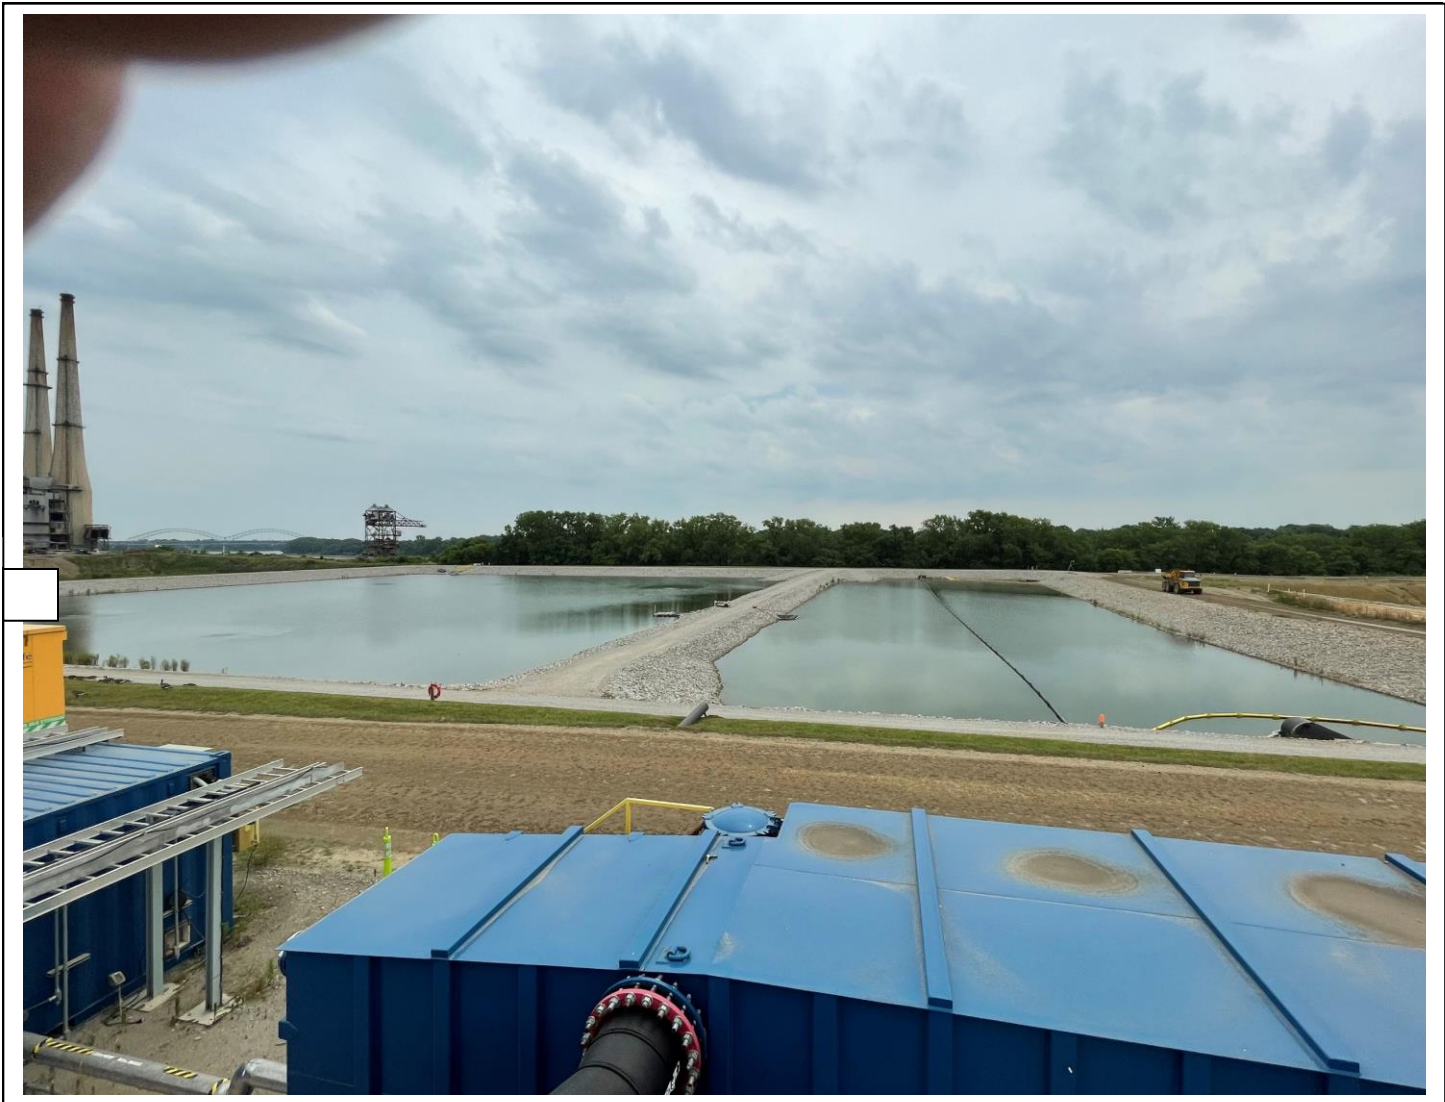
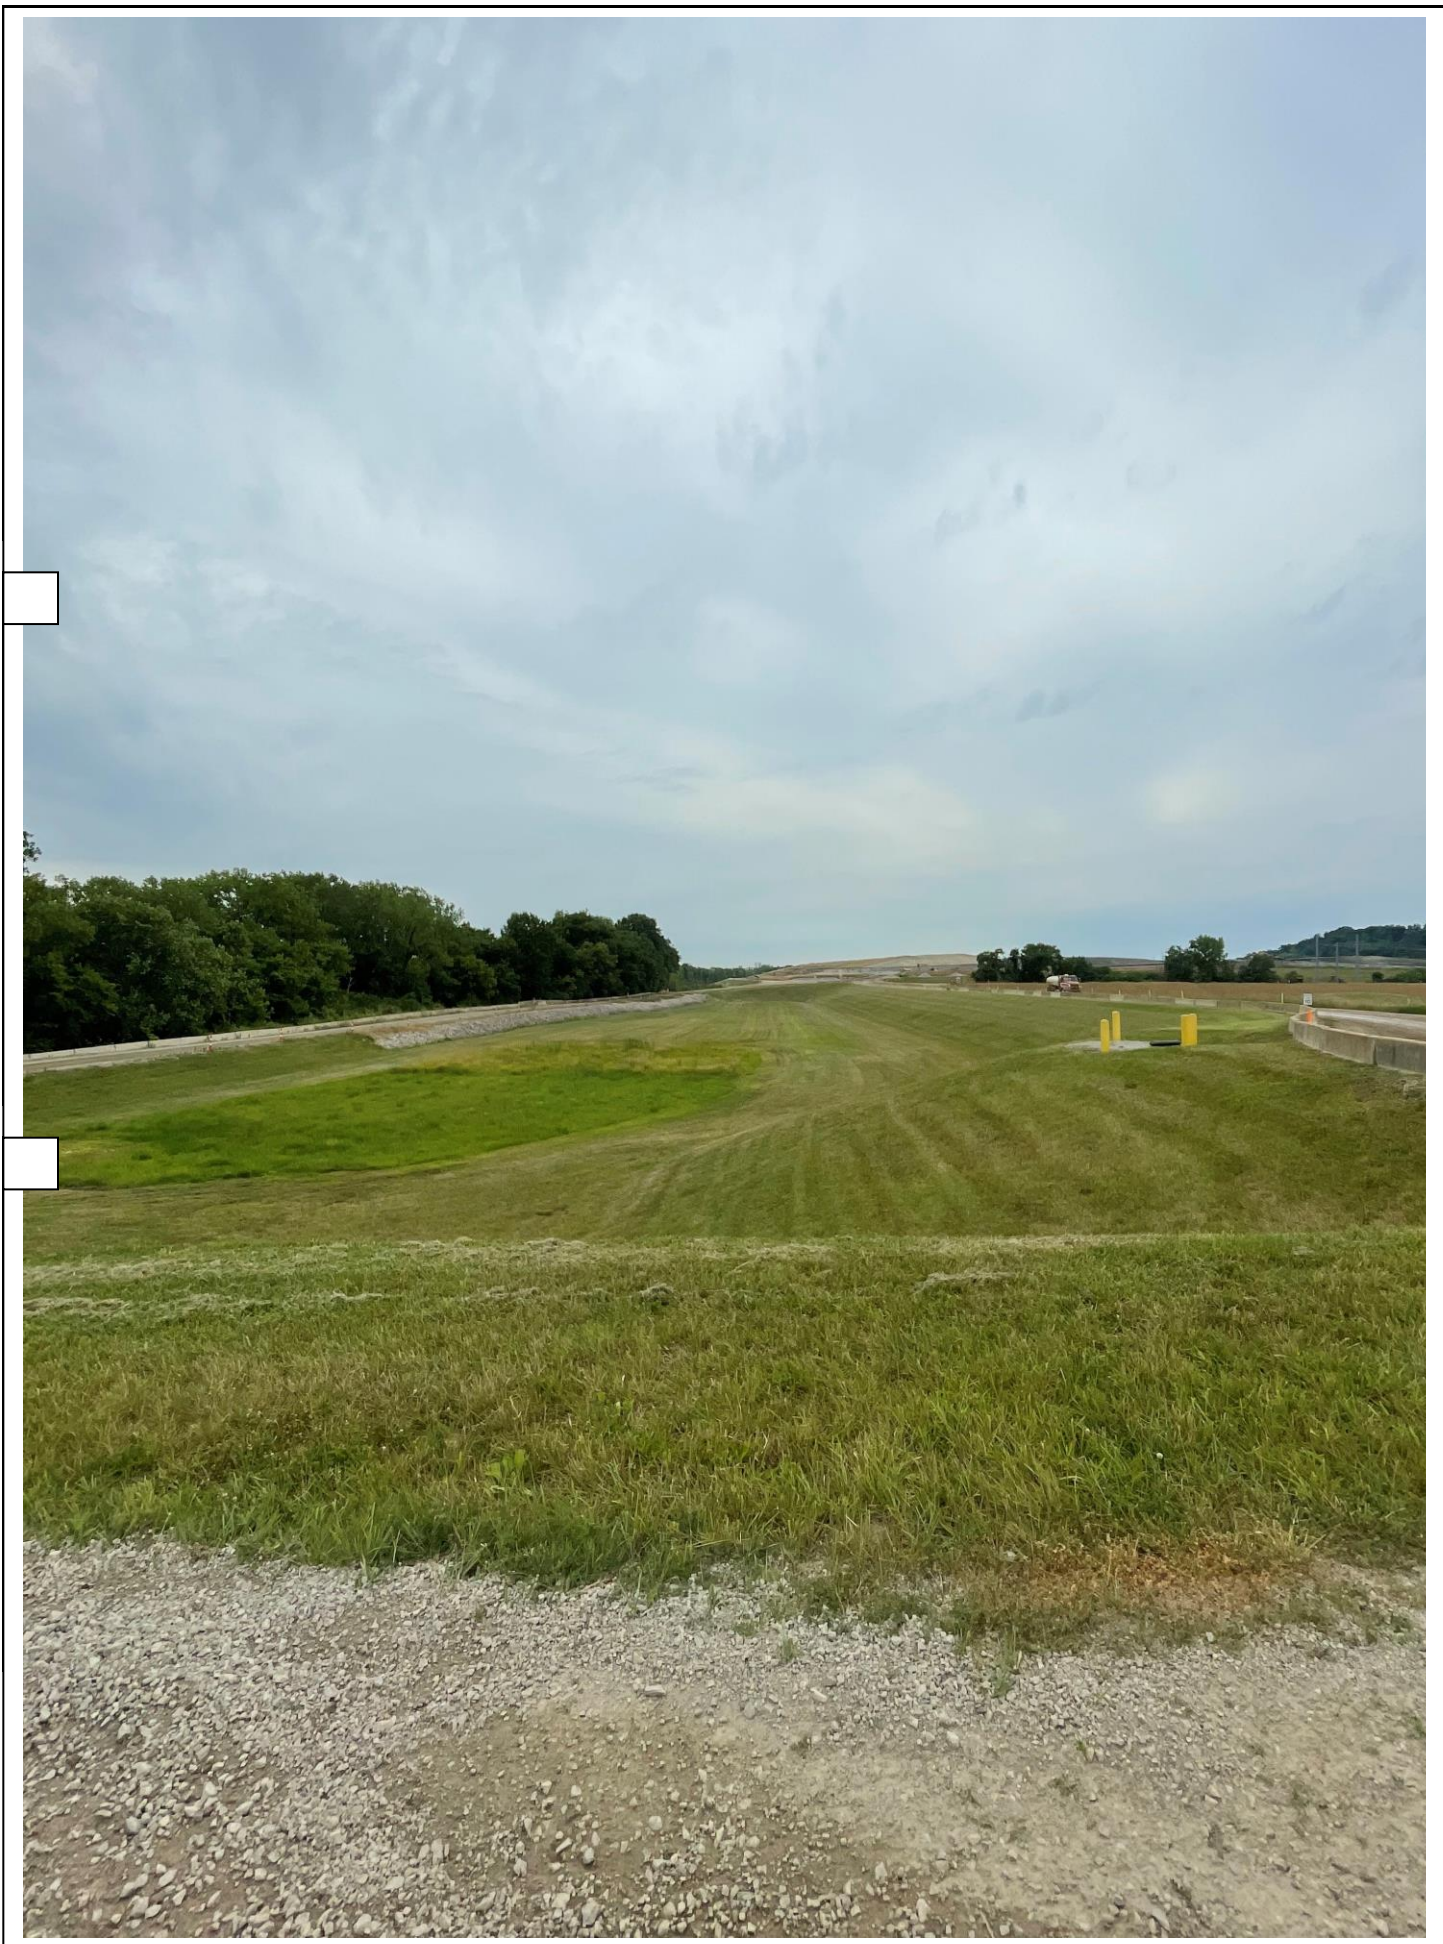
Number	10 & 11
	Description	<p><u>11 Coal Pile Ash Fill (LRB)</u> Standing on top of the waste water treatment looking east at the 2 pools.</p> <p><u>10 Secondary Ash Pond</u> North end looking South at the vegetated cover placed after all CCR was removed.</p>
	Photographer	Mike Sonnefeld
	Facility Name	Gallagher CCR
	Photo Date	June 19, 2024
	Others
