## Indiana Department of Environmental Management

**Re: Inspection Summary/ Noncompliance Letter**  
Shipshewana Wastewater Treatment Plant  
NPDES Permit No. IN0040622  
Shipshewana, LaGrange County

Date(s) of Inspection: June 24, 2024  
Type of Inspection: Compliance Evaluation Inspection  
Inspection Results: Violations were observed.

# NPDES Wastewater Facility Inspection Report

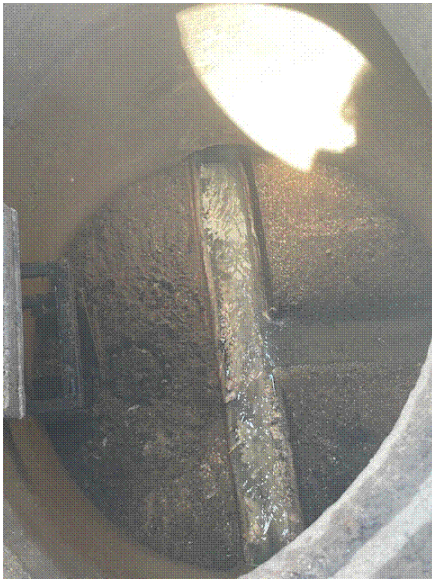
Facility: <b>Shipshewana Wastewater Treatment Plant</b>
Photographer: Lynn Stackhouse
Date: 6/24/2024      Time:
Others Present:
Location/Description: Manhole/sewer line at Maple and Summey Streets

- A. A manhole located at Maple and Summey Streets was inspected. This location captures the flow from the downtown area which contains one of the Town's main restaurant's. The sewer line in the manhole had approximately 2" of solidified grease along its sides and bottom. Grease balls (as noted at the treatment plant) were visible as part of the grease mat contained in the line. This grease will sluff off during times of regular flow, but would significantly increase during high flow periods that occur often in the popular tourist Town or wet weather flows. This manhole is located approximately 1 to 2 blocks from the restaurant. The condition noted in this sewer line did not happen over a course of a few months, but rather a long term problem. See attached photograph.

The current condition of the areas of the collection system/lift station evaluated for this inspection indicates the above has not been done. In addition, new treatment plant staff report they have looked at some local grease traps but when staff asked a restaurant for its cleaning documentation, none was provided. Town management must provide staff the means and support to enforce the SUO. Please note 327 IAC 5-22-10 requires the owner or governing body of a wastewater treatment plant to be responsible for providing adequate funding and oversight to ensure the proper operation, maintenance, management and supervision of

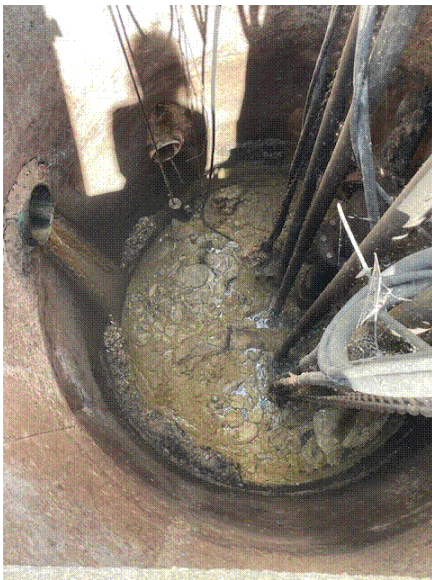
Facility: <b>Shipshewana Wastewater Treatment Plant</b>
Photographer: Lynn Stackhouse
Date: 6/24/2024      Time:
Others Present:
Location/Description: 5 and 20 lift station wet well

- B. The lift station at 5 and 20 was also inspected. This station's wet well was nearly completely covered in a very thick grease mat. See attached photograph.

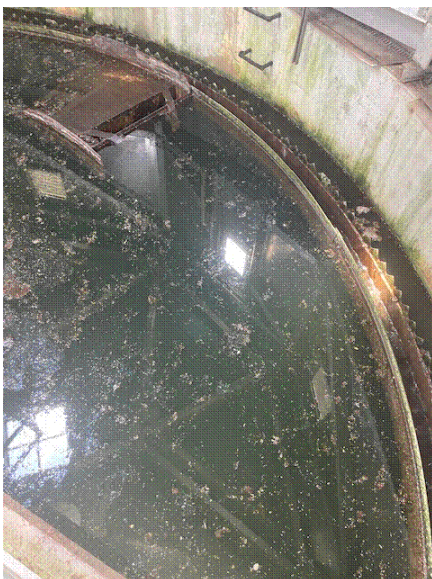
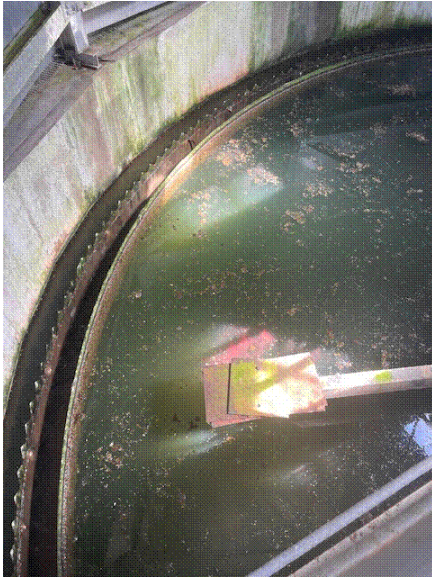
Operations was rated as marginal due to grease balls in the plant (see Collection System for additional comments). With the exception of grease balls on both the secondary and tertiary clarifiers surface, the plant was running well. Very good color and mixing was noted in the oxidation ditch with no foaming. Both clarifiers were settling well. Plant operators report they struggle with grease, but all grease was contained behind the clarifier weirs and not noted in the receiving stream. IDEM commends plant operators for continued cleaning/skimming of clarifiers.

Facility: <b>Shipshewana Wastewater Treatment Plant</b>
Photographer: Lynn Stackhouse
Date: 6/24/2024      Time:
Others Present:
Location/Description: Tertiary clarifier - note grease balls
