INDIANA DEPARTMENT OF NATURAL RESOURCES  
DIVISION OF RECLAMATION

COMPLIANCE INSPECTION REPORT

U-022 – Gibson County Coal, LLC. – Gibson County Coal Mine

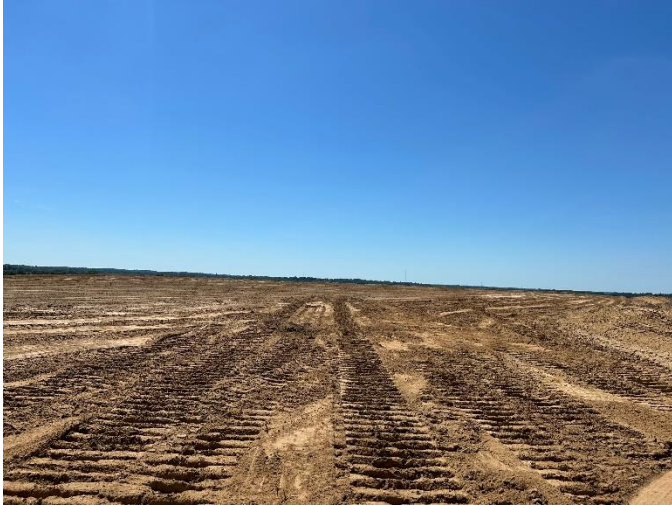
Gibson County Coal has been reclaiming a portion of the coarse refuse (gob) pile. They reclaim the top of the gob pile, approximately 8 acres.

Pic. 6/24/24 ... shows the reclaimed portion of the gob pile. The area includes approximately 8.0 acres.

Gibson County Coal needs to protect the soil from eroding, once they achieve final grade.
