INDIANA DEPARTMENT OF NATURAL RESOURCES  
DIVISION OF RECLAMATION

COMPLIANCE INSPECTION REPORT

S-333 Responsible Energy Operations, LLC, Charger Mine, White Church Field

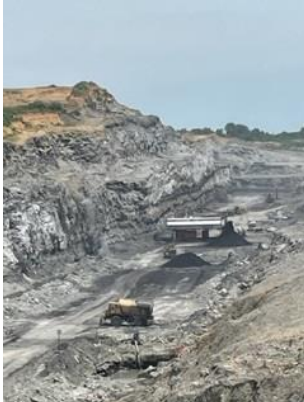
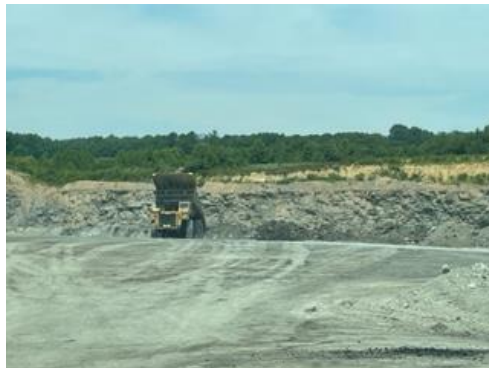
The east pit was active with blast preparation and surface recovery operations to the east. Highwall mining continues at intervals in the west portion. Mining is advancing back to the east part of the pit. Highwall miner holes are closed with exception of those required to remain by MSHA. Operator is reminded of the additional boring requirements set forth in non-sig 125 approved on 12-18-23 as advance to the western Zone 2B area follows:

Upper seam recovery continues in the east side of the pit. Photos of highwall operation and backfilling during inspection:

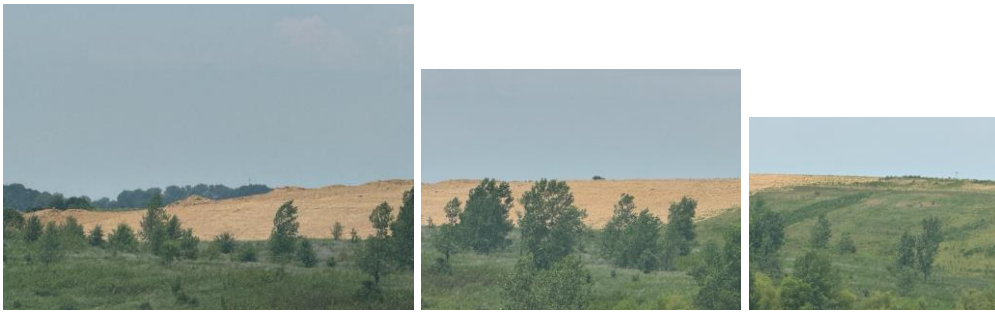
5./6. Pit advancement is occurring in the east pit. "Soils" remain as non-prime, with no soil segregation required in the immediate advance area of the pit. Permit revision has been approved to address the change in equipment from current permit language a truck/shovel operation and regarding soil removal and pit benching. The standard truck/shovel soil removal is 25' in advance and 10' along endwalls. Benching was satisfactory during inspection.

Soil material is being directly replaced behind the West end of the pit as removal occurs. Photos below:

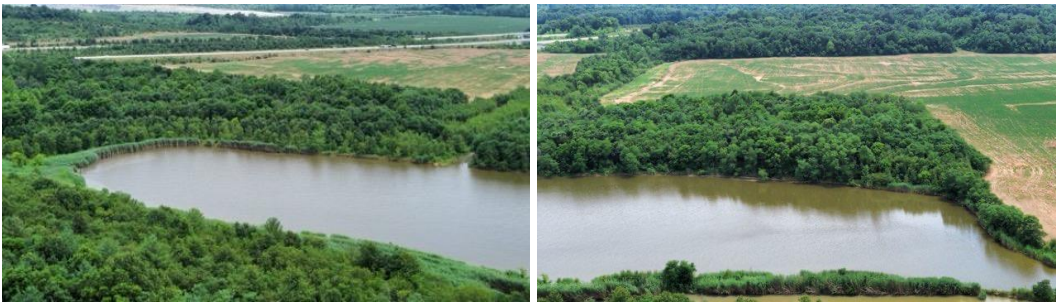
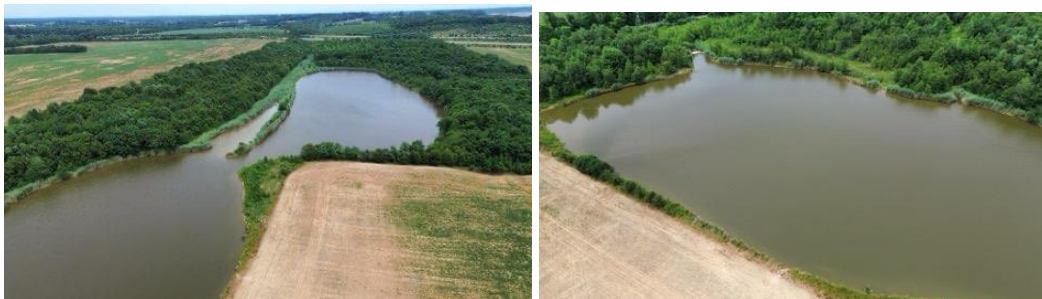
8. Diversion SS2-A remains stable and carrying pit water within the channel. Outfalls and ponds were stable at usual water levels. Drone photos were taken of Pond SBSS-2 during inspection:

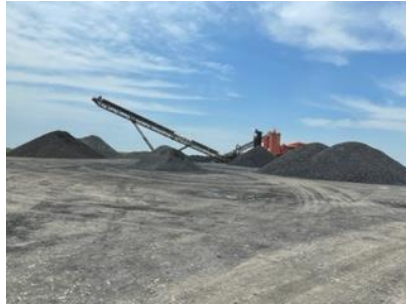
10. Processing plant was active during inspection. Photo below:
