HRS DOCUMENTATION RECORD - REVIEW COVER SHEET

Name of Site: Martinsville Ground Water Contamination Site

EPA ID No.: INN000508678

HRS DOCUMENTATION RECORD

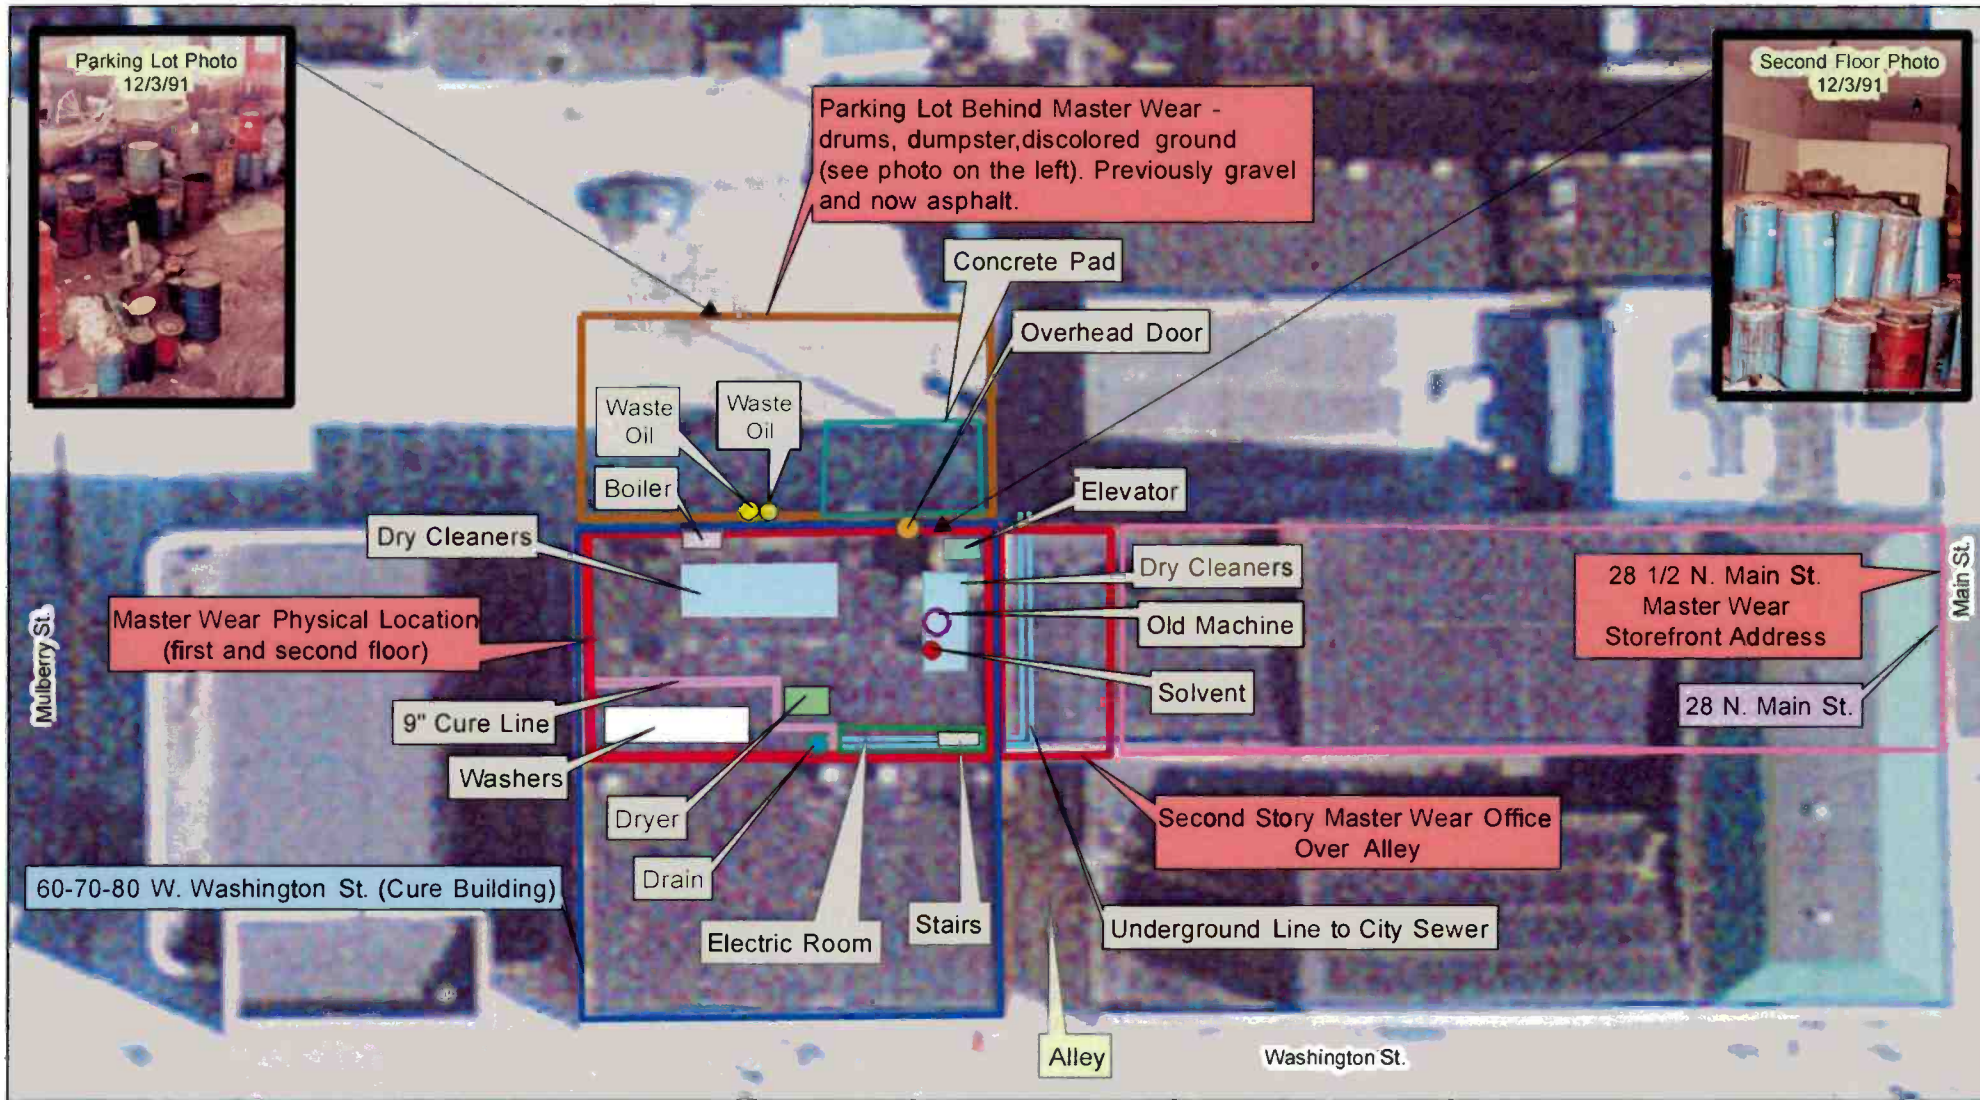
Site Features Map, Master Wear Site

NOTE: The Master Wear Facility occupied the: Master Wear Physical Location (first and second floors), the Second Story Master Wear Office Over the Alley, and the Parking Lot Behind Master Wear.

Master Wear Physical Location (bounded by the red box on the left):
 First floor - All items shown on the map within the Master Wear Physical Location (red box) were located on the first floor.
 Second floor - No information was available indicating where items were located other than pictures showing drums stacked on the second floor (see photo on the right).

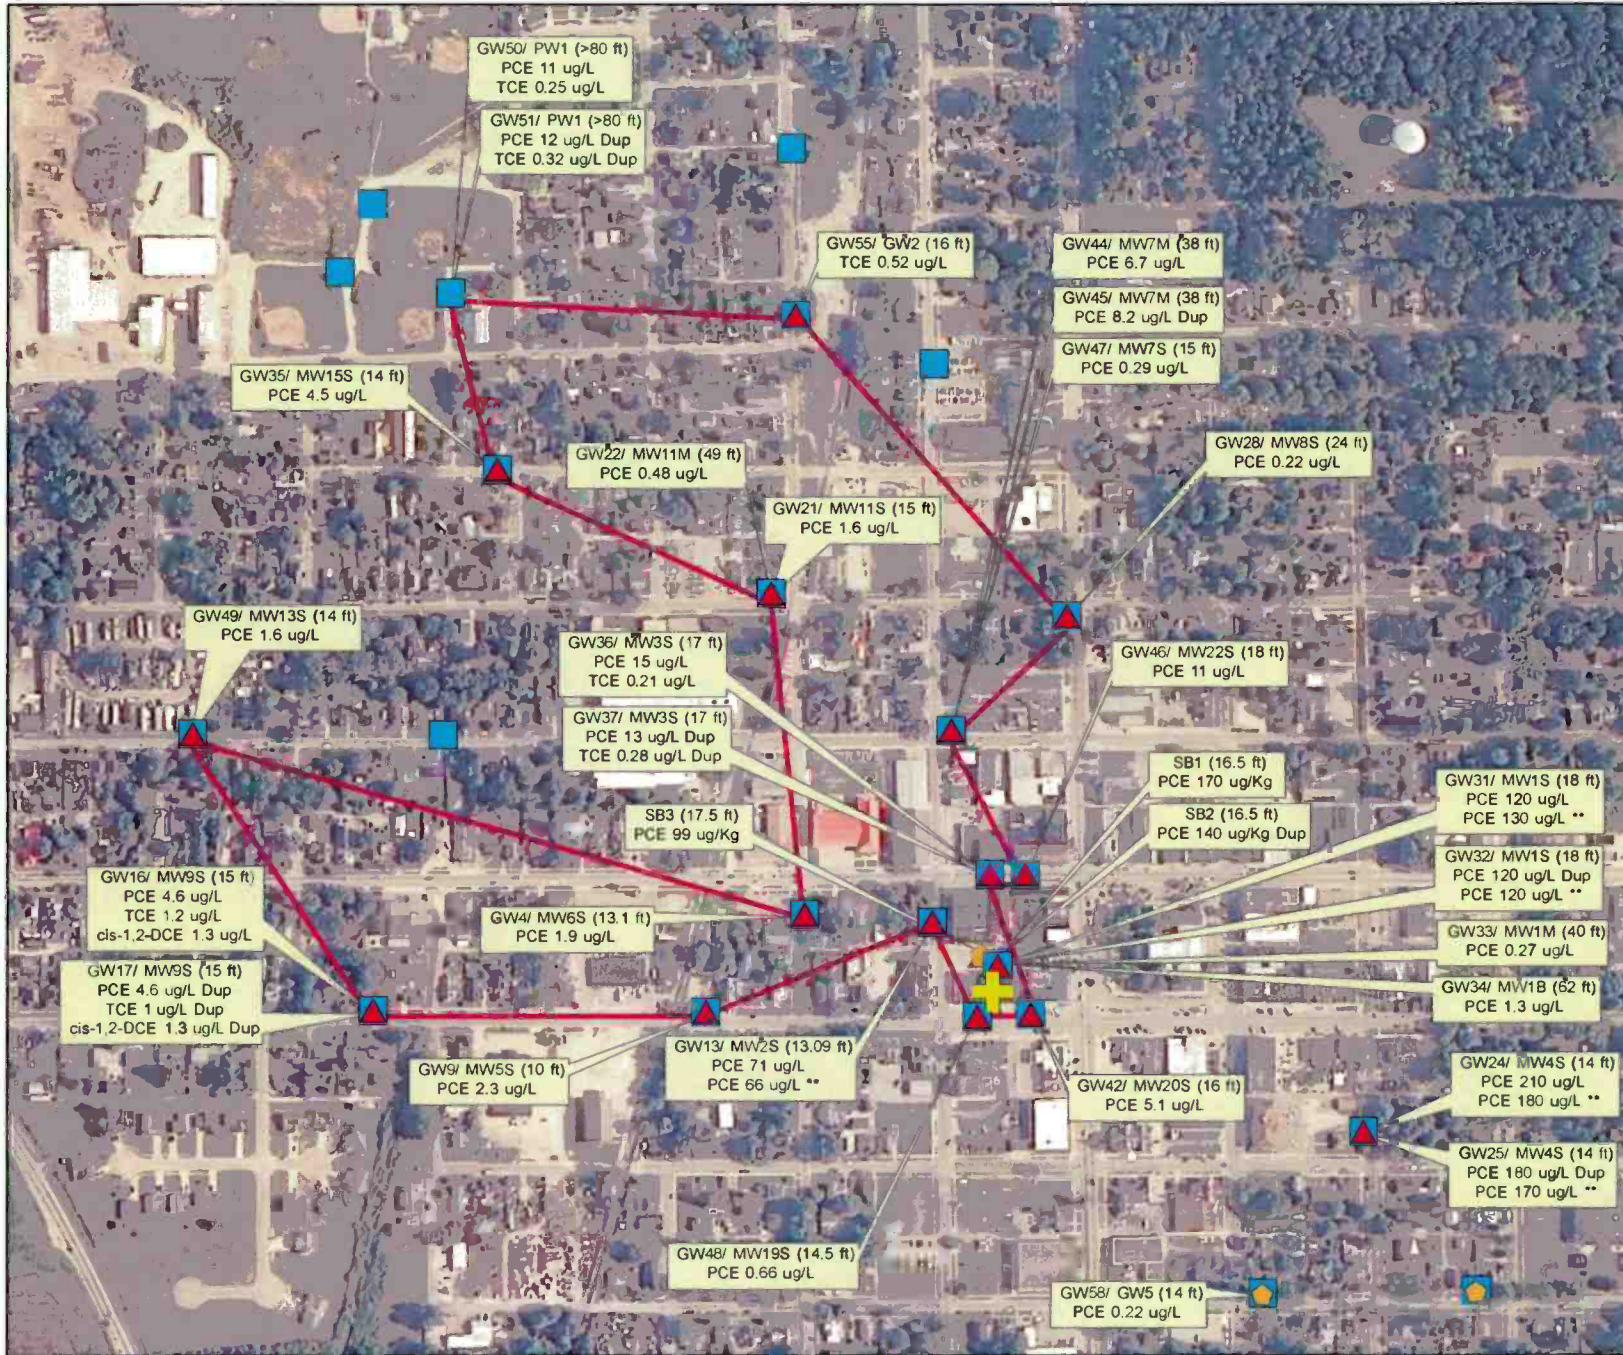
Master Wear Groundwater Plume Boundary Map:

Defined by PCE, TCE, and cis-1,2-DCE from the Key Findings List & Preliminary Assessment Groundwater Sampling (July 26-28 and August 3, 2010) Results
 Master Wear Site, Martinsville, Morgan Co., Indiana, EPA ID - INN000508678

- Groundwater Plume Boundary*
 - ▲ Contaminant of Concern
 - + Master Wear Site
 - Soil Sample Location
 - Water Sample Location
- * The Groundwater Plume Boundary Map, as referenced, was constructed using data from the 2010 Reassessment. The plume boundary line was digitized by connecting the wells locations that had contaminants of concern (PCE, TCE, cis-1,2-DCE) above contaminant concentration levels of concern. The boundary line represents the perimeter of the area sampled that had PCE, TCE, and cis-1,2-DCE concentration levels of concern.
