Indiana Department of Environmental Management

Re: Inspection Summary/ Noncompliance Letter
US Steel Midwest
NPDES Permit No. IN0000337
Portage, Porter County

Date(s) of Inspection: November 16, 2017 , November 17, 2017
Type of Inspection: Reconnaissance Inspection
Inspection Results: Violations were observed.

NPDES Industrial Facility Inspection Report

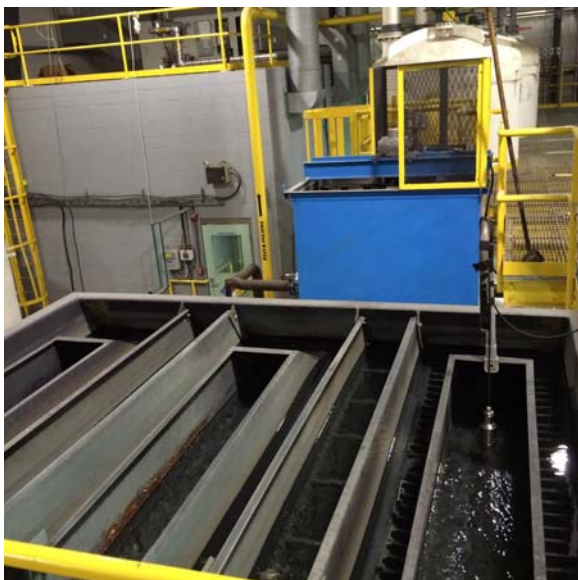
While the incident is still under investigation by US Steel personnel, it is believed that the operator may not have been conducting visual checks as required. The channel that did not overflow with solids has a turbidity meter that sends the data to a remote office. The two channels that overflowed did not have turbidity meters.

| South view of the lamella clarifier on A Train. Only one channel has a turbidity meter. Meters have been ordered for the other channels on both trains. | |

Corrective actions taken by US Steel - Midwest include: On-site personnel stated that turbidity meters have been ordered for the channels that did not have them previously, two for A Train and two for B Train; Additional pathing was added on the elevated platform for both trains to facilitate viewing and maintenance of both lamella clarifiers; The operator who was on-site was removed from the Chrome Treatment plant and is currently assigned to other duties.

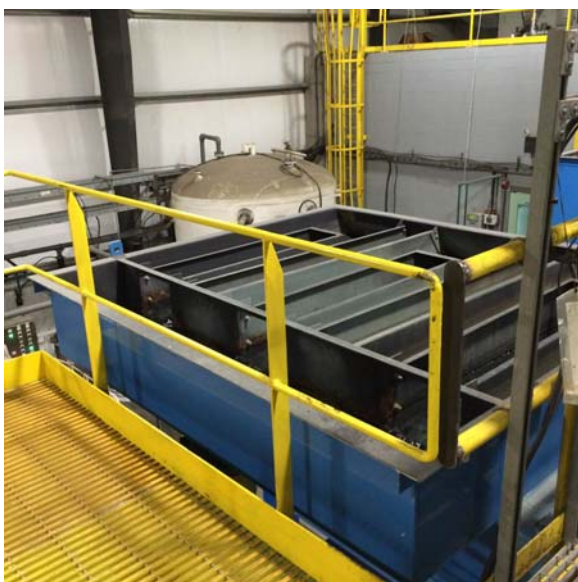
| Southeast view of the lamella clarifier of the A Train. The walkway on the left was installed after the total chromium exceedance in October 2017 to assist with observing and maintaining the clarifier. | |
