**INDIANA DEPARTMENT OF ENVIRONMENTAL MANAGEMENT
OFFICE OF AIR QUALITY
FIELD INSPECTION REPORT**

SOURCE INFORMATION	
<u>SOURCE NAME</u>	Co-Alliance – Scircleville Elevator
<u>SOURCE LOCATION</u>	16 South 1100 East Frankfort, IN 46041 Clinton County
<u>MAILING ADDRESS</u>	NA
<u>PLANT ID</u>	023-00019
<u>PERMIT INFORMATION</u>	Permit Type: Permit By Rule Permit Number: Permit Expiration Date: VFC Document No.(hyperlink):
<u>ATTAINMENT STATUS</u>	<input checked="" type="checkbox"/> Attainment for all criteria pollutants <input type="checkbox"/> Nonattainment for <input type="checkbox"/> SO ₂ <input type="checkbox"/> CO <input type="checkbox"/> O ₃ <input type="checkbox"/> NO ₂ <input type="checkbox"/> Pb <input type="checkbox"/> PM ₁₀ <input type="checkbox"/> PM _{2.5}
<u>SOURCE STATUS</u>	<input type="checkbox"/> PSD Major (326 IAC 2-2) <input type="checkbox"/> Major Source of HAPs <input type="checkbox"/> Emission Offset (326 IAC 2-3) <input type="checkbox"/> Area Source of HAPs <input type="checkbox"/> Acid Rain (326 IAC 21)

<u>SOURCE DESCRIPTION</u>	Grain Elevator

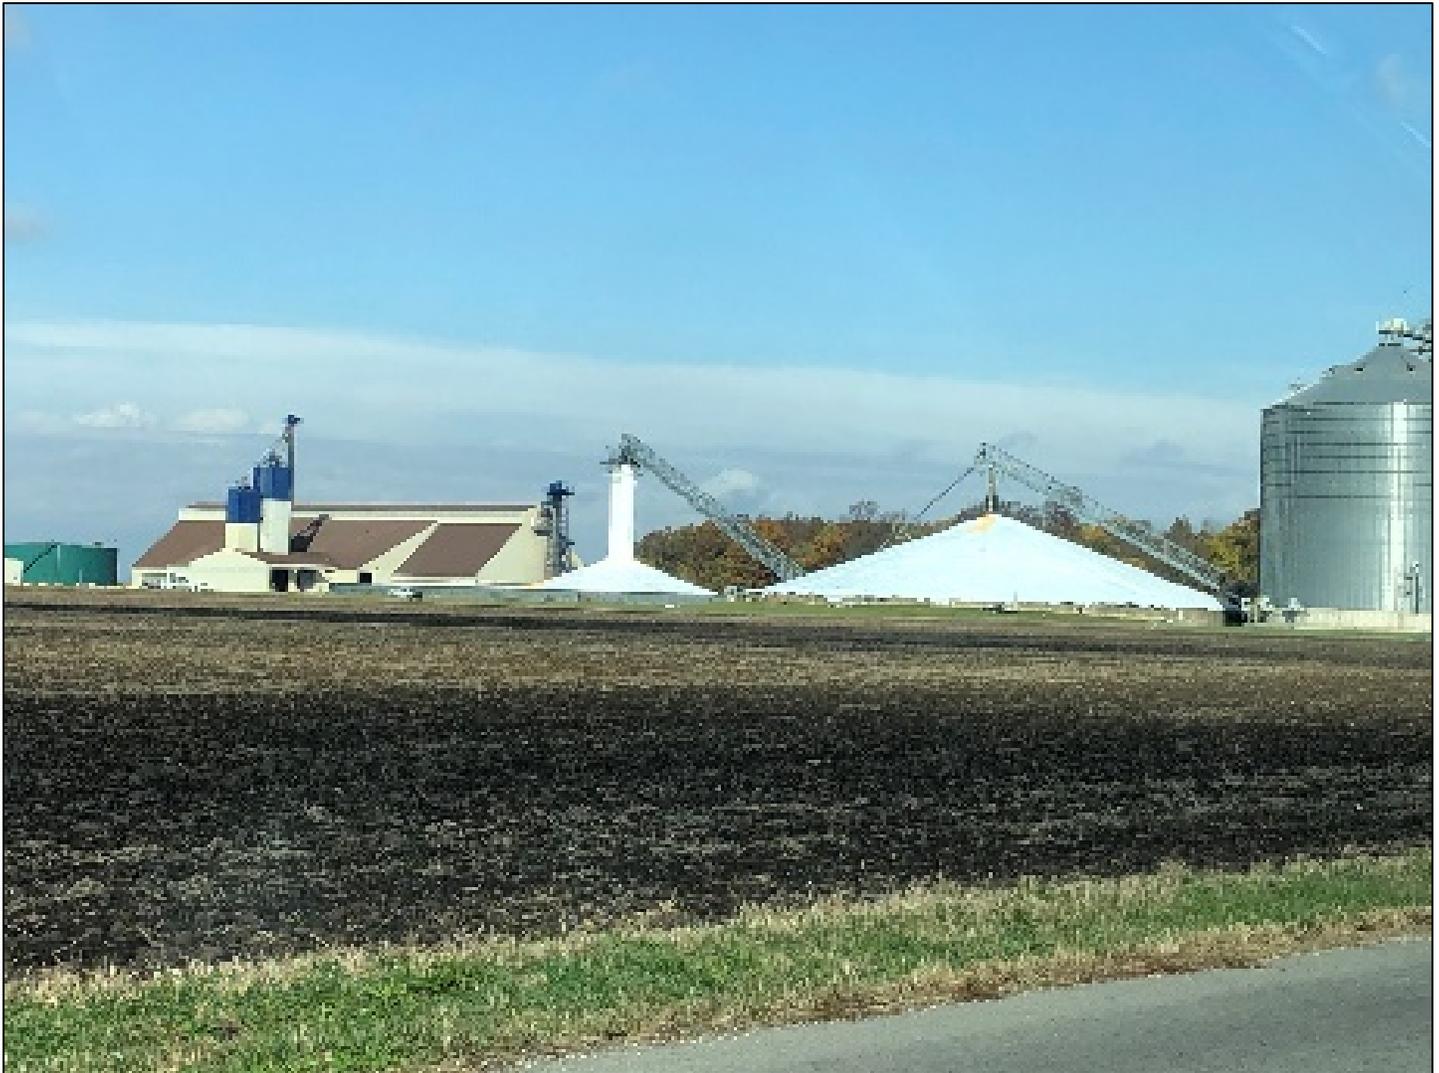
Photo No. 1

Source Name:	Co-Alliance – Scircleville Elevator
Photographer:	Rebecca Hayes, IDEM, Office of Air Quality
Date and Time:	10/21/2020 at 11:00 am
Description:	Photo taken from the road frontage at the overflow grain storage area

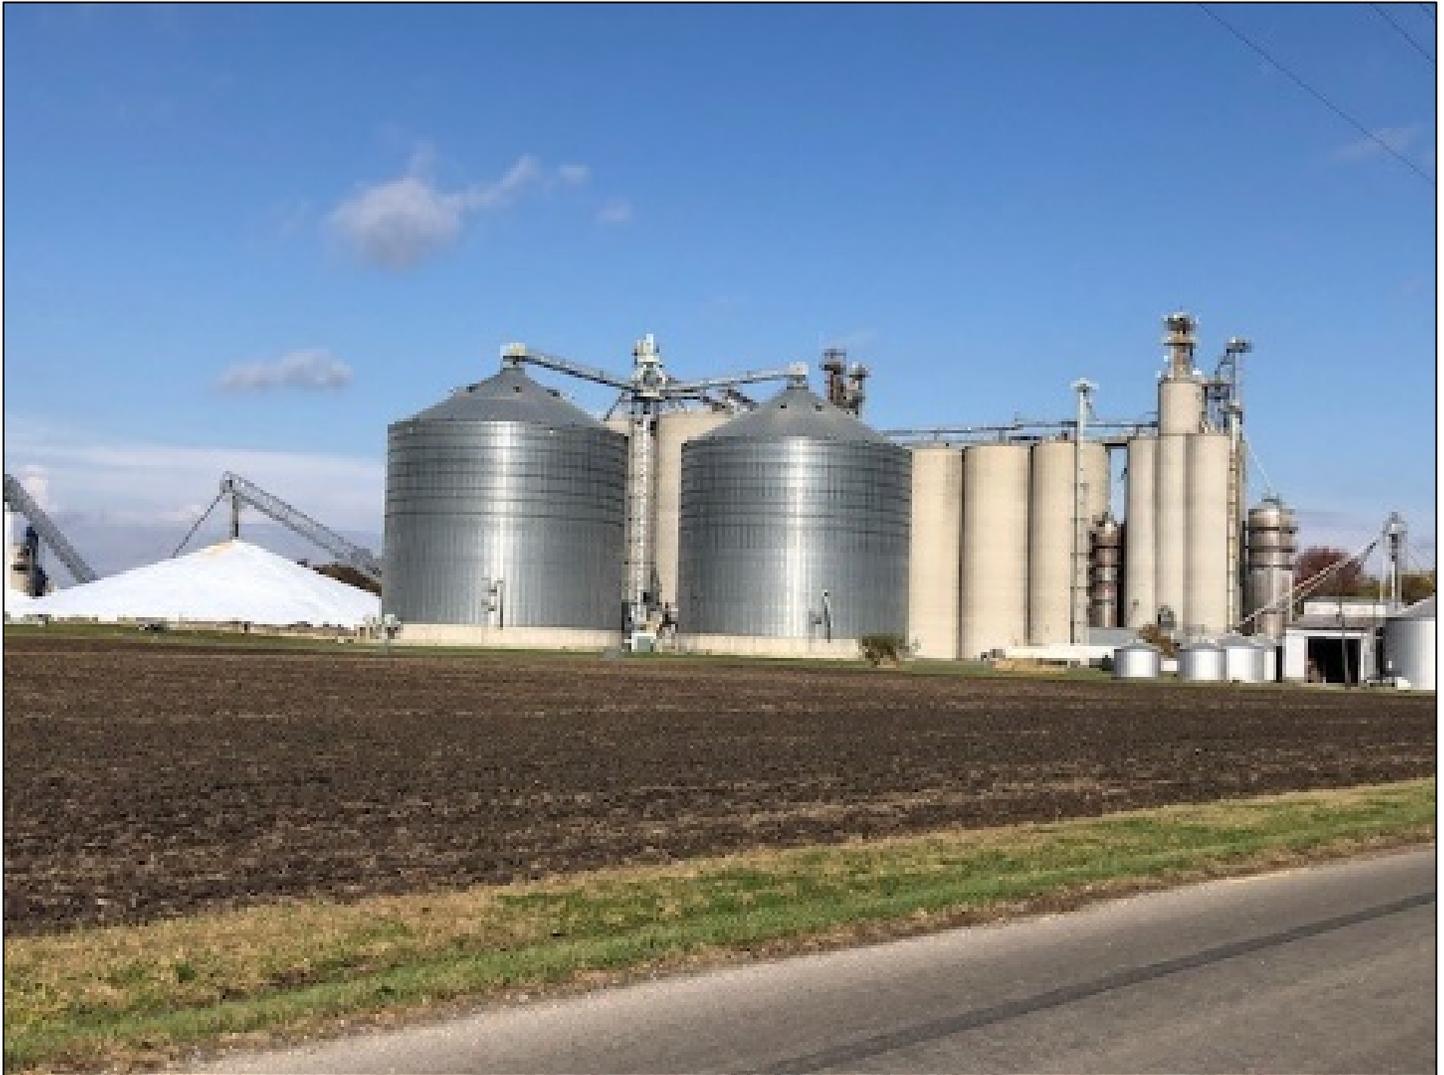
Photo No. 2

Source Name:	Co-Alliance – Scircleville Elevator
Photographer:	Rebecca Hayes, IDEM, Office of Air Quality
Date and Time:	10/21/2020 at 11:00 am
Description:	Photo taken from the road frontage at the main grain storage silo area

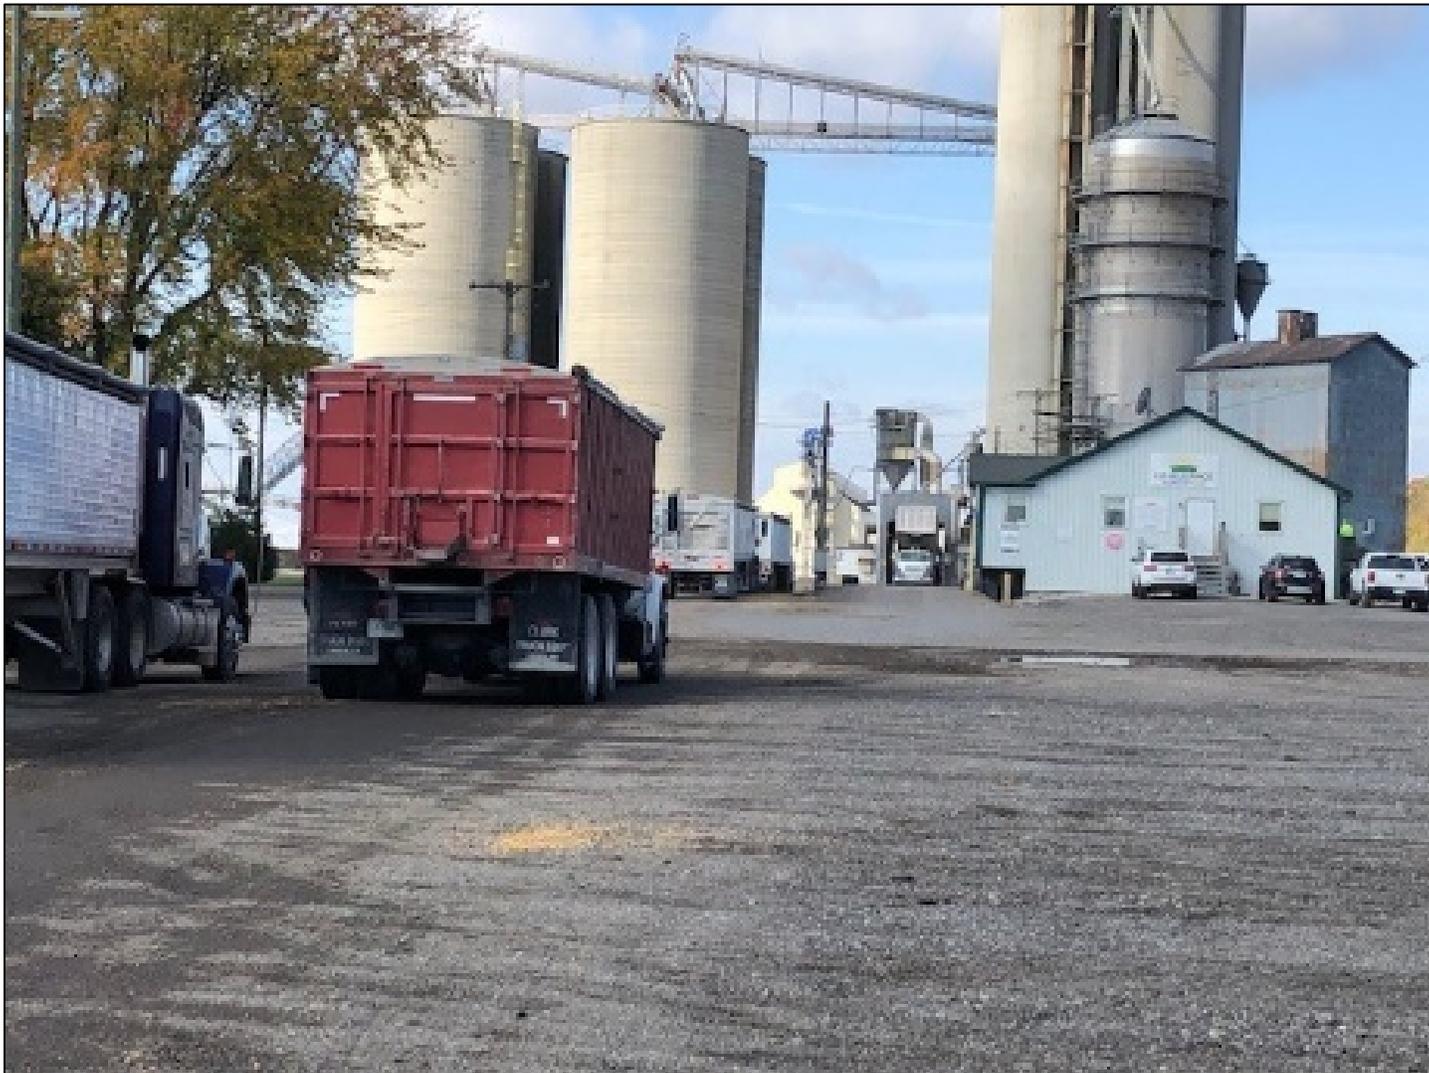
Photo No. 3

INSPECTION FINDINGS					
Observations and Comments:					
<p>During the surveillance, I observed semitrucks entering the property and unloading grain in the covered dump pit (see photo No. 3). Also I observed the overflow grain storage area to ensure that the grain was being tarped appropriately to prevent fugitive dust. The area was tarped and the tarp appeared to be in good condition and covering the storage pile appropriately (see Photo No. 1). No fugitive dust was observed from any of the processes operating during the surveillance.</p>					
Compliance Status:					
<input checked="" type="checkbox"/> No violations were observed or determined at the time of the inspection. <input type="checkbox"/> The following violations were determined at the time of the inspection: <table border="1" style="margin-left: 20px;"> <thead> <tr> <th><i>Condition/Citation</i></th> <th><i>Comments</i></th> </tr> </thead> <tbody> <tr> <td></td> <td></td> </tr> </tbody> </table>		<i>Condition/Citation</i>	<i>Comments</i>		
<i>Condition/Citation</i>	<i>Comments</i>				
RECOMMENDED ACTION	Closing Complaint ACES No. 251906				
EXIT INTERVIEW	NA

Source Name:	Co-Alliance – Scircleville Elevator
Photographer:	Rebecca Hayes, IDEM, Office of Air Quality
Date and Time:	10/21/2020 at 11:00 am
Description:	Photo taken from the road frontage at the grain receiving area
