Indiana Department of Environmental Management

Re: Inspection Summary/ Noncompliance Letter
PolyJohn
Whiting, Lake County

NPDES Industrial Facility Inspection Report

NPDES Permit Number: No Permit	Facility Type: Industrial	Facility Classification: Minor	TEMPO AI ID NA
Date(s) of Inspection: March 25, 2022			
Type of Inspection: Complaint Investigation			
Name and Location of Facility Inspected: PolyJohn 2500 Gaspar Whiting IN 46394		County: Lake	Receiving Waters/POTW: NA
			Permit Expiration Date: No Permit
			Design Flow: NA
On Site Representative(s):			
First Name	Last Name	Title	Email
Sam	Cooper	Chief Operations Officer	sam.cooper@polyjohn.com
Josh	Scheeringa	Yard Manager	josh.scheeringa@polyjohn.com
Phone: 800-292-1305			
Was a verbal summary of the inspection given to the on-site rep? Yes			
Certified Operator: NA	Number:	Class:	Effective Date:
	Expiration Date:	Email:	
Cyber Security Contact			
Name: Email:			
Responsible Official: Mr. Sam Cooper, Chief Operations Officer 2500 Gaspar Avenue Whiting, Indiana 46394		Permittee: PolyJohn	
		Email: sam.cooper@polyjohn.com

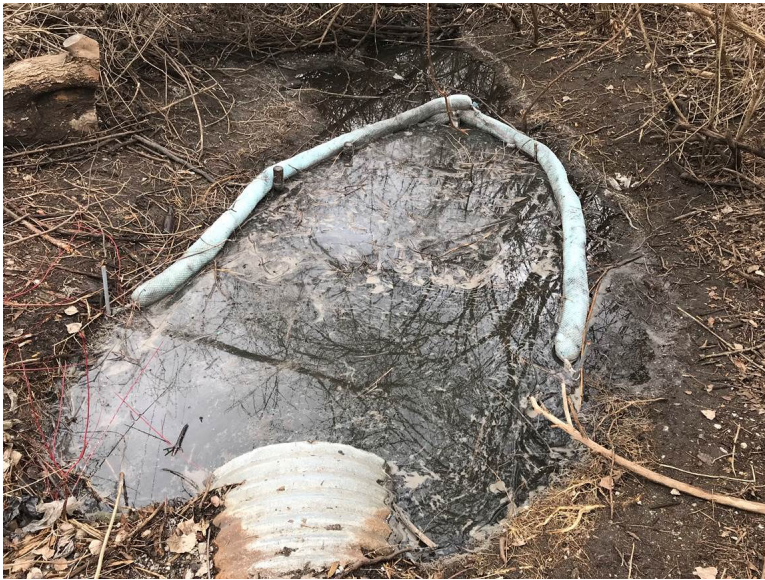
The material was identified as roto-powder and is composed of ground plastic pellets that are used in molding plastic materials on-site. Based on the amount of material found in the ditch, the PolyJohn investigation is focusing on the possibility of roto-powder clinging to bins that are stored outside and a ruptured bin or bins of roto-powder being stored outside.

327 IAC 2-1-6(a)(1) requires all waters to meet the minimum conditions of being free from substances, materials, floating debris, oil, or scum attributable to municipal, industrial, agricultural, and other land use practices, or other discharges: 1. That will settle to form putrescent or otherwise objectionable deposits; 2. That are in amounts sufficient to be unsightly or deleterious; 3. That produce color, visible oil sheen, odor, or other conditions in such degree as to create nuisance. At the time of the inspection, it was noted that fine plastics had been discharged to the ditch to a wetlands adjacent George Lake.

Facility:	
PolyJohn	
Photographer:	
Nicholas Ream	
Date: 03/25/2022	Time: 12:55 PM
Others Present:	
Location/Description:	
West and down view of the south discharge of storm water from PolyJohn. This water is combined with other storm water from the area prior to discharge. Fine grey plastic powder was observed in the waterway and on the bank.	
Others Present: Kelly Paulson and Ramelito Biscocho

A complaint was received by IDEM personnel on March 24, 2022. One of the complaints alleged plastic pellets were visible at a PolyJohn discharge point. A photograph was attached to the email and it appeared to show grey material next to a pipe discharge to a waterway. This complaint was entered into RM and issued RM Number 100561.			
Upon arriving at George Lake on March 25, 2022, we viewed the southern storm water discharge point for PolyJohn. Fine grey powder-like plastics were observed in the ditch at the discharge point and were also visible along the ditch banks, though noticeably less than the volume shown in the photograph supplied by the complainant.			
We entered the PolyJohn property and met with Mr. Sam Cooper, the Chief of Operations Officer. We made Mr. Cooper aware of the complaint. Mr. Cooper stated they were aware of the discharge and were actively investigating the source of the plastic. Mr. Josh Scheeringa, PolyJohn Yard Manager, joined the conversation and added clean up was ongoing with the plastic fines being vacuumed from the receiving stream on March 24, 2022, explaining the reduction of plastics since the complainants photograph was taken. Mr. Scheeringa also intended to continue the vacuum

Mr. Cooper stated the bins containing roto-powder would be moved to an indoor area to prevent exposure to wet weather. We requested a photograph from Mr. Scheeringa showing the storm water ditch after the completion of the vacuuming. We received the photograph on March 25, 2022 and it appeared to show no grey material in the water or on the ditch banks.

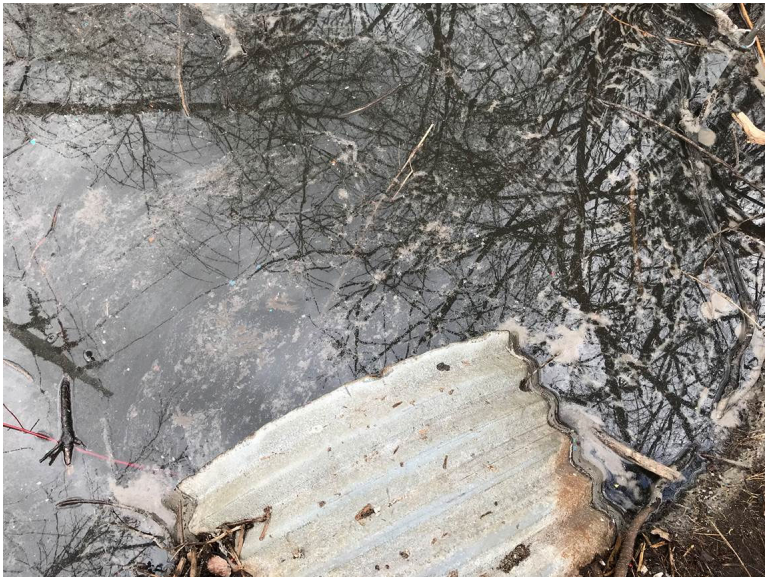
Facility:	
PolyJohn	
Photographer:	
Nicholas Ream	
Date: 03/25/2022	Time: 12:55 PM
Others Present:	
Location/Description:	
West and down view of the south discharge of storm water from PolyJohn. This water is combined with other storm water from the area prior to discharge. Fine grey plastic powder was observed in the waterway and on the bank.	
Others Present: Kelly Paulson and Ramelito Biscocho

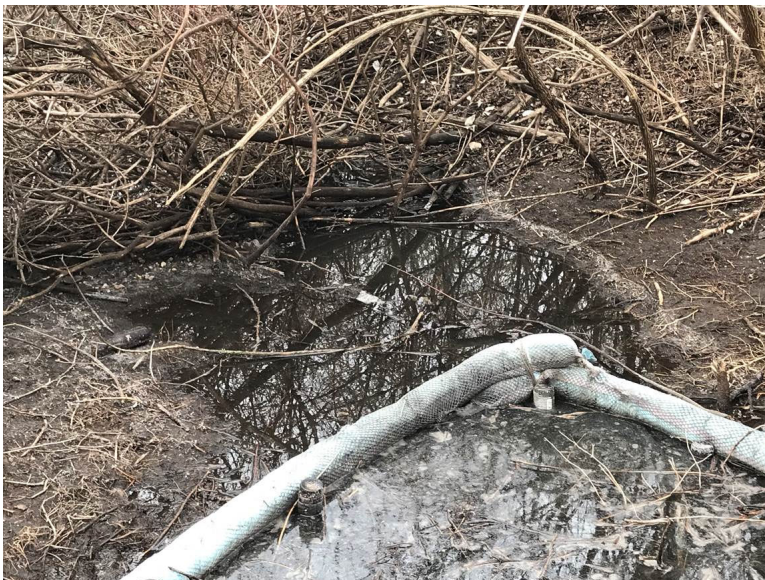
Facility:	
PolyJohn	
Photographer:	
Nicholas Ream	
Date: 03/25/2022	Time: 12:55 PM
Others Present:	
Location/Description:	
West and down view of the south discharge of storm water from PolyJohn. This water is combined with other storm water from the area prior to discharge. Fine grey plastic powder was observed in the waterway and on the bank.	
Others Present: Kelly Paulson and Ramelito Biscocho

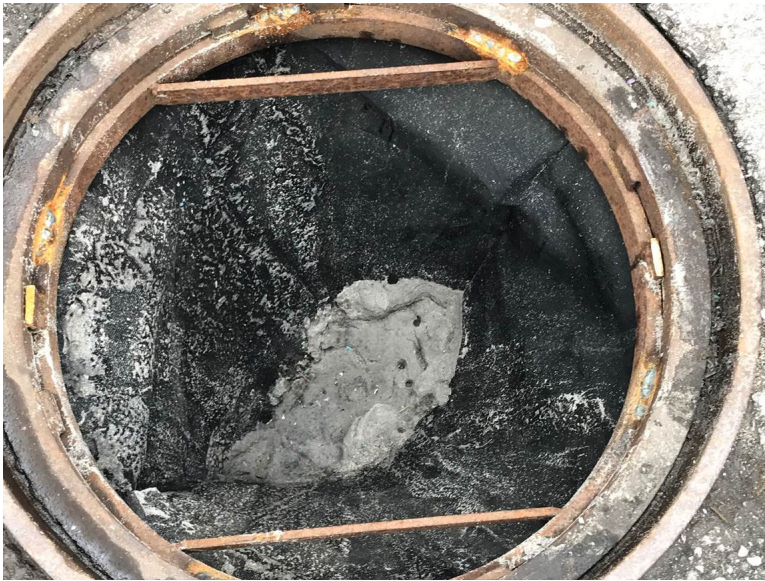
We investigated the facility and found two storm drains in which the 20 gauge mesh baskets contained roto-powder. Please refer to the attached photo in the complaint investigation report. These drains both discharge to the southern storm water system. The north storm water system was also investigated. There were no visual signs of the roto-powder at the north storm water collection system discharge. PolyJohn personnel also sealed the overflows on the mesh baskets to prevent high water levels flowing past the baskets.

Facility: PolyJohn	
Photographer: Nicholas Ream	
Date: 03/25/2022	Time: 1:30 PM
Others Present:	
Location/Description: One of two storm water drains opened that had roto-powder visible in the mesh strainer.	
Others Present: Sam Cooper, Josh Scheeringa, Kelly Paulson and Ramelito Biscocho

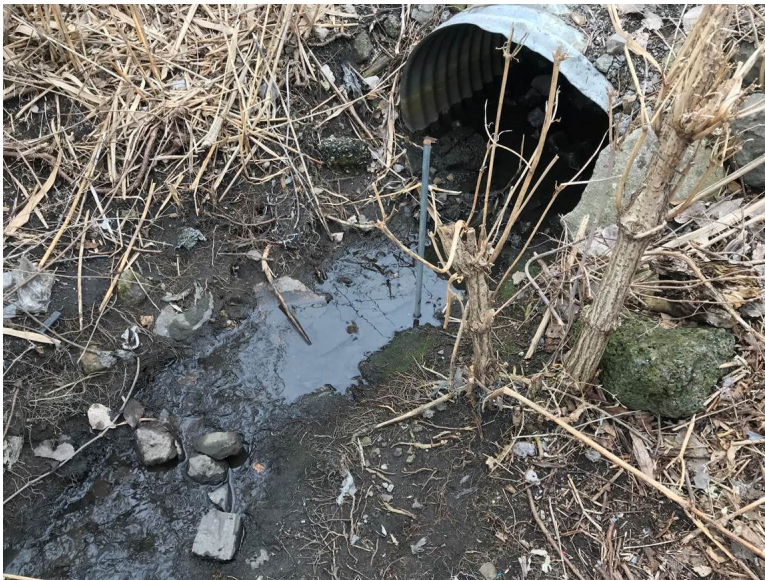
Facility: PolyJohn	
Photographer: Nicholas Ream	
Date: 03/25/2022	Time: 1:35 PM
Others Present:	
Location/Description: Northeast view of the north storm water discharge. No evidence of roto-powder was observed at the discharge point.	
Others Present: Sam Cooper, Josh Scheeringa, Kelly Paulson and Ramelito Biscocho
