Re: Inspection Summary Letter
SW Program IDs 77-03 & 77-041

RESTRICTED WASTE SITE TYPE I OR II INSPECTION REPORT

Facility Name Merom Generating Station [SW Program ID 77-03 & 77-04]

Inspection Date (month, day, year) October 31, 2022

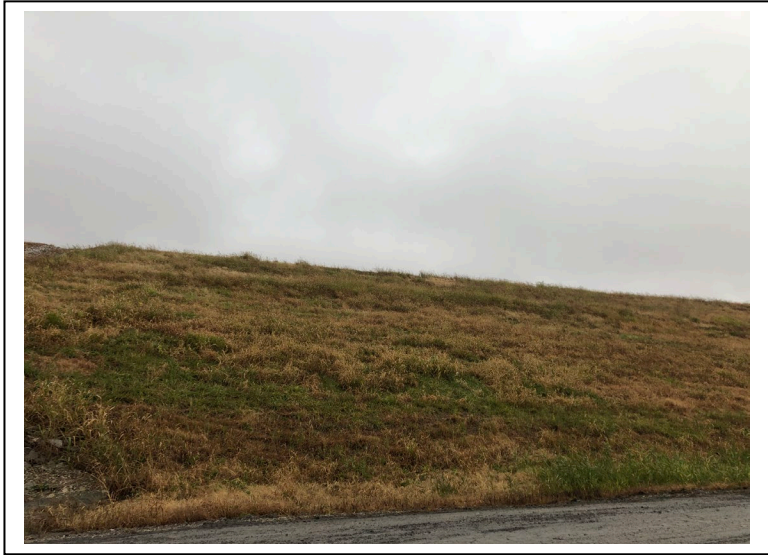
Photo 1

IDEM staff drove around the perimeter of Area 1. IDEM staff observed established vegetation the side slopes. No leachate or erosion issues were observed (See photos 1).

Location & Description: Area 1 side slope

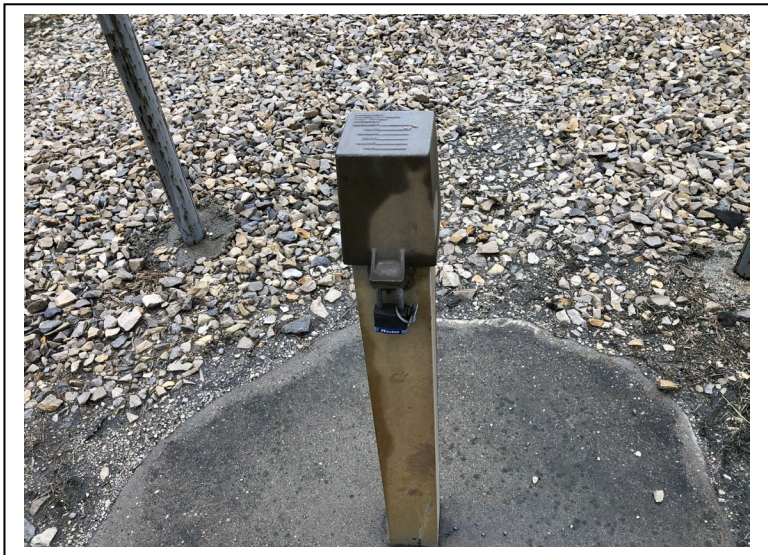
Photo 2

A restricted waste site (RWS) inspection was conducted at Hoosier Energy-Merom Generating Station on October 31, 2022. IDEM staff arrived on-site and met with Mr. Matt Deal, Mr. Darrell Bayless, Mr. Larry Snellenberger inside material handling building. IDEM staff observed the facility's plot plans, weekly landfill inspection logs, and operator licenses. No issues were found. IDEM staff then drove to the landfill. While traveling, IDEM staff inspected monitoring well SW-45. This well was locked, labeled, and well maintained.

Location & Description: Monitoring well SW-45

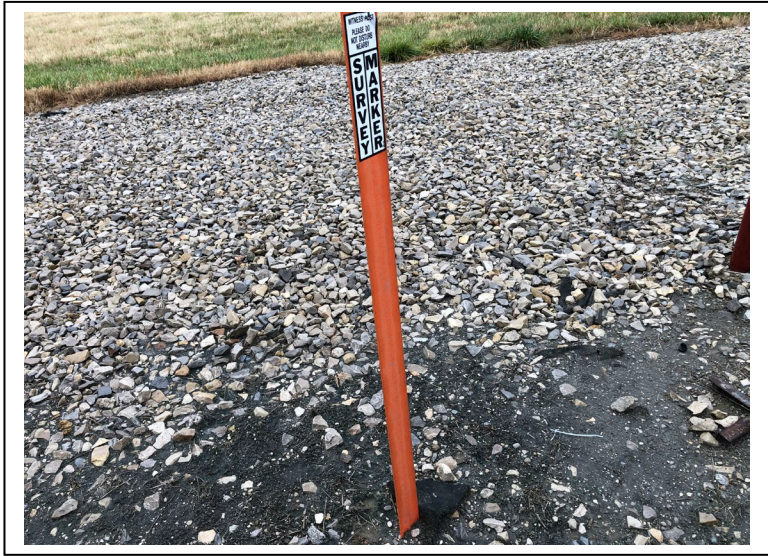
Photo 3

IDEM staff drove around Area 3. At the time of the inspection, IDEM staff observed the facility actively disposing of waste in Cell 2. IDEM staff drove around the perimeter of Cell 1, observing a site benchmark and monitoring wells (See photos 2-4).

Location & Description: Site benchmark

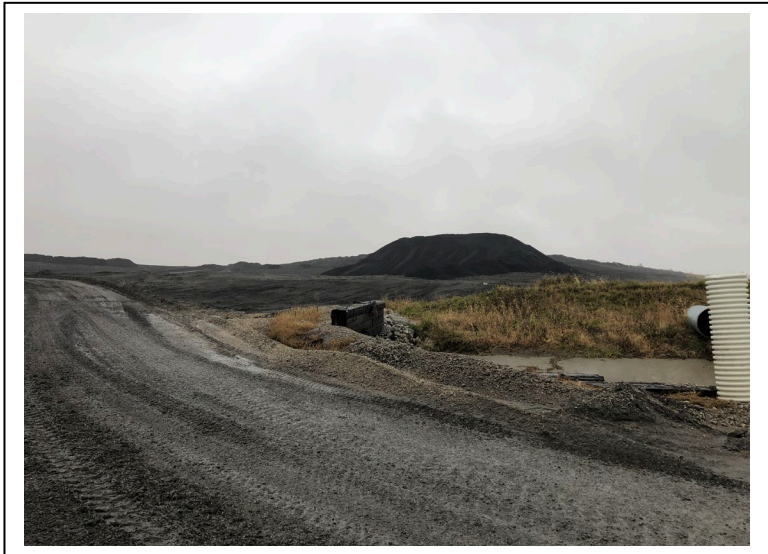
Photo 4

Location & Description: Area 3 Cell 2 disposal area

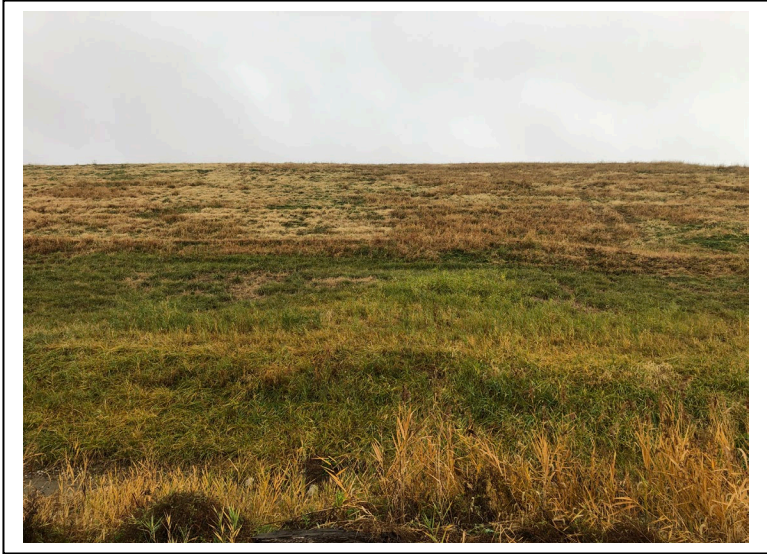
Photo 5

IDEM staff drove around the perimeter of Area 2A. At the time of the inspection, IDEM staff did not observe any seeps occurring on the base slopes. Vegetation cover was established on the side slopes. Additionally, IDEM staff did not observe any chemical odors or any white precipitate occurring (See photo 5).

Location & Description: Area 2A side slope

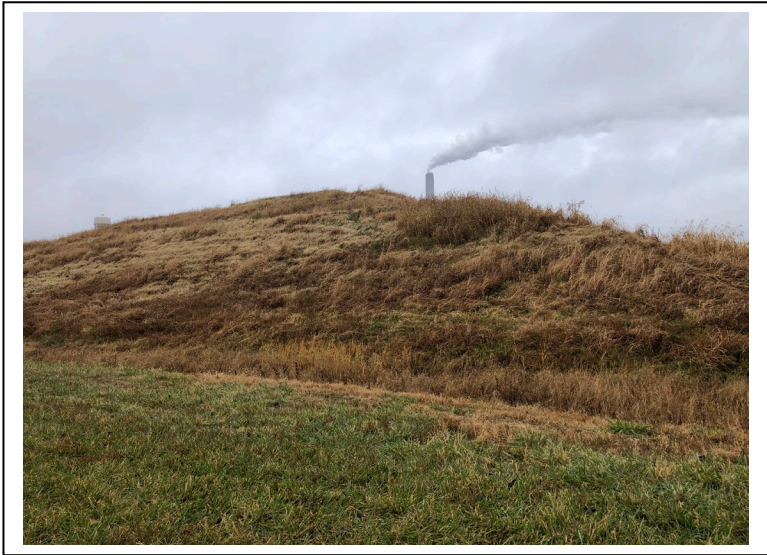
Photo 6

IDEM staff drove around the perimeter of Area 2B. IDEM staff observed well established vegetation on the side slopes of Area 2B (See photo 6).

Location & Description: Area 2B side slope
