## **Appendix D**

### **Photograph Log**

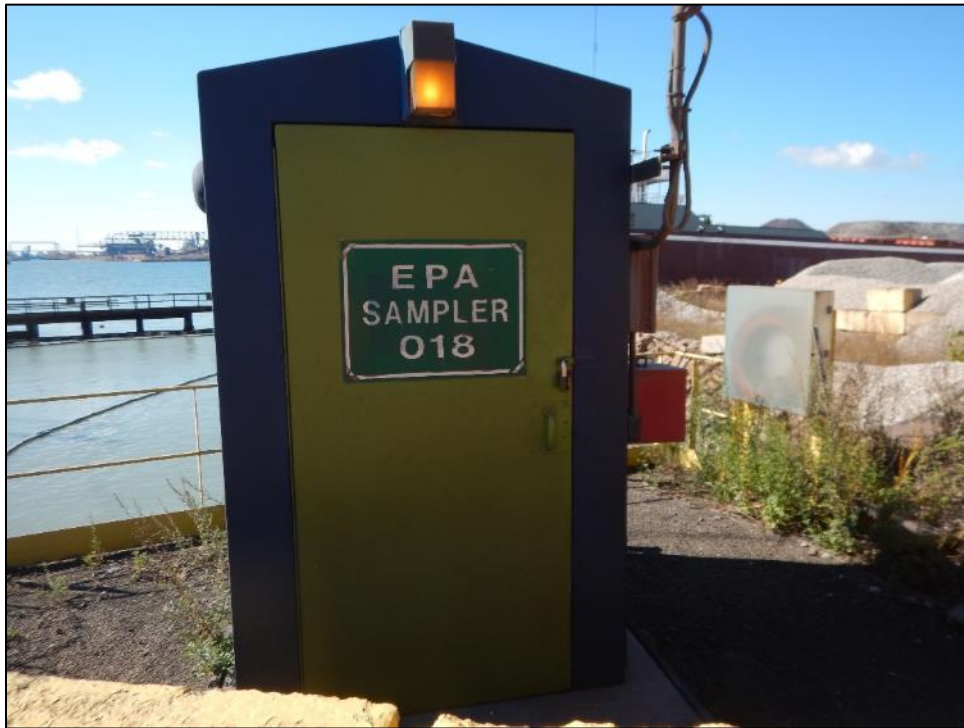
**Photograph 1. Outfall 018** – View, facing west, of the Outfall 018 composite sample shed.

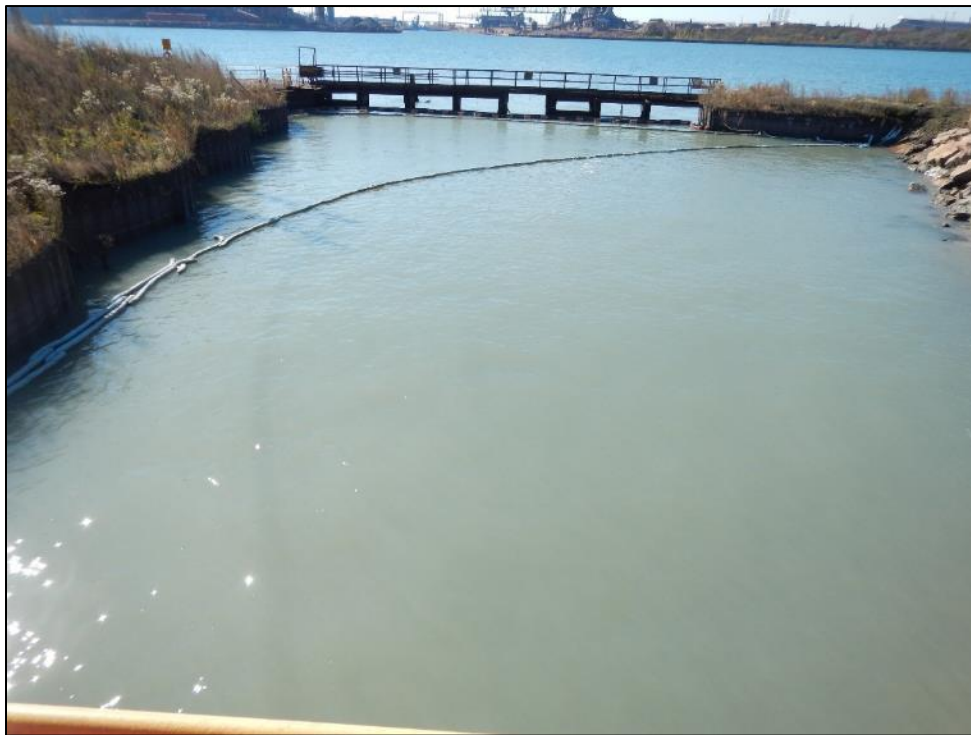
**Photograph 2. Outfall 018** – View, facing west, of the Outfall 018 discharge area. Note the water was cloudy. Facility representatives stated they believed the cloudy conditions were caused by recent precipitation and wind in the lake.

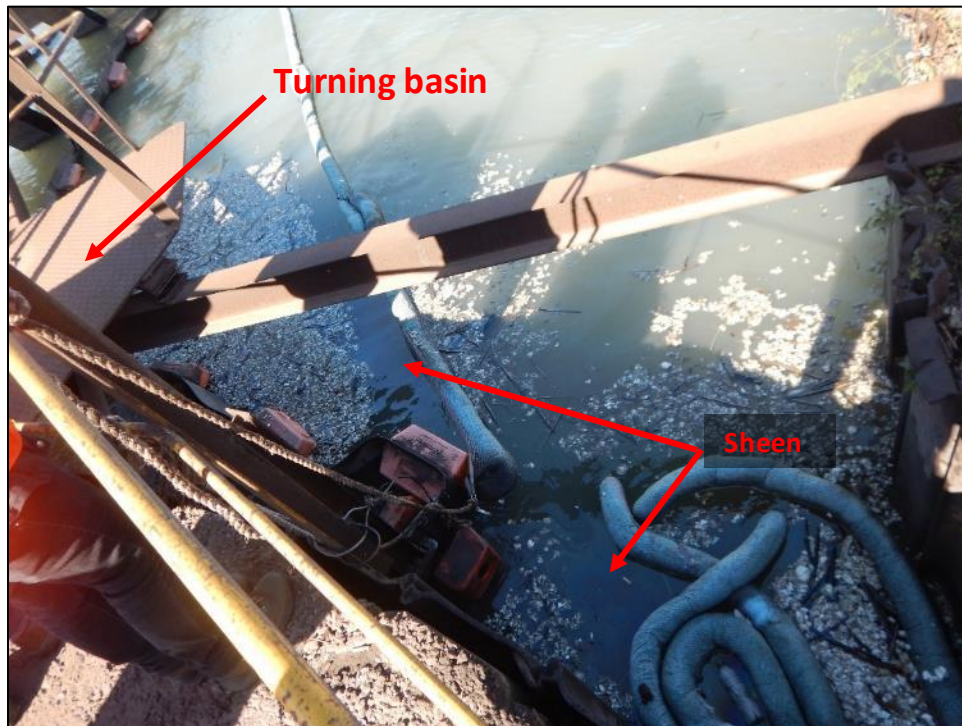
**Photograph 3. Outfall 018** - View of the west end of the Outfall 018 discharge area. Sheen was observed leaking from the booms

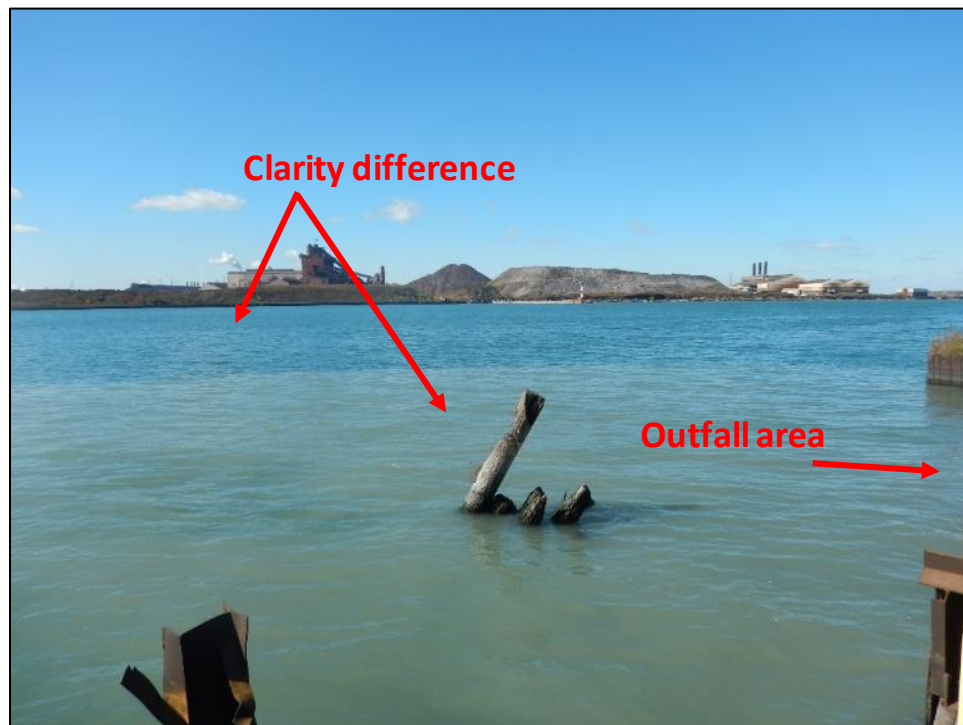
**Photograph 4. Outfall 018** – View, facing northwest, of the Indiana Harbor Turning Basin in the vicinity of the Outfall 018 discharge area. Note the difference in water clarity.

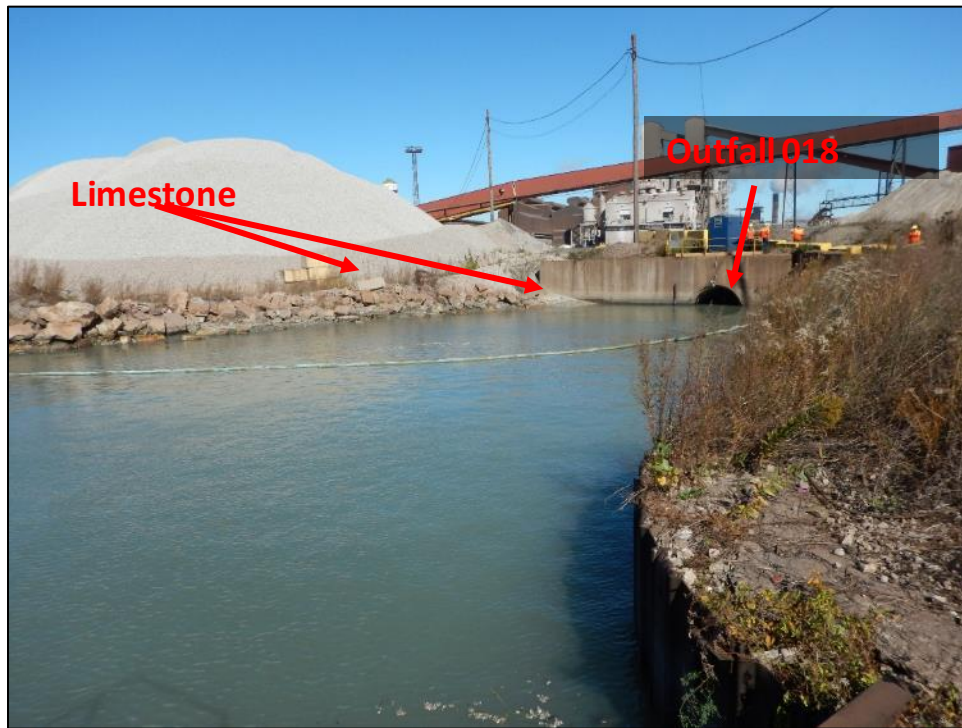
**Photograph 5. Outfall 018** – View, facing north, of Outfall 018 and adjacent limestone stockpile. Note that the material was stored beyond the concrete barrier containment and some material had migrated to the edge of the receiving water.

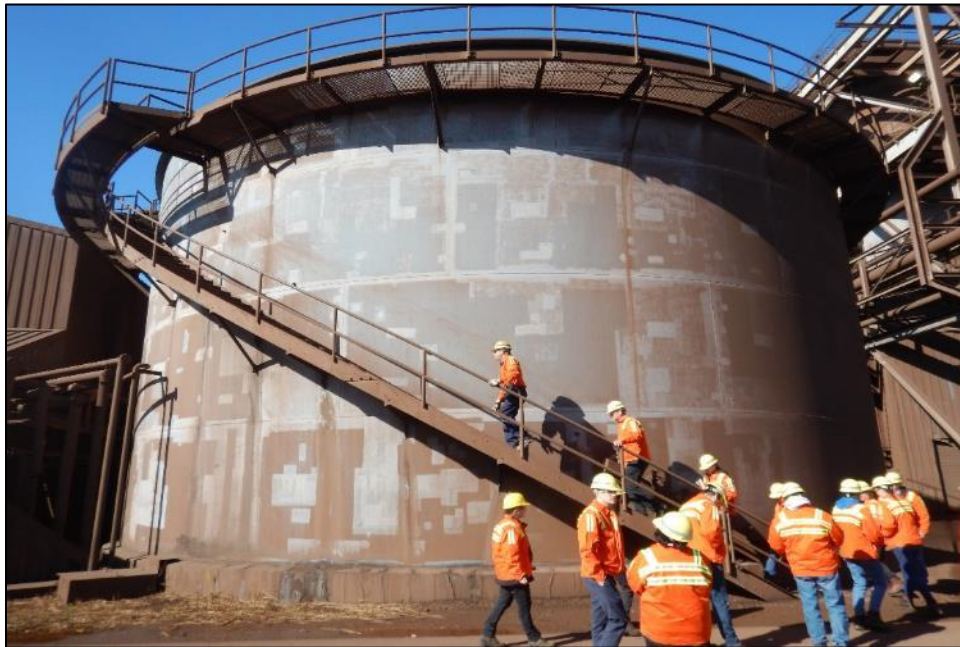
**Photograph 6. No. 4 Steel Plant Treatment System** – View, facing north, of the south clarifier tank.

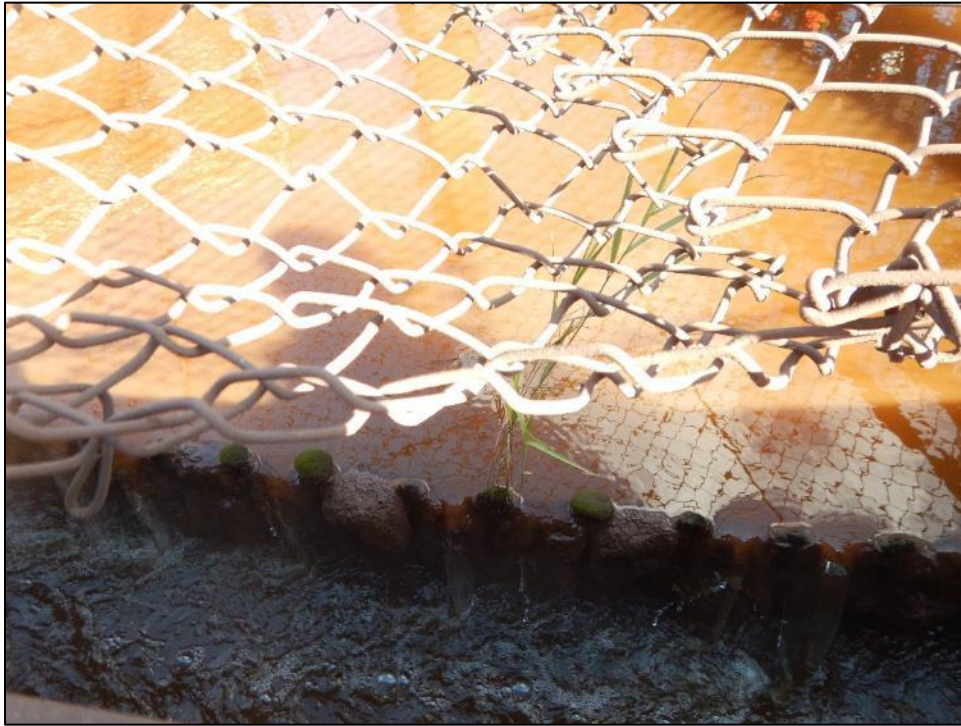
**Photograph 7. No. 4 Steel Plant Treatment System** – View of vegetation and algae in the north clarifier weirs.

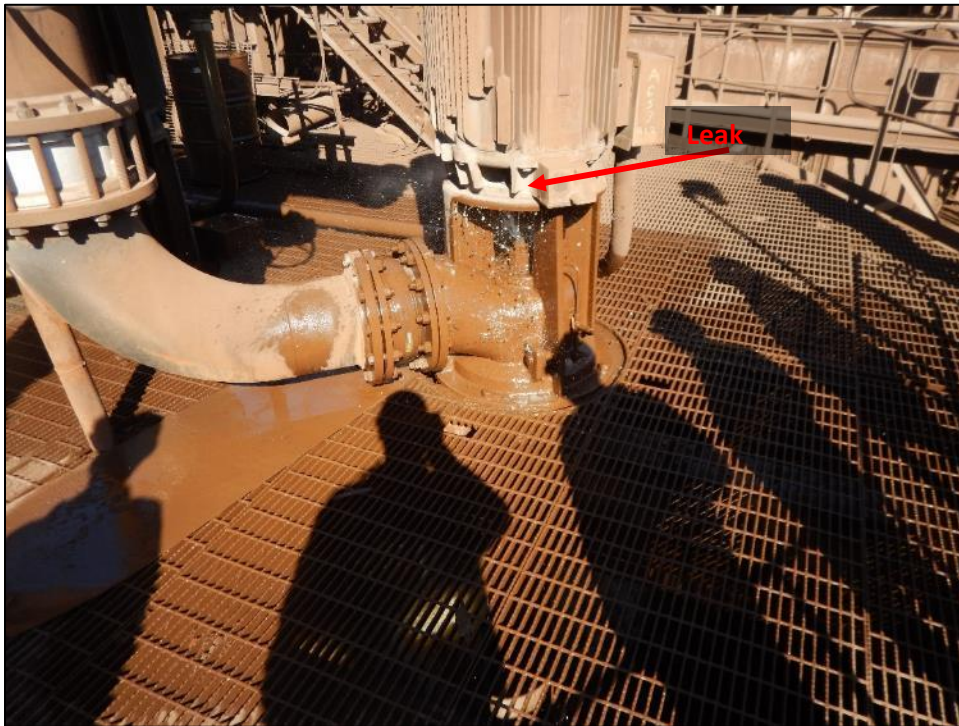
**Photograph 8. No. 4 Steel Plant Treatment System** - View of a leak in the No. 8 Clearwell Pump.

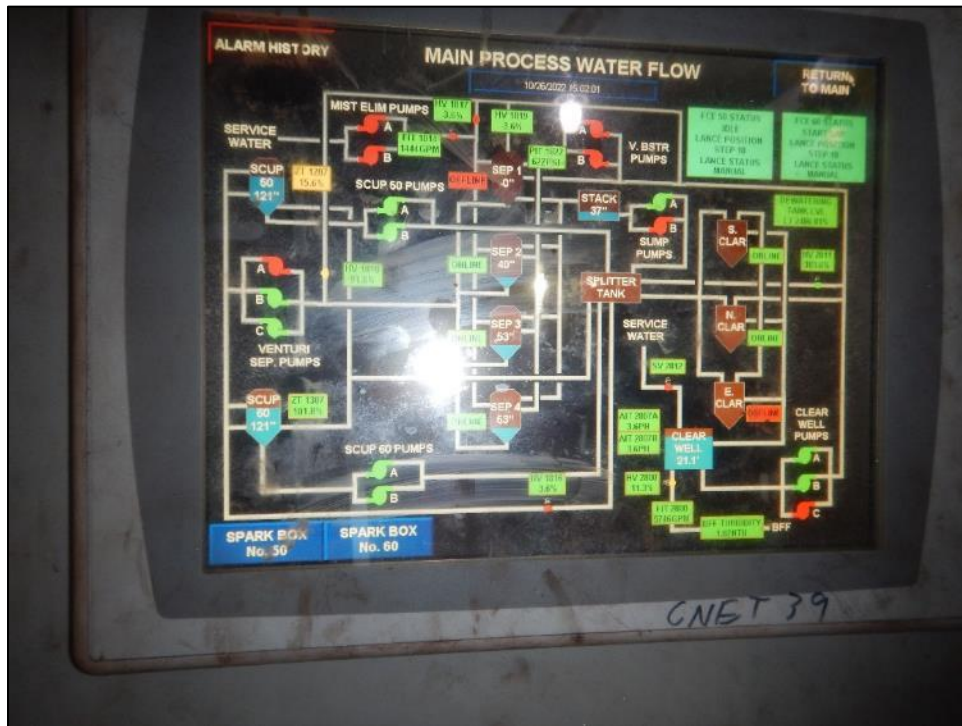
**Photograph 9. No. 4 Steel Plant Treatment System** – View of the SCADA system that supports the treatment system.

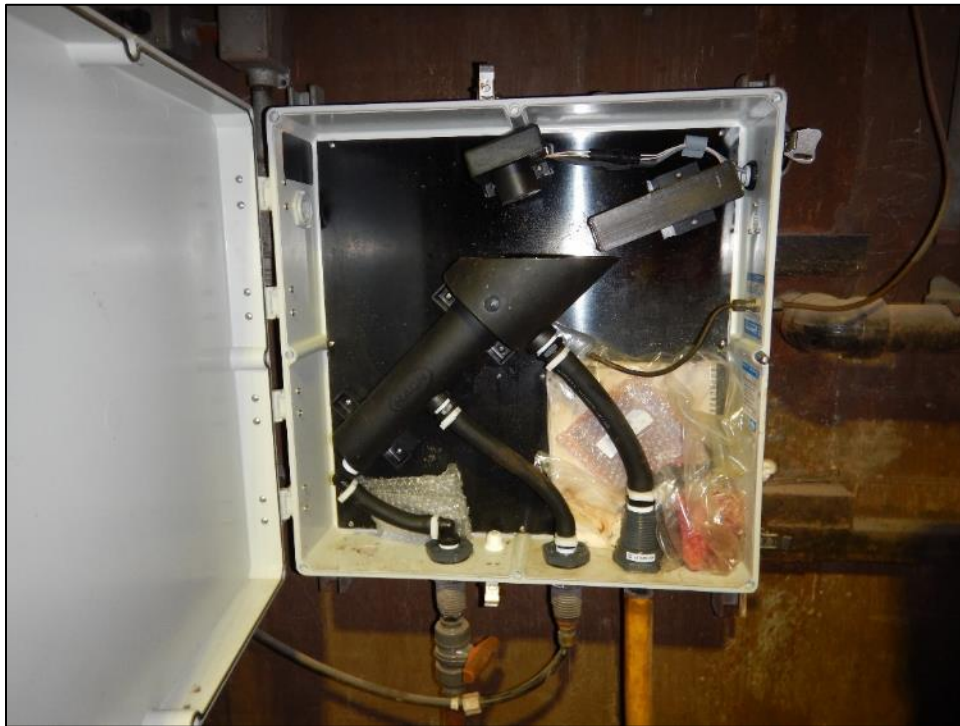
**Photograph 10. No. 4 Steel Plant Treatment System** – View of the turbidimeter for Outfall 618.

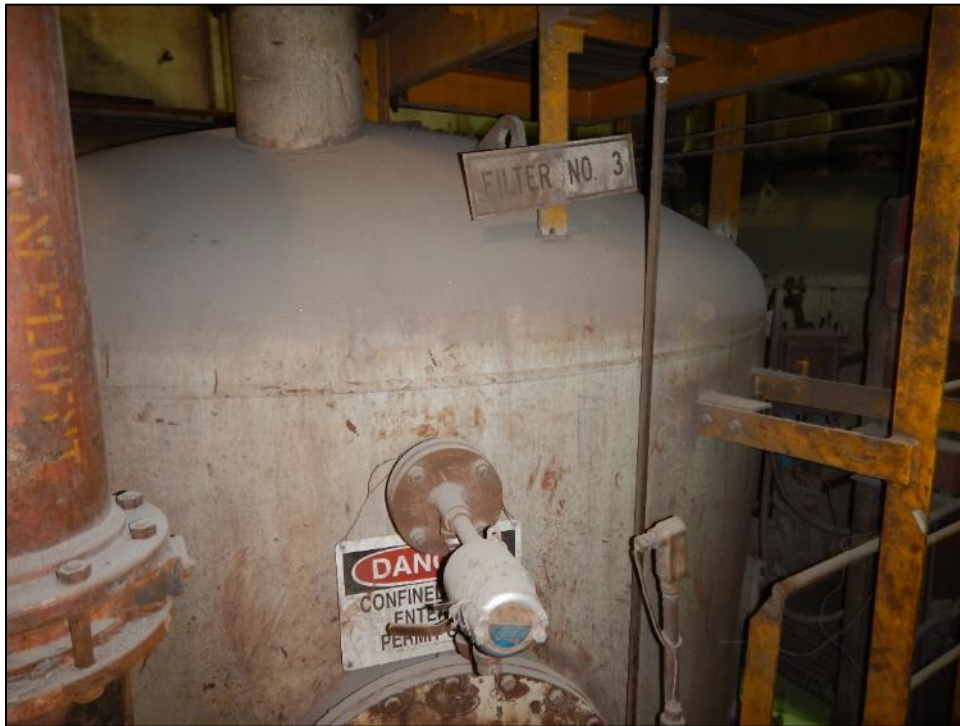
**Photograph 11. No. 4 Steel Plant Treatment System - View of Sand Filter No. 3.**

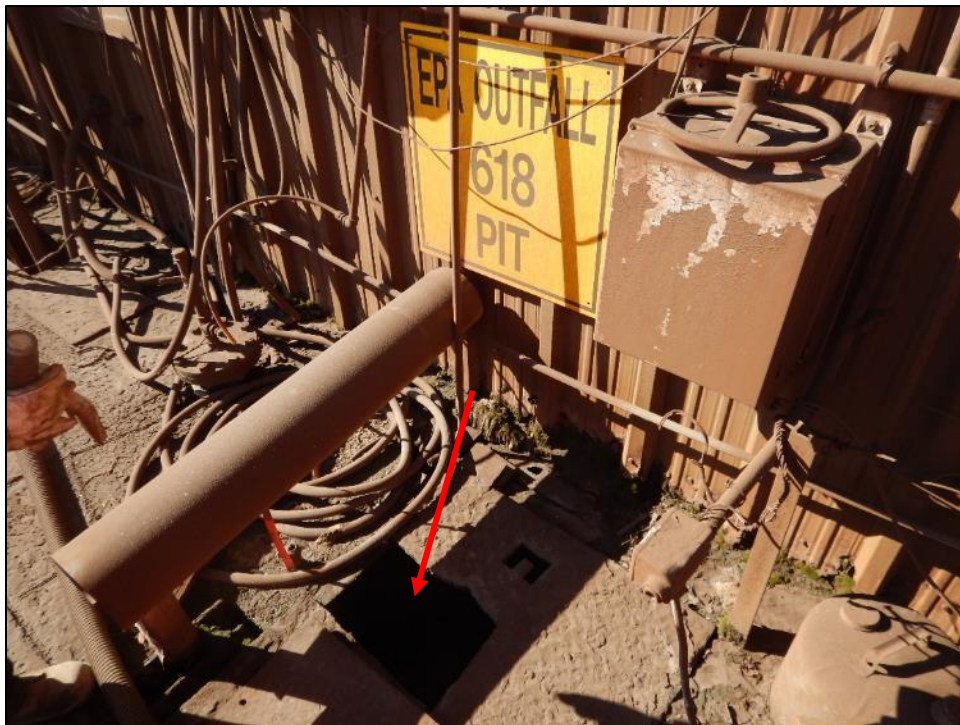
**Photograph 12. No. 4 Steel Plant Treatment System - View of the Outfall 618 effluent pit.**

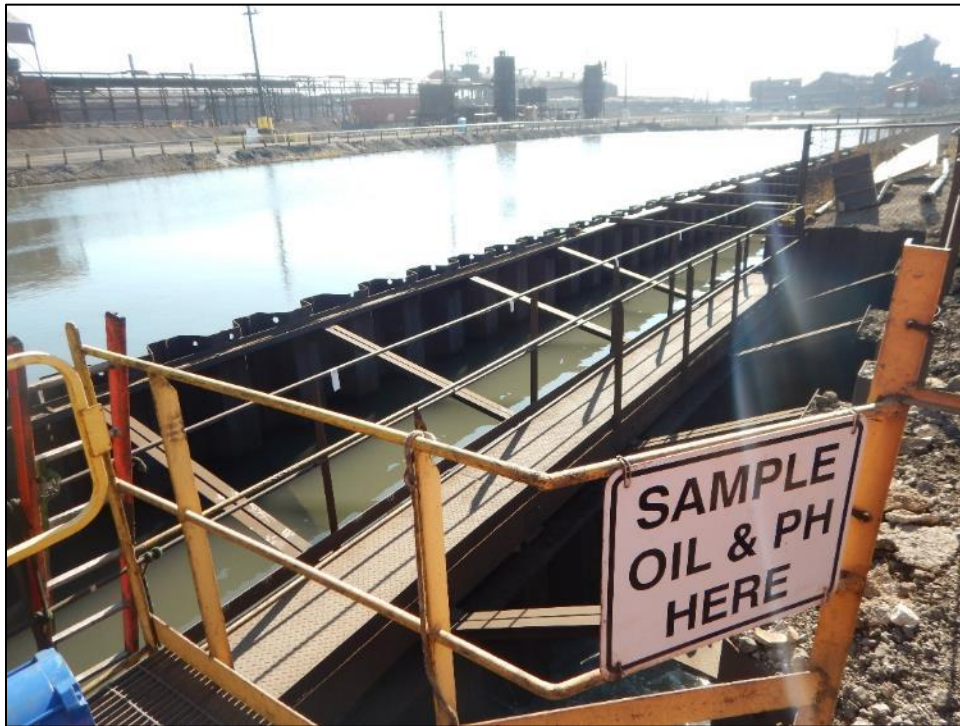
**Photograph 13. Terminal Treatment Plant West** – View, facing southwest, of the treatment plant.

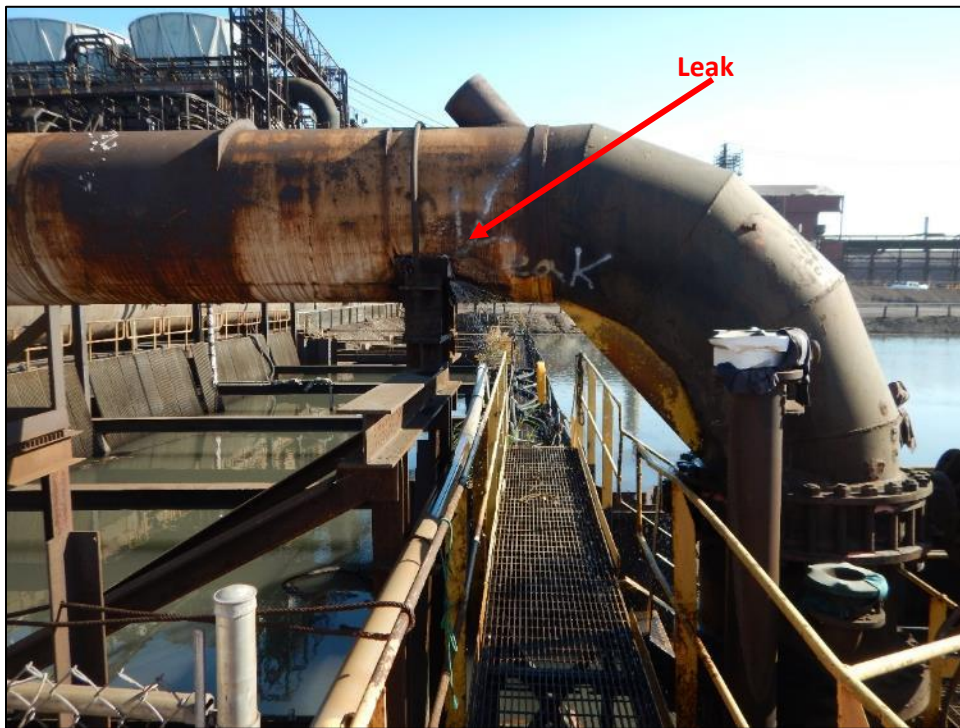
**Photograph 14. Terminal Treatment Plant West** - View of a leak in a pipe entering the effluent channel.

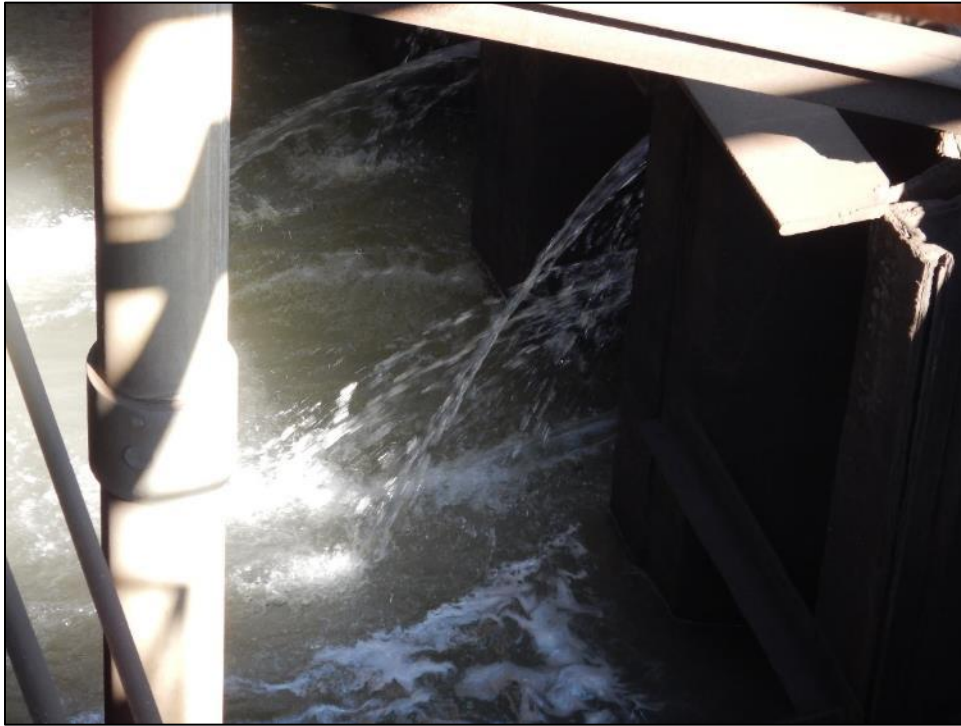
**Photograph 15. Terminal Treatment Plant West** – View of leaks in the metal tank walls between the settling basin and effluent channel, on the north side of the plant.

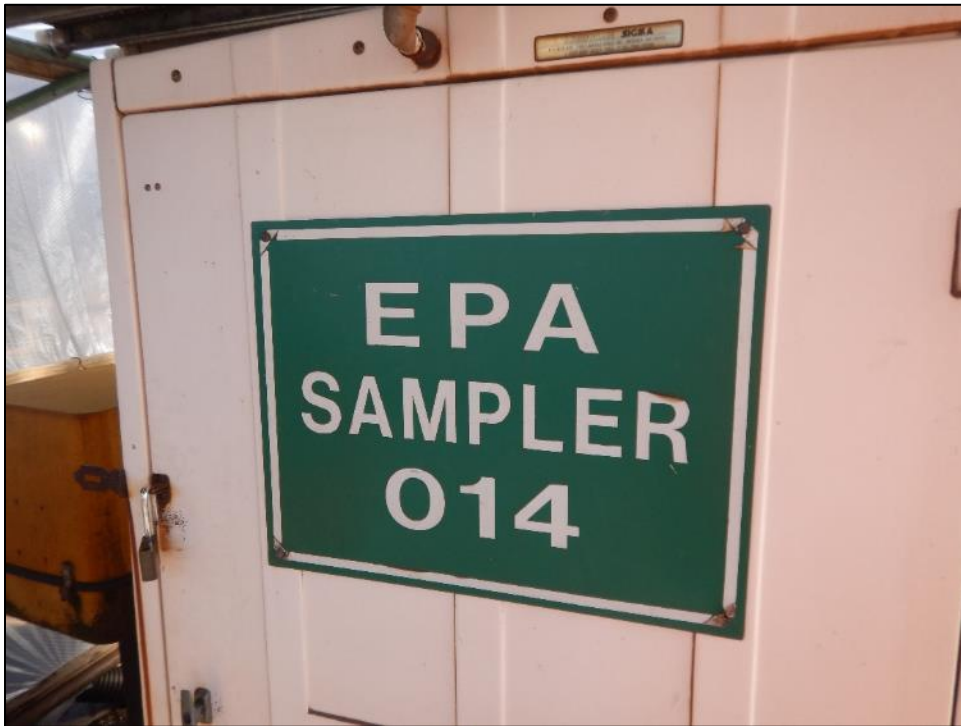
**Photograph 16. Outfall 014** - View of the Outfall 014 composite sample shed.

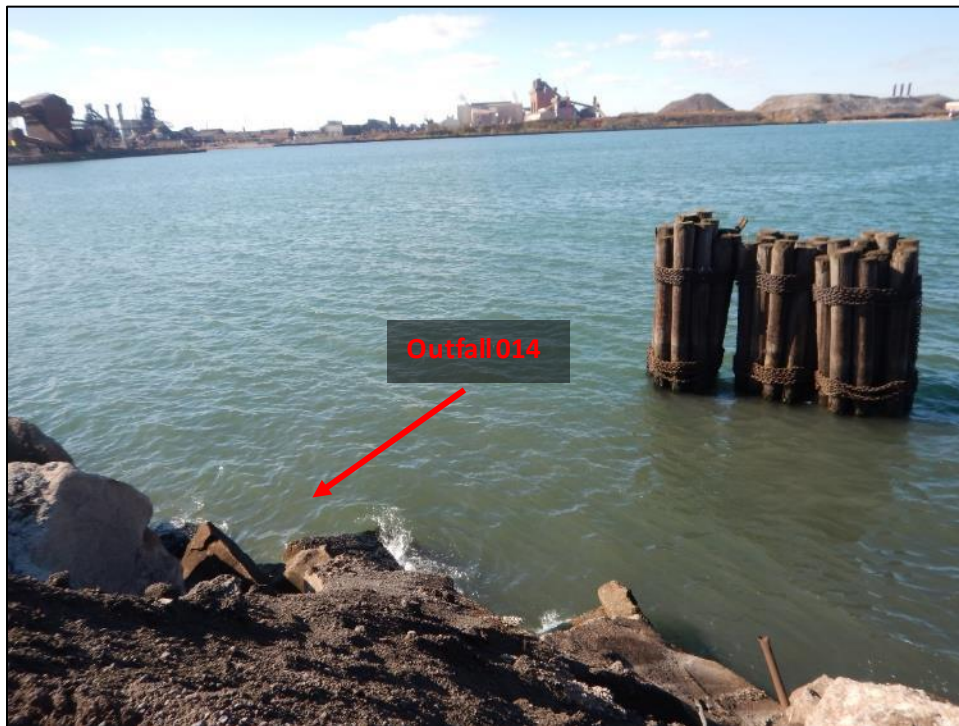
**Photograph 17. Outfall 014 - View, facing northwest, of the vicinity of Outfall 014.**

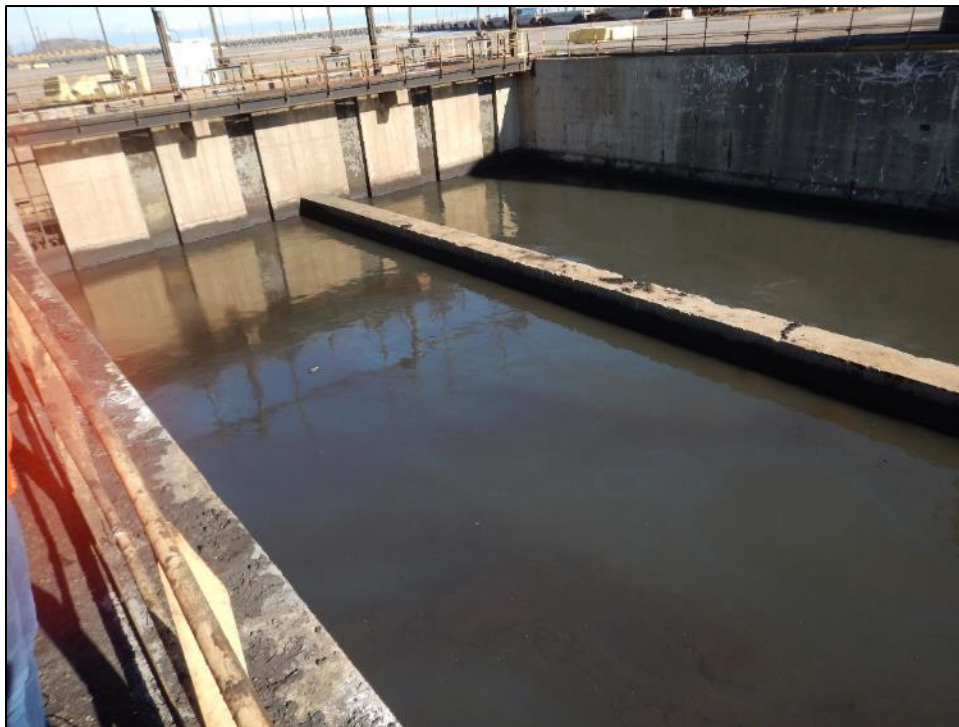
**Photograph 18. Terminal Treatment Plant East - View, facing southeast, of the scalping tanks.**

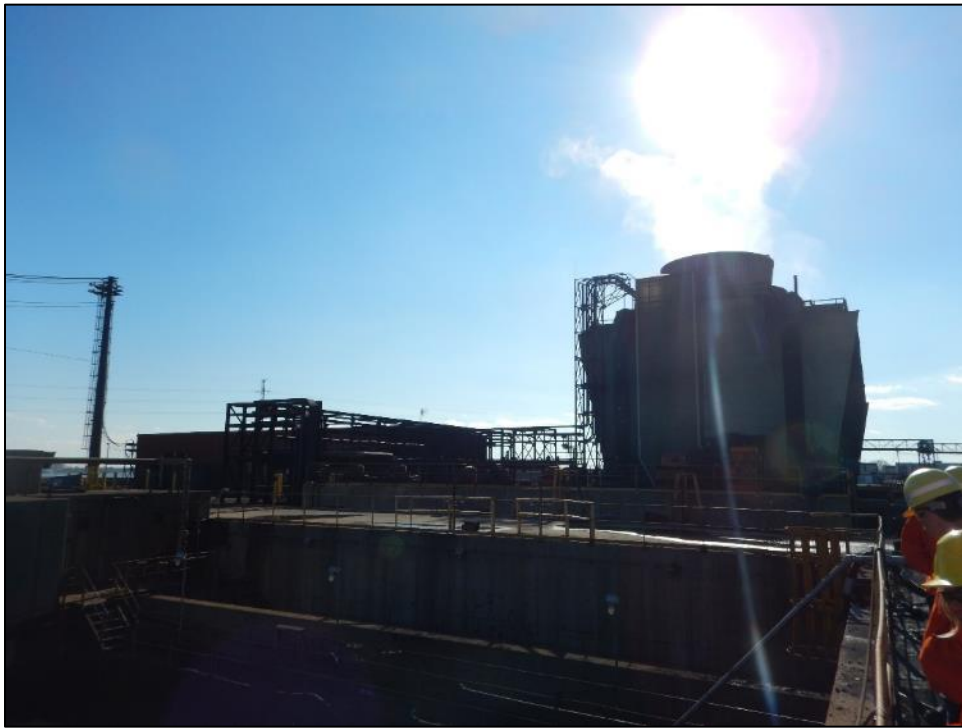
**Photograph 19. Terminal Treatment Plant East** – View, facing southwest, of the cooling towers.

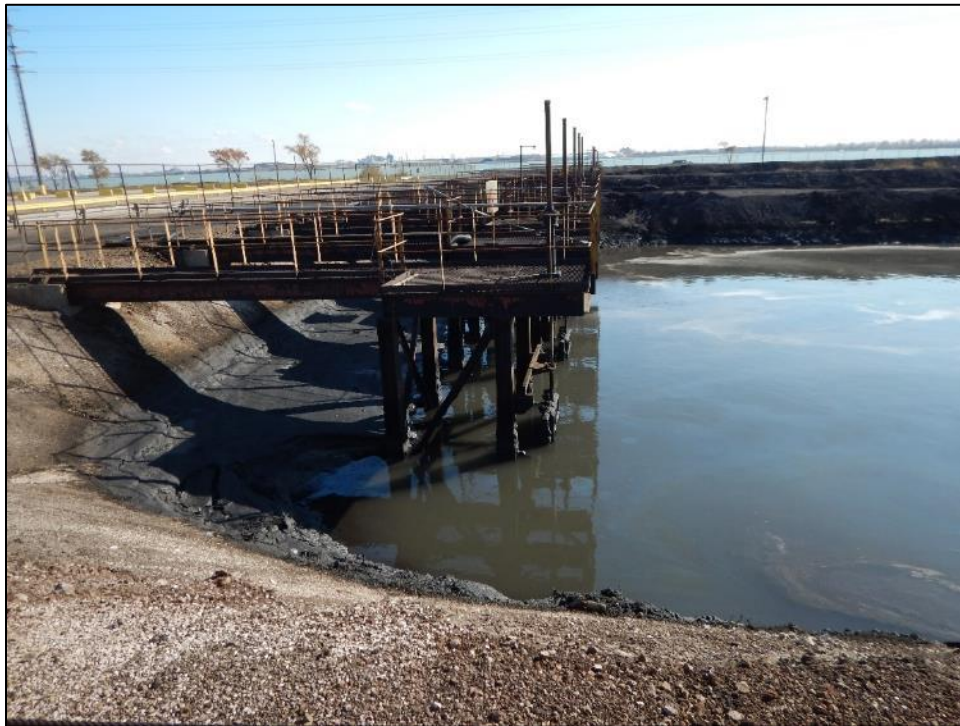
**Photograph 20. Terminal Treatment Plant East** – View, facing south, of the settling basin. Oil Tech has been contacted to remove and recycle oil from the basin.

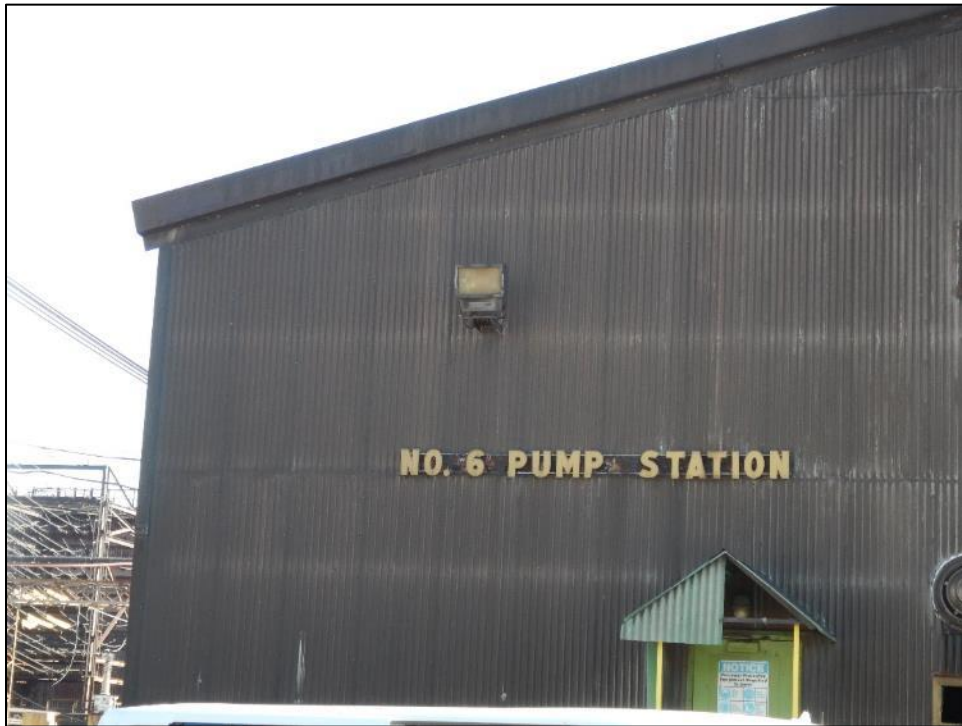
**Photograph 21. No. 6 Pump House** - View of the No. 6 Pump House building.

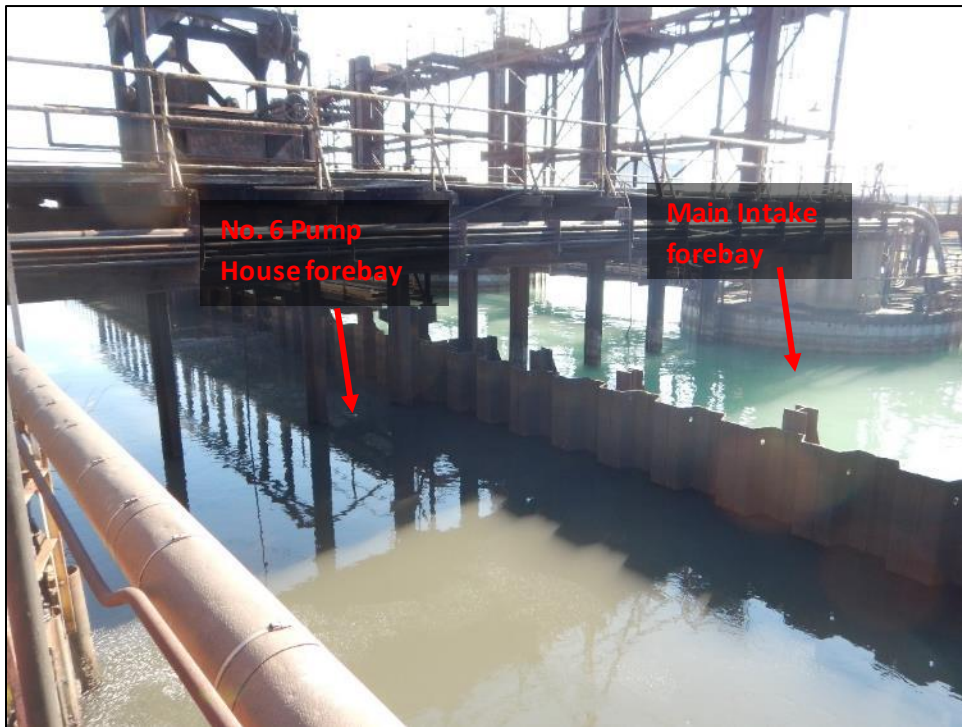
**Photograph 22. No. 6 Pump House** – View, facing south, of the Main Intake and No. 6 Pump House forebays. This is the location where overflows from the No. 6 Pump House side had entered into the Main Intake side in the past.

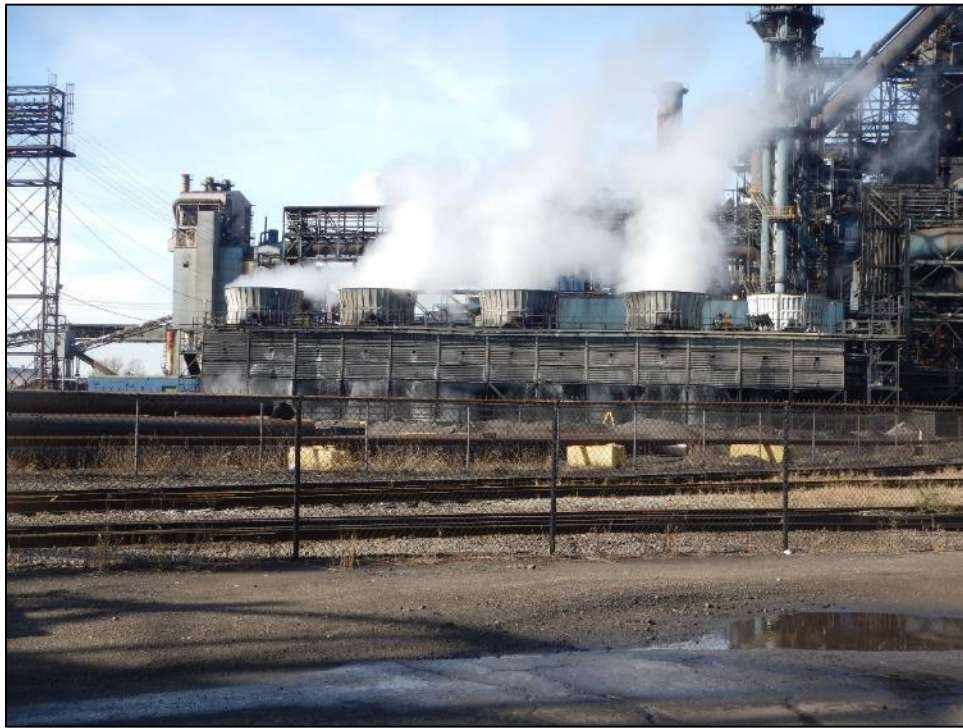
**Photograph 23. No. 7 Blast Furnace Blowdown Treatment System** – View, facing north, of the cooling towers.

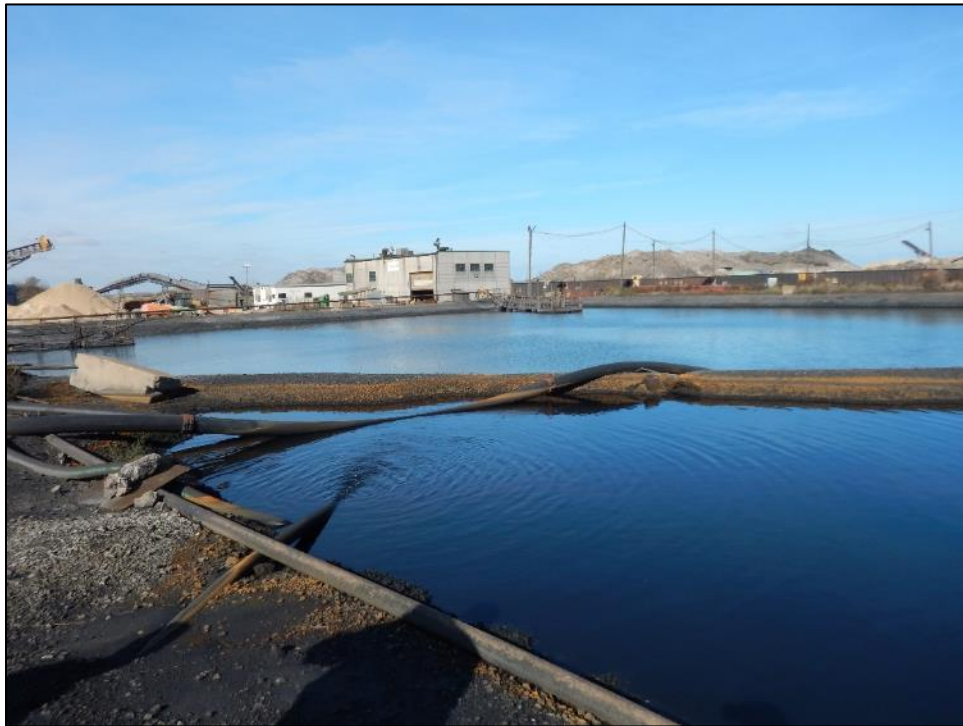
**Photograph 24. No. 7 Blast Furnace Blowdown Treatment System** - View, facing northeast, of the process wastewater ponds. The small pond section in the foreground of the photo feeds the treatment system.

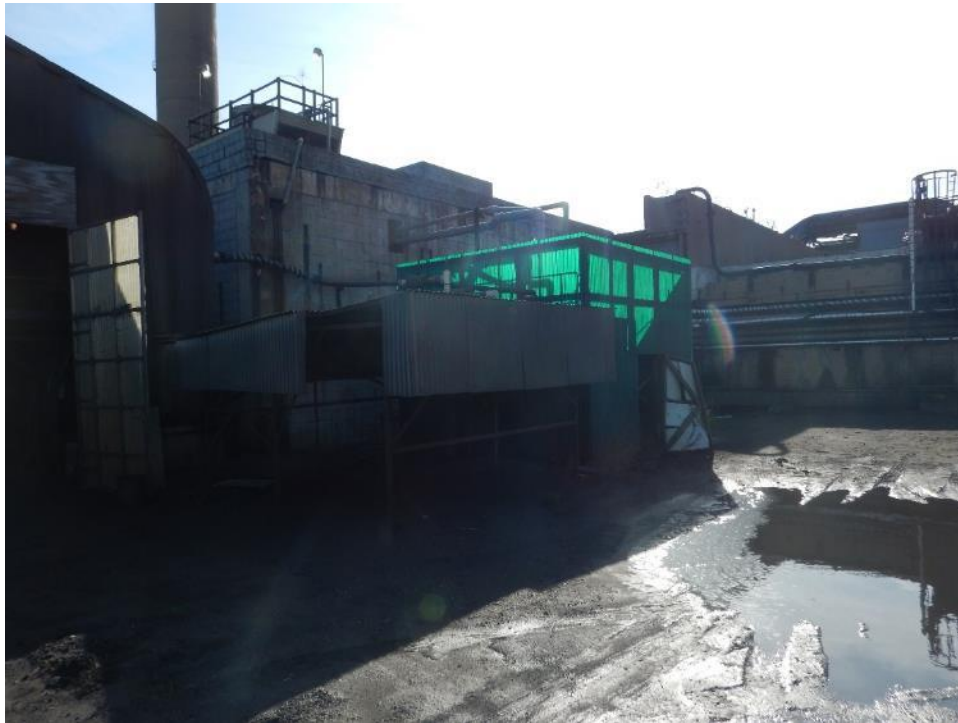
**Photograph 25. No. 7 Blast Furnace Blowdown Treatment System** – View, facing southeast, of the 100 Tank building (green roof).

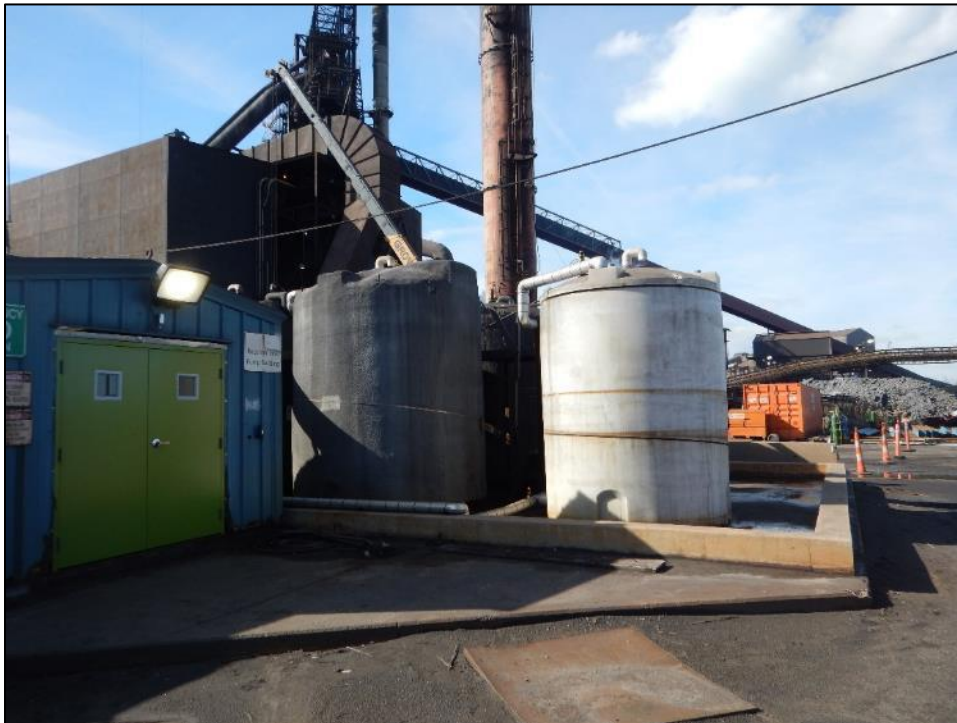
**Photograph 26. No. 7 Blast Furnace Blowdown Treatment System** – View, facing north, of sulfuric acid and ferric chloride chemical and mixing tanks.

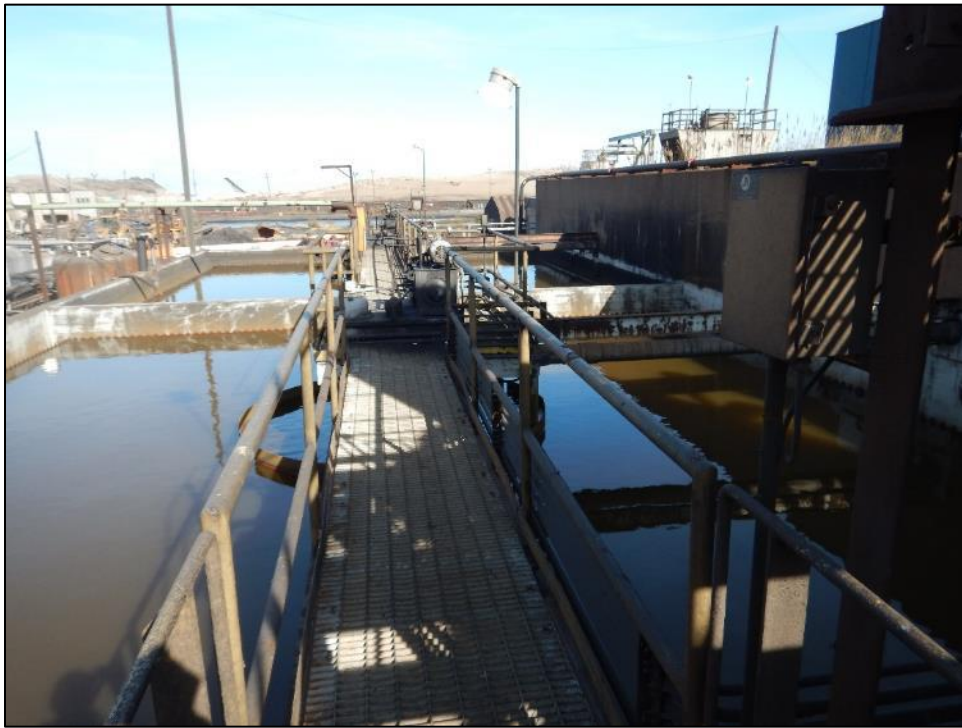
**Photograph 27. No. 7 Blast Furnace Blowdown Treatment System** – View, facing east, of the plant's two clarifiers.

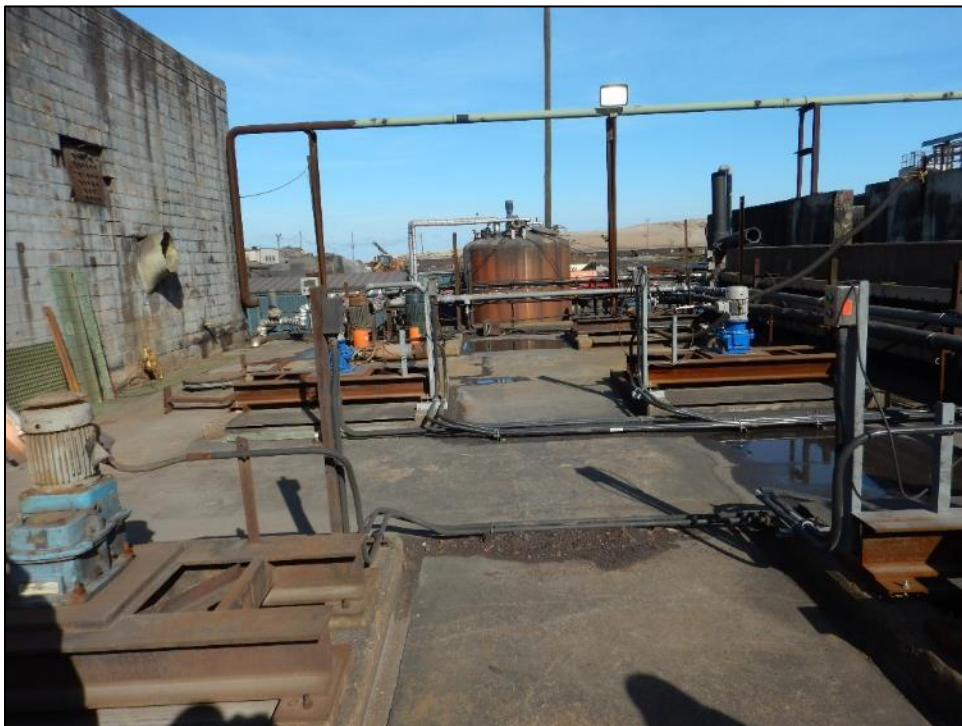
**Photograph 28. No. 7 Blast Furnace Blowdown Treatment System** – View, facing east, of the plant's multiple reaction chambers.

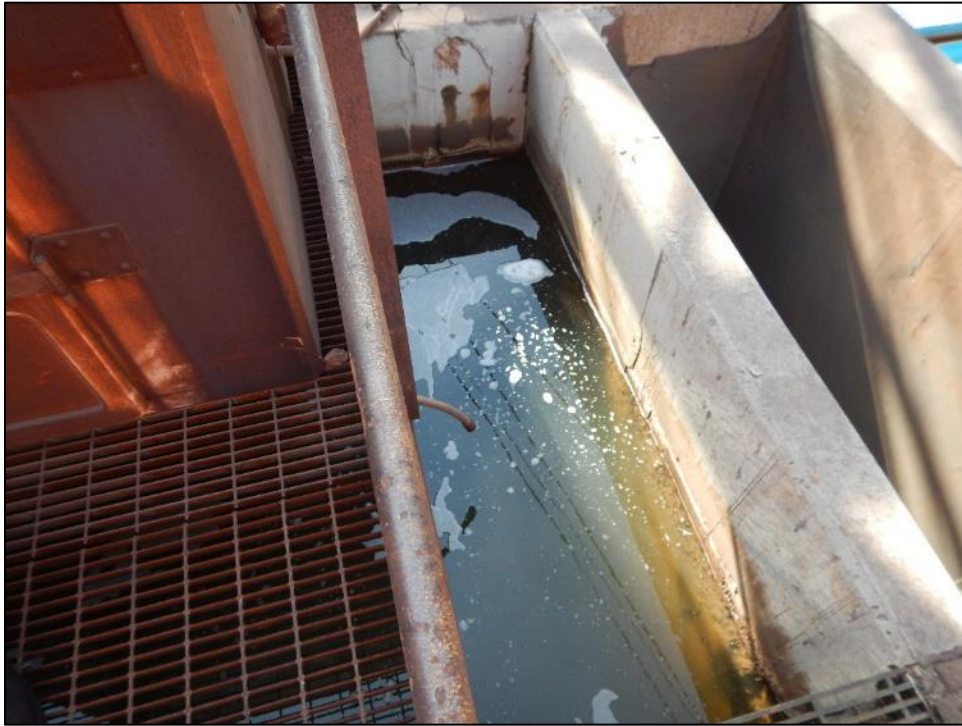
**Photograph 29. No. 7 Blast Furnace Blowdown Treatment System – View of the Outfall 518 effluent pit.**

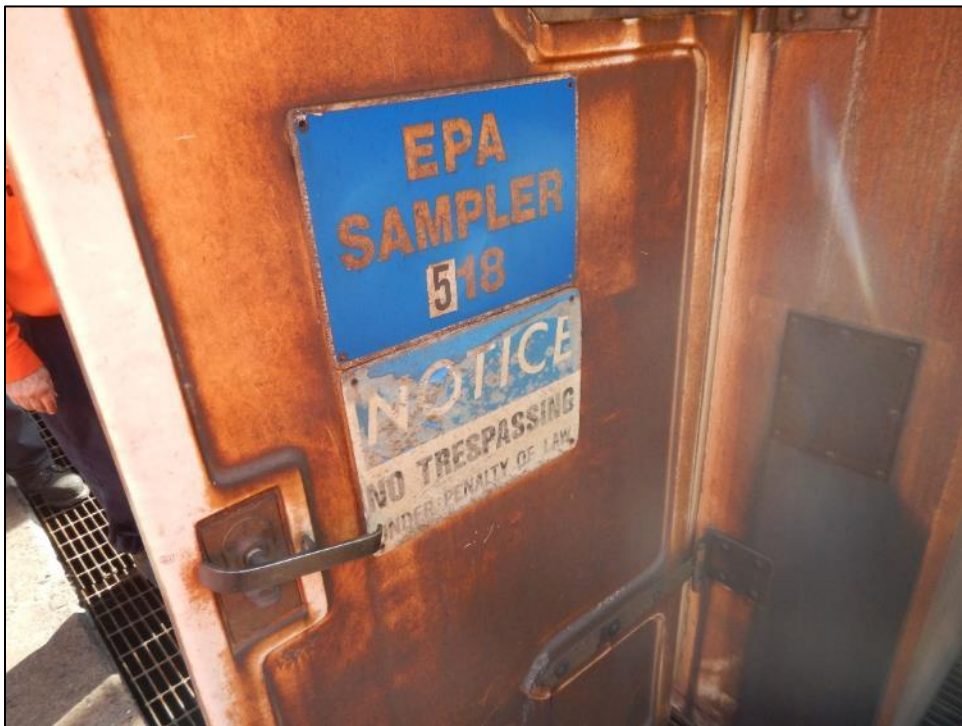
**Photograph 30. No. 7 Blast Furnace Blowdown Treatment System – View of the Outfall 518 composite sample shed.**

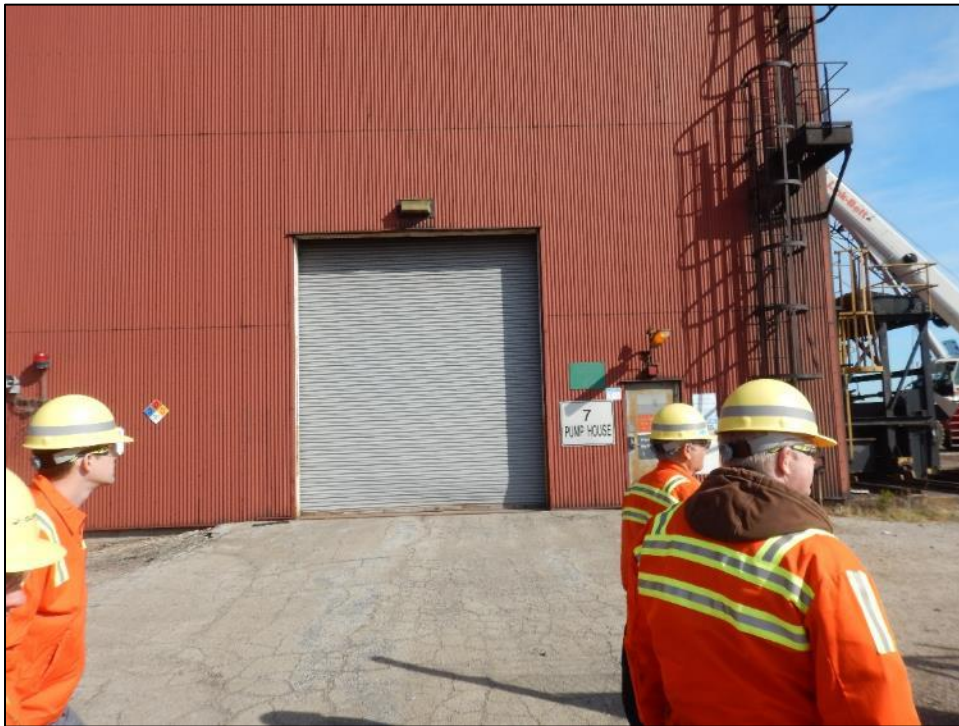
**Photograph 31. No. 7 Pump House** – View, facing east, of the No. 7 Pump House building.
