## **Appendix D**

### **Photograph Log**

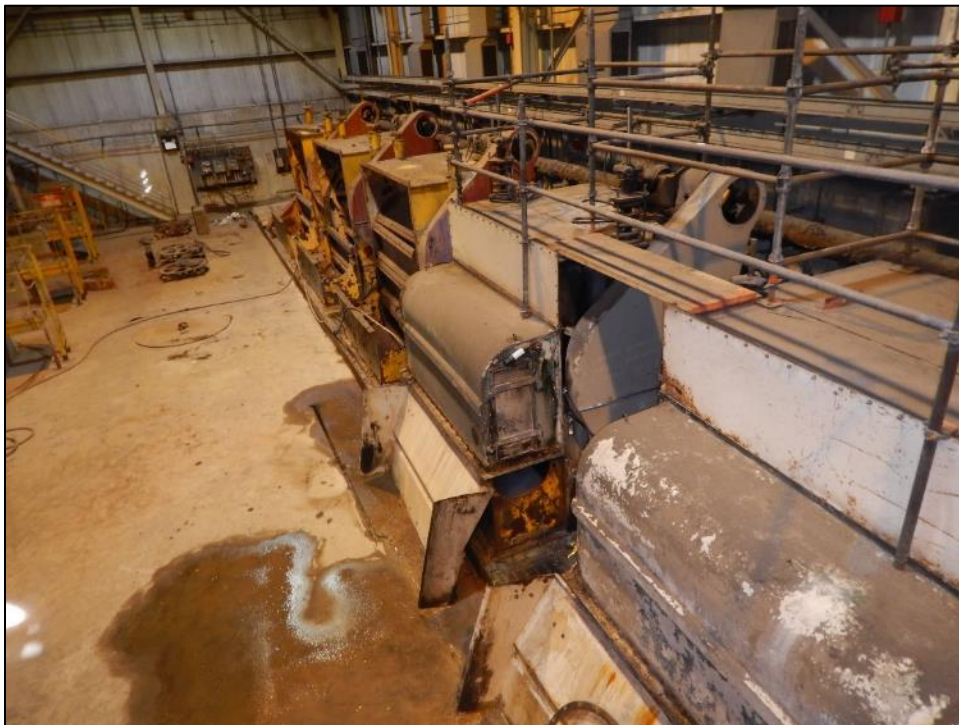
**Photograph 32. No. 7 Pump House** – View of the intake screens inside the pump house building.

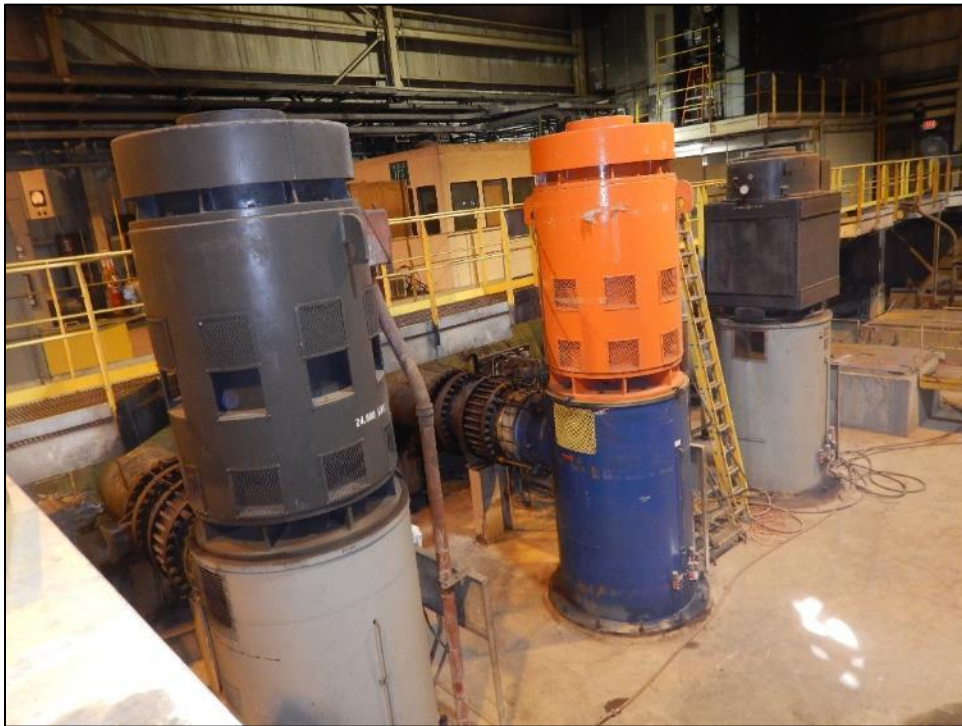
**Photograph 33. No. 7 Pump House** – View of three of the No. 7 Pump House intake pumps (orange pump in operation).

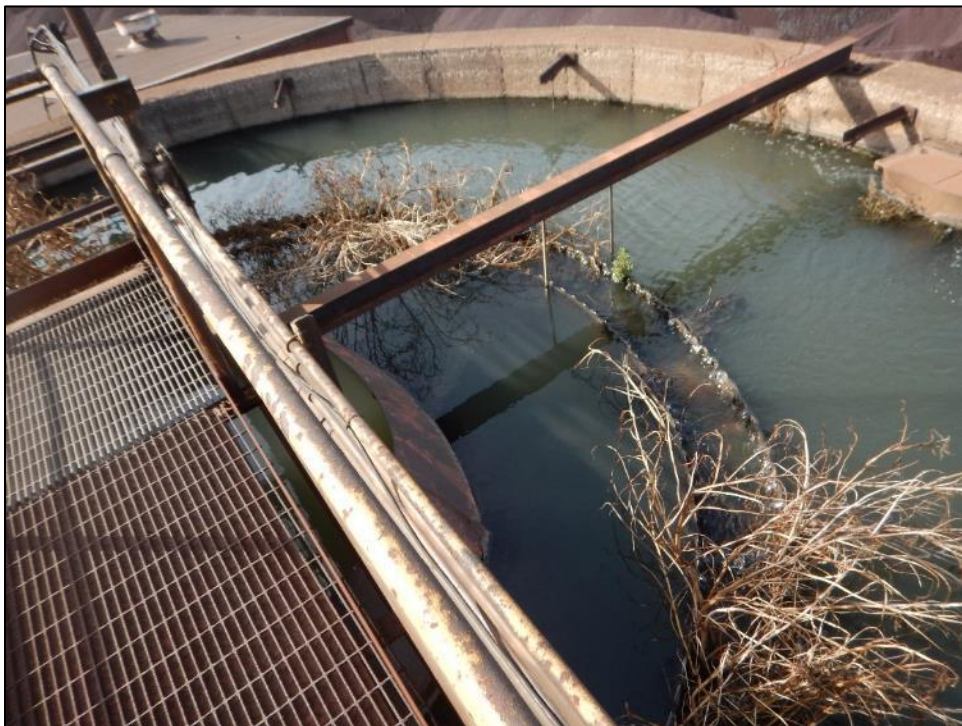
**Photograph 34. No. 3 Sewage Treatment Plant** – View of vegetation in the primary clarifier weirs.

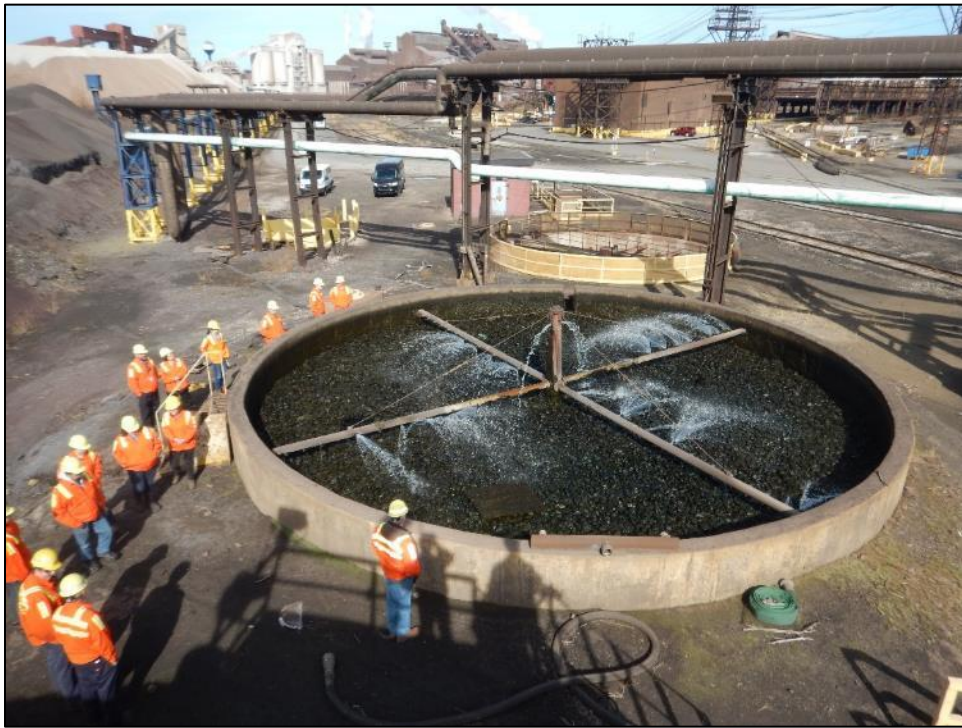
**Photograph 35. No. 3 Sewage Treatment Plant – View of the trickling filter.**

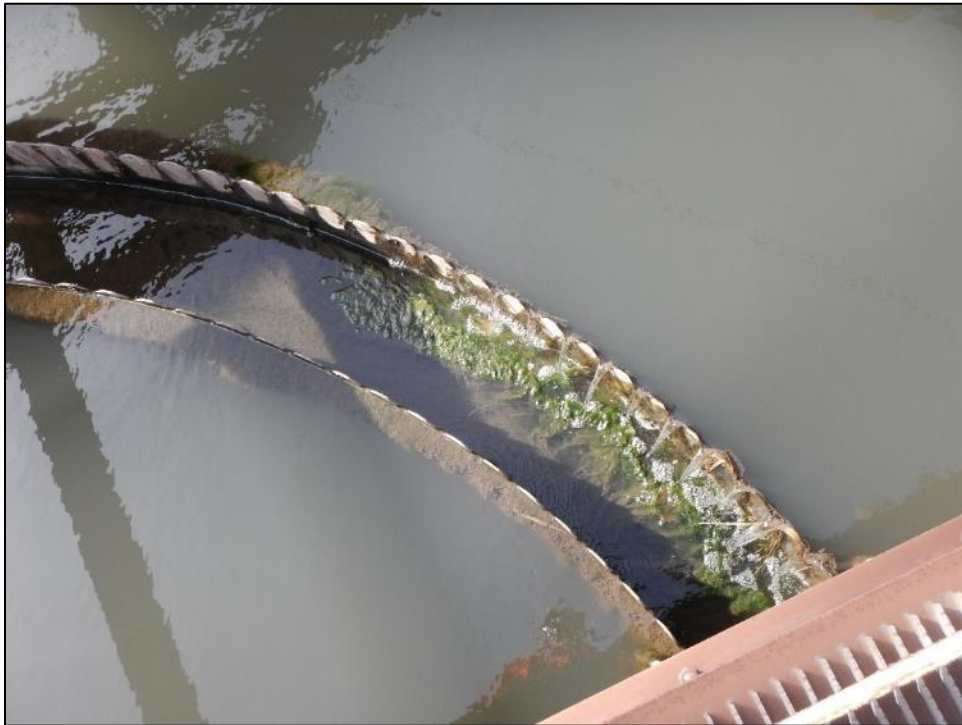
**Photograph 36. No. 3 Sewage Treatment Plant – View of algae in the weirs of the secondary clarifier.**

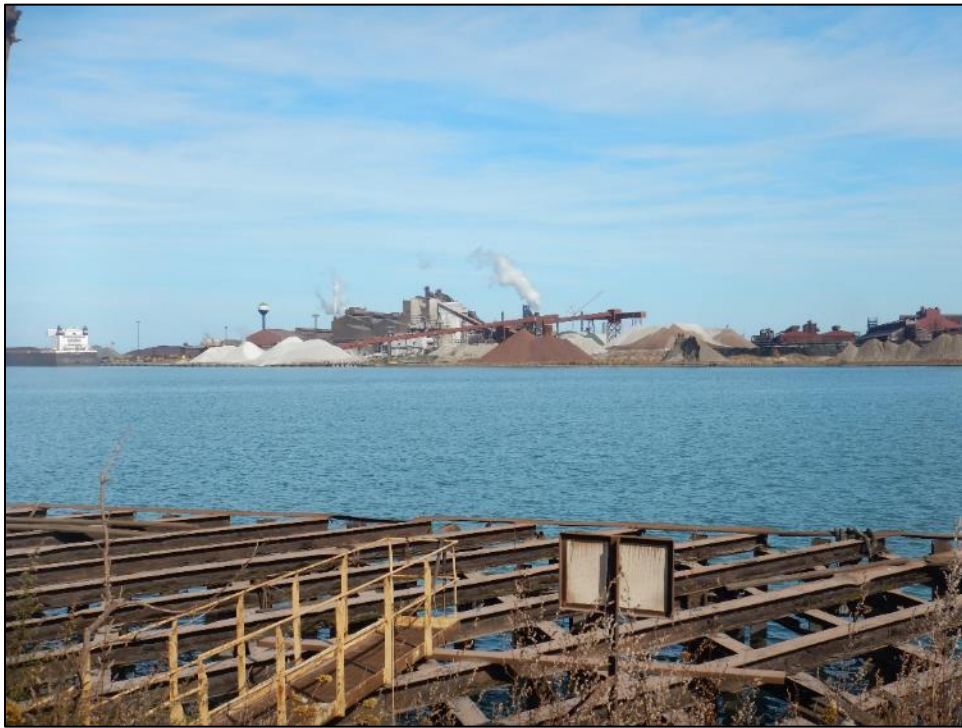
**Photograph 37. Outfall 011** – View, facing northeast, of the turning basin, in the vicinity of Outfall 011.

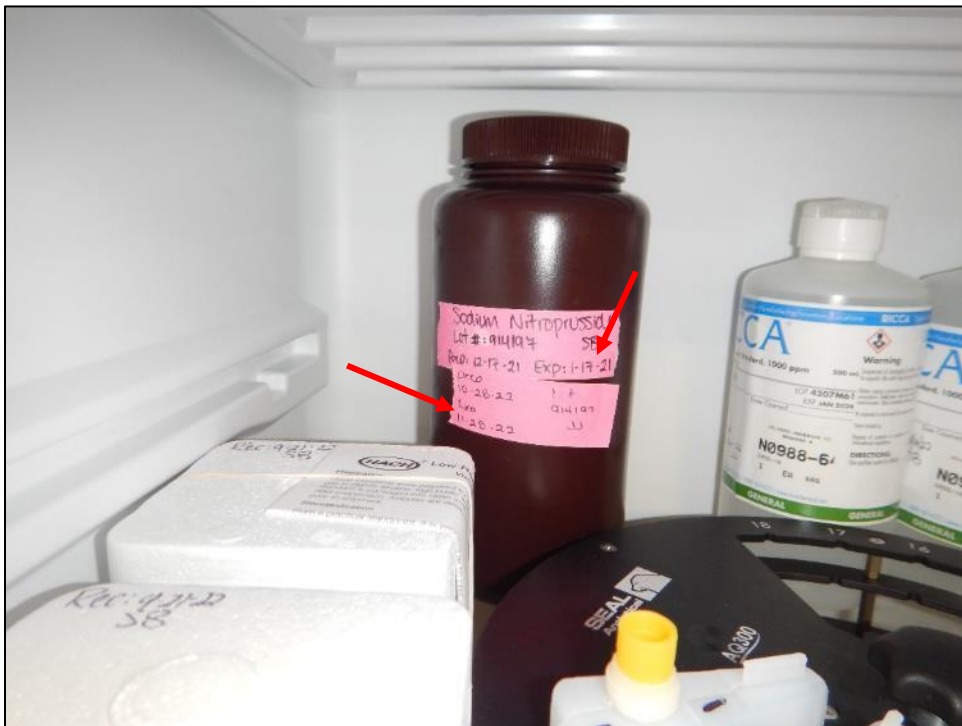
**Photograph 38. Onsite Laboratory** – View of a reagent bottle in the onsite laboratory refrigerator with labels showing expired and current dates (as of the date of the inspection, October 27, 2022).

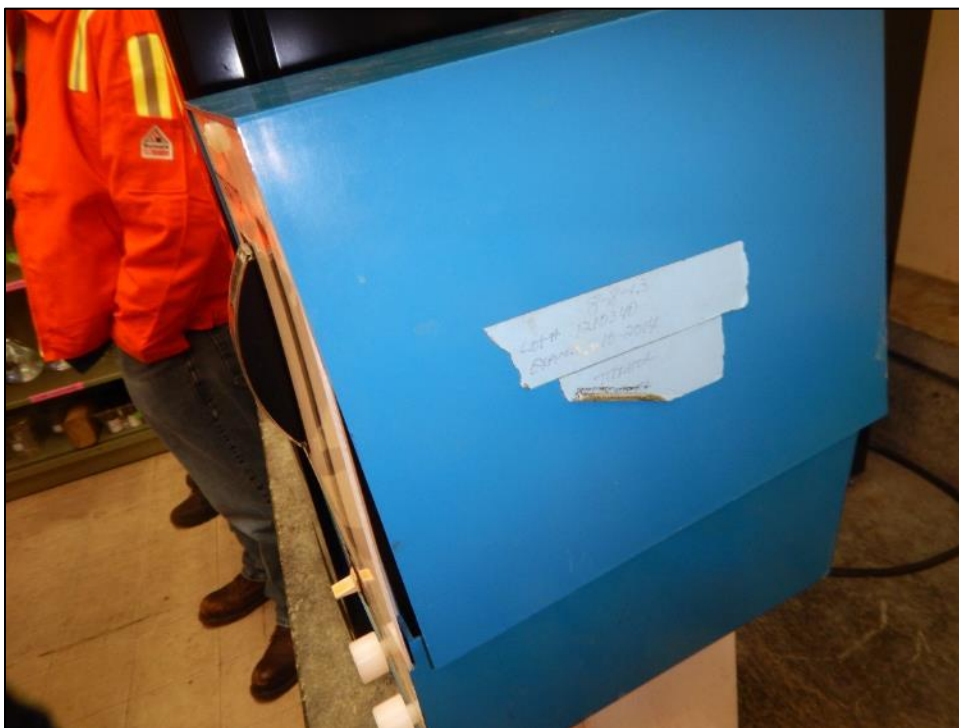
**Photograph 39. Onsite Laboratory** – View of a titrator in the onsite lab with a sticker showing an expiration date from 2014. Laboratory representatives were unsure of what the date referred to, but stated the equipment was not being used at the time of the inspection.

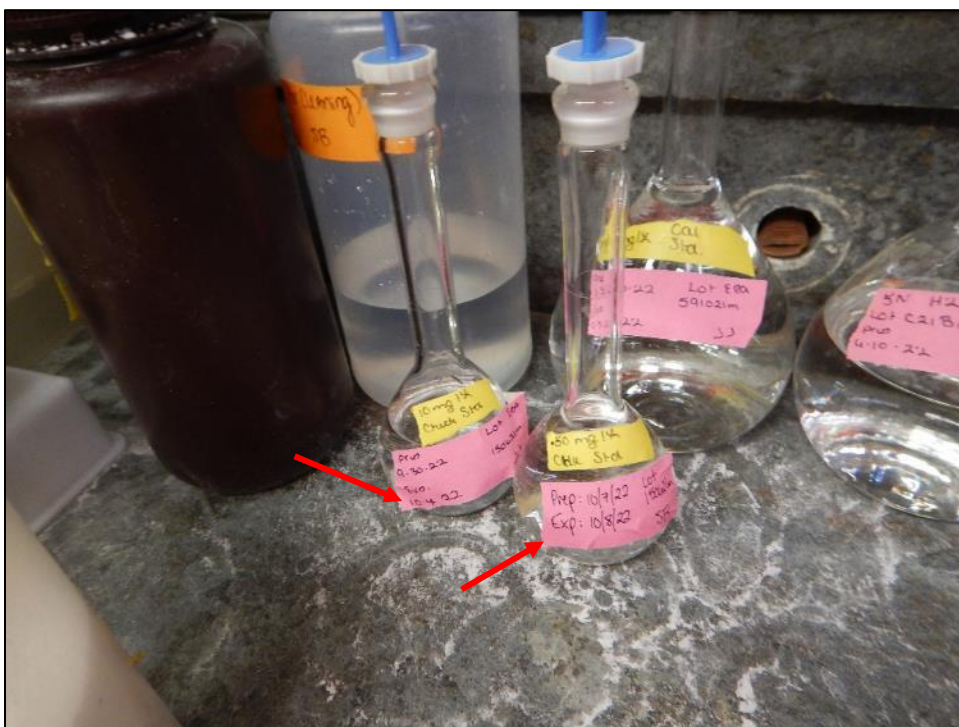
**Photograph 40. Onsite Laboratory** – View of ammonia analysis reagents with expiration dates two to three weeks prior to the date of the inspection (October 27, 2022). Laboratory representatives stated new reagents would be mixed prior to the next analysis.
