**FINANCIAL ASSURANCE
DOCUMENTS**

Designated Operator Monthly Visual Inspection Checklist Casey's Tier 1 Inspection Report

Facility Name: Casey's - 3470
 Facility Address: 102 W Broadway St, Monon, IN
 Designated Operator: Scott Fleming
 Designated Operator Inspector: Jerry Wiley

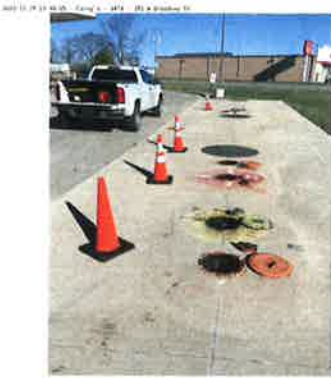
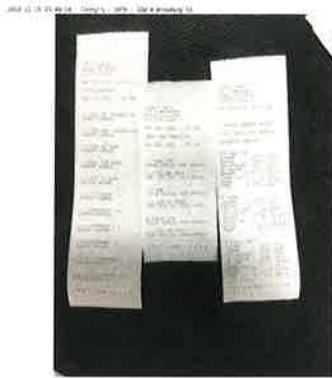
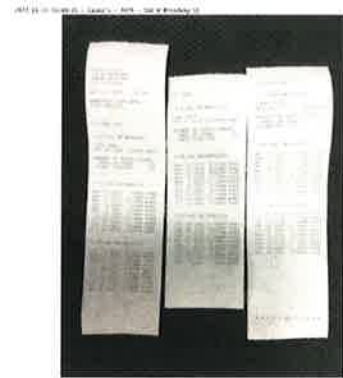
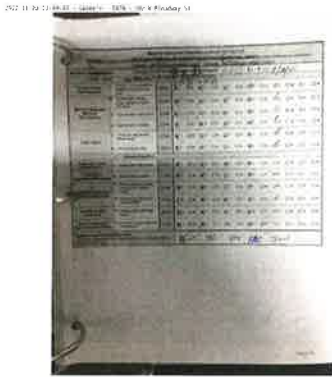
#	Comment
04	Current COFR not available for review.
45	Empty (fullness: empty)
47	0

#	Priority	Info
04	6	records - cfr - certificate of financial responsibility - presence
47	None	waste drum - liquid - measurement

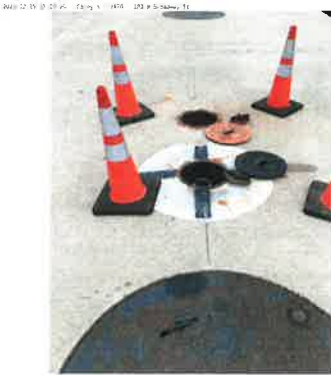
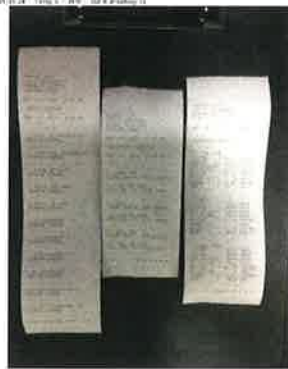
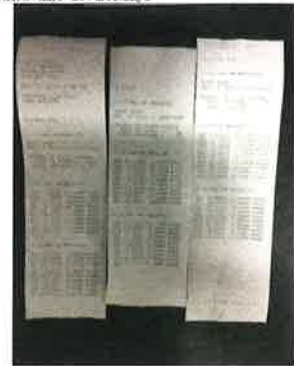
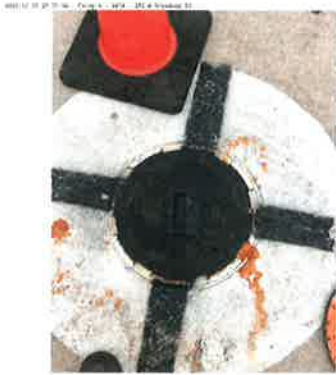
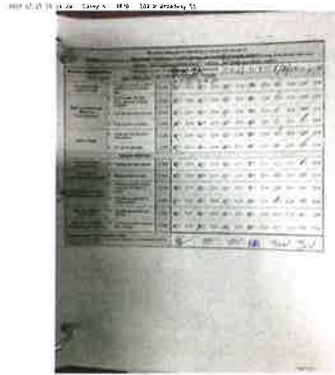
#	Comment
04	Current COFR not available for review.
27	RUL lid is not identified. [: RUL]
47	1/3 [: 1/3 Full]
48	0 [: empty]
