Re: **Inspection Summary Letter**  
Solid Waste Program ID 83-12

# RESTRICTED WASTE SITE TYPE I OR II INSPECTION REPORT

**Facility Name** Duke Energy Cayuga RWS Type I Landfill

**Inspection Date** (month, day, year): June 18, 2024

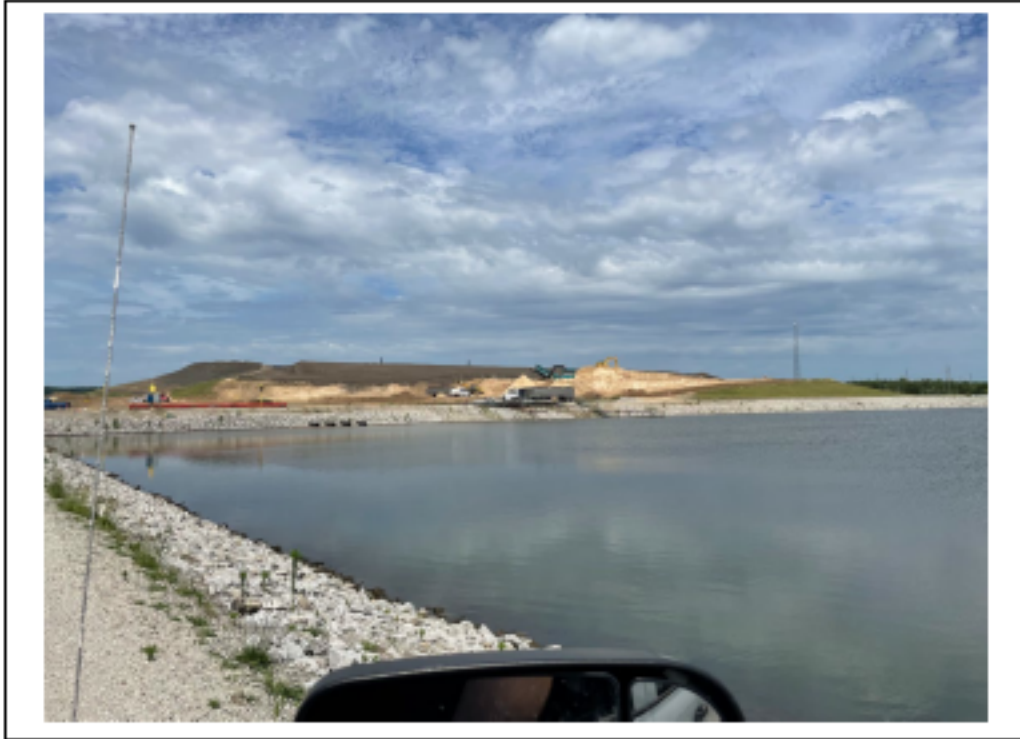
### Photo 1

Location & Description: Location of the facility's gypsum mining operations with landfill in the background.

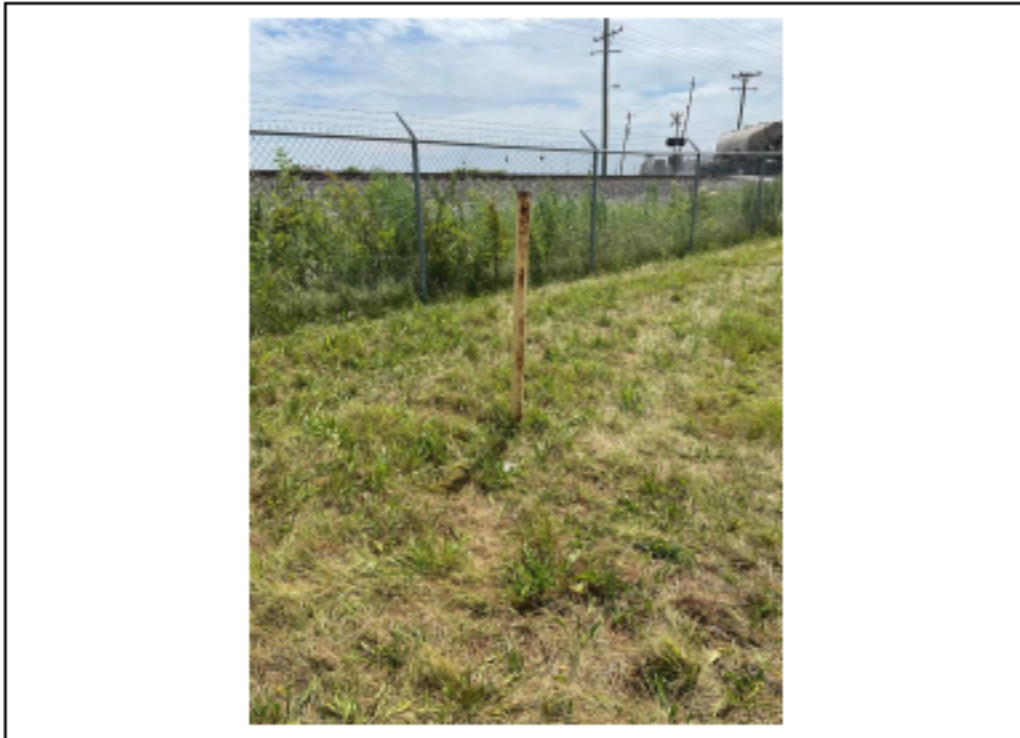
### Photo 2

Location & Description: Location of a site benchmark.

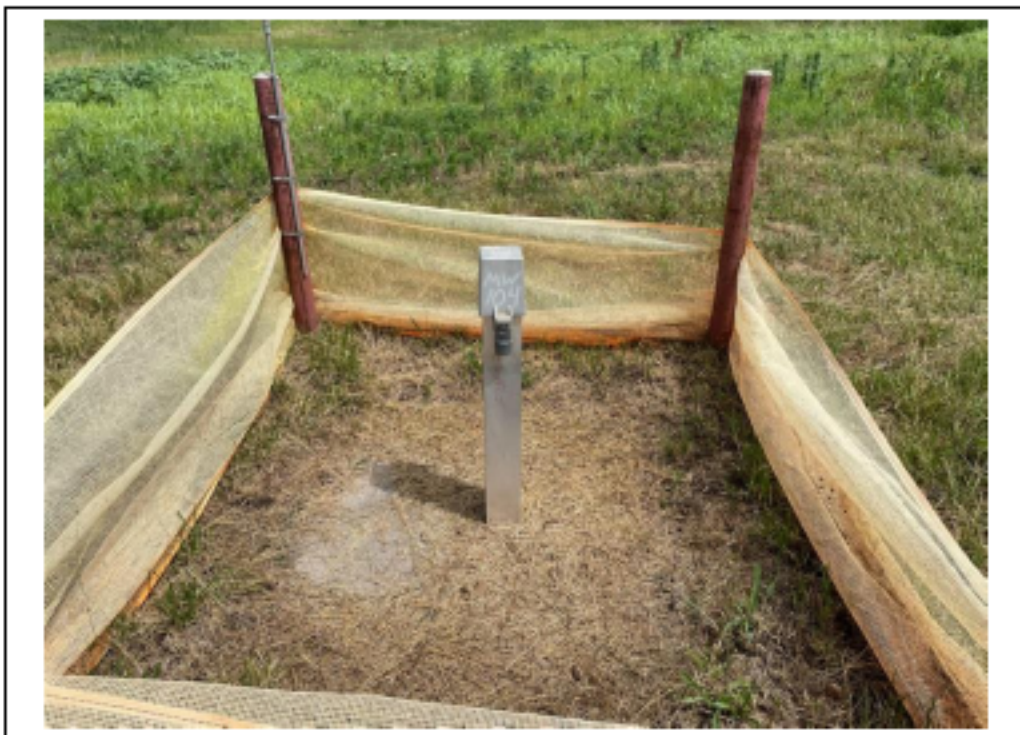
### Photo 3

IDEM staff and Mr. Osborn began driving around the ash pond. IDEM staff observed well-established vegetation and no issues were noted. IDEM staff and Mr. Osborn continued to the landfill, where gypsum was being mined out of the landfill (See Photo Log, Photo 1). While driving around the perimeter of the landfill, IDEM staff observed well established vegetation and all waste was properly compacted with no fugitive dust issues. IDEM staff also observed a site benchmark and monitoring well MW-104, which was locked, labeled, and in good condition (See Photos 2 and 3).

Location & Description: Location of MW-104.
