INDIANA DEPARTMENT OF NATURAL RESOURCES  
DIVISION OF RECLAMATION

COMPLIANCE INSPECTION REPORT

Permit U-025 - Prosperity Mine, LLC – Prosperity Mine

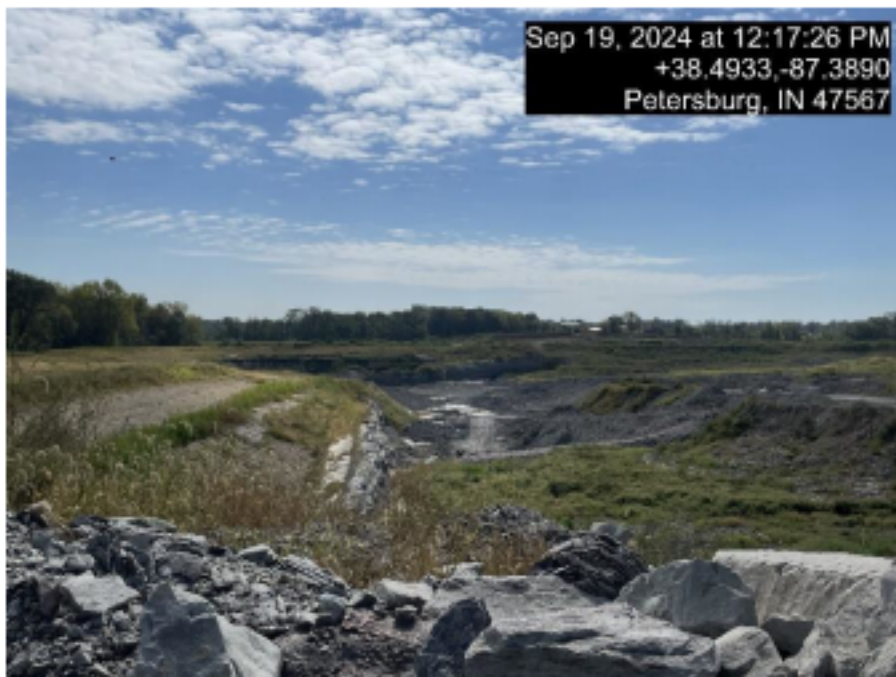
A temporary cessation of operations has been approved for this permit, until further notice. This was shown today upon inspection with no activity.

Coal was stockpiled in the coal yard and equipment was parked.

The following is a photo from the inspection of the pit:

Once the open pit is idle for more than 180 days a grading deferral is required to be submitted to the Division of Reclamation.

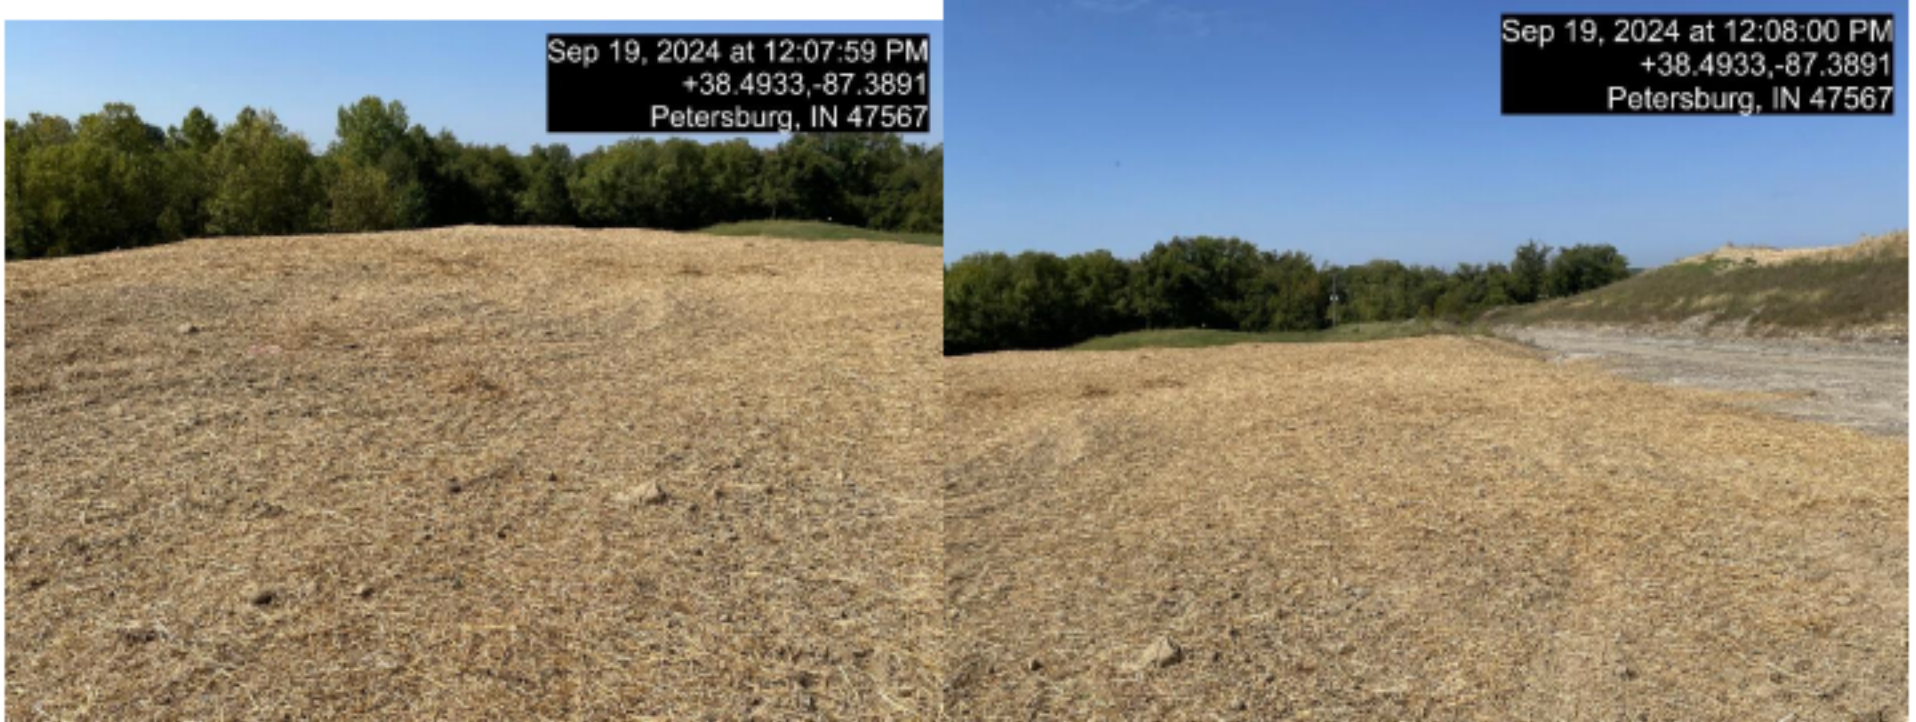
Areas around the slurry impoundment near ponds "I" and "J" have been worked on and was seeded and mulched with a final grade done.

Any new topsoil and subsoil stockpiles need to be seeded and mulched after 30 days of inactivity. They also need to have signs placed on them.

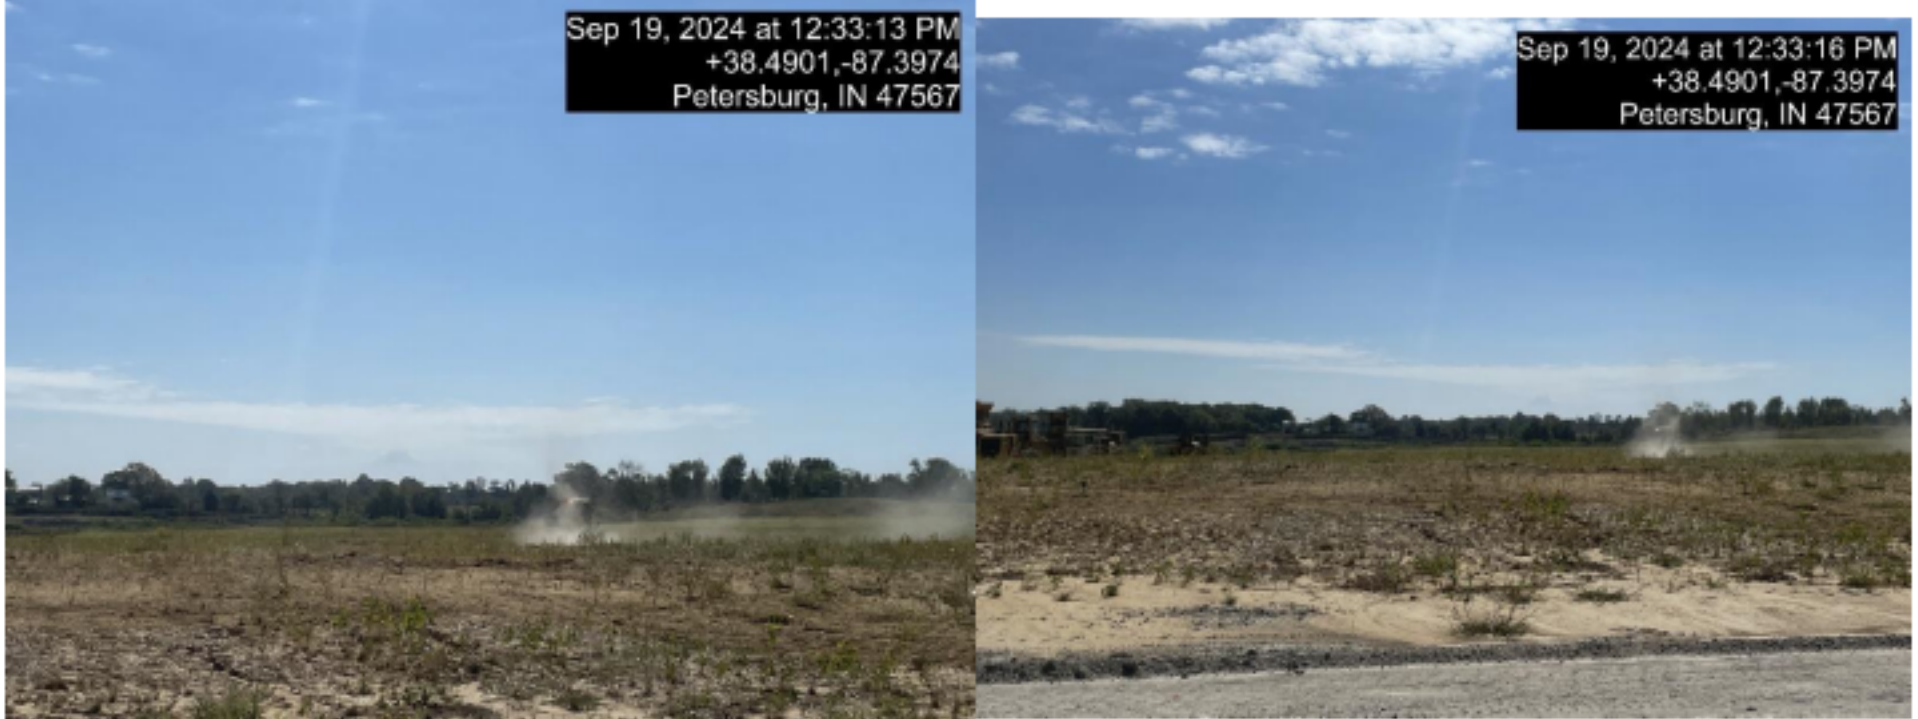
A tractor was seen on the soil next to the open pit, spreading seed and fixing areas of erosion. This is pictured below.

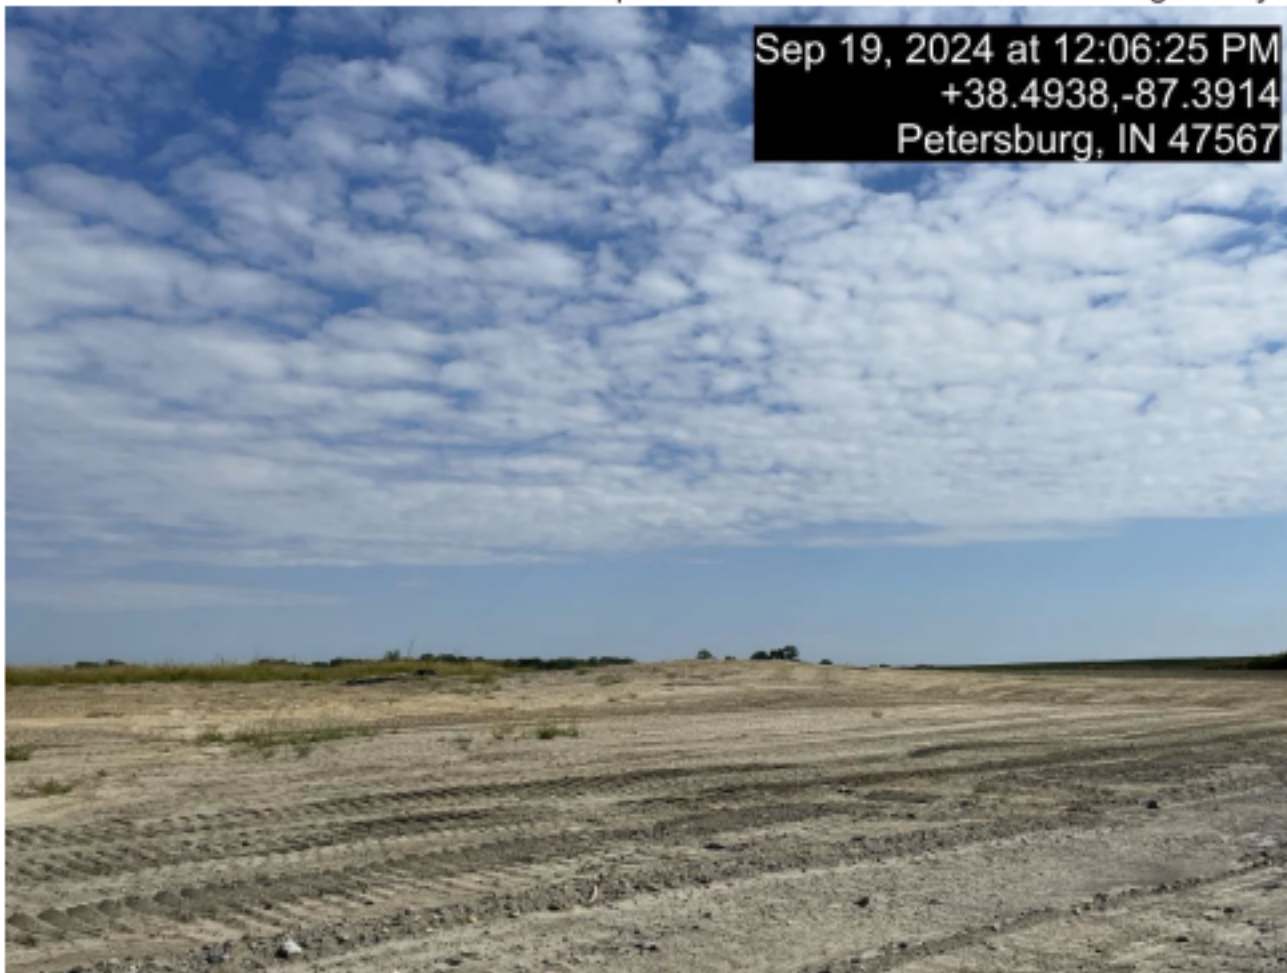
The overburdened material is being used to cover the coarse refuse (slurry) impoundment.

Sunrise Coal has been using the overburden material that is non-toxic, non-acidic, non-combustible earthen material to reclaim the fine refuse slurry impoundment.
