Re: Inspection Summary Letter  
Dollar General - Knox South US 35  
PWSID# IN2750046  
Knox, Starke County

# Summary of Deficiencies Identified

## Public Water System Sanitary Survey Report

PWS ID: IN2750046    PWS Name: DOLLAR GENERAL - KNOX    South US 35

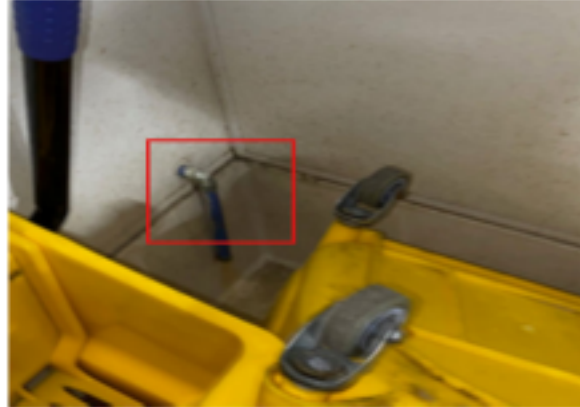
- 3 A **Minor** deficiency was identified regarding: **Cross connection(s) in the treatment process**

The inspector noted: "Deficiency - 327 IAC 8-10 An air gap is needed between the Water Treatment Equipment Regeneration discharge line and the Sanitary Drain. A minimum of one (1) inch is to be provided."

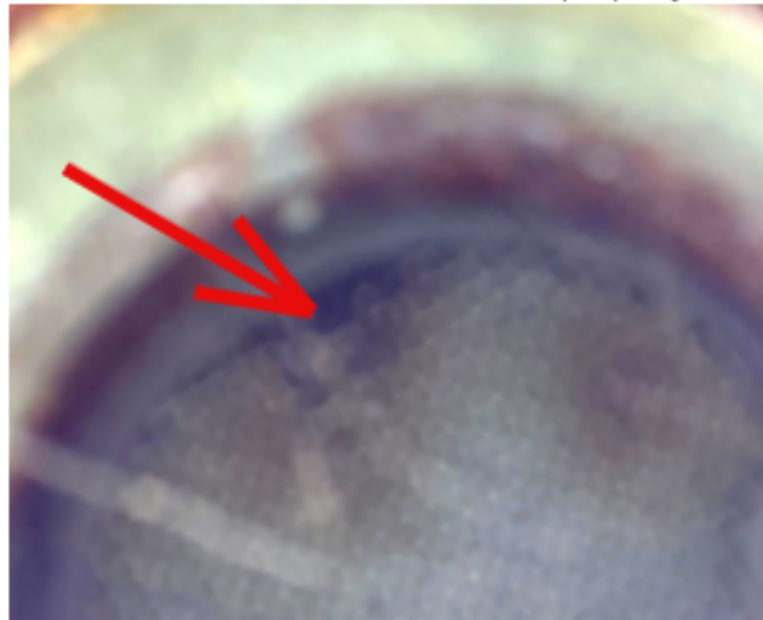
- 10 **Is the well vent screened and properly constructed?**  
Deficiency - 327 IAC 8-2-8.2(e)(1)(G)(iii)  
The well casing vent screen is to be repaired or replaced with a 24 mesh screen.  
SO11

Well vent not screened or properly constructed

MIN  
Deficiency

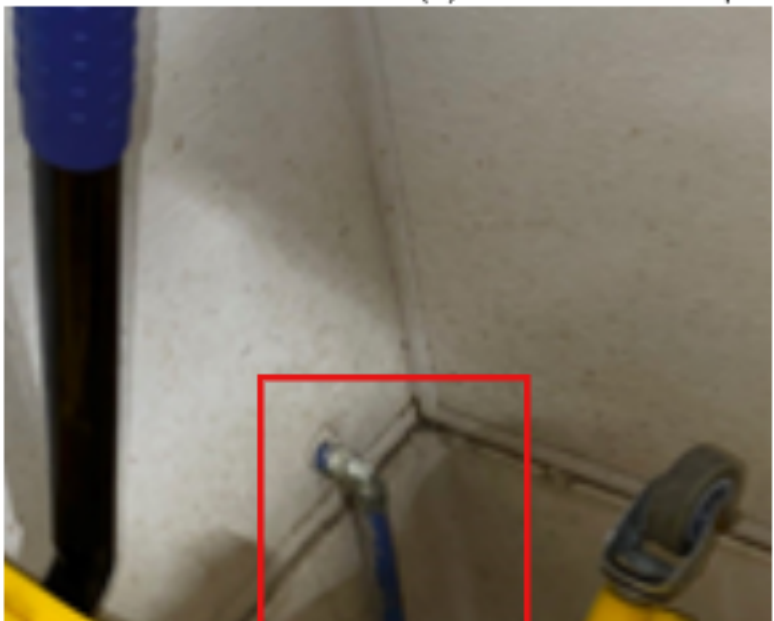
- 11 **Was the treatment process free from uncontrolled cross connections and are backflow prevention devices installed at all appropriate locations?**

Deficiency - 327 IAC 8-10  
 An air gap is needed between the Water Treatment Equipment Regeneration discharge line and the Sanitary Drain. A minimum of one (1) inch is to be provided.  
 TR11 Cross connection(s) in the treatment process

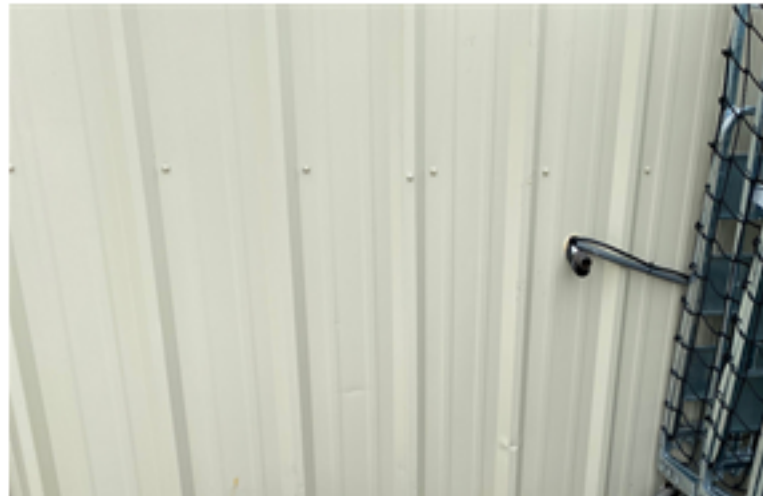
- 8 **Is the installation, testing, and inspection of cross connection control devices conducted in accordance to 327 IAC 8-10?**  
 If the Irrigation System is to be reconnected, it must be tested by a licensed backflow inspector and annually thereafter.  
 DS08 Cross connection control devices are not properly installed, tested, or inspection

MIN  
Deficiency
