Re: Inspection Summary Letter

Gibson County OHH Complaint Haubstadt, Gibson County

# INDIANA DEPARTMENT OF ENVIRONMENTAL MANAGEMENT OFFICE OF AIR QUALITY OUTDOOR HYDRONIC HEATER (OHH) FIELD INSPECTION REPORT

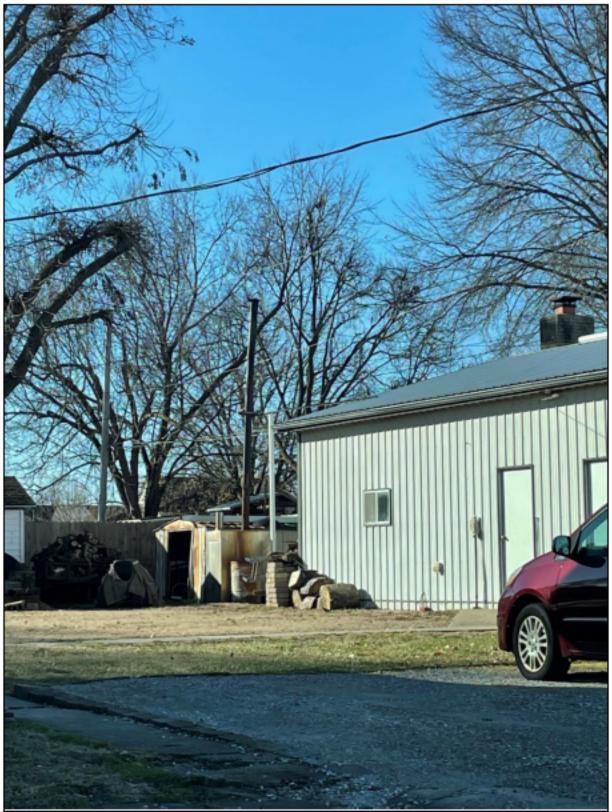
## Photo No. 1

On February 3, 2025, IDEM Air Inspector Nicole Fellows conducted surveillance of the property located at 406 E Haub Street, Haubstadt, Indiana and owned by Timothy and Angela Kramer. The property has an outdoor hydronic heater located at the back of the house (northwest side) near the pole barn, shown in Photo No.1. The stack extends 5 feet above the peak of the roof of the pole barn, at a total height of the stack around 20 feet to 22 feet. The stack was not being operated.

Source Name:	Gibson County OHH Complaint
Photographer:	Nicole Fellows, IDEM, Office of Air Quality
Date and Time:	February 3, 2025, 10:29 AM
Others Present:	N/A
Description:	Outdoor Hydronic Heater stack on residence property.

No violations noted. Recommend to close.
