Re: **Inspection Summary Letter**

**INDIANA DEPARTMENT OF ENVIRONMENTAL MANAGEMENT
OFFICE OF LAND QUALITY
COMPLIANCE INSPECTION REPORT**

EPA ID NUMBER: Non-notifier
NAME: American Axle & Manufacturing, Inc.
Metal Forming, Columbus Manufacturing Facility
ADDRESS: 2805 Norcross Drive
CITY & COUNTY: Columbus, Bartholomew County
INSPECTION DATE(S): September 10, 2025
INSPECTOR(S): George Ritchotte (IWCS)

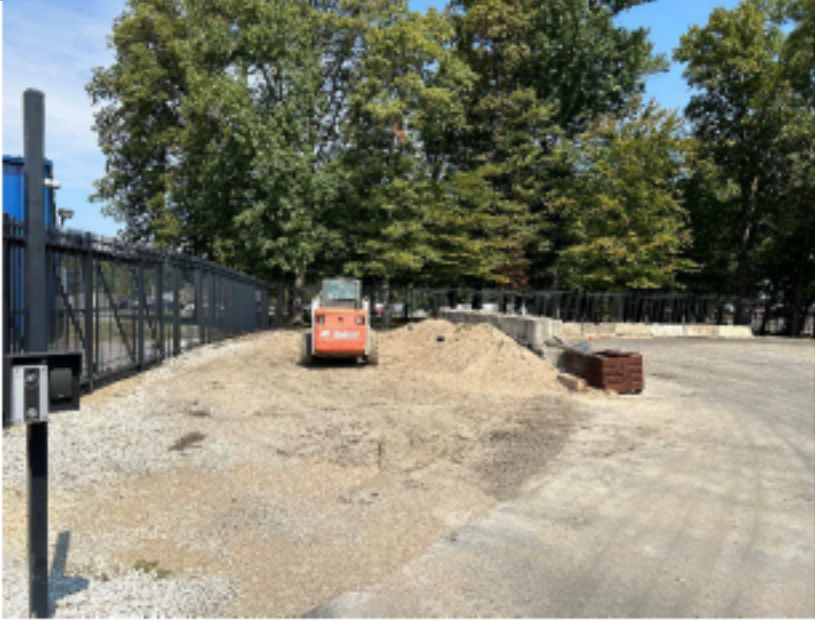
Staff was then shown the area where the tailings and new sands to be used in the pits are stored. (See attached Photo Log, photo 1) At the time of the inspection, the facility was only storing new sands that had been brought on-site to be used to pack around the anvil in the pits to secure it in place. Staff inquired about the disposal practices for the material he referred to as tailings. Mr. Brodhead indicated that the company that removes and reinstalls the anvils manages that material, and he was unaware of their management practice. Staff discussed the need to make a "waste determination" on the sands to determine if they had been impacted by the industrial activity, and if they had, they would be considered a solid waste and must be disposed at a municipal solid waste landfill, such as the nearby Bartholomew Co. Landfill.

Photo #:	1
	Description:	Storage area for anvil pit sand and "tailings."
	Photographer:	George Ritchotte
	Facility Name:	American Axle & Manufacturing, Inc. 2805 Norcross Drive Columbus, Bartholomew County
	Photo Date:	September 10, 2025
	Others:	Robert Brodhead (facility)

Required Action: Immediately make a waste determination on the tailings. If it has been determined that the sands have been impacted by industrial activities including, but not limited to; metal contamination, or hydraulic oils, the tailings would be considered a solid waste and you must immediately cease current management practices and properly dispose of this waste in a permitted facility based on the outcome of the generator responsibilities listed above. Within 30 days of receipt of this inspection report, please submit written information demonstrating the determinations made from this required action.
