**Project Name:** Lower Eel WMP

**Plan Type:** Watershed Management Plan

# Lower Eel River Watershed Management Plan

**ARN 5-134 Final Report**

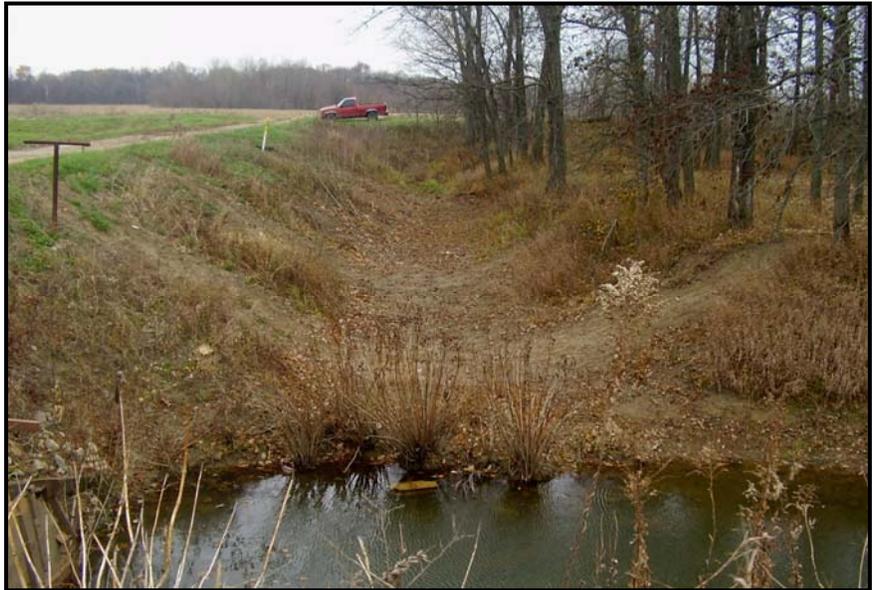
**Plate 3.1** ATV trails at Wabash & Erie Canal testing site.

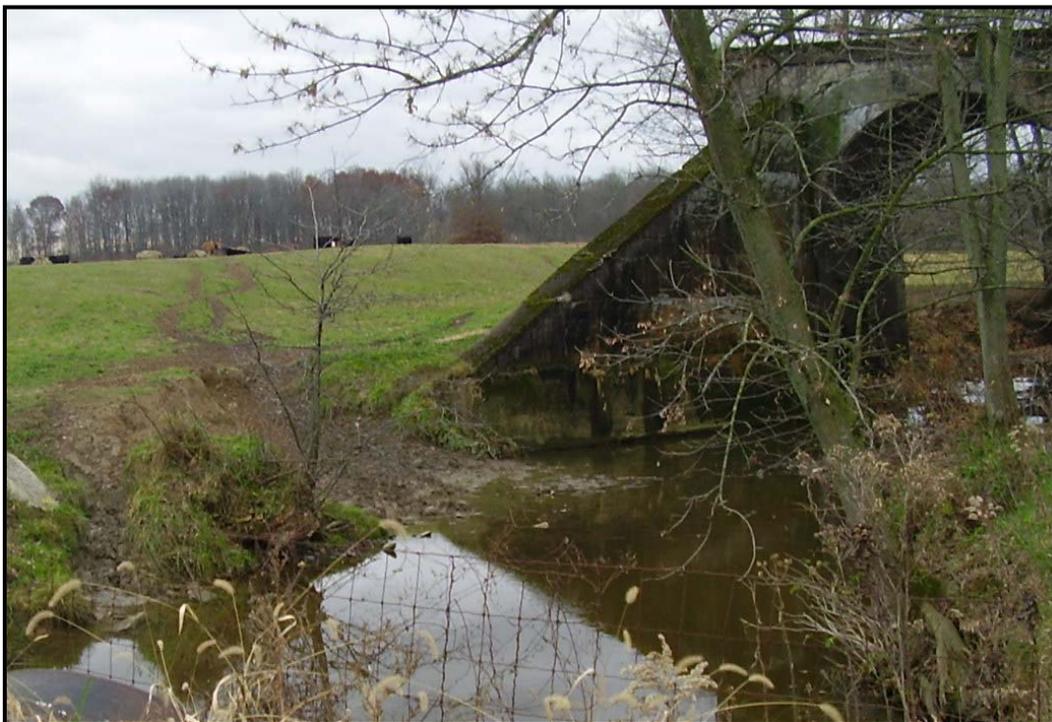
**Plate 3.2** Hog Creek bank erosion caused from livestock with access to the stream.

Livestock have direct access to streams or ponds in many cattle and some hog operations. As can be seen in Figure 3.2 where livestock have direct access to streams, they trample the sides of the streams causing the banks to break down thus adding sediment to streams. Another concern is the lack of pasture for the amount of fenced livestock. Cattle and horses consume more grass than the land can produce. Because of this, these areas become highly susceptible to erosion. GPS computers, fertilizer applicators, winter feeders, and fencing/rotational grazing practices are greatly needed on these livestock farms.

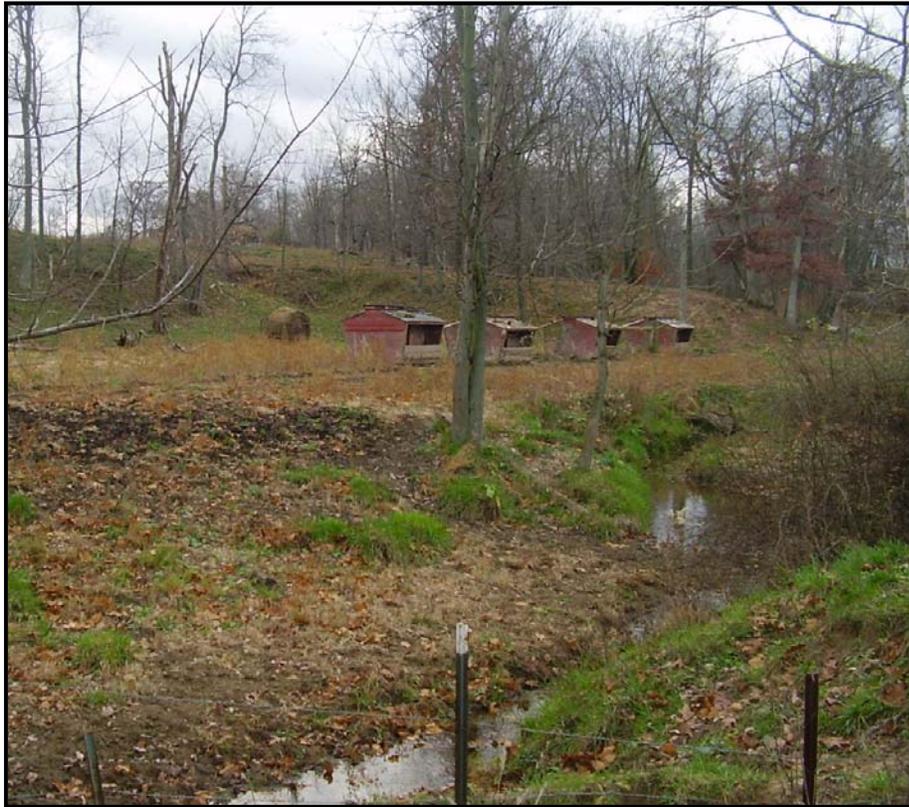
**Plate 3.3** Open feedlot next to a stream showing streambank erosion and animal access to the stream.

open feedlots, large amounts of manure accumulate in relatively small areas. When these feedlots are on slopes with little or no vegetation, runoff is even more prevalent. In the photo to the right, the feedlot is next to Lick Creek, where livestock have access to the stream. The stream lacks vegetation and buffers or any other means of preventing manure from entering the stream. are mismanaged, poorly designed, or poorly constructed.

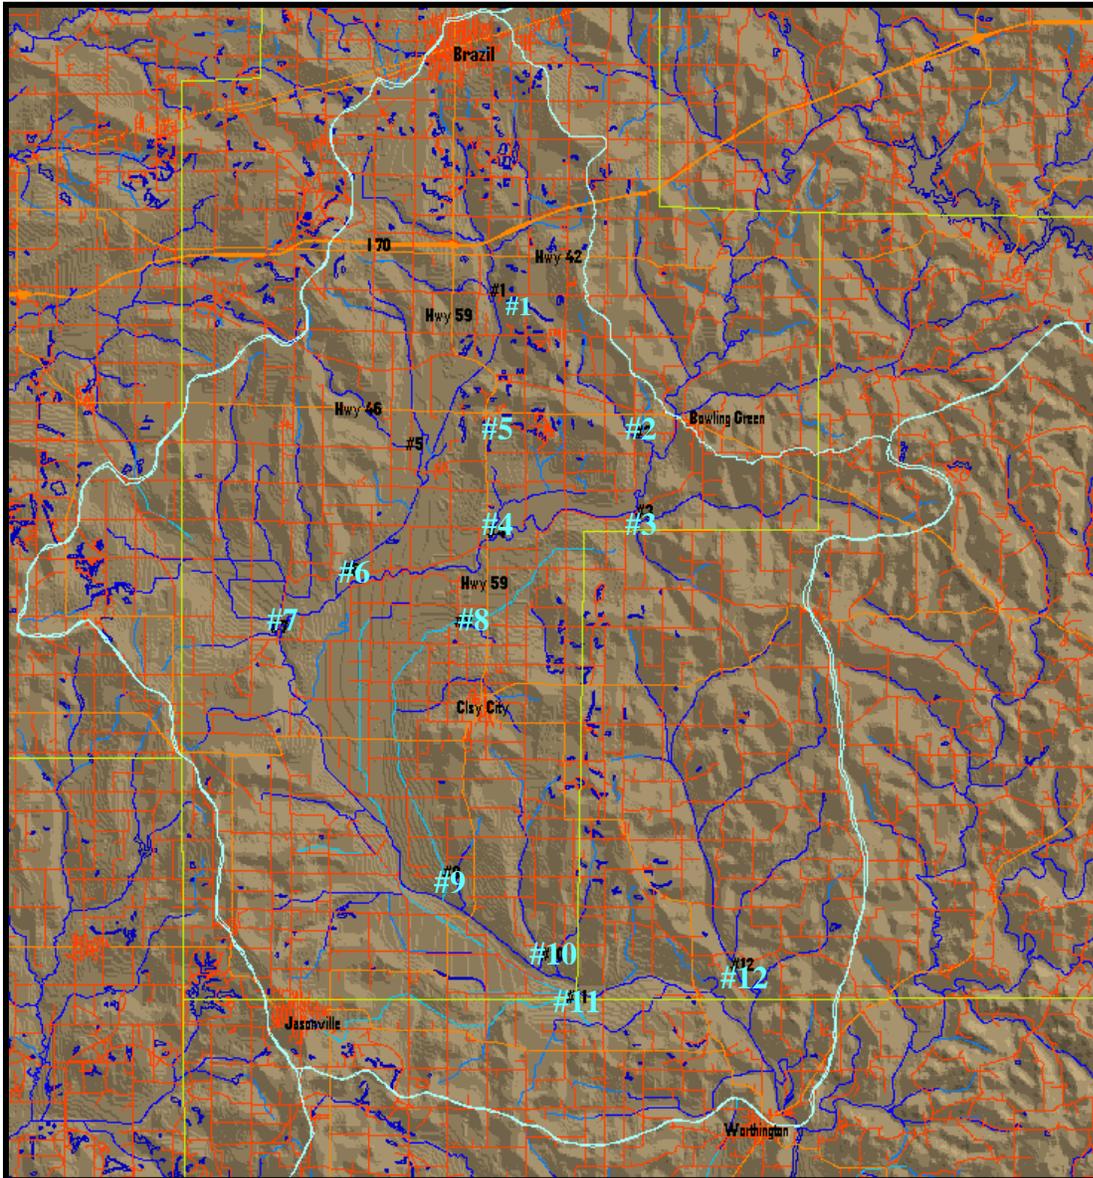
**Figure 4.0 Clay County SWCD Water Monitoring Sites**

Over a two-year period the Clay County Soil and Water Conservation District tested ten (10) different tributaries of the Eel River at twelve (12) different locations. Stream sites were tested every month from April through October. See Figure 4.0: Clay Co. SWCD Sites.

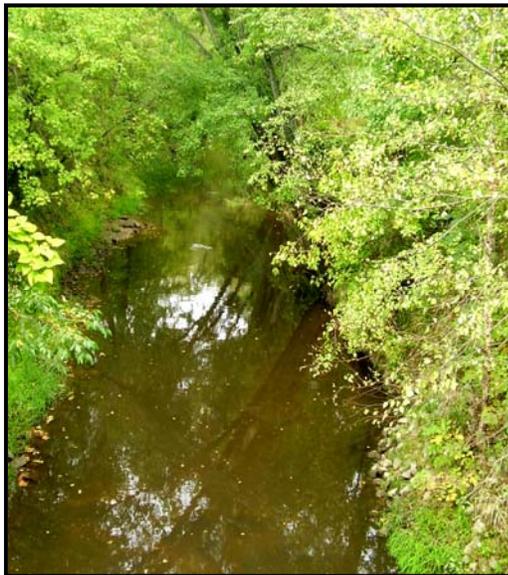
Plate 4.1 Testing Site #1: Birch Creek (north)

Dissolved oxygen did not show up as a real problem at Site #1. The percentage of saturation of oxygen in the stream ranged between 70% and 90% . The low of 70% was hit during a July test when water levels were very low. This suggests that low flow may be limiting DO entrainment or that decomposition may be occurring faster than DO can be replaced. Nitrate and nitrite levels were always low and under the committee benchmark of 4 mg/L; the two-year average was around 1.4 mg/L.

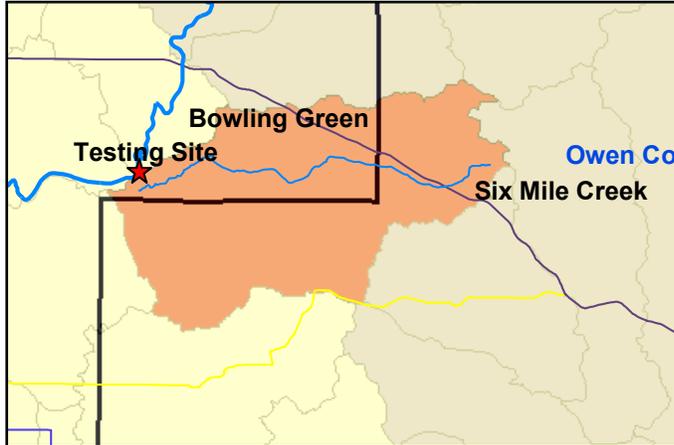
Figure 4.1. Six Mile Creek Watershed

Six Mile Creek is a well-buffered stream that begins to the east of Clay County in neighboring Owen County and runs 8.09 miles. Each side of Six Mile Creek is lined with 20 feet of trees and vegetation, which is the minimum width of a buffer recommended by the Natural Resource

Service. Most of the 17,409 acres that drain into Six Mile Creek are used for agriculture. The terrain in the Six Mile Creek Watershed has the steepest slopes of any of the sub-watersheds. Because of this, it also contains a large amount of HEL Soils. The flow from this stream is generally low despite the rather large watershed, which drains into it. Six Mile Creek dumps directly into the Eel River at River Road. Our testing site was only 50 feet from where the creek dumps into the river.

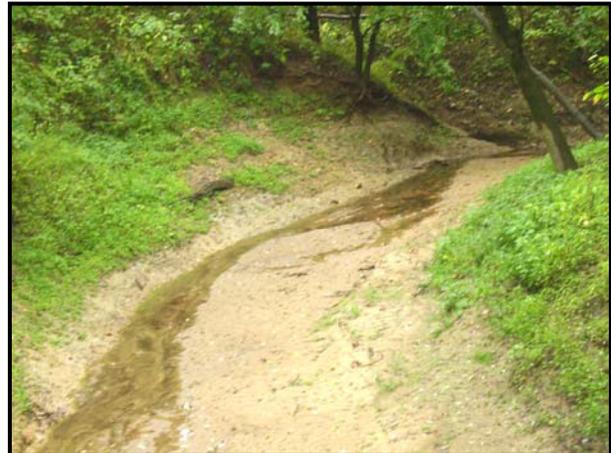
Plate 4.2. Testing Site #2: Six Mile Creek

The saturation of oxygen in the stream ranged between 70 mg/L and 90 mg/L. The low of 70 mg/L was hit in July of 2006, a date in which water levels were very low. This may indicate that decomposition is occurring faster than the dissolved oxygen can be replaced, or the flow may be limiting the dissolved oxygen total.

The two-year average levels of nitrate and nitrite, which were around 1.4 mg/L, were always low and under our benchmark. Phosphorus tests came back lower than our benchmark of 0.29 mg/L. The E. coli count came in at 475 cfu /100 mL, which was over our benchmark, but, unlike Site #1, Six Mile Creek did not have a large spike in any one month. Over the two-year testing period, the range for E. coli came in between 100 and 1,000 cfu /100 mL. IDEM did not sample Six Mile Creek.

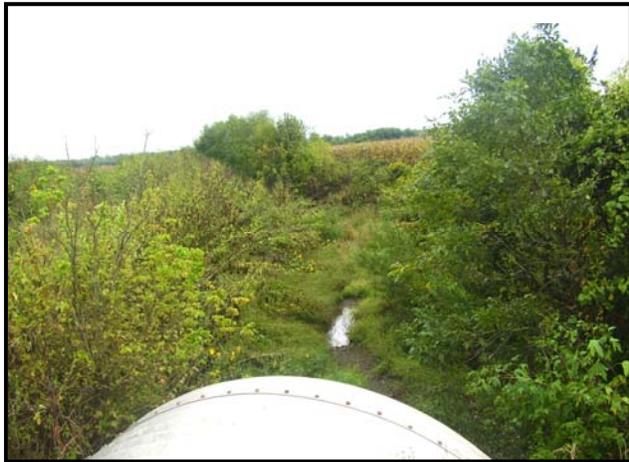
Plate 4.3 Testing Site #3: Hog Creek

The sampling at Site #3, located a mile west of the Eel River, yielded interesting results. In back to back months of July and August of 2007, the dissolved oxygen showed only 4 mg/L. When taking the temperature into account for the month of August, the percent of saturation showed only 44%. The water flow was extremely low both times; therefore, the low level of saturation could be attributed to low flow limiting DO entrainment, or decomposition may be occurring faster than DO can be replaced. The average percentage of saturation in Hog Creek was only about

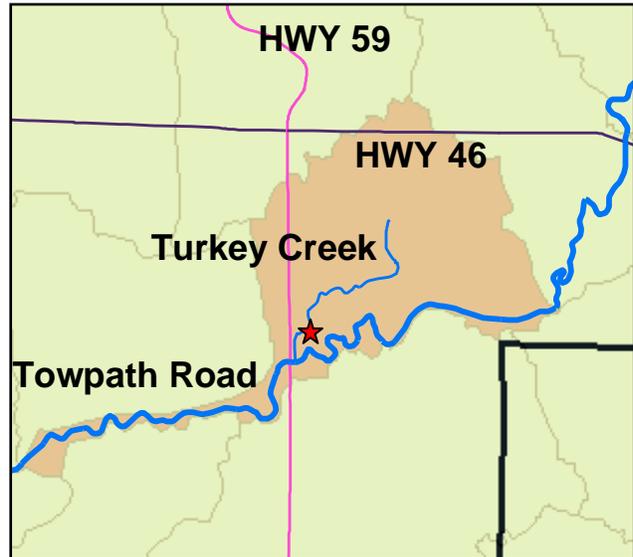
Figure 4.3 Turkey Creek Watershed

Turkey Creek is a natural creek, which runs through the Eel River bottoms. The creek's headwaters begin in a cattle pasture just south of Dietz Lake Recreation Camp Grounds, which is one quarter of a mile north of County Road 100 South. In some areas the stream has an adequate natural riparian buffer; however, through the river bottoms most of the buffer has been cleared in order to farm more acres. The flat ground surrounding this stream is drained by tile; most of the tile drains directly into the Turkey Creek. When flood stage for the Eel River is breached, water often backflows into Turkey Creek, which in turn causes it to flood as well. The Eel River floods at least once per year. Flooding is of especial concern due to the concentrated amounts of HEL soils. Two cattle operations and one small confined swine operation are located in the Turkey Creek Watershed. Most of the land in this watershed is used primarily for row crops. There are some residential areas in the watershed, and Dietz Lake, a private campground, also contains several permanent homes. This area is a concern due lack of a sewage treatment system.

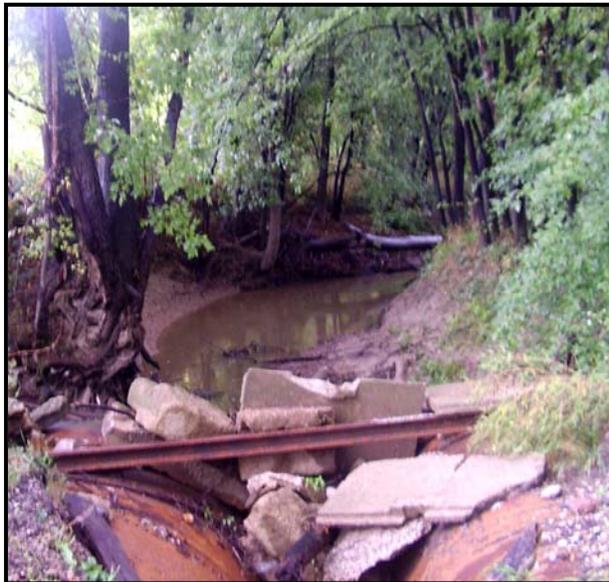
Plate 4.4 Testing Site #4: Turkey Creek

In October of 2007 the dissolved oxygen in Turkey Creek was at a low of 4 mg/L. When the lower than average temperature is taken into account with this reading, the saturation percentage of dissolved oxygen totals only 41%. In August of 2006 the dissolved oxygen also reached a low of 4 mg/L. However, the warmer water temperature kept the percent of saturation at 46%. The average dissolved oxygen for this area was 7.05 mg/L, which is much lower than the state average of 9 mg/L. The amount of available oxygen for organisms in Turkey Creek is a serious concern.

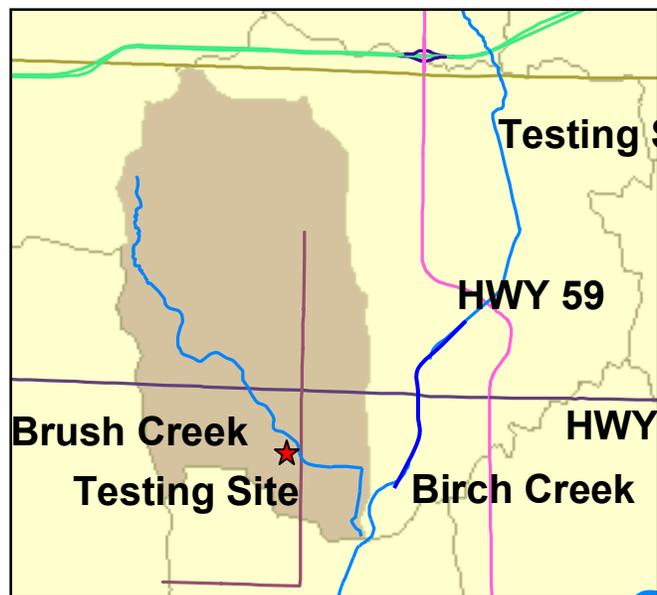
Plate 4.4 Testing Site #5: Brush Creek

The dissolved oxygen readings for Brush Creek ranged consistently between 6 mg/L and 9 mg/L and had an average reading of 7.65 mg/L. There were no real concerns here as dissolved oxygen readings were usually very consistent.

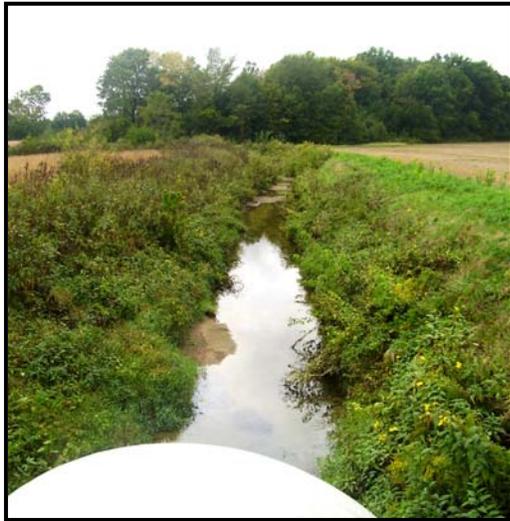
Plate 4.5 Brush Creek Testing Site

At times the E. coli counts for Brush Creek yielded alarming results. In April of 2007 the E. coli was 10,000 cfu /100 mL. It maintained an average of almost 1,000 cfu /100 mL in 2006;

however, after the spike that occurred in April, the stream only averaged 370 cfu /100 mL for the rest of 2007. One can only speculate that top applications of dairy manure over the winter followed by heavy spring showers in April resulted in the large spike. Despite the heavy showers that preceded the April test, all but one of the other testing sites tested that day yielded lower than average counts of E. coli. Therefore, one can deduce that while the rain likely increased the number, it was not the only factor in the spike. The results from IDEM's sampling of Brush Creek should not be confused with the SWCD's results from Brush Creek, which occurred in Clay County. The sampling results from Brush Creek, which a tributary of Lick Creek in Owen County, can be found under the Lick Creek Testing information in Section 4.410.

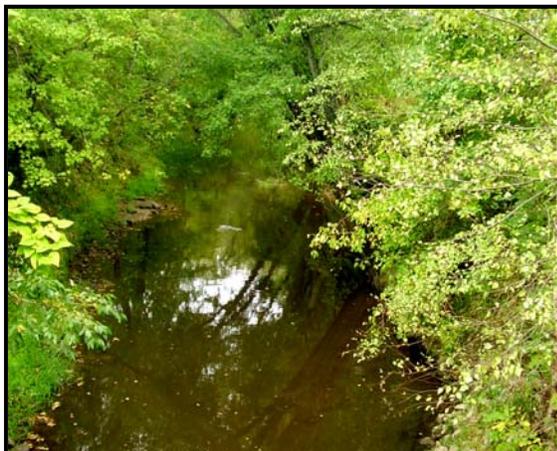
Plate 4.6. Testing Site #6: Birch Creek (south)

The visual data remains the same on the south end of this tributary as it was at testing site #1, Birch Creek (north). Because of the size of this stream, which is 22.88 miles long and 26,181 acres, it was tested at its headwaters as well as a quarter mile up stream from where it empties into the Eel River. The main difference between the two sites is the surrounding topography. Due to the close proximity of the Eel River at the lower site, the surrounding area is much flatter. The soil types, of course, are much different as well. One of the biggest differences in the soils is the fact that this watershed contains a high concentration of HEL Soils.

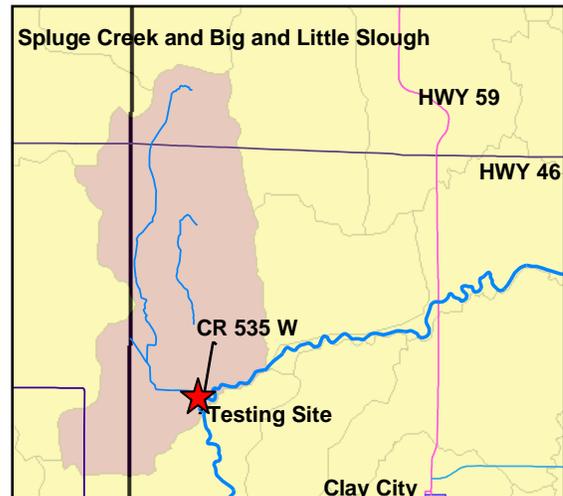
Figure 4.6 Splunge Creek Watershed

At the testing site, Splunge Creek has a shale bottom and is buffered on one side by a grassed levee and on the other side by a narrow row of trees and natural vegetation. This creek drains 29,747 acres of farming land in the “reservoir,” as it is known in The Lower Eel River Watershed. In the past the Big Slough Reservoir held water for the Wabash & Erie Canal. Now the reservoir, a flat area of land, is used solely for the production of row crops. Locks and gates are used to control flooding in the area. When water levels reach a certain point, the gates are opened and water is released into Splunge Creek, which then drains into the Eel River. The Splunge Creek-Cutoff / Little Slough runs for 25.79 miles.

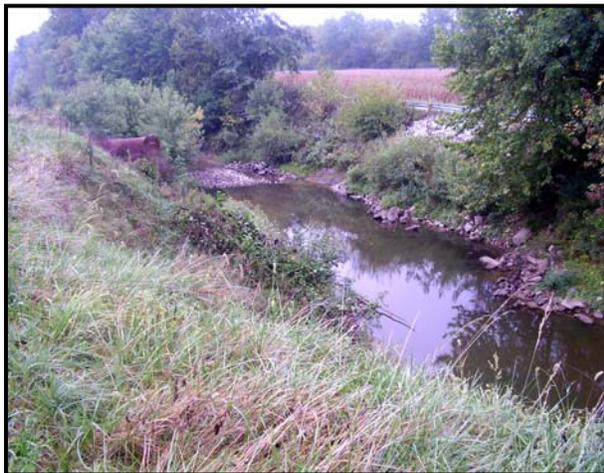
Plate 4.7 Testing site #7: Splunge Creek

Like most of the other streams tested, orthophosphate, nitrates, and the pH in Splunge Creek were below the state averages. Turbidity in this stream was low at times and held a two-year average of just 44 cm. This total was the second lowest among streams tested. Turbidity ranged as high as a full tube (60 cm.) all the way down to a low of just 4 cm. in May of 2006. After the first two samples were taken at the beginning of the project, Splunge Creek’s turbidity was averaging just 10 cm. However, as rain slowed down, the average increased.

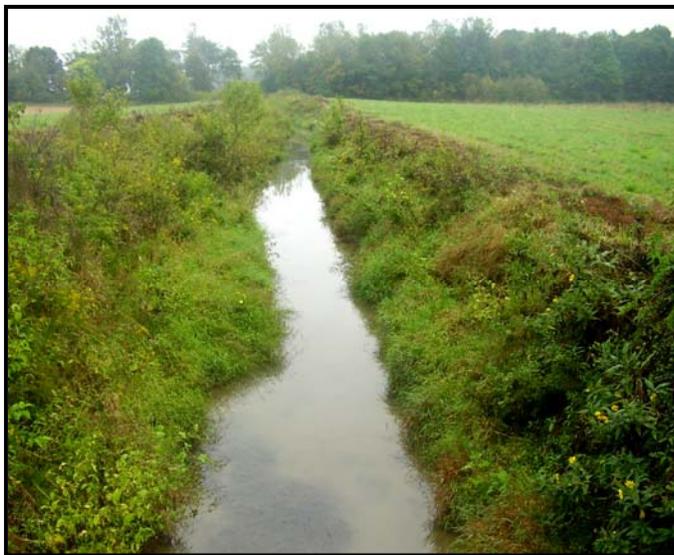
Plate 4.8 Testing Site Connley Ditch (north)

Dissolved Oxygen in Connley Ditch (north) carried an average of 7.9 mg/L., which was the third highest of the twelve sites. One of the two sites higher than this one was Connley Ditch (south).

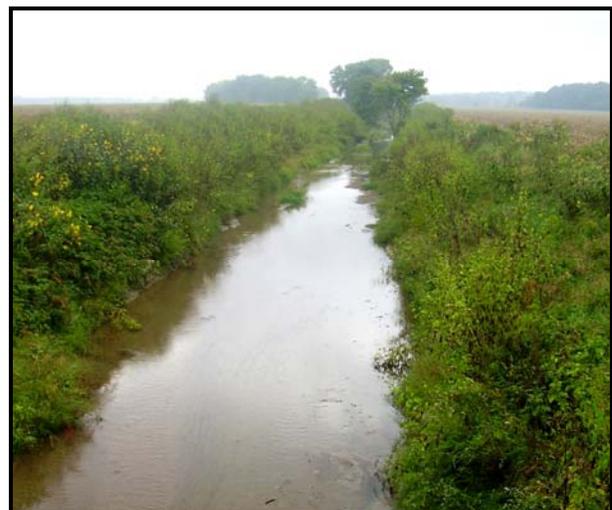
Plate 4.9 Testing Site #9 Connley Ditch (south)

As was written above, the stream's headwaters were relatively low in E. coli; however, the southern section was much different. Over the two years of testing, E. coli in the southern section of Connley Ditch averaged 800 cfu /100 mL, which is more than double the results of the northern section of Connley Ditch. Located between the two Connley Ditch testing sites #8 and #9 are two non-permitted hog operations and two non-permitted cattle operations. Connley Ditch also had a dramatic change from 2006 to 2007. In 2006 the E. coli count averaged almost 1,300 cfu /100 mL; however, in 2007 the same site yielded results of only 300 cfu /100 mL. Determining the causes of these results is nearly impossible. The turbidity

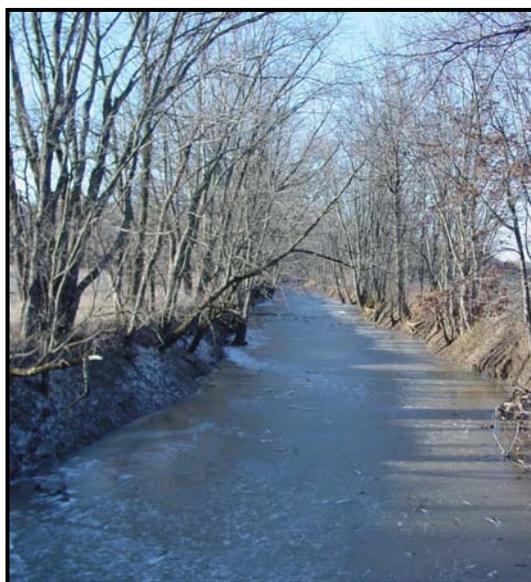
**Plate 4.10** Testing Site: Lick Creek

Over the two years, E. coli averaged 700 cfu /100 mL; however, it is important to note that in 2007 the average E. coli test resulted in a count of 280 cfu /100 mL. It appeared to be a more glaring problem in 2006 when the E. coli average was over 1,100 cfu /100 mL. The Lick Creek Watershed does contain

several cattle feedlots; therefore, livestock manure could be an issue. There was more precipitation in 2006 than in 2007. However, the discrepancy of E. coli was not as apparent at any of the other sites that were tested during the same time periods.

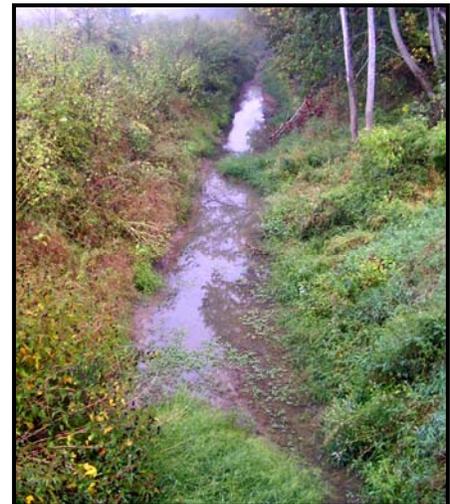
Erie Canal is a serious concern. Turbidity results ranged Plate 4.11. Testing Site #11: Wabash & Erie Canal

Muck soil, usually dark black in color and a clay texture, can be found in the bottom of the stream. The darker than normal color of this sediment is believed to be a big reason for the poor turbidity of the stream. However, if best management practices can be installed to reduce erosion and runoff, this should increase the clarity of the water.

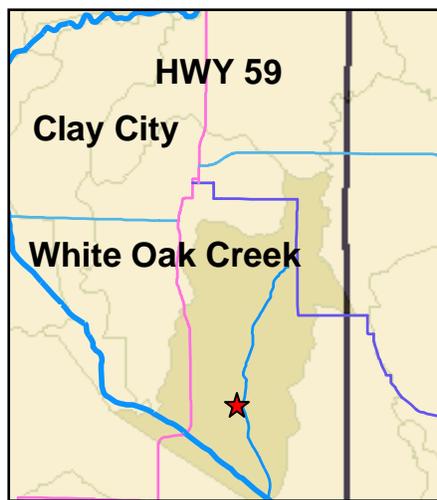
Figure 4.11 White Oak Watershed

White Oak Creek is a natural creek in the southeastern part of Clay County that flows approximately five miles through flat bottom ground south of the town of Clay City. The White Oak Watershed drains 10,847 acres. In the past, coal was mined from a considerable portion of the ground in this watershed. Like most of the other streams, row crops surround the majority of White Oak Creek. Many of these crops are planted on reclaimed mine ground, which has been abandoned for many years.

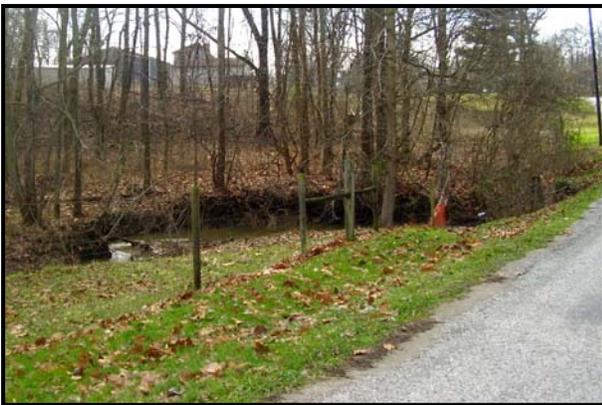
**Plate 5.0** Critical Area in Hog Creek Watershed. The photo to the left was taken in Clay County. It shows Hog Creek in the foreground. Behind the trees on the hill is a barren feedlot with three horses. Wastes from the feedlot drains down the hill into a ditch that runs directly into Hog Creek. This creek runs through a pasture for sheep; they have direct access to the creek.

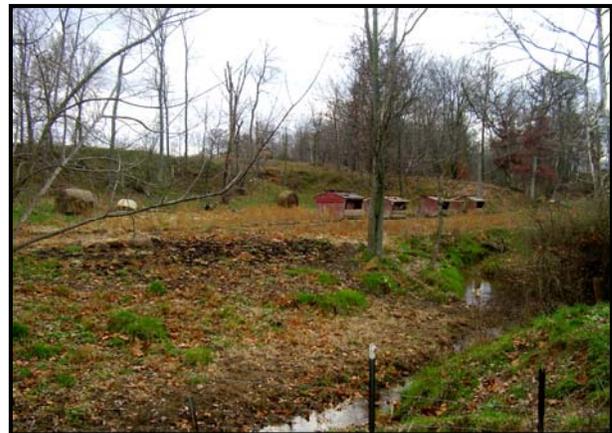
**Plate 5.1** Critical Area in Lick Creek Watershed. The photo to the left was taken at Lick Creek in Owen County, which is a part of the Lower Eel River Watershed. The feedlot drains directly into the creek, and the cattle have direct access to the stream. Streambank erosion has taken place over a number of years where the livestock have entered and exited the stream.

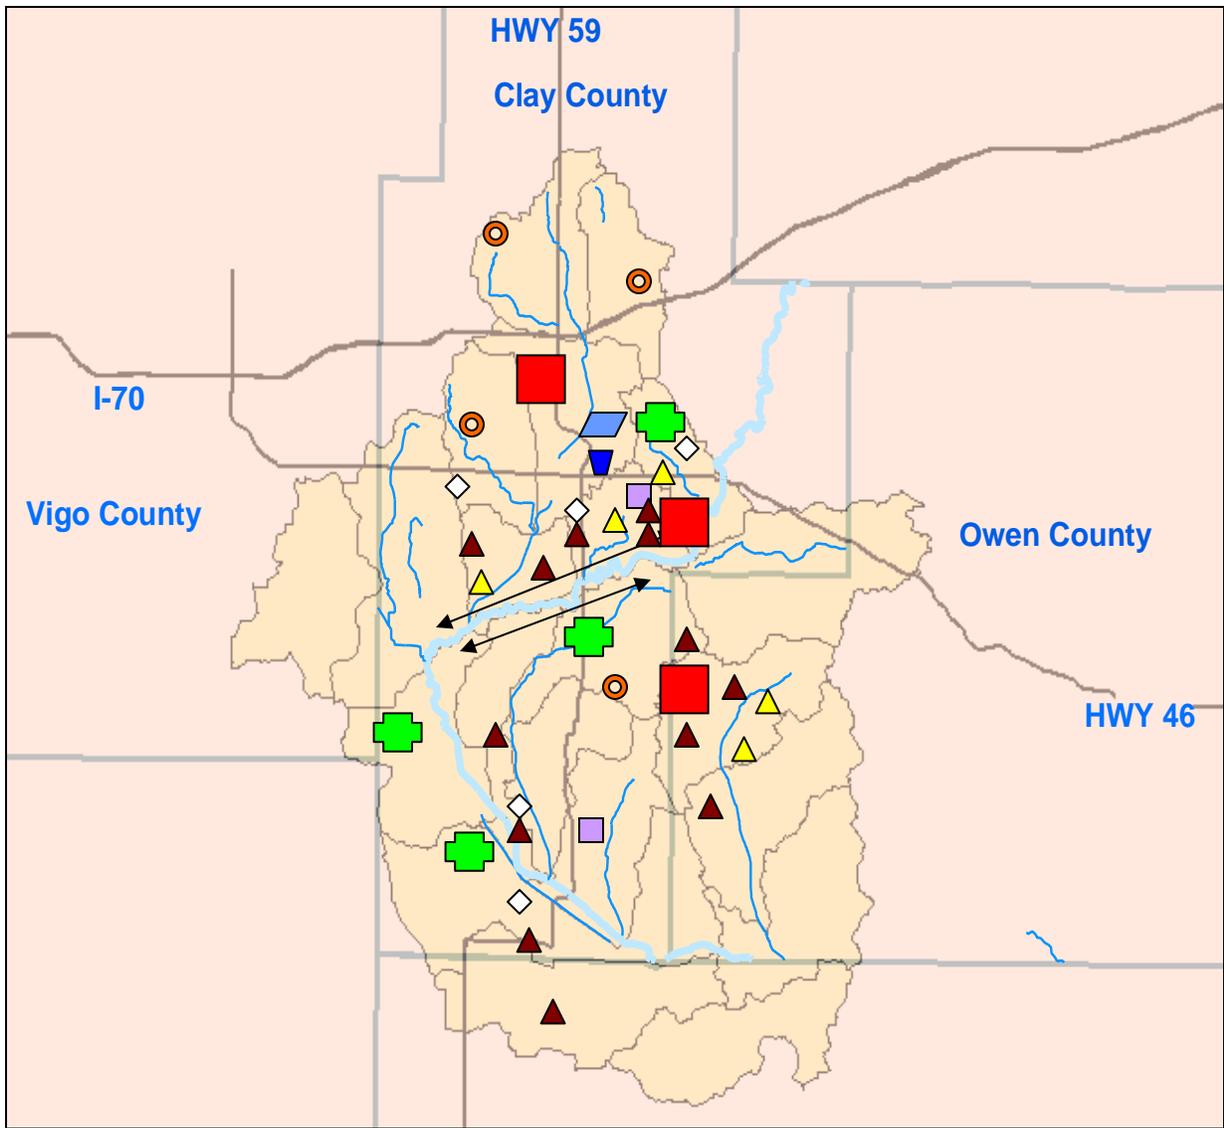
**Figure 5.0 Probable Sources of Pollution Map**

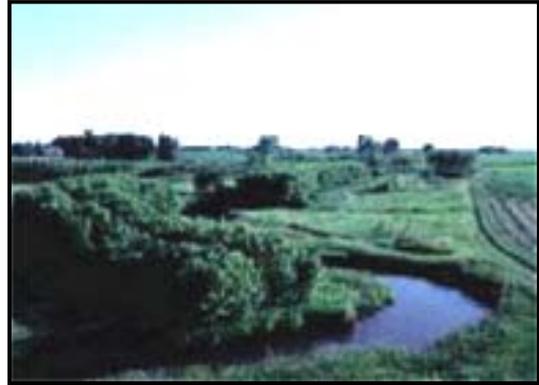
Plate # 8.0 Riparian buffer strips protect stream water quality. Photo courtesy of USDA Natural Resources Conservation Service.

Riparian buffers protect streambanks best; however, a second alternative, when it is not possible to install riparian buffers, would be the use of deep-rooted filter strip grasses such as big blue stem or switch grass.

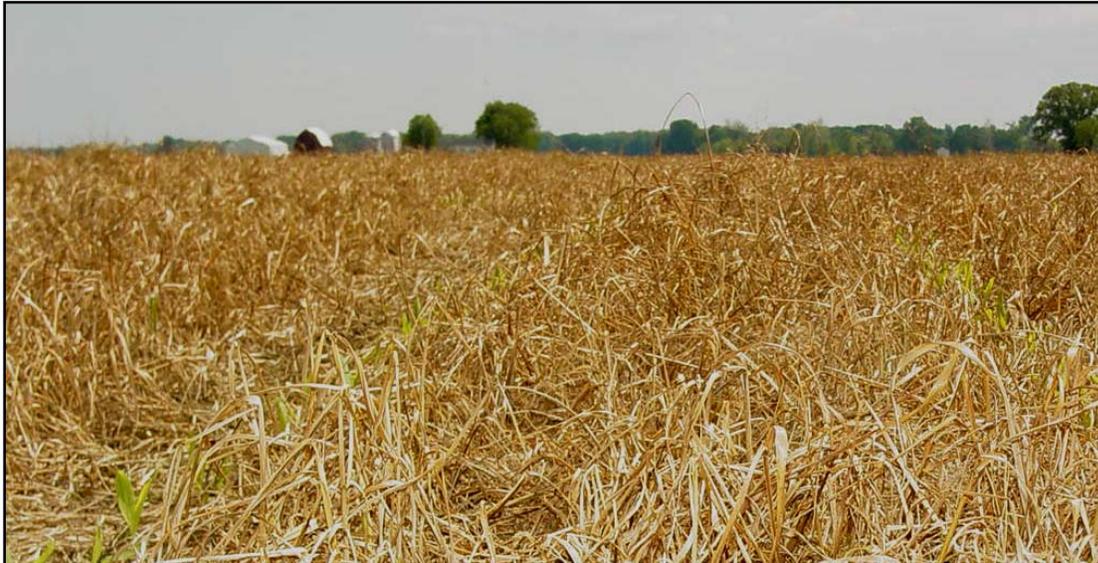
**Plate 8.1** Below is a cover crop of rye grass, which has been killed off. Rows of corn are beginning to emerge through the mat of rye, which will protect the soil throughout the year from run-off due to heavy rain events.

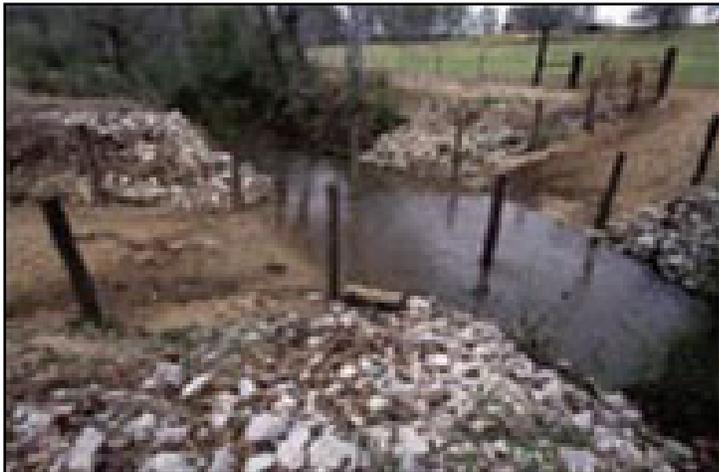
**Plate 8.2** Pictured to the left is an example of “limited access fencing” with a stream crossing, which reduces livestock time in the stream, erosion, and pollution. The sides of these banks were stabilized using rip rap.

When livestock need to cross streams, they should be provided with controlled stream crossings that are lined with coarse gravel to provide animals with firm footing, while discouraging them from congregating or wallowing in the stream (Undersander and Pillsbury, 1999). In areas where streambanks or riparian vegetation is degraded and livestock exclusion is necessary, high tensile fence, solar-powered electric fences, and woven fence can be used relatively inexpensively to exclude livestock from streams. Encouraging animals to drink or cross at managed points will reduce random trampling of streambanks and decrease the risk of animal injury. (Lyons, 1999).

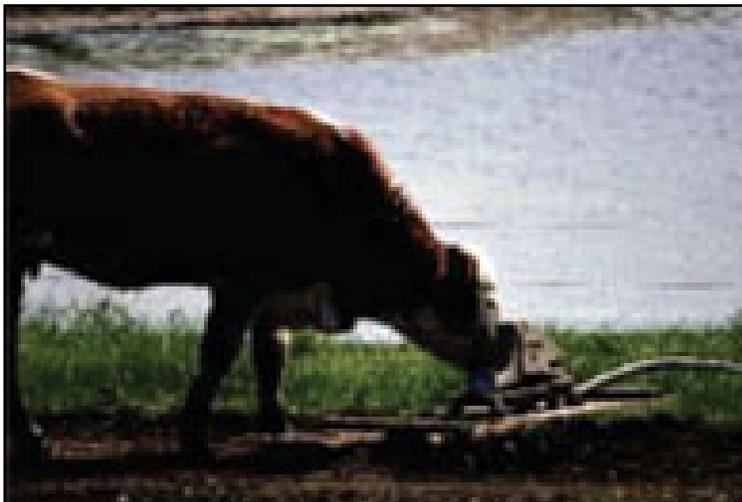
**Plate 8.3** A nose water pump for livestock reduces the need of streams for drinking water . Using a nose pump provides cleaner water for livestock.
