**Office of Water Quality
Total Maximum Daily Load Program**

**Total Maximum Daily Load for
Escherichia coli (*E. coli*) in the Cicero Creek Watershed,
Hamilton, Tipton, Boone and Clinton Counties**

September 8, 2011

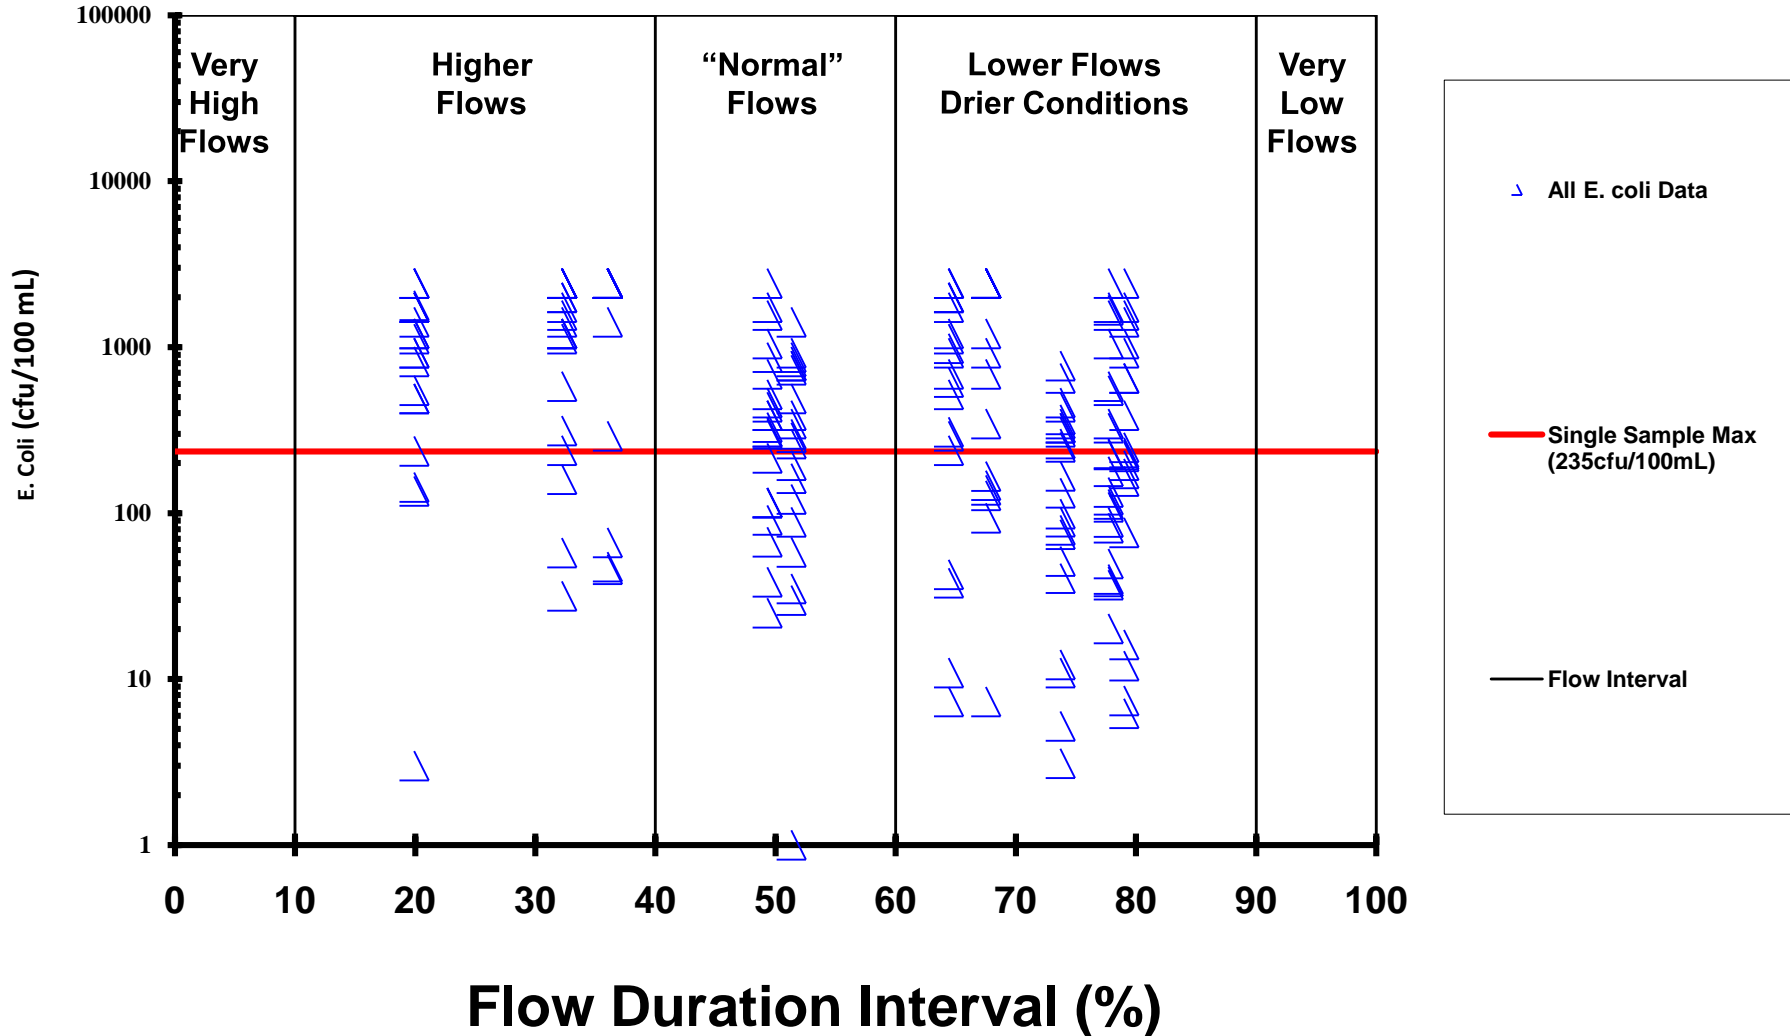
Cicero Creek Watershed

E. coli Load Duration Curve (all sites)

To investigate further the potential sources mentioned above, an *E. coli* duration curve analysis, as outlined in an unpublished paper by Cleland (2002), was developed for each of the 41 (reservoir sites were not included) sampling sites in the Cicero Creek watershed (Attachments C, D, E). The method considers how stream flow conditions relate to a variety of pollutant loadings and their sources (point and nonpoint).

Load duration curves were created for all the sampling sites in the Cicero Creek watershed (Figure 3, Attachment C, D, E). These sampling sites were sampled for *E. coli* August through September 2006. The data indicate that the largest exceedances of the *E. coli* WQS were prevalent during all flow conditions and weather events (noted by diamonds above the curve on the far left side of the figure in Attachment D).

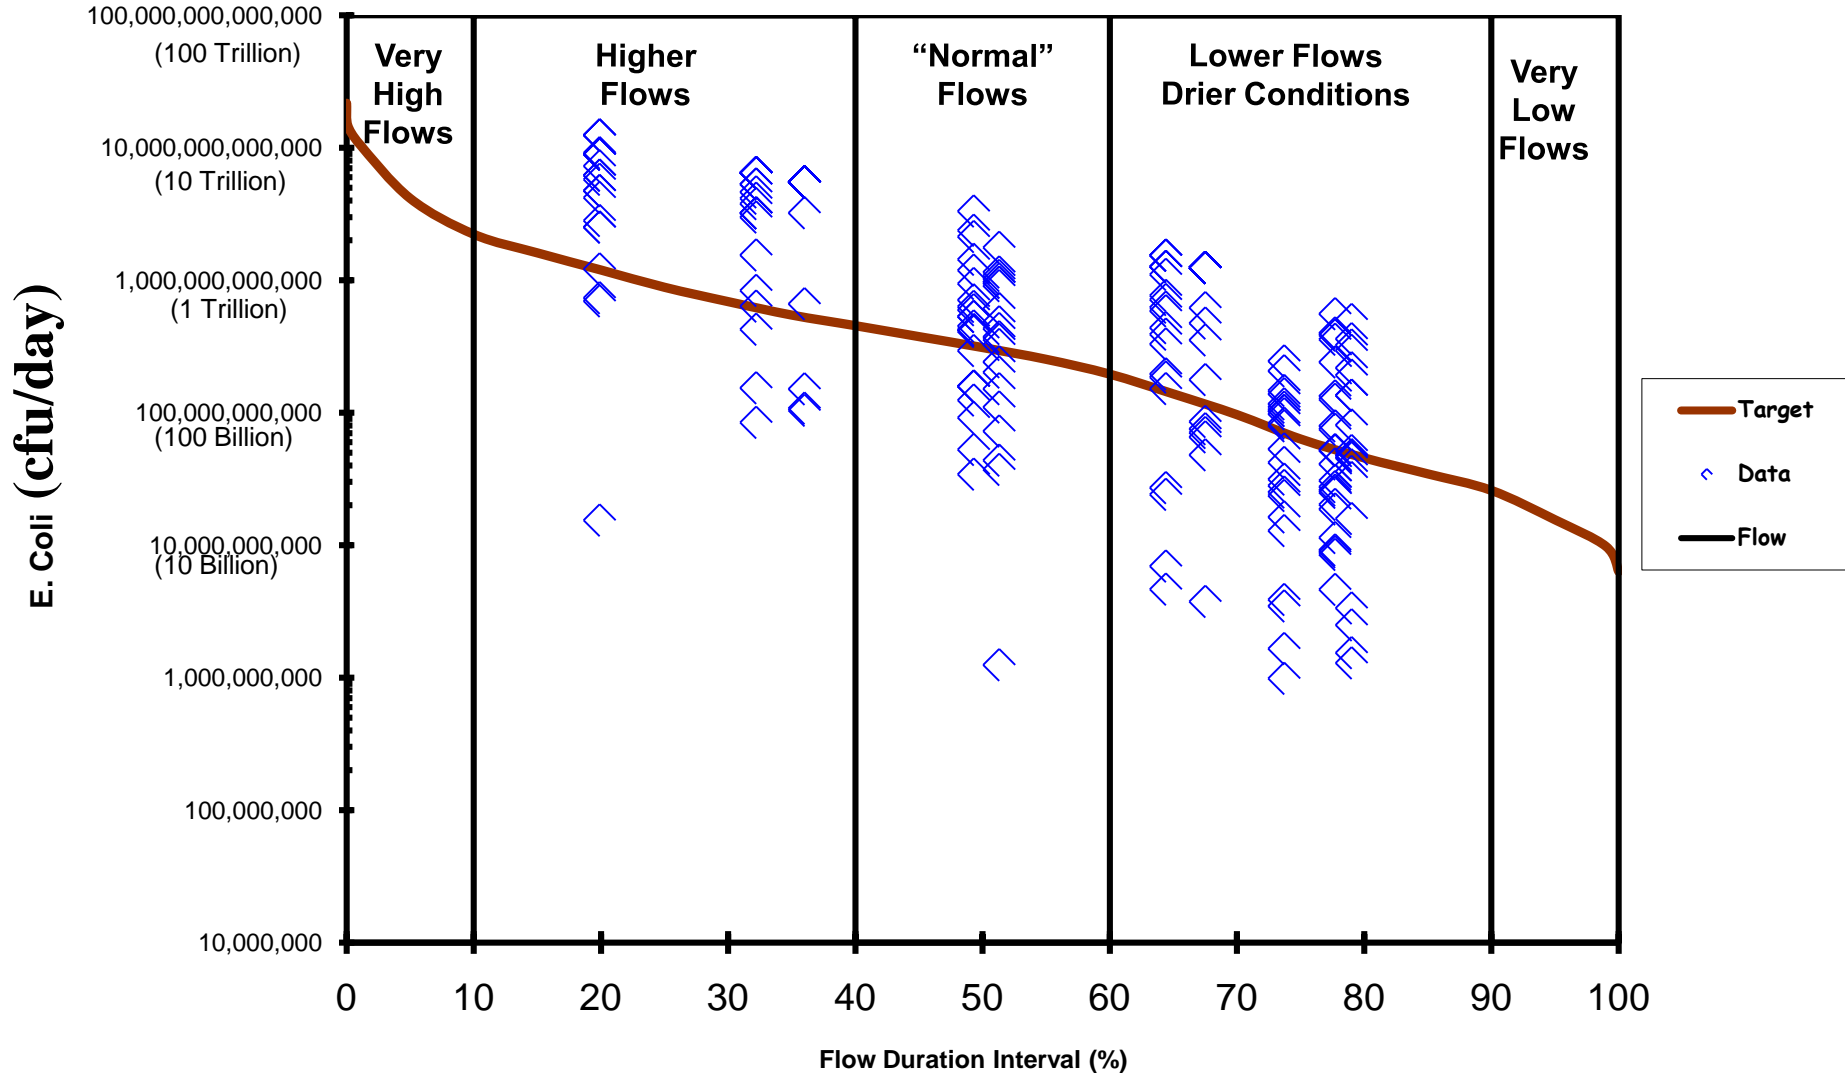
Cicero Creek Watershed

E. coli Load Duration Curve (all sites)

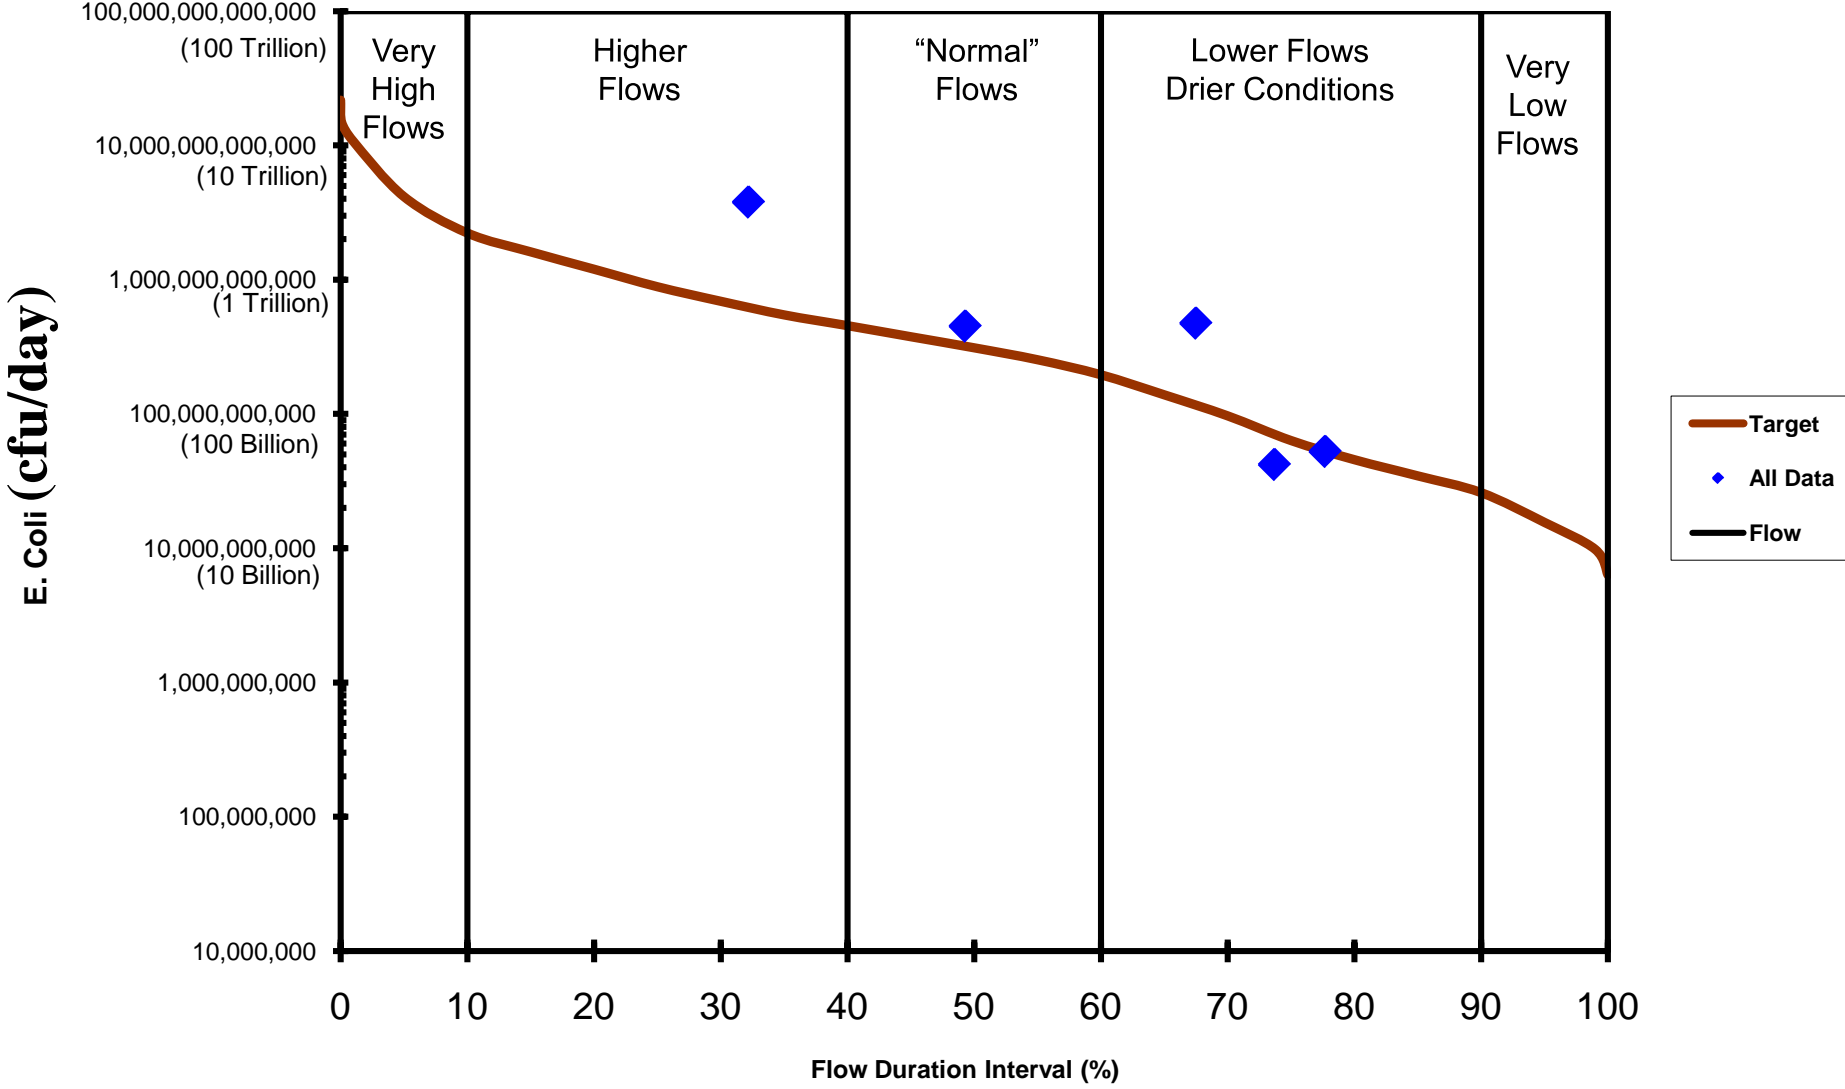
Christy Ditch At CR 1100 W

E. coli Load Duration Curve - Site: 19
