RM 112732

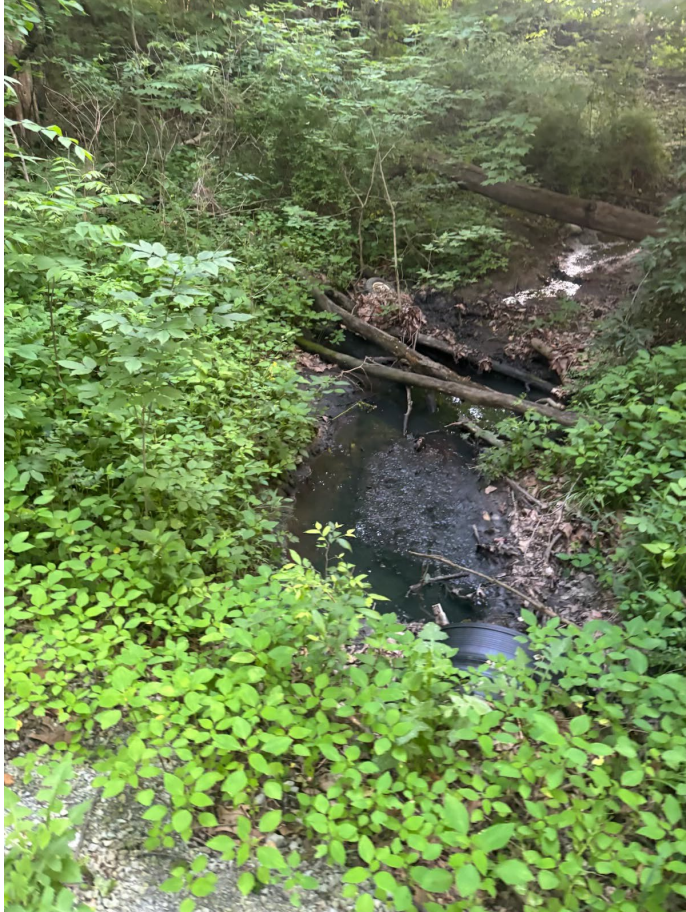
- Facility
 - CoCoJo's RV Campground
- Photographer
 - CO Harmon
- Date/Time
 - 6/1/24
- Others Present
 - N/A
- Possible sewage near bridal trail

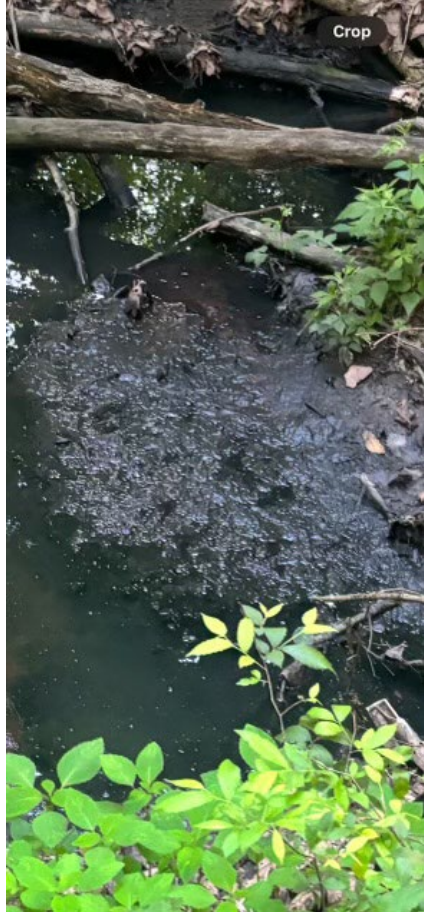
- Facility
 - CoCoJo's RV Campground
- Photographer
 - CO Harmon
- Date/Time
 - 6/1/24
- Others Present
 - N/A
- Possible Sewage

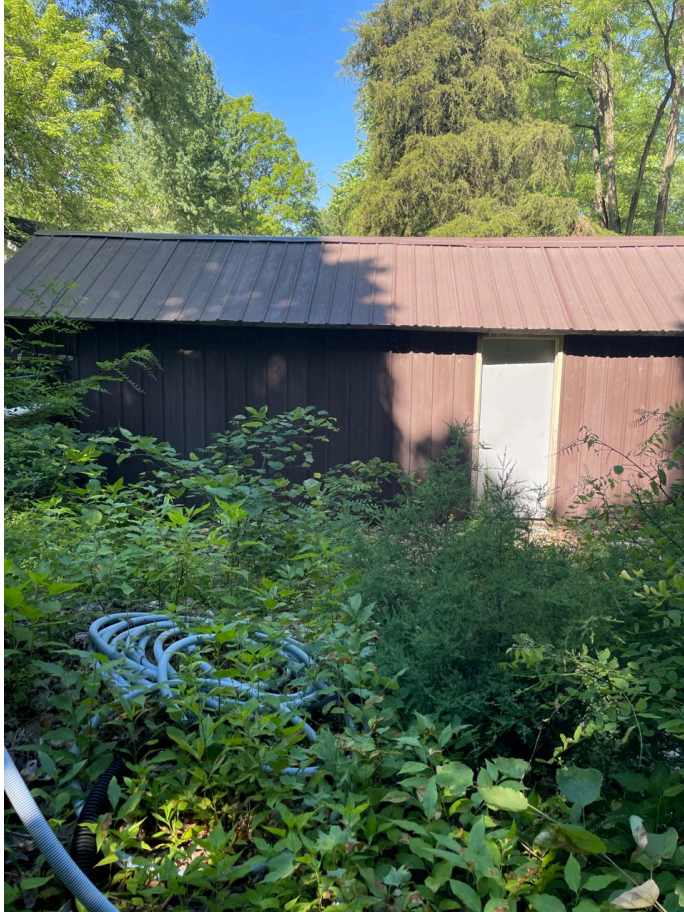
- Facility
 - CoCoJo's RV Campground
- Photographer
 - OSC Caldwell
- Date/Time
 - 6/7/24
- Others Present
 - N/A
- WWTP building

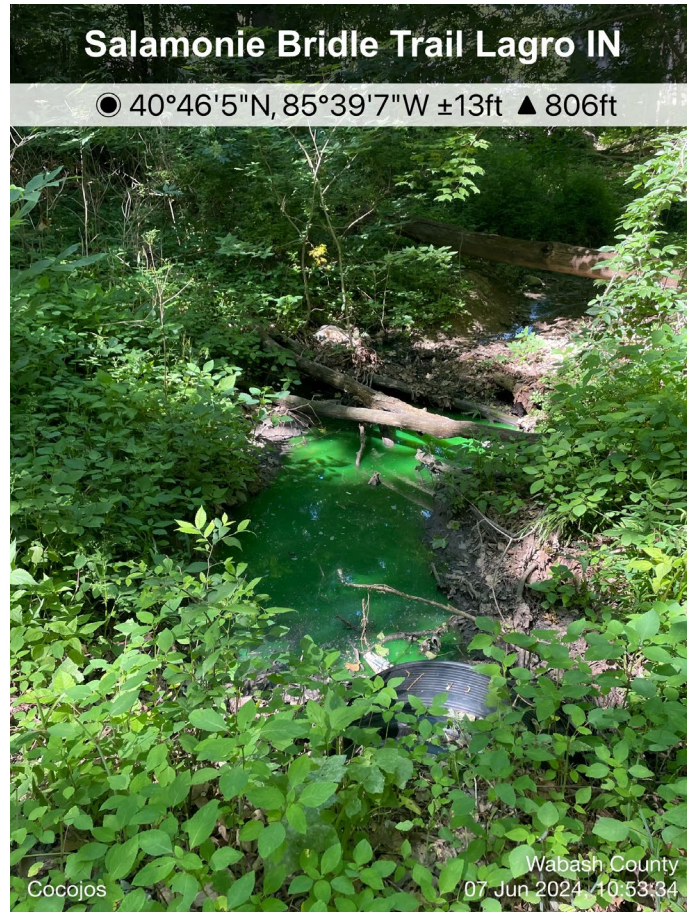
- Facility
 - CoCoJo's RV Campground
- Photographer
 - OSC Caldwell
- Date/Time
 - 6/7/24
- Others Present
 - N/A
- Dye discharging after tablets were placed in WWTP effluent.

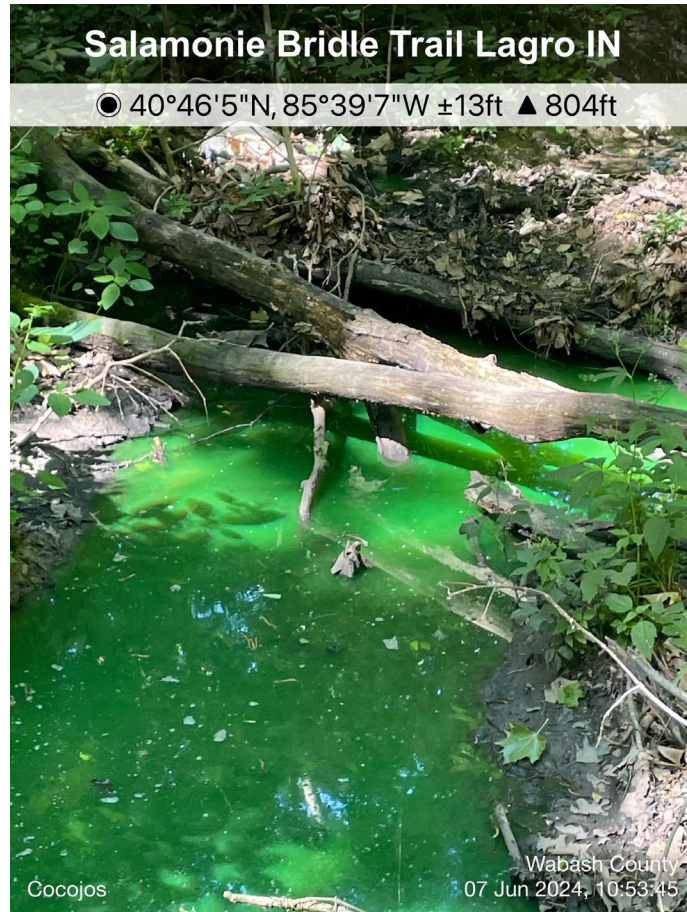
- Facility
 - CoCoJo's RV Campground
- Photographer
 - OSC Caldwell
- Date/Time
 - 6/7/24
- Others Present
 - N/A
- Dye near the bridal trail
