ISOLATED WETLAND INDIVIDUAL PERMIT

PERMIT NO.: IWIP 2023-367-29-GCW-A
PROJECT NAME: Penn One Eleven Development
AUTHORITY: IC 13-18-22-3
DATE OF ISSUANCE: June 6, 2023
DATE OF EXPIRATION: June 6, 2025

PERMITTED ACTIVITY: Discharge 1,400 CY of clean earthen fill, concrete,
and gravel into a 0.86 acre Class III Isolated forested
wetland to facilitate the construction of a multiple-use
development complex.

Wetland Delineation Report

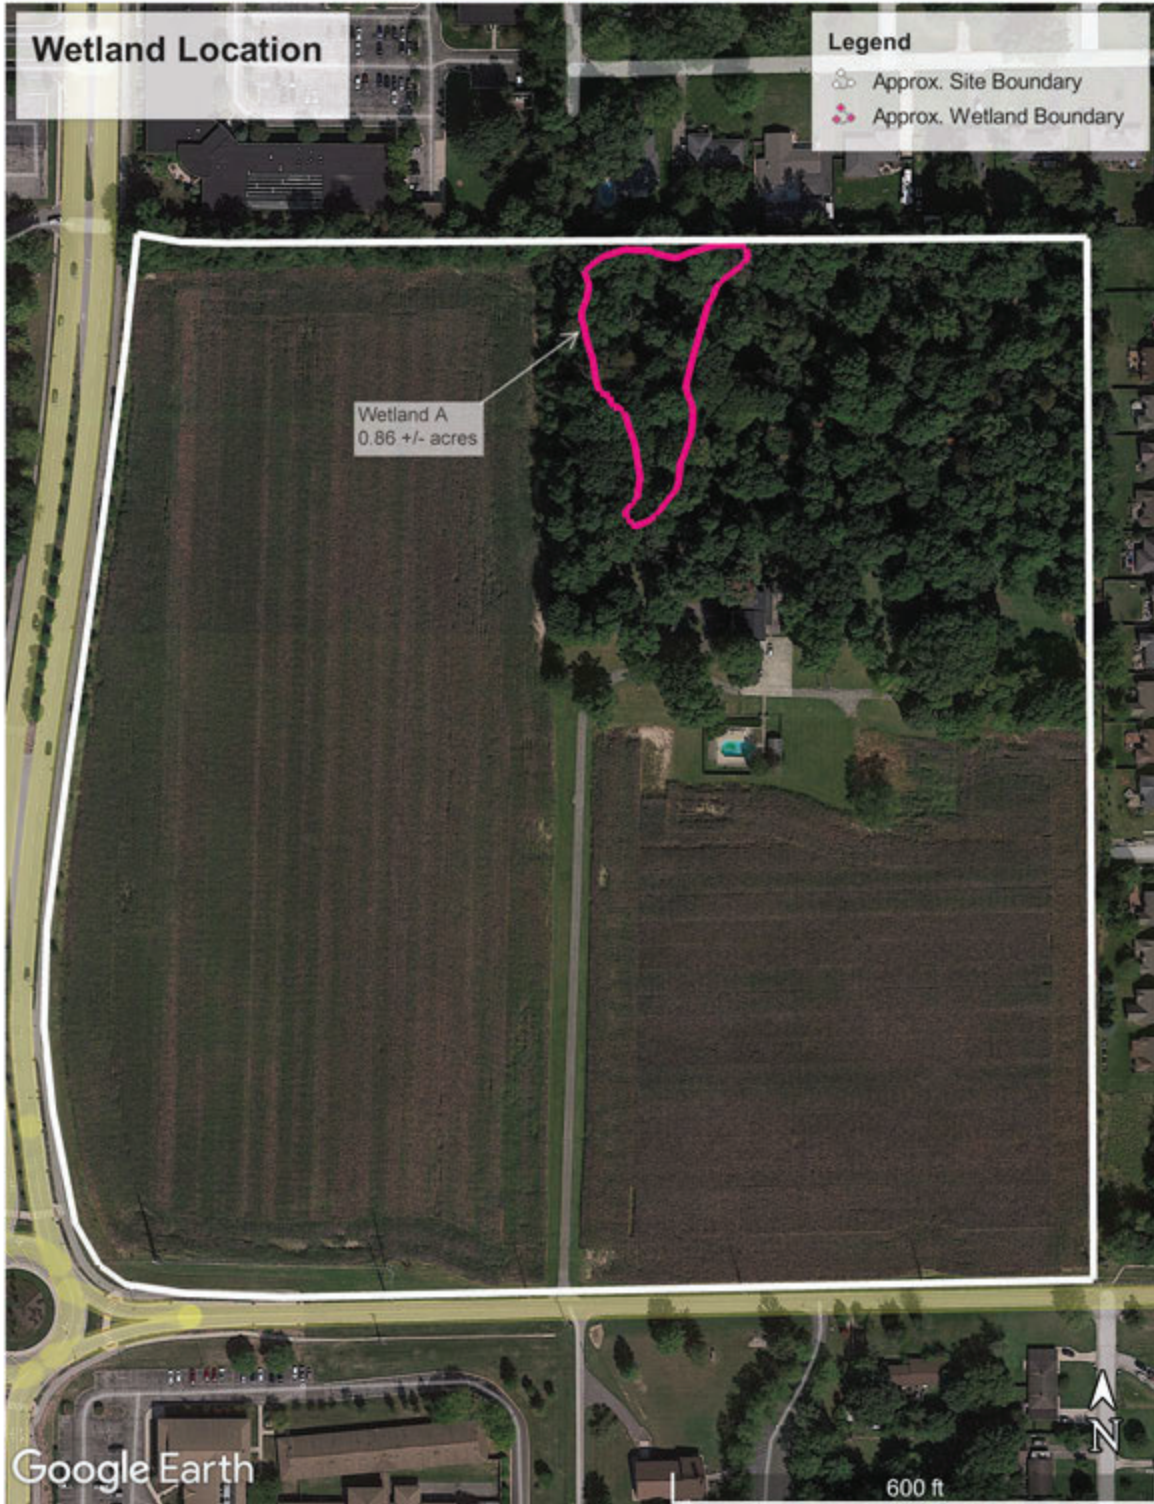
Figure 6. Approximate wetland location.

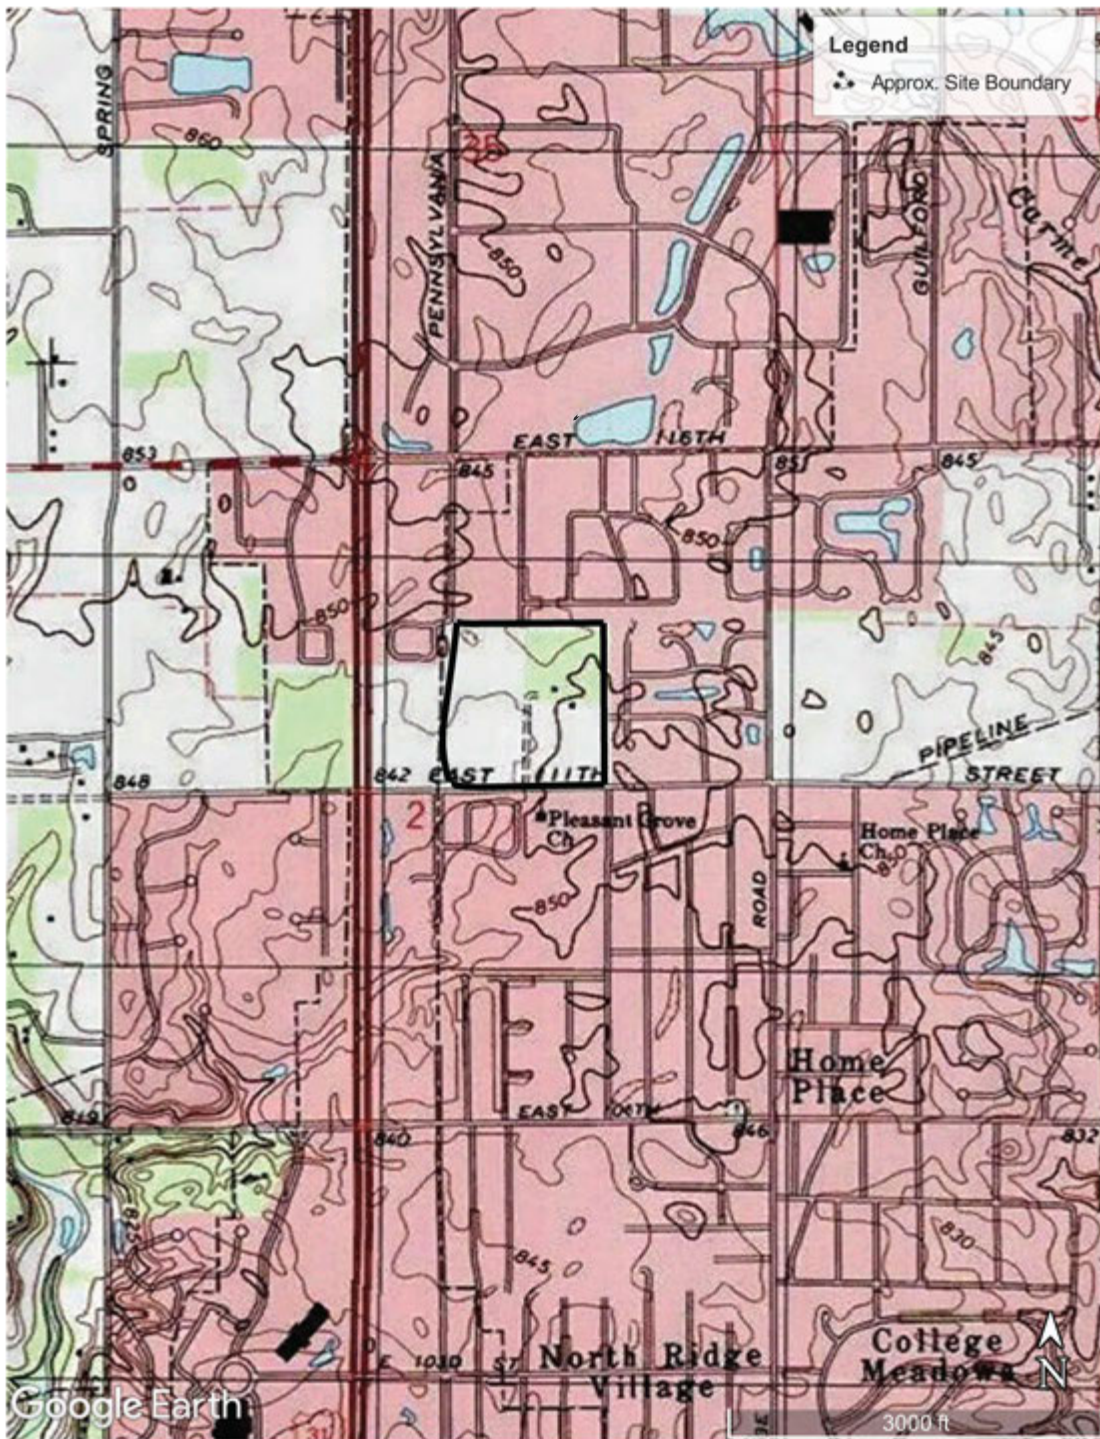
Figure 1. USGS 7.5-minute series of the Carmel Indiana topographic quadrangle.

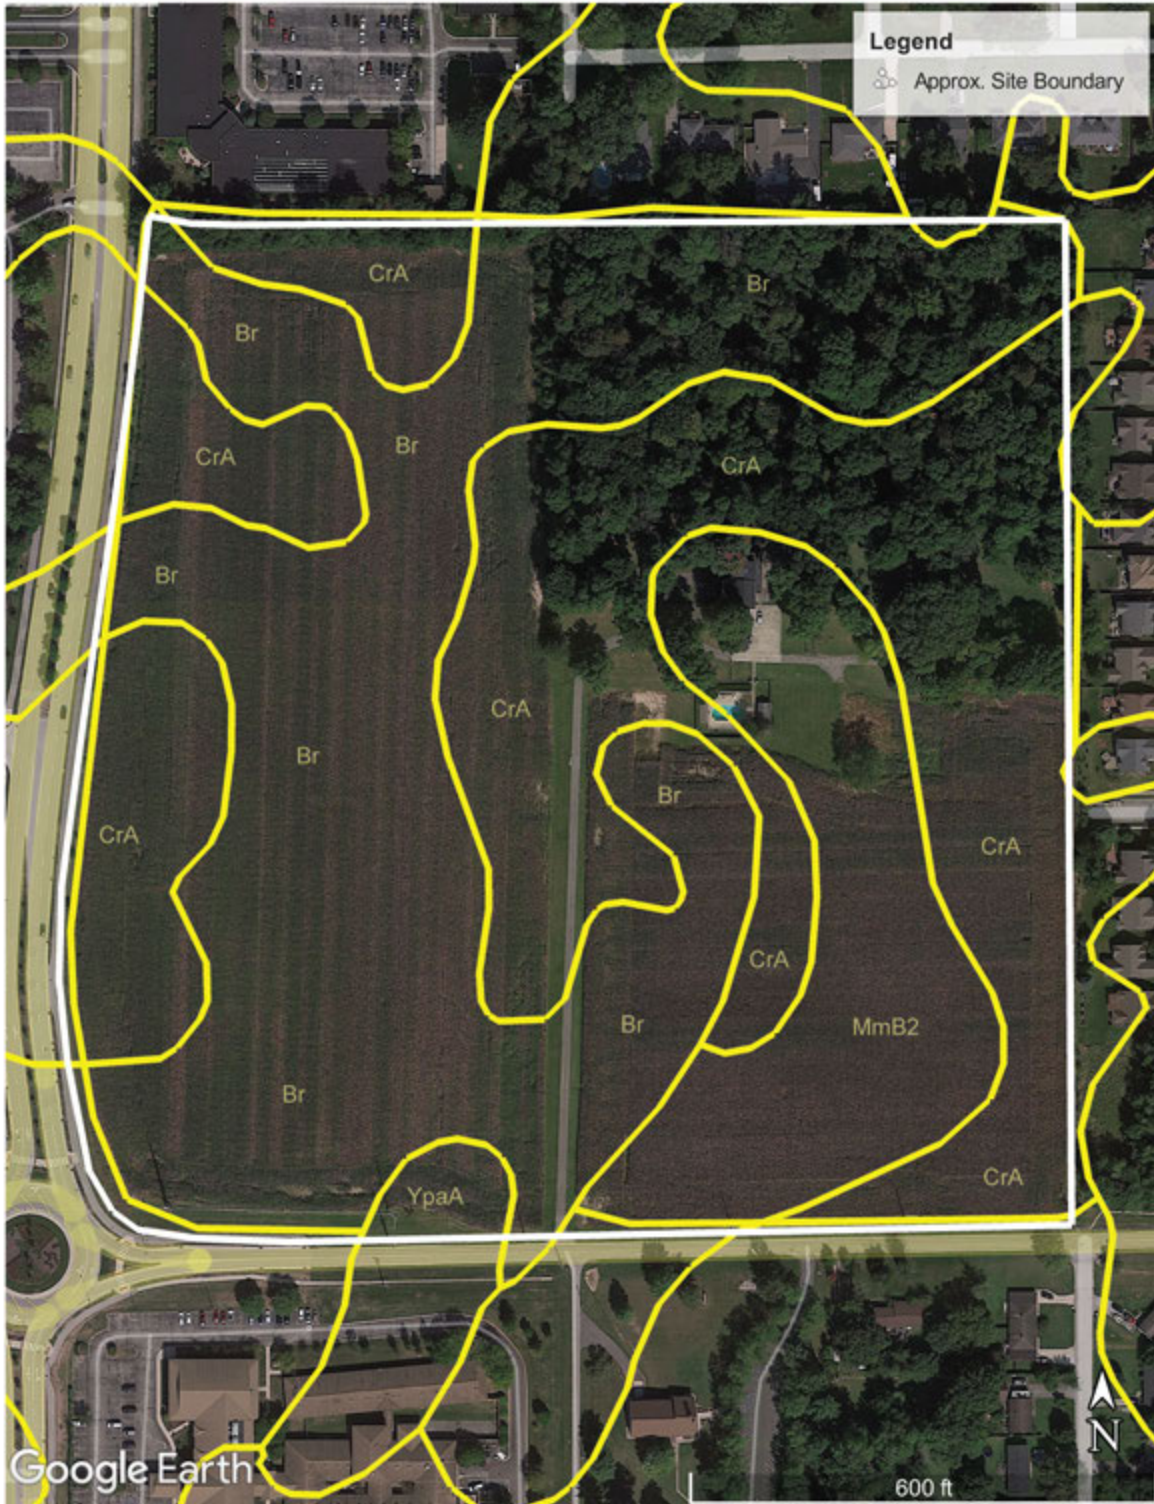
Figure 4. NRCS Soil Survey map.

Map Unit Symbol	Map Unit Name	Drainage	Hydric Soil Rating
Br	Brookston silty clay loam, 0 to 2 percent slopes	Poorly drained	Yes
CrA	Crosby silt loam, fine-loamy subsoil, 0 to 2 percent slopes	Somewhat poorly drained	No
MmB2	Miami silt loam, 2 to 6 percent slopes, eroded	Moderately well drained	No
YpaA	Patton silty clay loam-Urban land complex, 0 to 2 percent slopes	Poorly drained	Yes

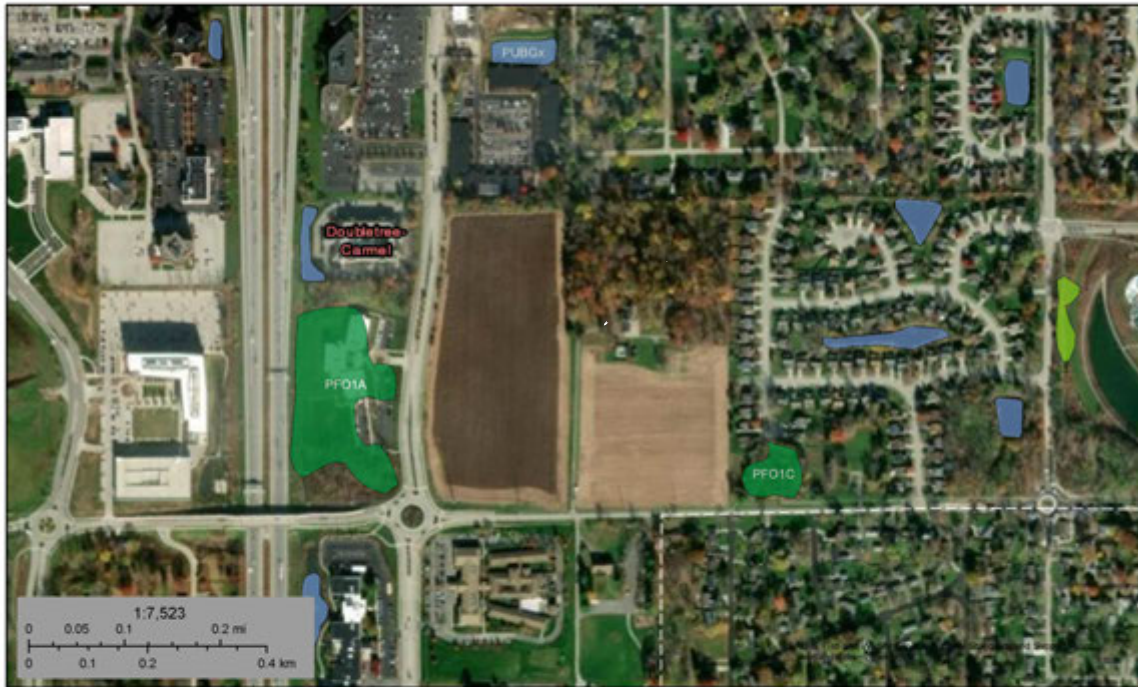
Figure 5. USFWS National Wetlands Inventory map.

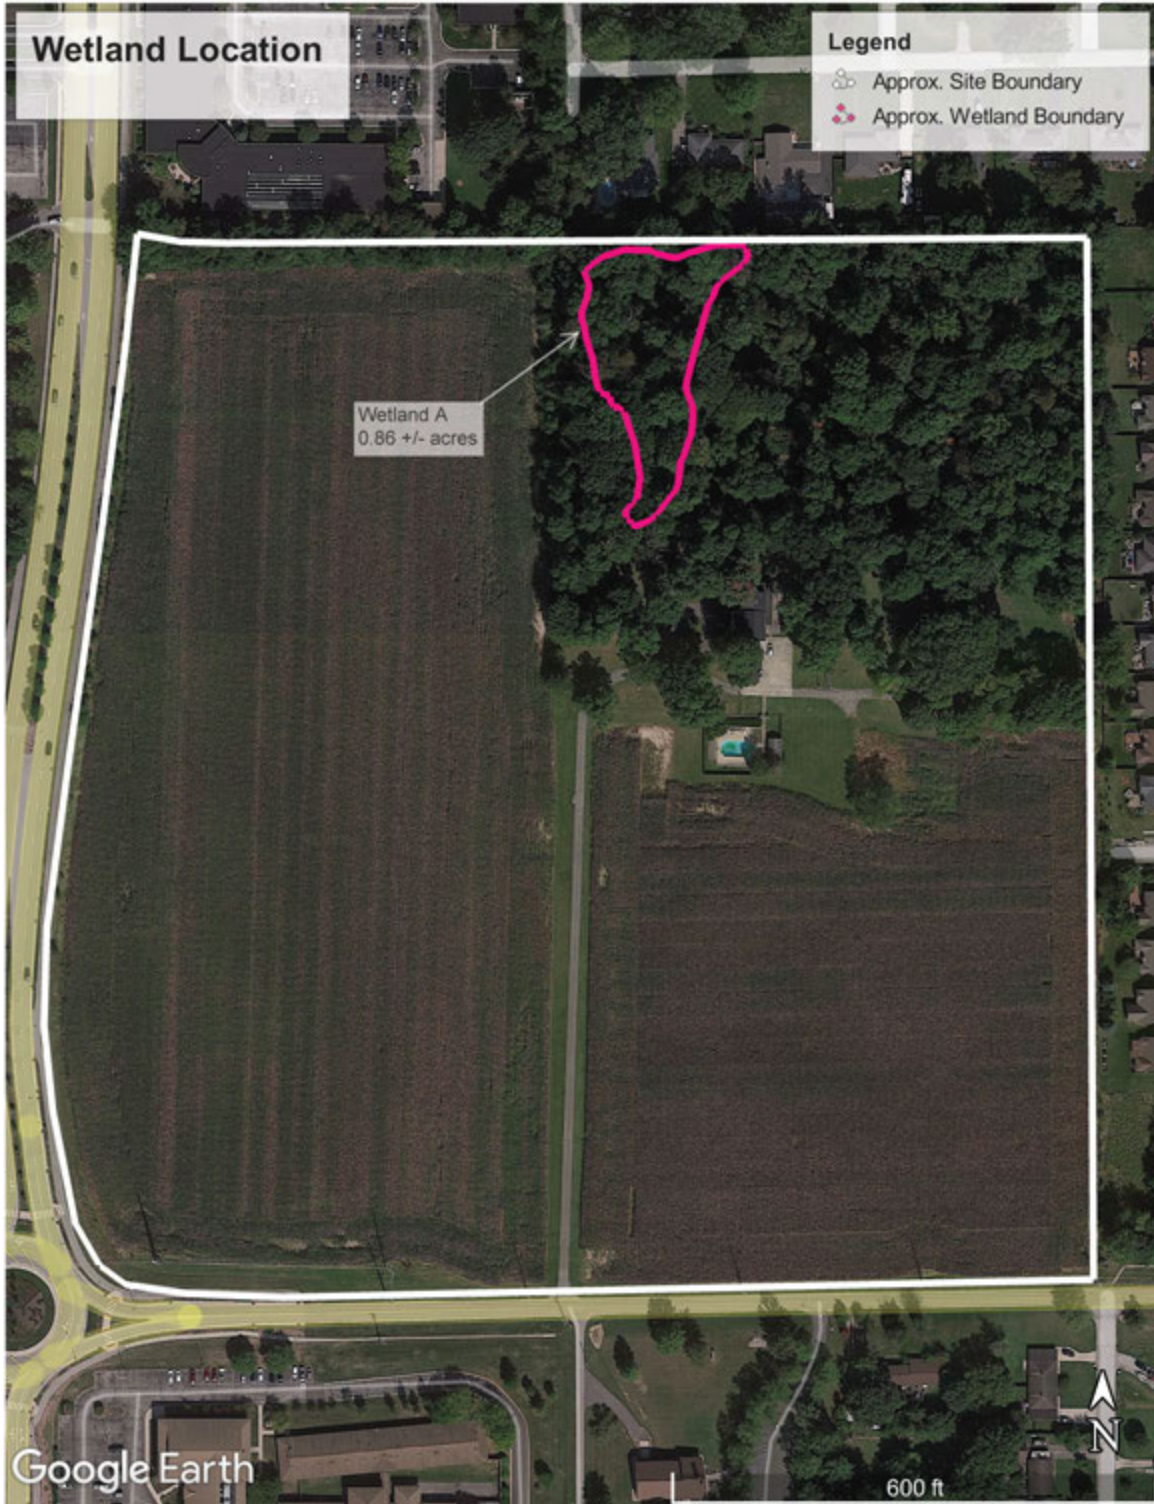
Figure 6. Approximate wetland location.

Wetland	Size (acres +/-)	Type	Estimated JD Status
A	0.86	PFO (Forested)	Isolated

We observed and delineated one wetland (Wetland A) in the forested portion of the site. Wetland A appears to be an isolated forested wetland, approximately 0.86 +/- acres in size.

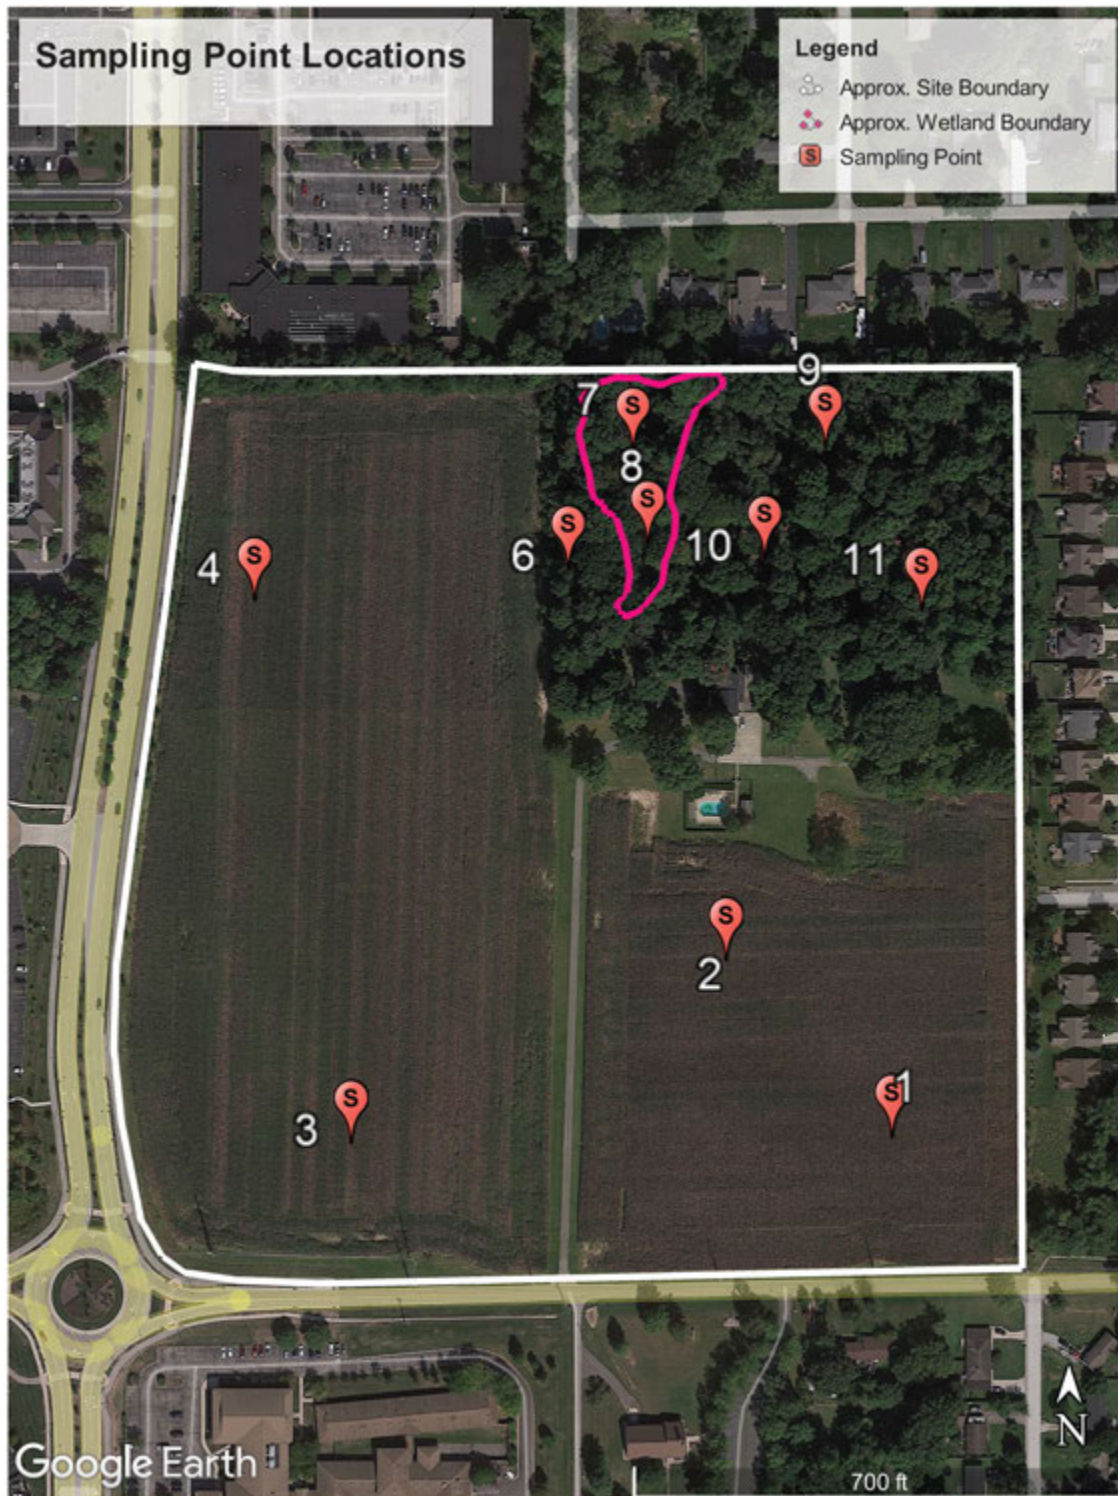
Figure 7. Sampling Point locations.

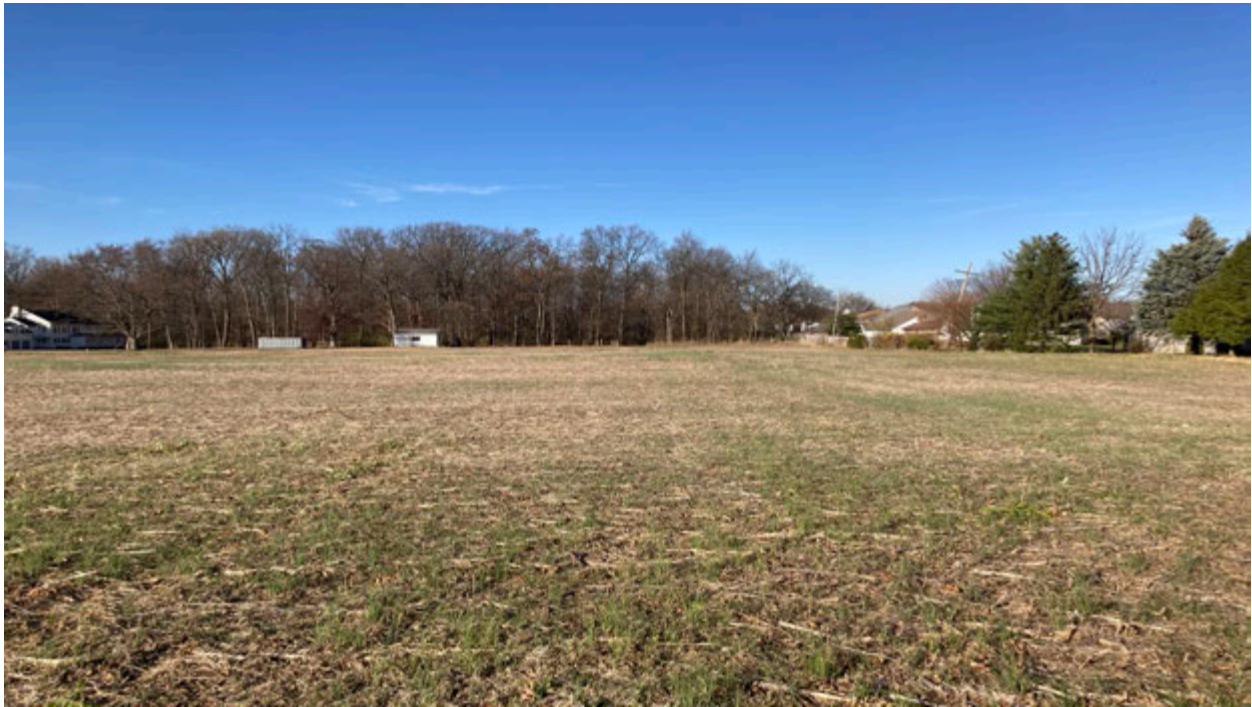
Photo 1. Facing north from Sampling Point # 1. Field appears to have a working subsurface drainage system.

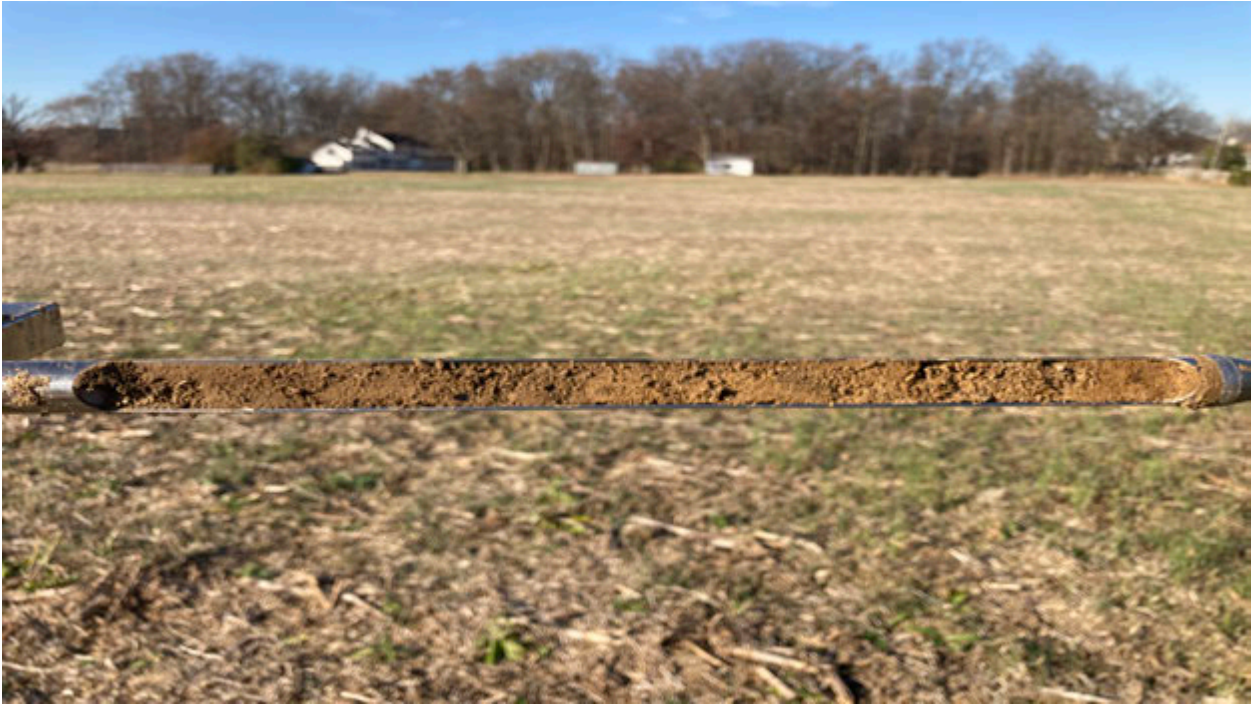
Photos 2. Typical soil profile of Miami silt loam (MmB2), taken at Sampling Point # 1.

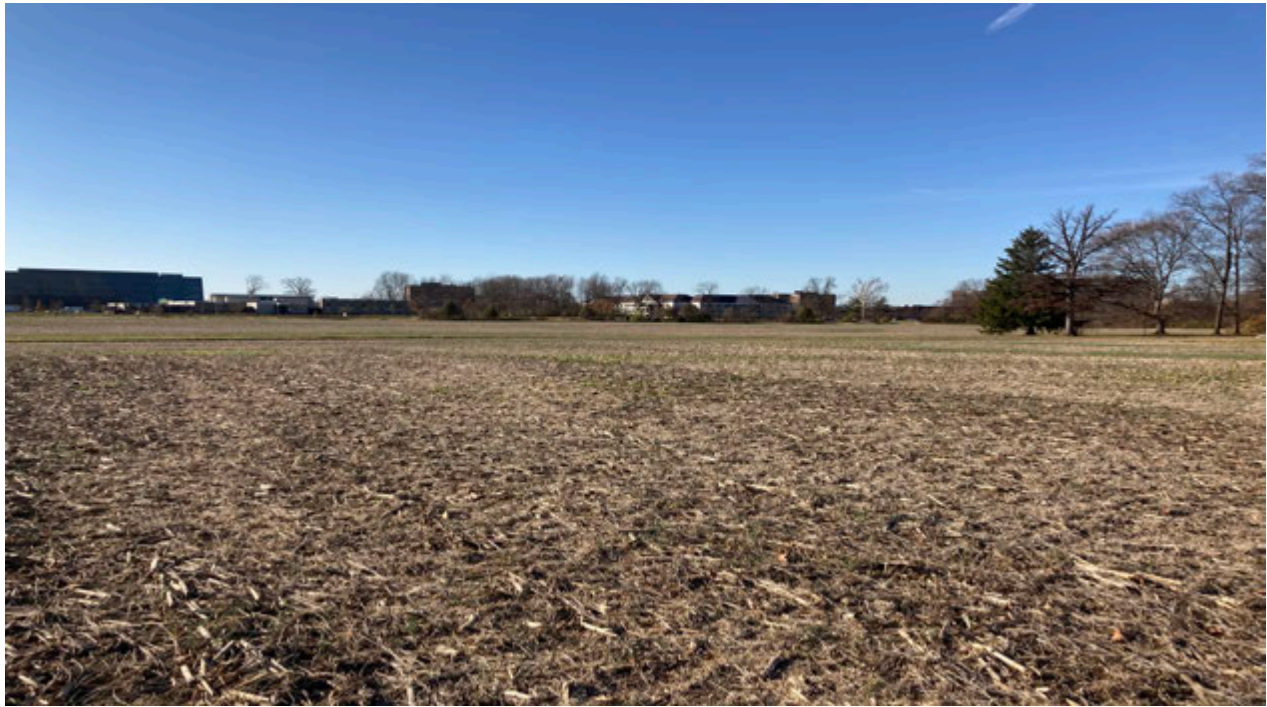
Photo 3. Facing northwest toward western row crop field, taken at Sampling Point # 2.

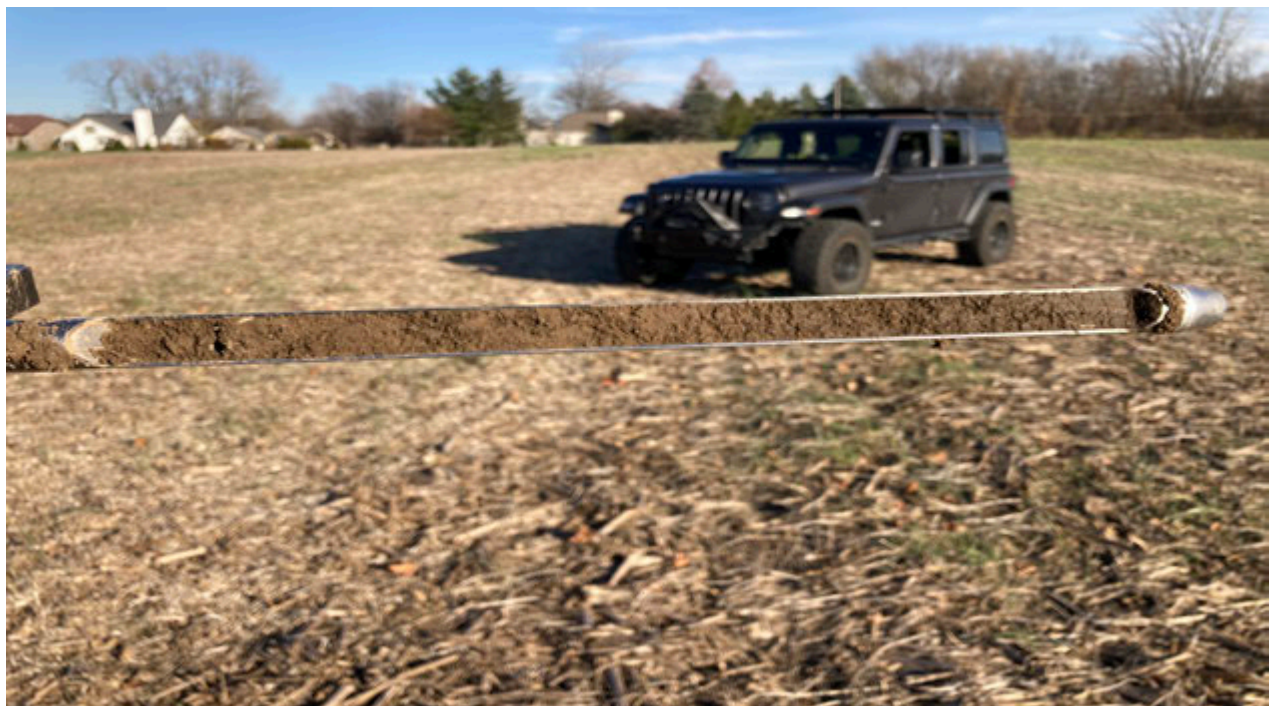
Photo 4. Atypical soil profile of Crosby-Brookston Complex, taken at Sampling Point # 2.

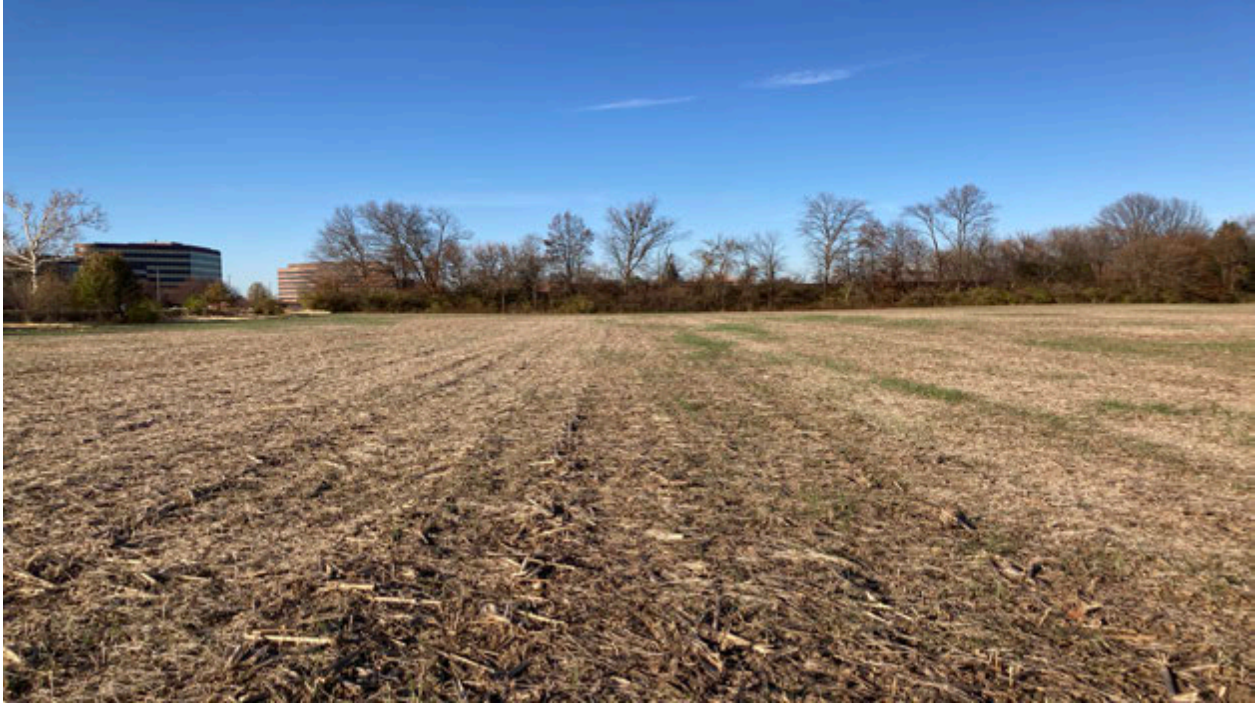
Photo 5. Observing north toward northern site perimeter, taken at Sampling Point # 4.

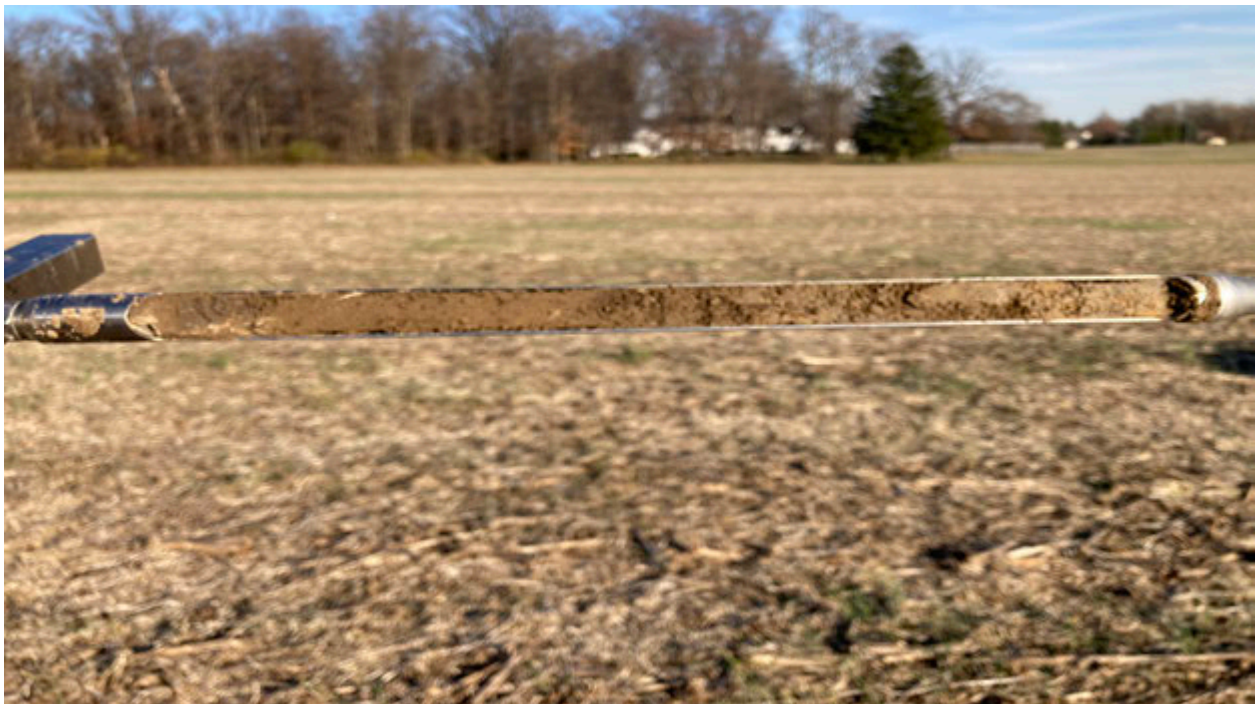
Photo 6. Atypical soil profile of Miami-Crosby Complex, taken at Sampling Point # 4.

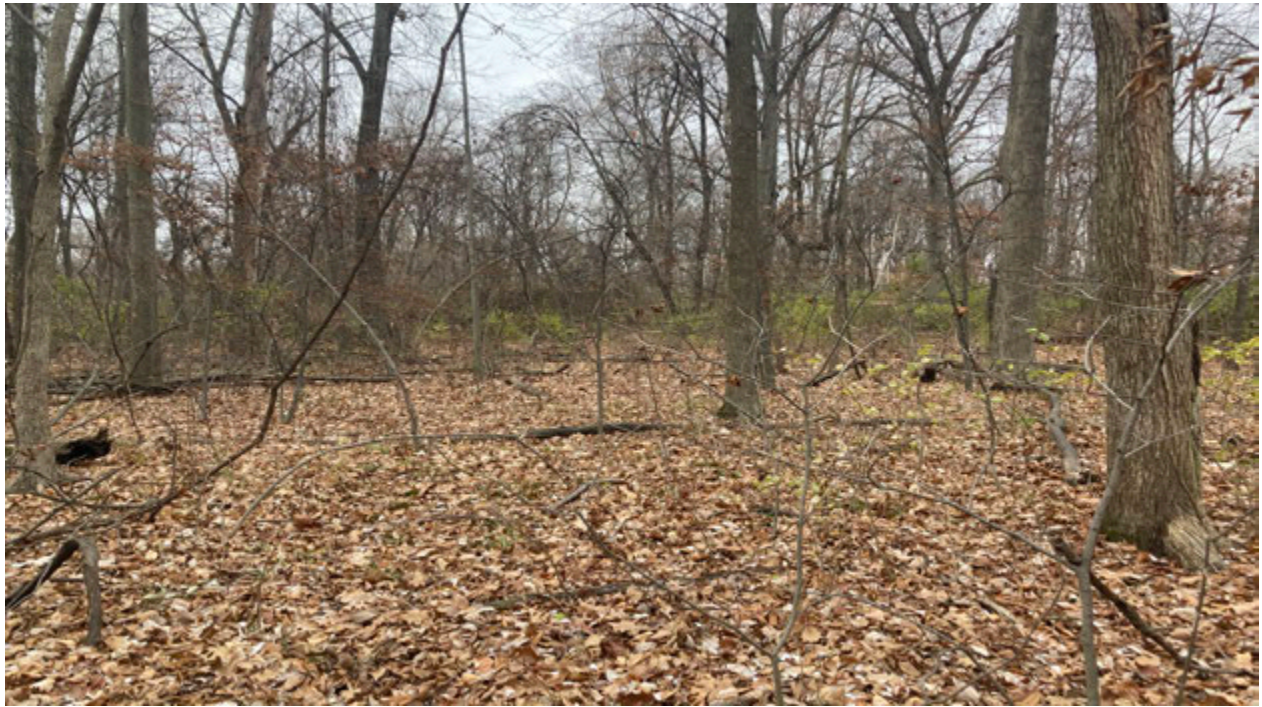
Photo 9. Typical view at northern end of Wetland A, taken near Sampling Point # 7.

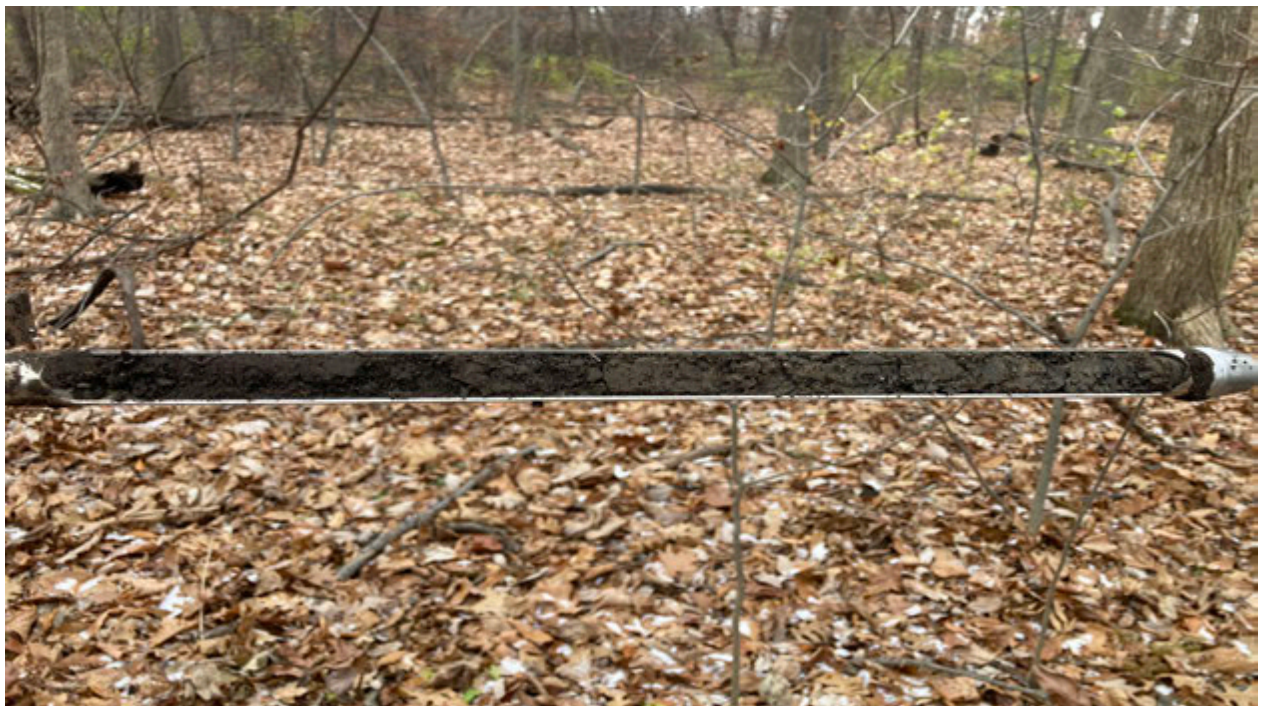
Photo 10. Typical soil profile of Brookston silty clay loam (Br), taken at Sampling Point # 7.
