Re: Inspection Summary Letter
Portage Water Reclamation Facility
NPDES Permit No. IN0024368
Portage, Porter County

Type of Inspection: Complaint Investigation

# NPDES Wastewater Facility Inspection Report INDIANA DEPARTMENT OF ENVIRONMENTAL MANAGEMENT

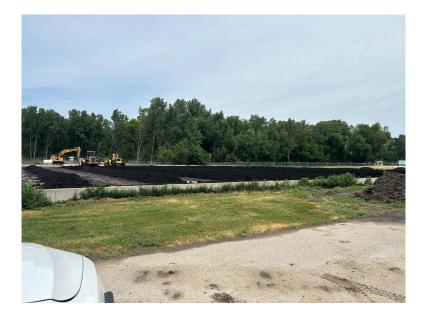
The solids storage area was observed prior to entering the wastewater plant. Sludge was stored in rows in the northeast corner of the property and soil with woody vegetation was observed immediately south of the sludge. While the sludge did have an odor, it was not overly strong at the time of the investigation.

North view of the sludge rows on the sludge drying pad in the northeast corner of the solids drying area.

Mr. Nelson stated that the rows of sludge had been turned on June 24, 2024, which may have increased any potential odors. Mr. Nelson also stated that the piles of soil and woody vegetation south of the sludge drying bed was material removed in preparation for the installation of solar panels.

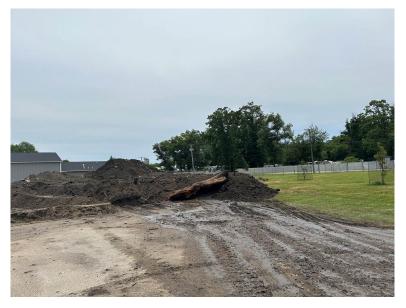
East view of soil removed in preparation for the installation of solar panels. This pile was located immediately south of the sludge drying pad.

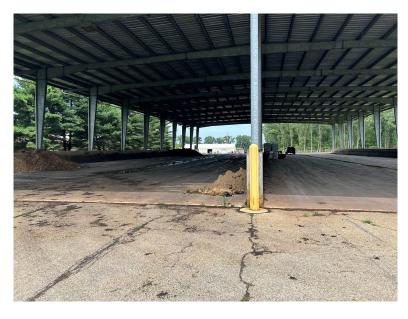
North view of the covered sludge holding area, which was mostly empty.
