Indiana Department of Environmental Management

Re: Inspection Summary/ Noncompliance Letter
Holland Dairies, Inc.
NPDES Permit No. IN0058513
Holland, Dubois County

Date(s) of Inspection: June 19, 2024
Type of Inspection: Reconnaissance Inspection
Inspection Results: Violations were observed.

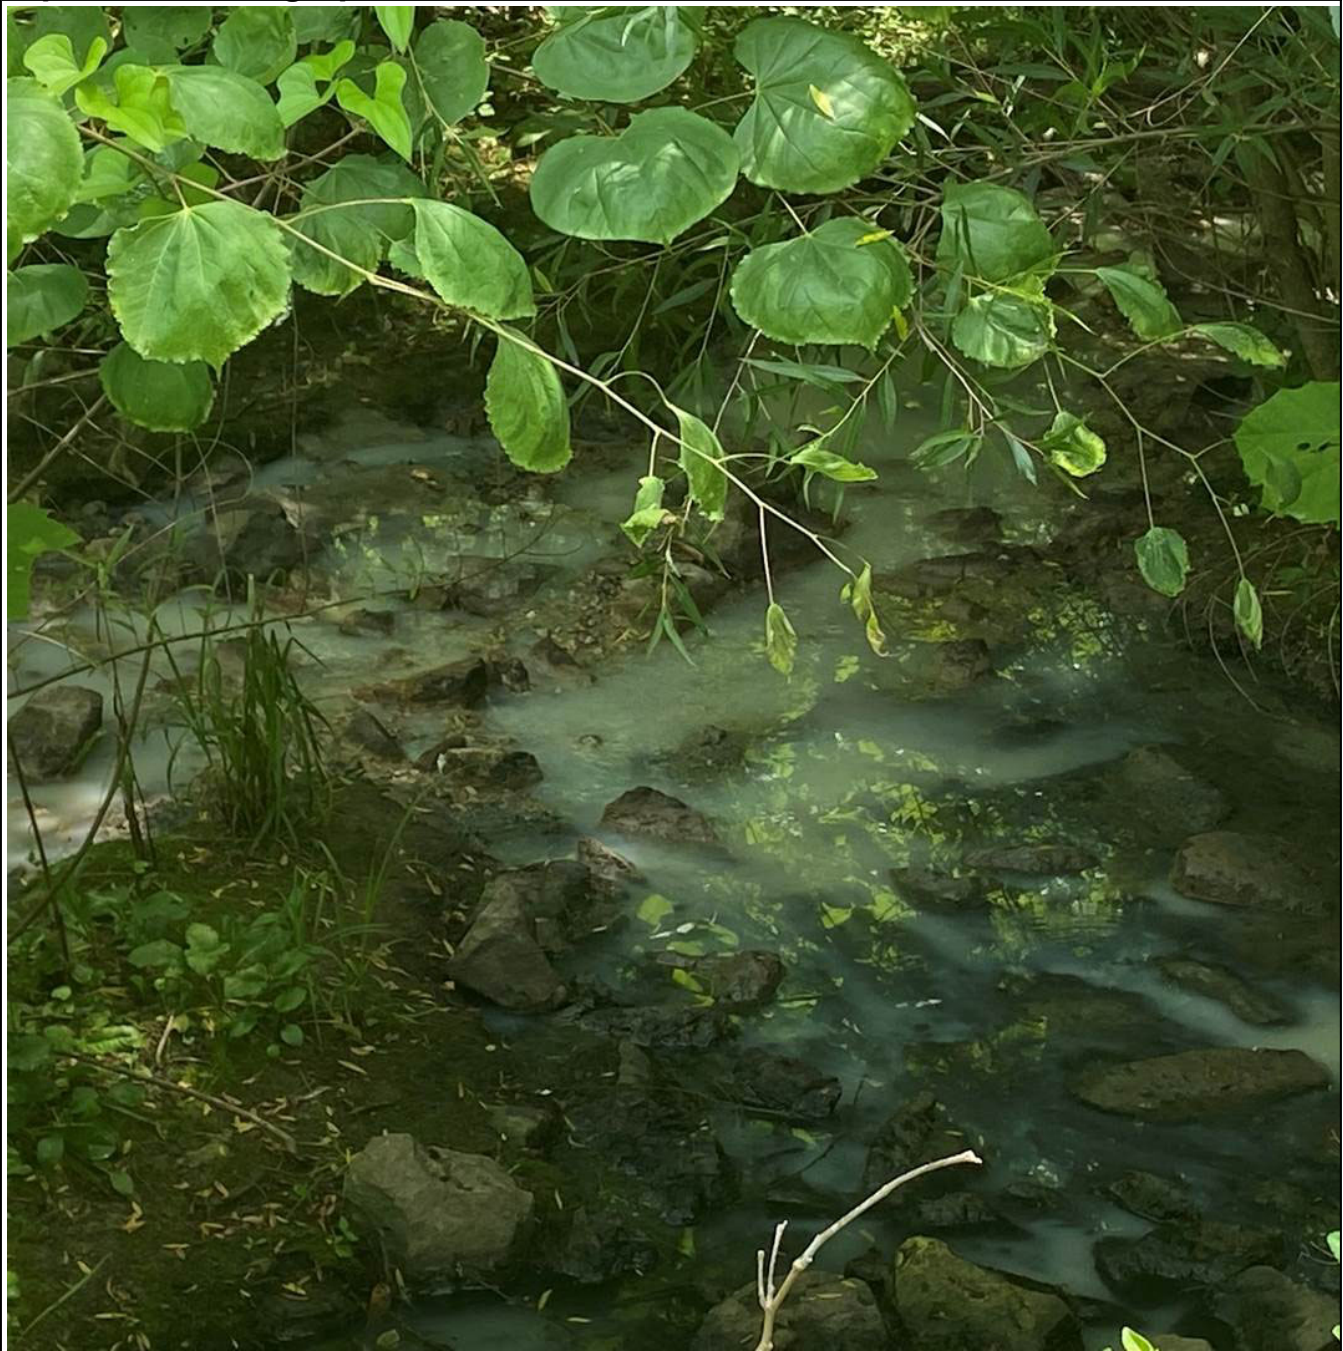
Facility: Holland Dairies, Inc.		Location/Description: A milky discharge was noted in the North Fork Little Pigeon Creek. (Photo from Charles [Andy] Stinchfield)
Photographer: Jeremy Ferguson		
Date: 06/18/2024	Time:	
Others Present:

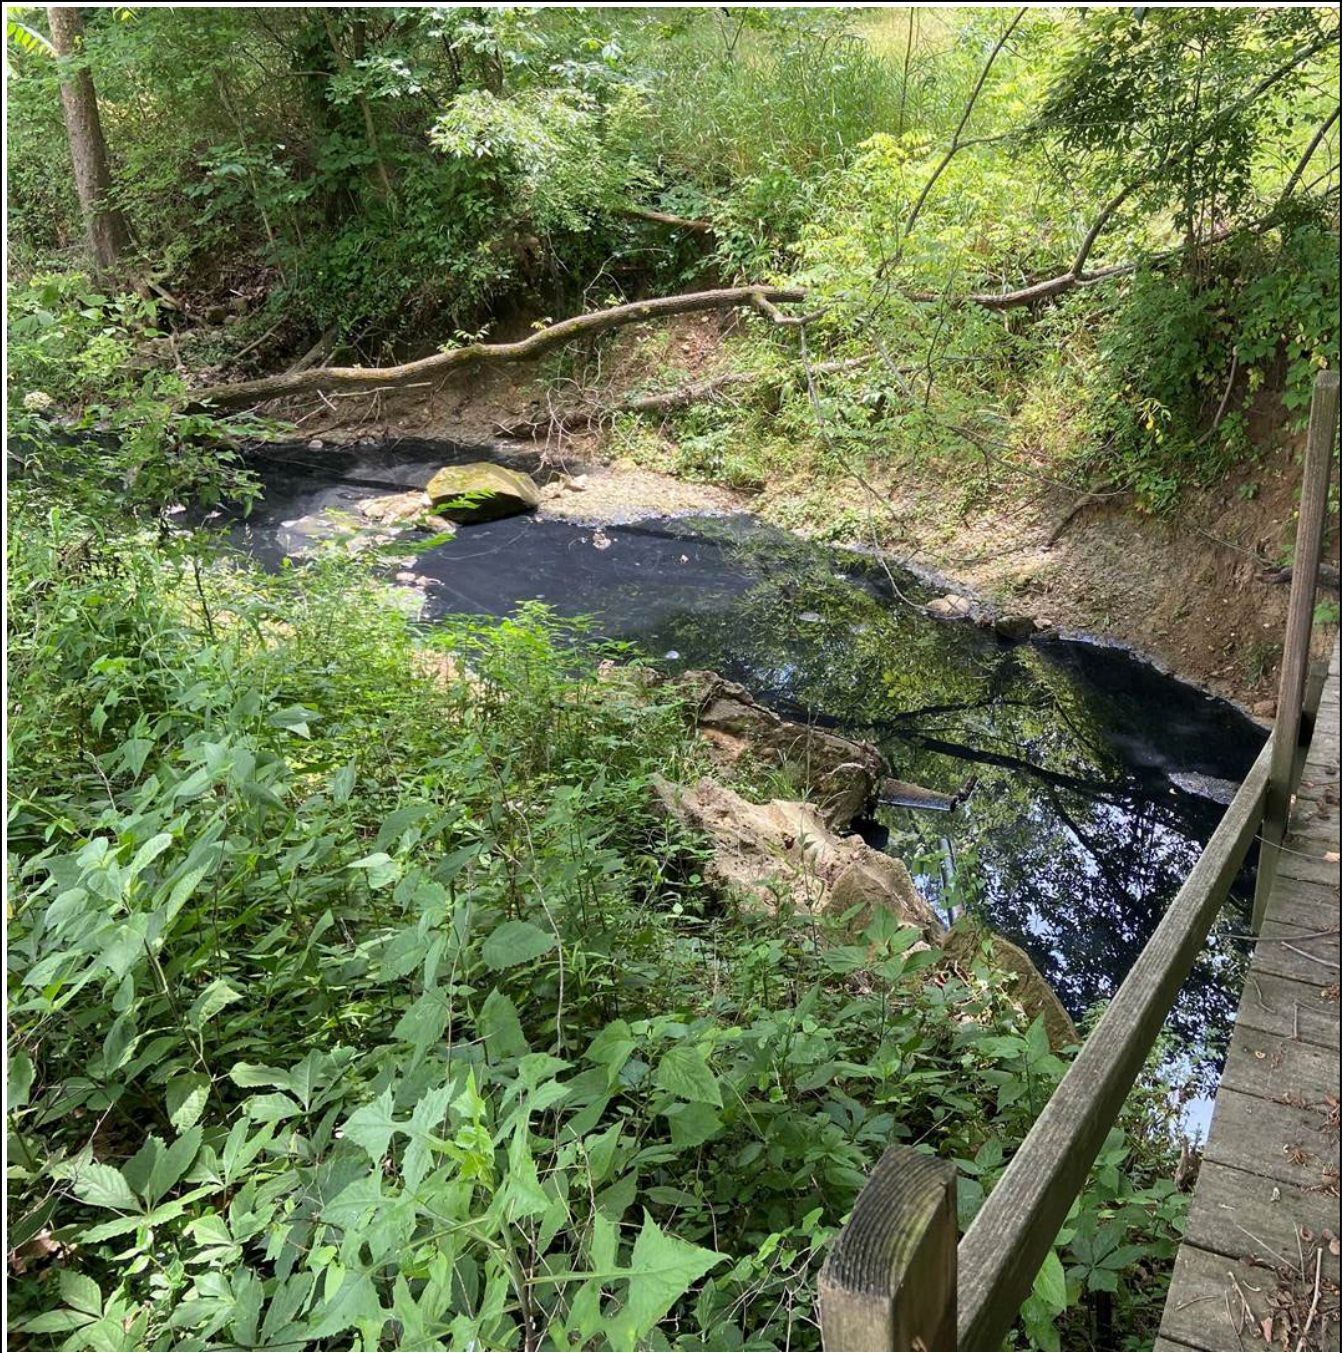
- A. will settle to form putrescent or otherwise objectionable deposits;
 - B. are in amounts sufficient to be unsightly or deleterious; produce color, visible oil sheen, odor, or other conditions in such degrees as to create a nuisance;
 - C. are in concentrations or combinations that will cause or contribute to the growth of aquatic plants or algae to such a degree as to create a nuisance;
 - D. be unsightly, or otherwise impair the designates uses; and are in amounts sufficient to be acutely toxic to, or to otherwise severely injure or kill aquatic life, other animals, plants, or humans.
2. The facility had various illicit discharges entering into the North Little Pigeon Creek from the Town's storm drains. The appearance of this (receiving stream) creek is unsatisfactory. Upon inspection, creek was black (see photo) and had a very putrescent scent like rotten milk within it.

Facility: Holland Dairies, Inc.		Location/Description: Near complaint location east of highway 161. Discharge from the plant had become septic and turned the creek black. (Photo from Charles [Andy] Stinchfield)
Photographer: Jeremy Ferguson		
Date: 06/18/2024	Time:	
Others Present:

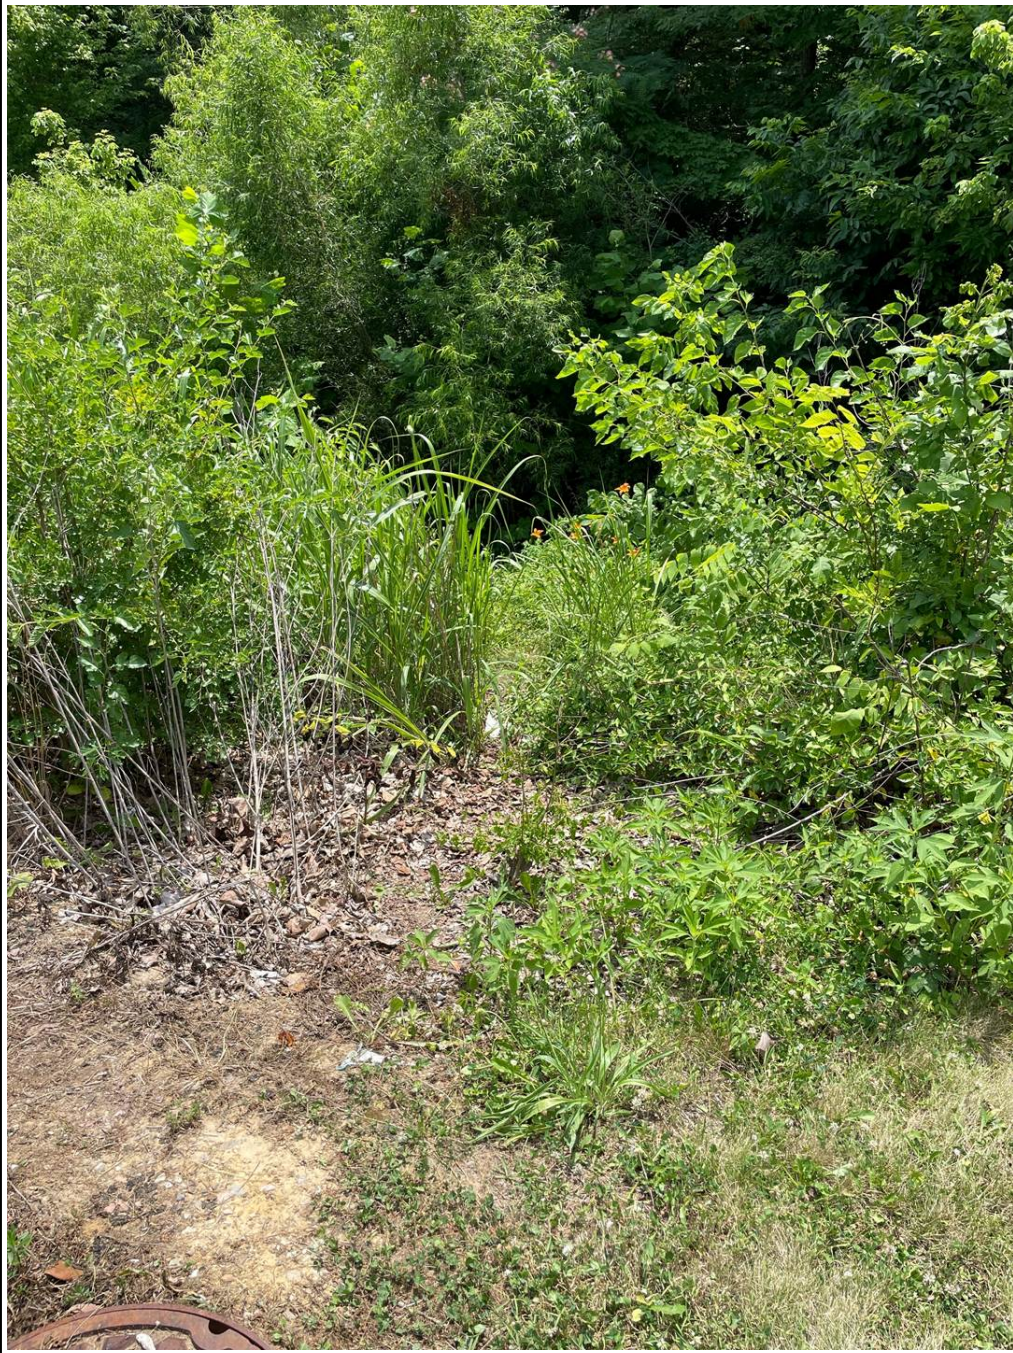
The permittee failed to notify IDEM of known releases from their facility for an extended period of time. A path was noticeable on the ground from the facility to the release area made by the passing of personnel to the known bypass point located at the culvert of 1st Ave. & Kentucky. Onsite personnel also stated it was known these events were occurring (See photo).

Facility: Holland Dairies, Inc.		Location/Description: A worn path to culvert at 1st Ave. & Kentucky to North Fork Little Pigeon Creek.
Photographer: Jeremy Ferguson		
Date: 06/19/2024	Time:	
Others Present:

Personnel stated that they failed to document these site visits and the IDEM Inspector informed personnel that they must provide proper documentation of these events. Regular monitoring and documentation of these checks of North Fork Little Pigeon Creek is required until all discharges cease.

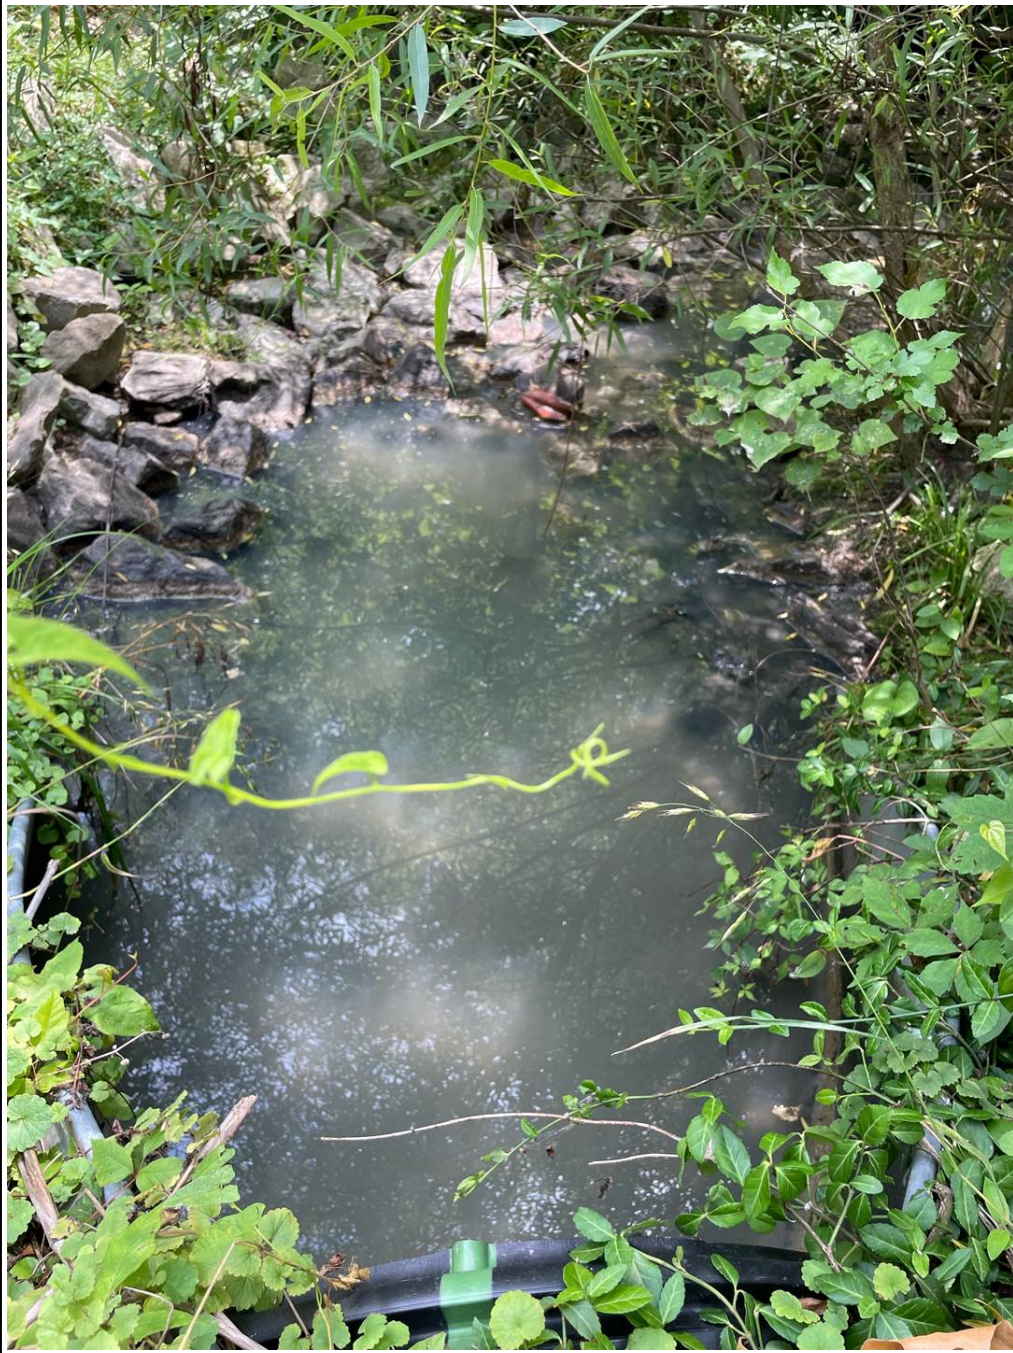
Facility: Holland Dairies, Inc.		Location/Description: Milky colored water in the North Fork Pigeon Creek
Photographer: Jeremy Ferguson		
Date: 06/19/2024	Time:	
Others Present:

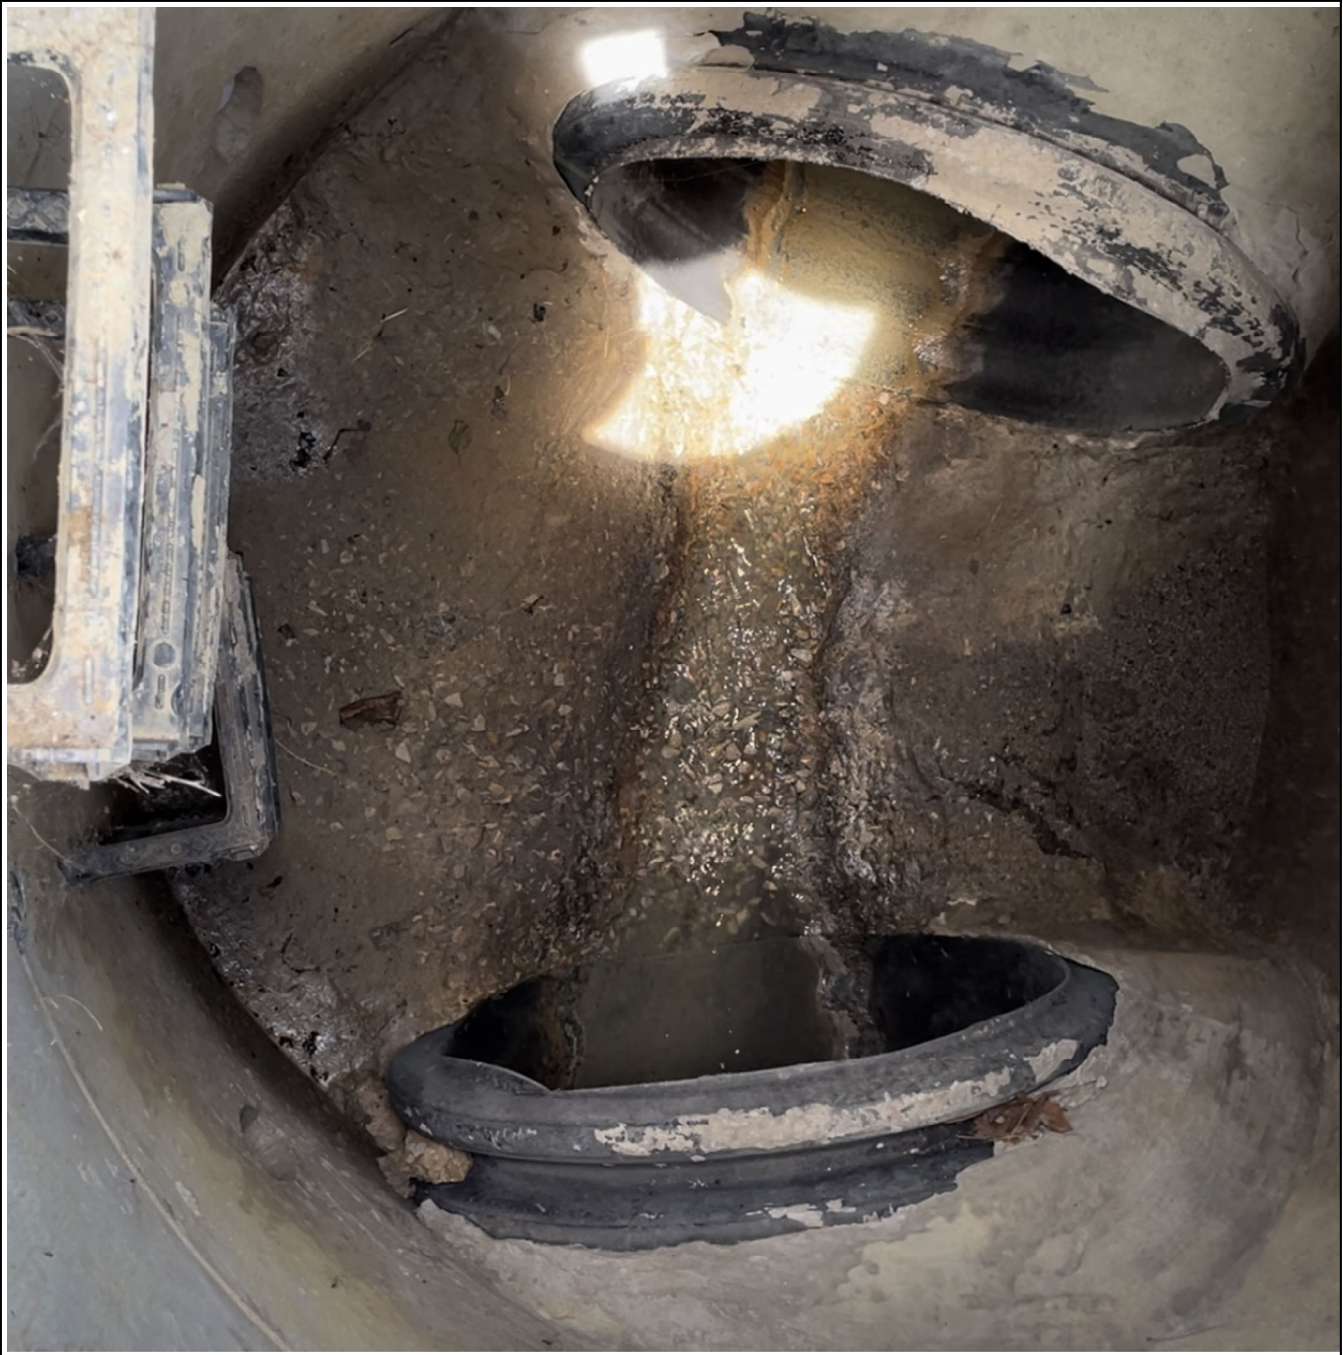
On June 19, 2024, IDEM Wastewater Inspector, Jeremy Ferguson, went to North Fork Little Pigeon Creek to check to see if ALL discharges had stopped flowing to the creek. During the inspection, it was discovered that there was still flow being received via the culvert located near 1st Ave. and Kentucky. A storm drain manhole was opened to better see the flow at the time of the inspection and a video was taken. The discharge was slightly turbid at the time of the inspection and personnel were unaware as to whether or not flow was process water or wash water.

Facility: Holland Dairies, Inc.		Location/Description: Flow inside opened storm drain manhole leading to North Fork Little Pigeon Creek.
Photographer: Jeremy Ferguson		
Date: 06/19/2024	Time:	
Others Present:

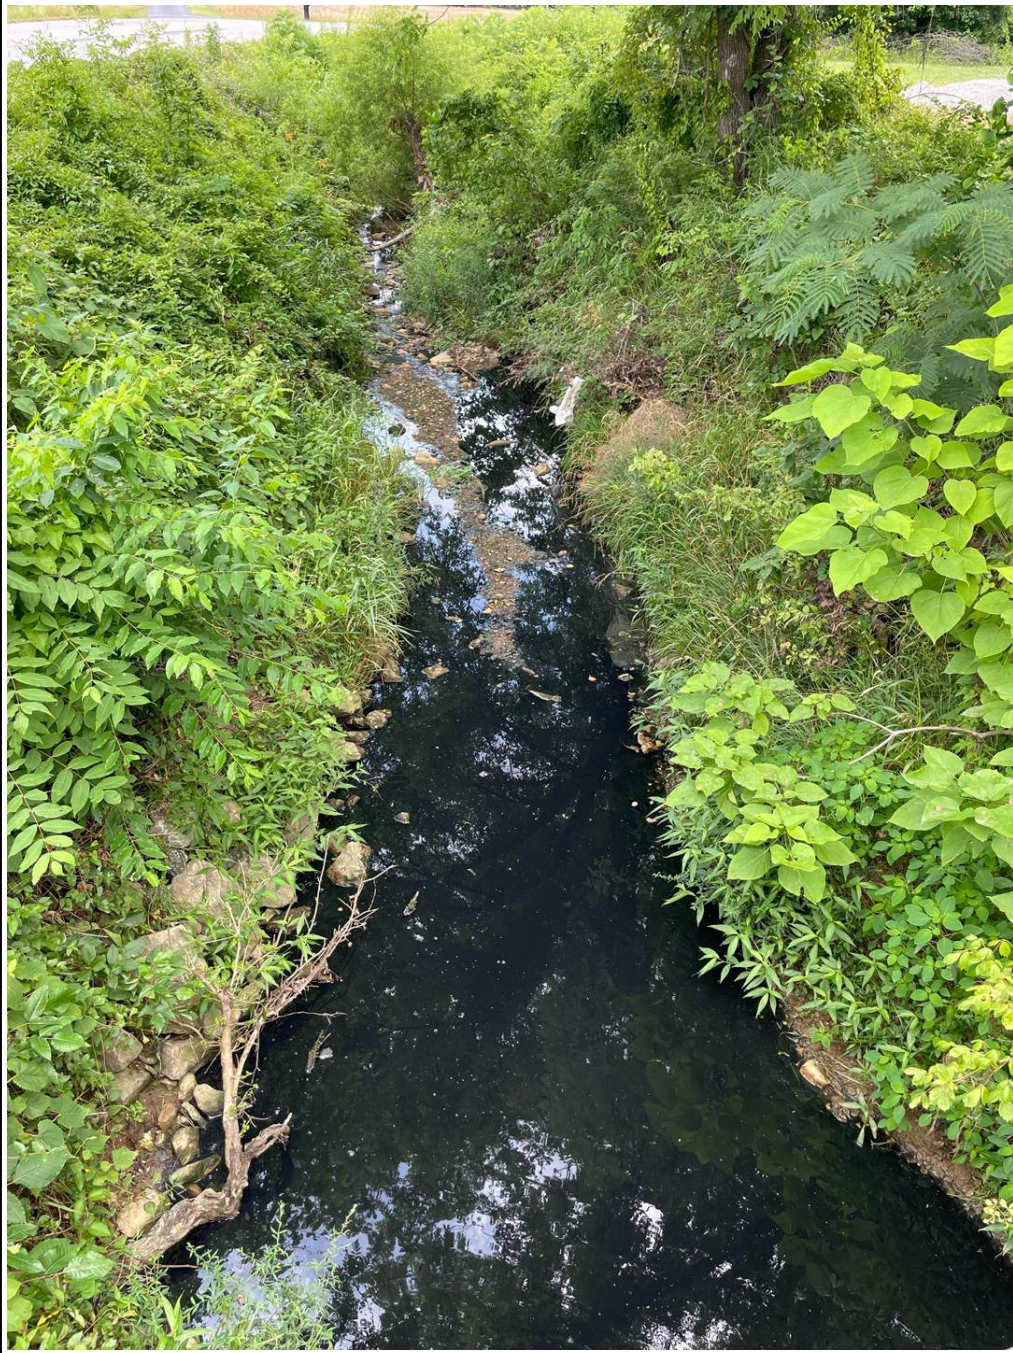
The IDEM Wastewater inspector observed that the North Fork Little Pigeon Creek was black in color and the stream had a putrescent smell similar to that of rotten milk. The inspector followed the creek from 1st Ave &

Facility: Holland Dairies, Inc.		Location/Description: North Fork Little Pigeon Creek East of culvert.
Photographer: Jeremy Ferguson		
Date: 06/19/2024	Time:	
Others Present:

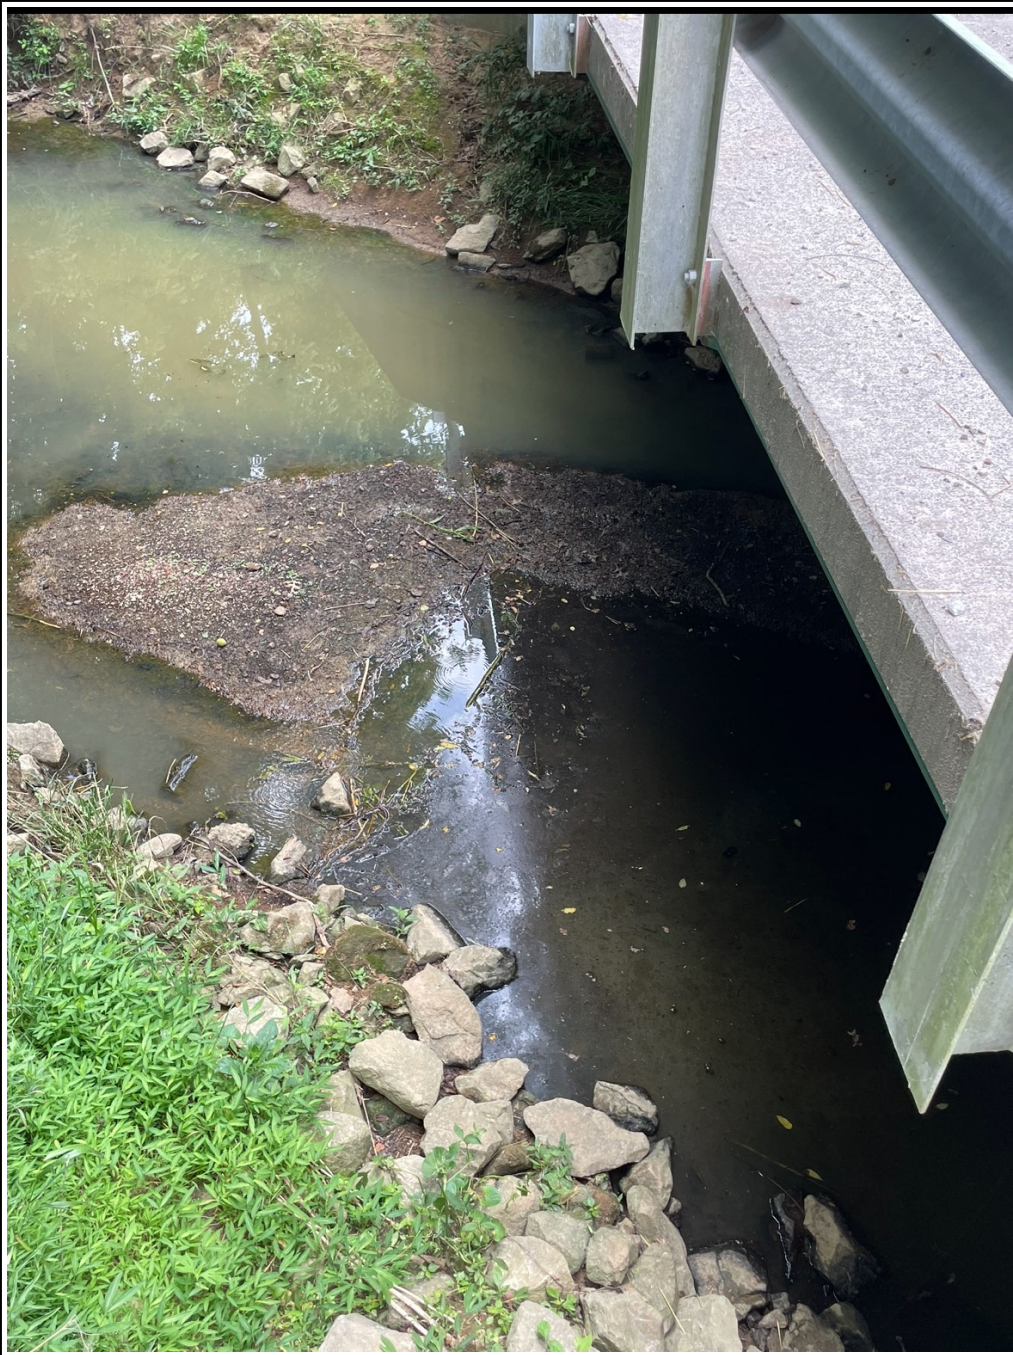
Kentucky culvert East past Highway 161 all the way to a bridge located off of County Road 600 West. The industrial discharge impacted approximately 8,840 feet (1.67 miles) of the stream (see photos).

Facility: Holland Dairies, Inc.		Location/Description: Bridge at County Road 600 W. - See black water starting to be diluted.
Photographer: Jeremy Ferguson		
Date: 06/19/2024	Time:	
Others Present:

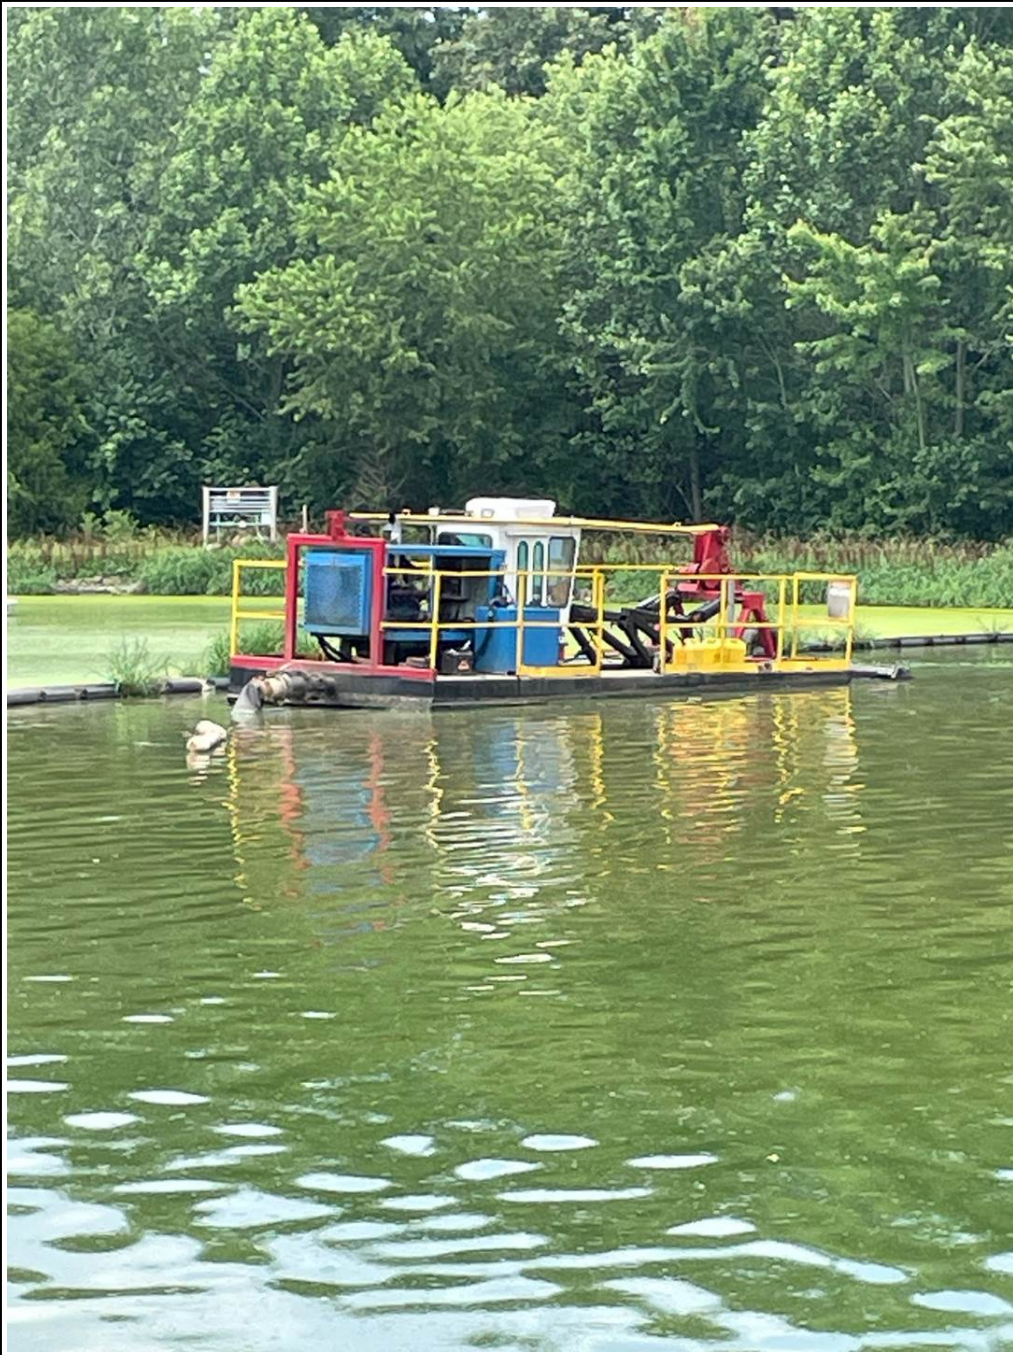
The facility had contracted out a third party company to dredge out their lagoon. The sludge being removed from the bottom of the lagoon is being directed to two large geotextile bags. These bags are contained within makeshift berms that have plastic lining. A diesel pump is located onsite and directs water escaping the bags back into the lagoon (See photos).

Facility: Holland Dairies, Inc.		Location/Description: Dredging unit within the lagoon
Photographer: Jeremy Ferguson		
Date: 06/19/2024	Time:	
Others Present:

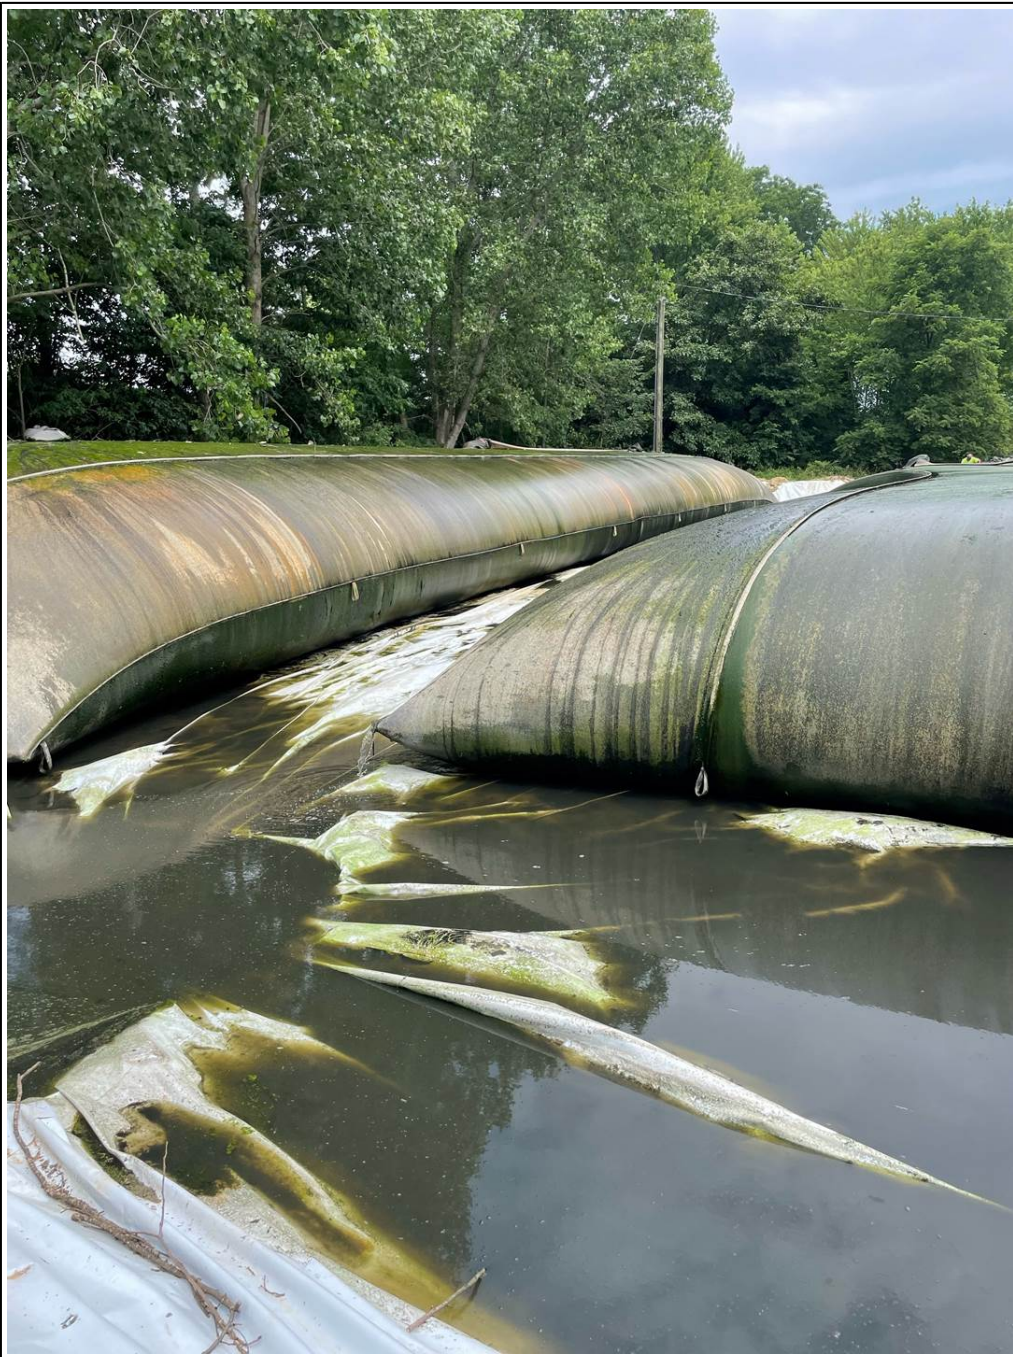
Facility: Holland Dairies, Inc.		Location/Description: Geotextile bags the dredged sludge being sent to.
Photographer: Jeremy Ferguson		
Date: 06/19/2024	Time:	
Others Present:

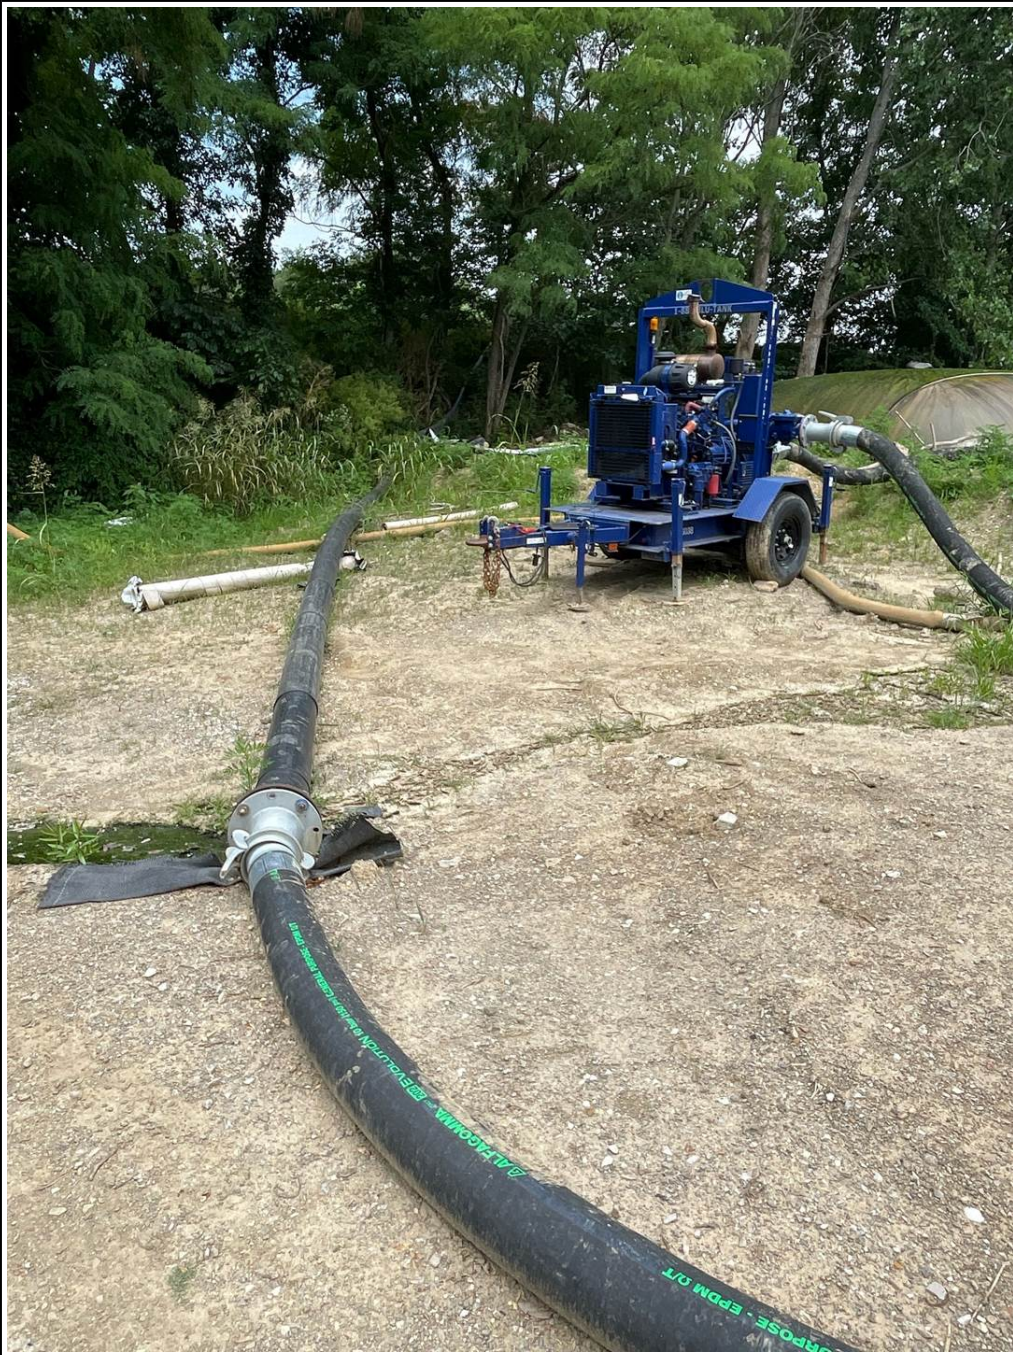
Facility: Holland Dairies, Inc.		Location/Description: Diesel Engine that is taking water from the geotextile bags and directing it back to the lagoon.
Photographer: Jeremy Ferguson		
Date: 06/19/2024	Time:	
Others Present:
