Re: Inspection Summary/ Noncompliance Letter
MasterGuard Corporation (Flex-N-Gate)
NPDES Permit No. INP000188
Veedersburg, Fountain County

Date(s) of Inspection: June 19, 2024
Type of Inspection: Complaint Investigation (#112972)
Inspection Results: Violations were observed.

Inspection Photographs

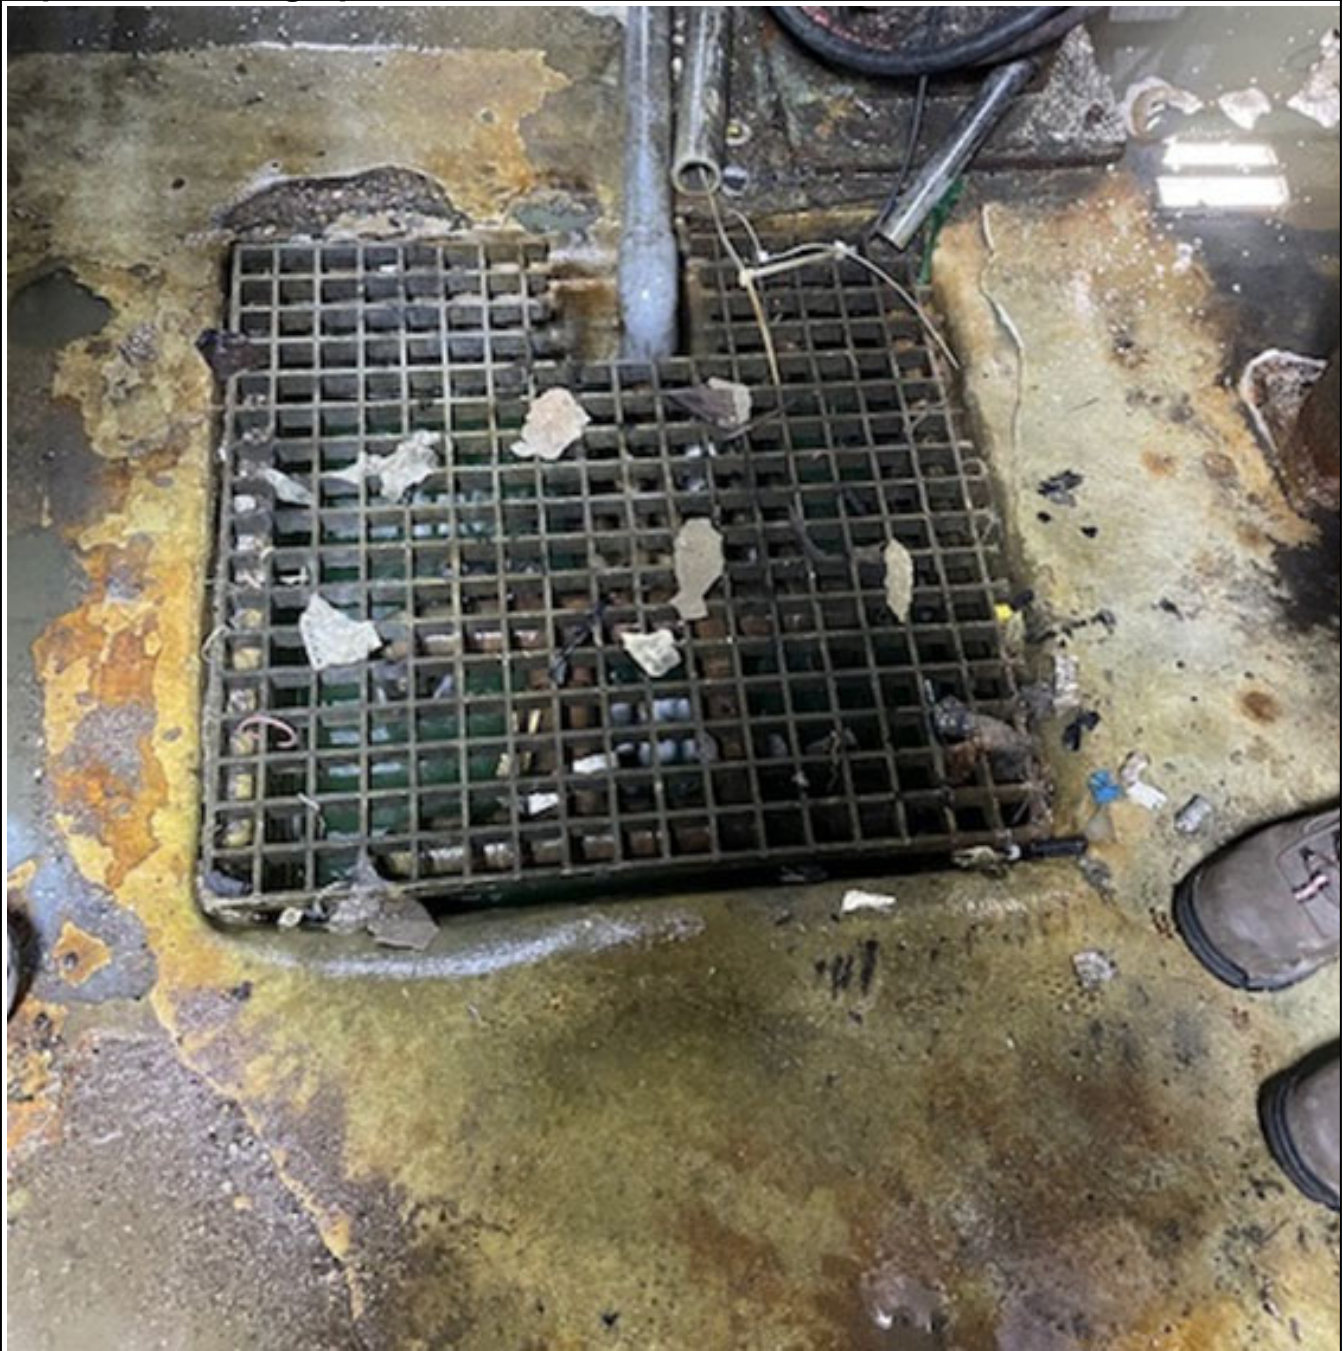
Operational logs and process control logs reviewed indicated that a Nickel tank dump from the production line on 6/15/2024 caused treatment efficiency issues at the WWTP and overflowed a treatment tank. Also, routine process control and operator logs are missing for the Sunday night (6/16/2024) shift from 7:00 PM to 7:00 AM. Based on the information reviewed, it does not appear that the treatment system was properly manned or monitored during that time. During the inspection, it appeared that a tank overflow had occurred due to trash and debris accumulation at the pretreatment system sump.

Facility: MasterGuard Corporation (Flex-N-Gate)		Location/Description: Floor staining and debris around sump appear that a tank overflow recently occurred. According to staff, this sump directs flow back to the EQ tanks. However, the EQ tanks may not be properly sized for the EQ needs of this facility. Several tanks were full at the time of this inspection. The facility should have sufficient EQ capacity for process slugs and spills to protect the pretreatment system and the POTW.
Photographer: Holly Zurcher		
Date: 06/19/2024	Time:	
Others Present:

Part II. A. 9. of the permit requires that all facilities and systems (and related appurtenances) for collection and treatment that are installed or used by the permittee and necessary for achieving compliance with the terms and conditions of the permit in accordance with 327 IAC 5-2-8(9) must be maintained in good working order and efficiently operated at all times.

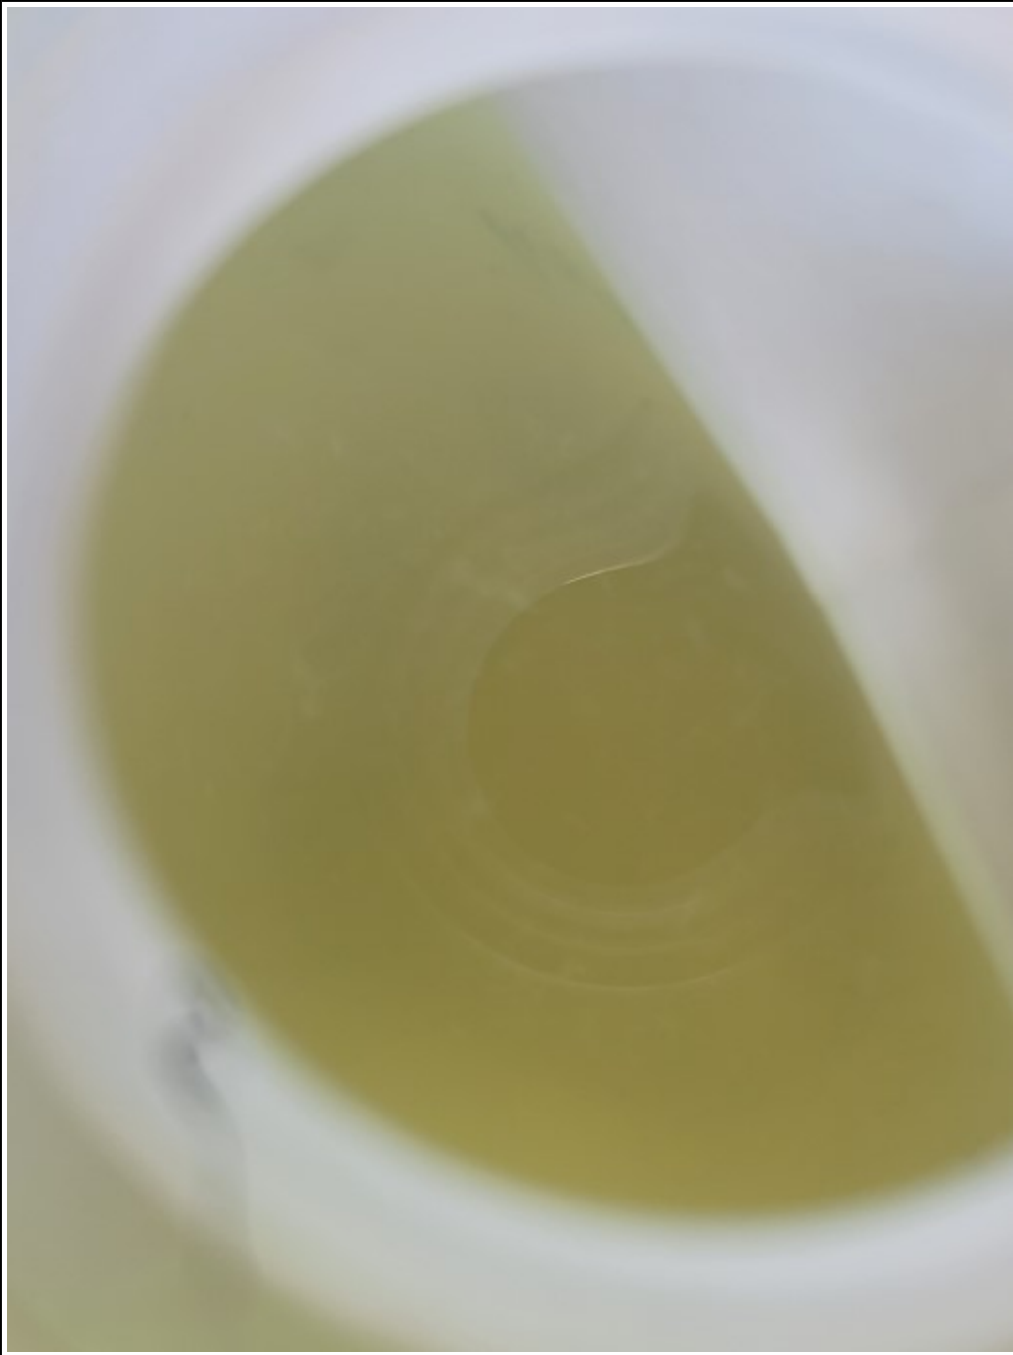
When inspectors were made aware of the complaint, a call was made to the POTW to ascertain if any anomalies were noted at the POTW. The POTW had taken a composite sample that appeared to be abnormal (see photo). This sample is being sent to the POTW's contract lab for analysis.

Facility: MasterGuard Corporation (Flex-N-Gate)		Location/Description: Picture taken by POTW of sample from MasterGuard's sampling location at Outfall 002 on June 18, 2024. Photo quality is blurry but a noticeable yellow tint is present.
Photographer: Holly Zurcher		
Date: 06/18/2024	Time:	
Others Present:
