RE: **Underground Storage Tank System Closure Report**
Mullin Rental Service
2528 East Michigan Street
Indianapolis, Indiana 46201
FID # 11630; Crossroads Project Number: 156.004.001

**UST Closure Report (State Form 56554) and
LUST Initial Incident Report (State Form 54487)**

**UNDERGROUND STORAGE TANK SYSTEMS
CLOSURE REPORT**

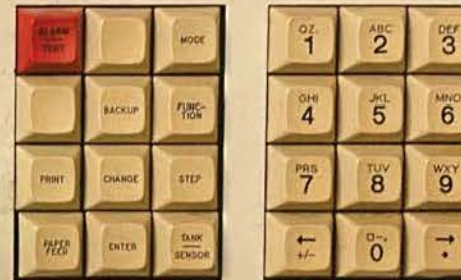
Leak Detection Results

Leak detection results provided in this section were included in the most recent IDEM UST Inspection Report dated September 14, 2024.

TANK LEAK TEST HISTORY
T 1:KEROSENE
LAST GROSS TEST PASSED:
NO TEST PASSED
LAST ANNUAL TEST PASSED:
NO TEST PASSED
FULLEST ANNUAL TEST PASS
NO TEST PASSED
LAST PERIODIC TEST PASS:
SEP 14, 2023 9:22 AM
TEST LENGTH 50 HOURS
STARTING VOLUME = 266
PERCENT VOLUME = 26.6
TEST TYPE = CSLD

TANK LEAK TEST HISTORY
T 2:DIESEL
LAST GROSS TEST PASSED:
NO TEST PASSED
LAST ANNUAL TEST PASSED:
NO TEST PASSED
FULLEST ANNUAL TEST PASS
NO TEST PASSED
LAST PERIODIC TEST PASS:
SEP 14, 2023 10:56 AM
TEST LENGTH 68 HOURS
STARTING VOLUME = 403
PERCENT VOLUME = 40.3
TEST TYPE = CSLD

TANK LEAK TEST HISTORY
T 3:NOLEAD
LAST GROSS TEST PASSED:
NO TEST PASSED
LAST ANNUAL TEST PASSED:
NO TEST PASSED
FULLEST ANNUAL TEST PASS
NO TEST PASSED
LAST PERIODIC TEST PASS:
SEP 14, 2023 10:25 AM
TEST LENGTH 77 HOURS
STARTING VOLUME = 422
PERCENT VOLUME = 42.2
TEST TYPE = CSLD
