Re: **Violation Letter**
Pike County Landfill #2
SW ID: 63-03
Winslow, Pike County

Type of Inspection: Follow-Up
Results of Inspection: Violations were observed (see attached inspection report).

Name of registration or Tempo (RM): Pike County Landfill 2 (AI ID: 52478)	Location: 50 S & 475 E, Winslow, IN 47598	Type of Inspection: Routine
County: Pike County	Permit #: 63-03	Permit Expires: Closed

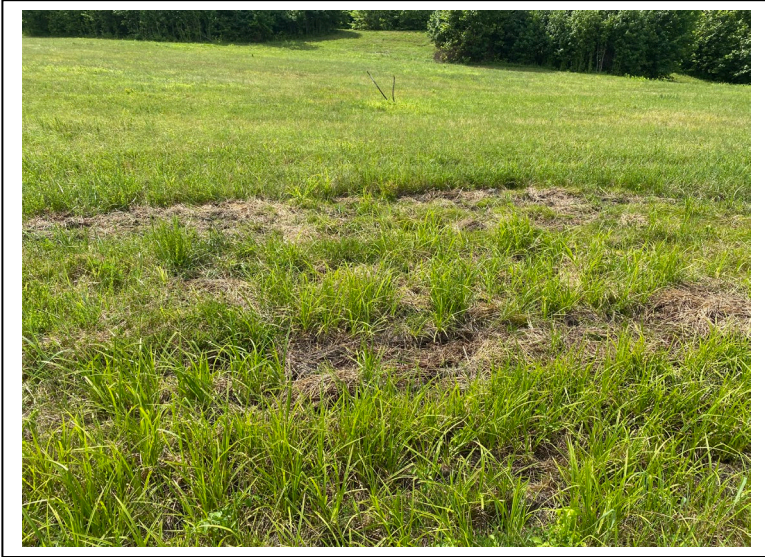
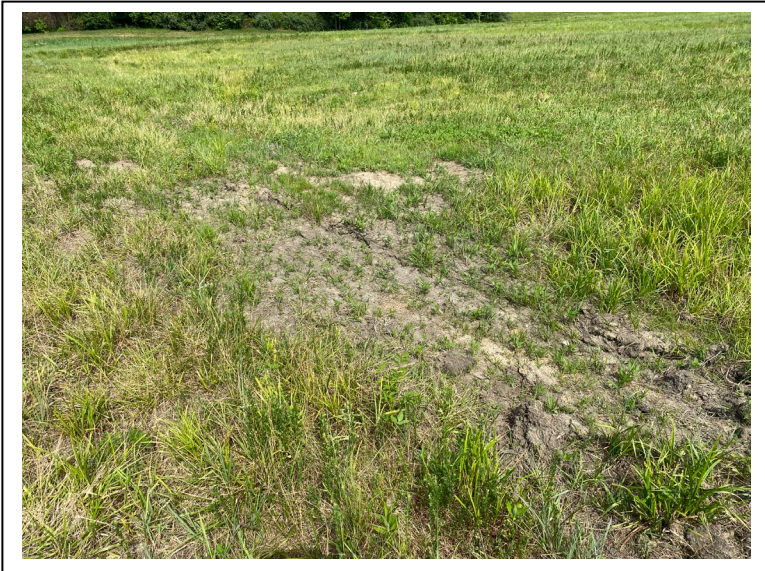
The inspection walkthrough began at the northeast side of the landfill on the access road and continued clockwise. IDEM staff first viewed an area on the east side of the landfill where ruts were observed during the November 1, 2023, inspection. The ruts have been filled with topsoil, reseeded, and covered with straw to prevent erosion while vegetation is established (*see attached photo log – photos 1 & 2*). No issues were noted on the areas that have been repaired.

Ruts that have been filled with soil, reseeded, and covered with straw to reduce erosion.

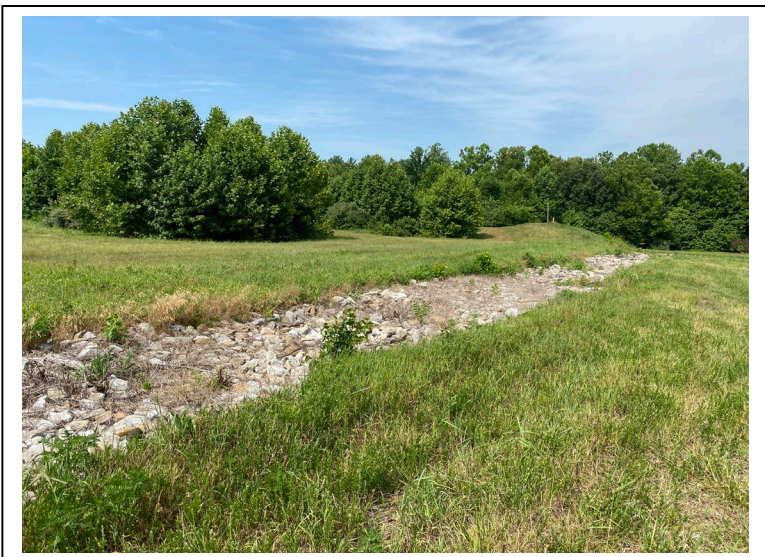
Photo 3

IDEM staff then viewed the riprap water diversion channel located on the southwest side of the landfill (*see attached photo log – photo 3*). IDEM staff asked Ms. Dischinger how often the vegetation was removed from the riprap channel. Ms. Dischinger stated that the highway department removes woody vegetation as needed. At the time of the inspection, IDEM staff observed some woody vegetation growing within the channel, however, IDEM staff also observed evidence that woody vegetation was recently cut to be removed (*see attached photo log – photo 4*). No violations were cited at this time for the woody vegetation remaining in the channel. However, IDEM staff recommended removing woody vegetation more frequently to ensure the integrity of the riprap channel and the landfill cap underneath.

Riprap channel.

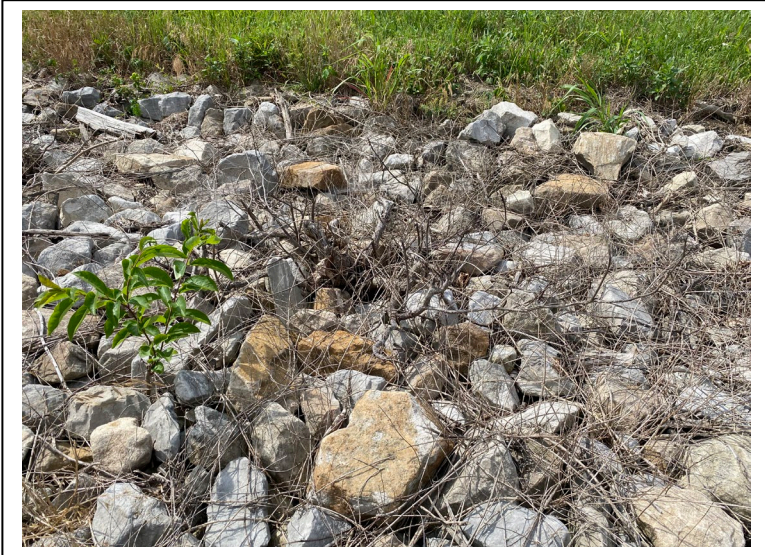
Photo 4

Woody vegetation cut from the riprap channel.

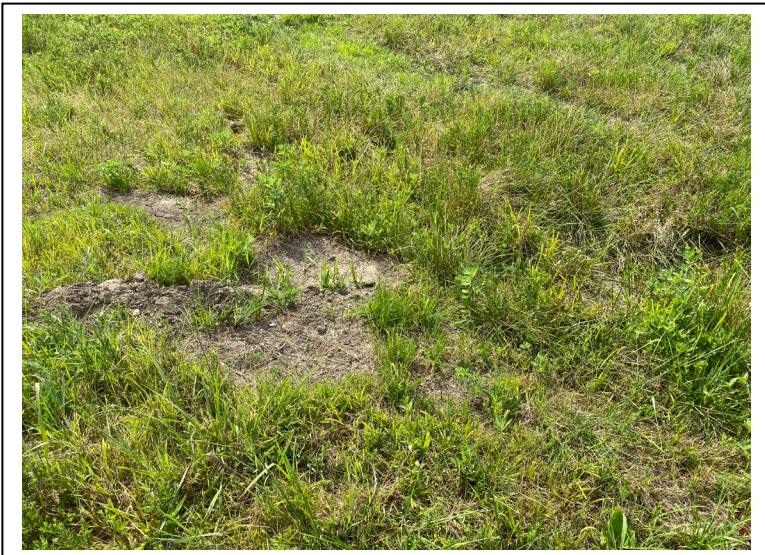
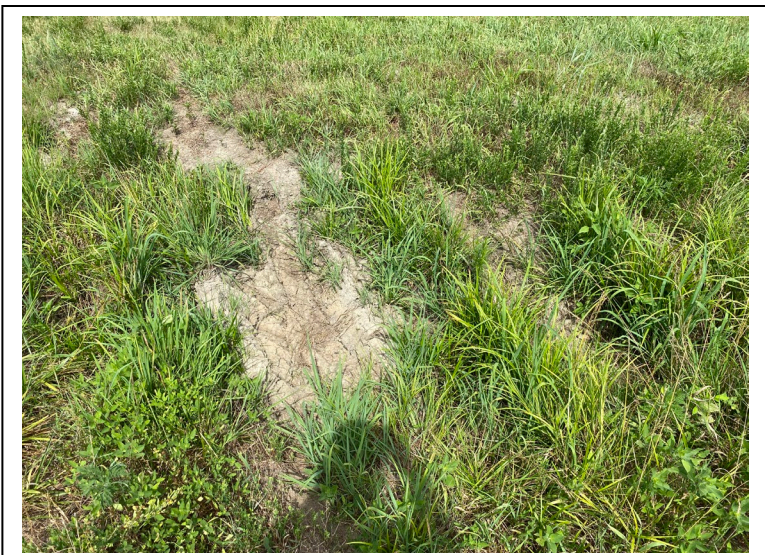
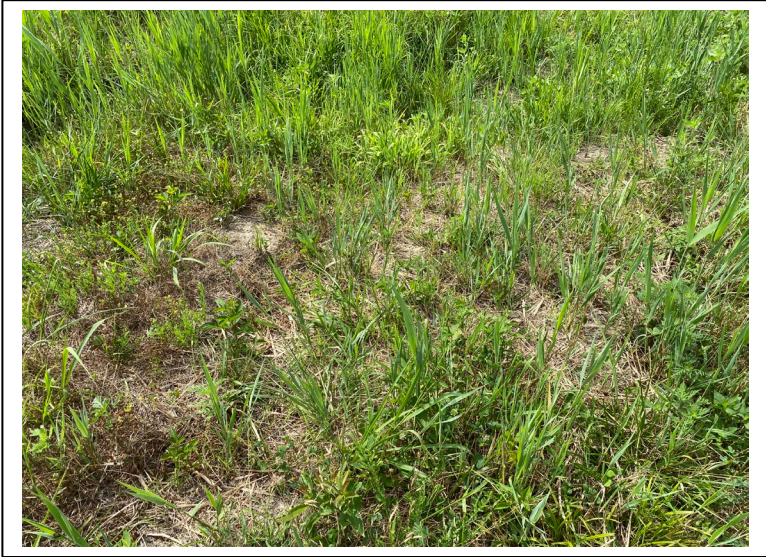
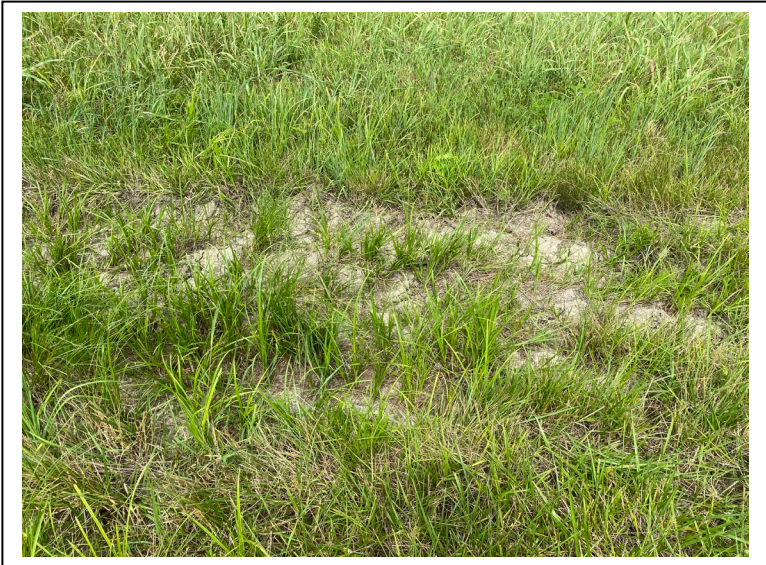
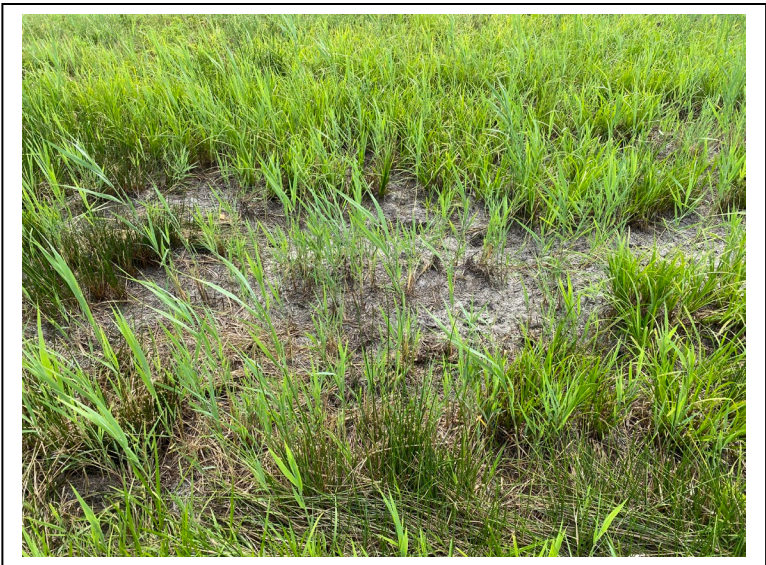
Along the west side of the landfill, IDEM staff observed some smaller ruts remaining from vehicle tracks (*see attached photo log – photos 5-9*). IDEM staff recommended that they be filled with topsoil and reseeded before they become larger and damage the landfill cap.

Small rut within the landfill cap.

Ruts on the landfill cap.

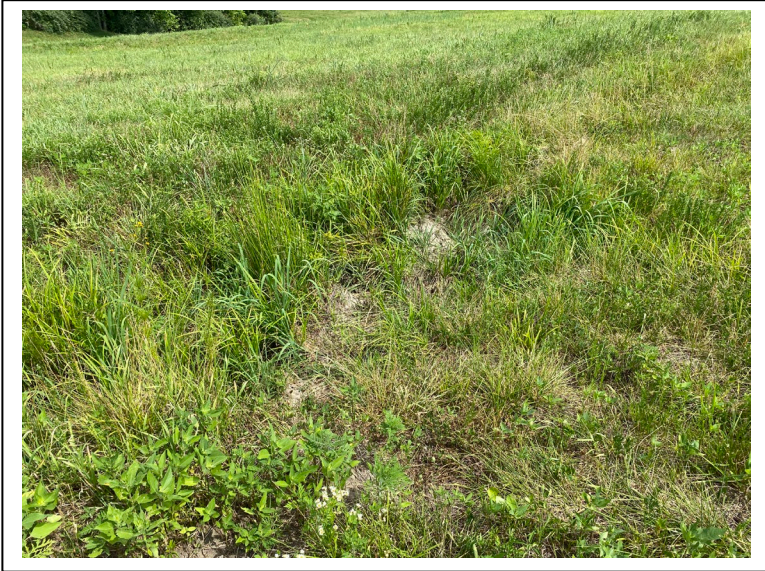
Photo 10

IDEM staff observed a depression in the landfill cover resulting from an erosion rill forming near the riprap channel (*see attached photo log – photo 10*). IDEM staff discussed the importance of maintaining positive drainage off the landfill cover to ensure no water infiltrates the landfill cap. IDEM staff stated that due to its depth and size, the rill and depression may have damaged the landfill cap, and it needs to be repaired. IDEM staff recommended filling the depression with compacted clay, adding 6” of topsoil, reseeding the area, and then covering it with temporary erosion control measures until vegetation can be established. IDEM staff and Ms. Dischinger discussed the timeframe in which this can be completed. Ms. Dischinger stated that the issue could be fixed by the end of summer, around September or October.

Large erosion rill that has formed a depression near the riprap channel.

Violation Details: During the June 25, 2024, inspection, IDEM staff observed an erosion rill that had formed a depression that had altered the contours of the cover and did not promote positive drainage off the landfill cap (see attached photo log – photo 10).

Required Action: Within 90 days of receiving this report, repair the landfill cap with additional compacted clay, regrade with topsoil to promote positive drainage, reseed to establish vegetation, and cover with temporary erosion control measures until vegetation can be established. Additionally, please contact IDEM Solid Waste Compliance staff once repairs have been made.

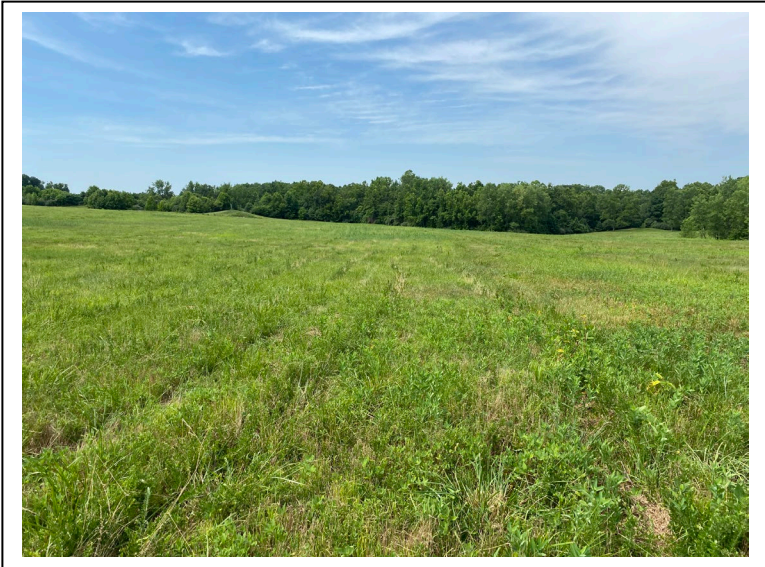
Photo 11

The inspection walkthrough continued northeast back to the access road. Overall, the landfill cap is well vegetated and well maintained (*see attached photo log – photo 11*). The walkthrough concluded at approximately 12:00 PM.

Overall vegetation on the landfill cap.
