From: [Robinson, William](#)
To: [Ron Dixon](#)
Cc: [Matthews, Scott A CIV USARMY CELRL \(USA\)](#); [Sarah Harrison@fws.gov](#); [Boszor, Brian](#); [DNR INSWMP-Inquiry](#)
Subject: 2023-28-49-WLR-A Parks at Decatur 401 WQC
Date: Thursday, June 29, 2023 1:34:00 PM
Attachments: [2023-28-49-WLR-A 401 WQC Permit Parks at decatur.pdf](#)
[image002.png](#)
[image003.png](#)
[image004.png](#)
[image005.png](#)
[image006.png](#)

Section 401 Water Quality Certification

IDEM Number: 2023-28-49-WLR-A
USACE Number: LRL-2021-707-sam
Project Name: Parks at Decatur
Authority: 327 IAC 2. CWA Sections: 301, 302, 303, 306, 307, & 401
Date of Issuance: 6/29/2023
Impacts must be completed by: 6/29/2025

PARKS AT DECATUR

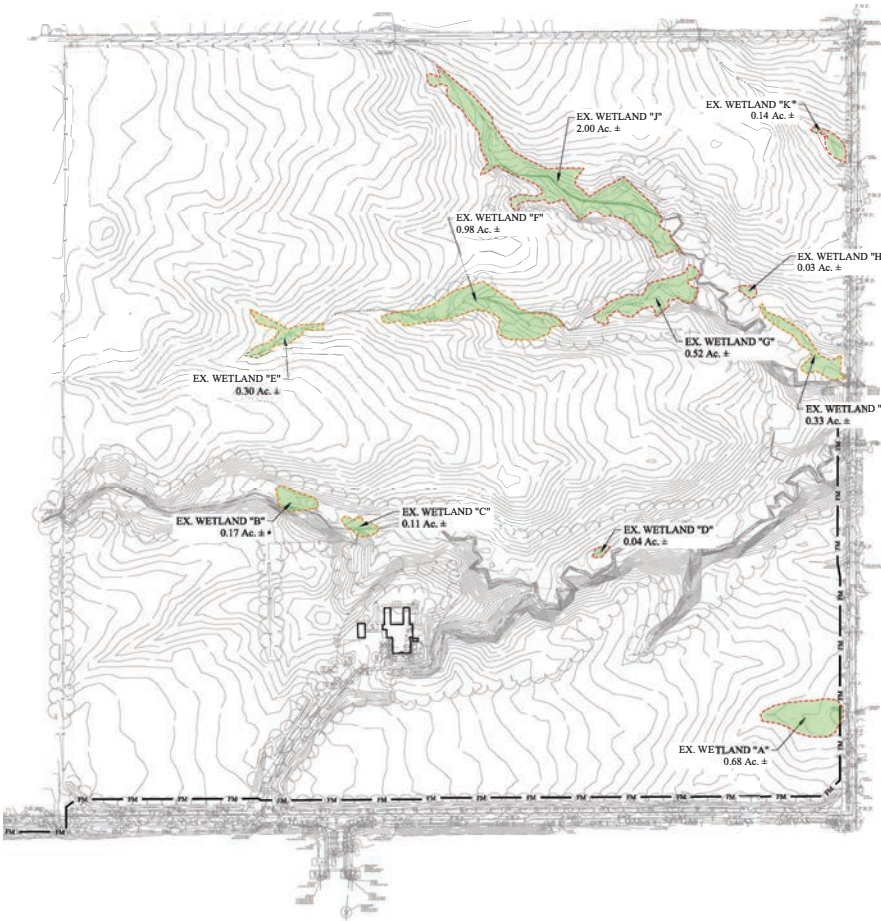
WETLAND IMPACTS
 TOTAL AREA = 2.72 Ac±
 PEM AREA = 1.95 Ac±
 PEM/PSS AREA = 0.77 Ac±

STREAM IMPACTS
 STREAM = 797 Lineal Feet

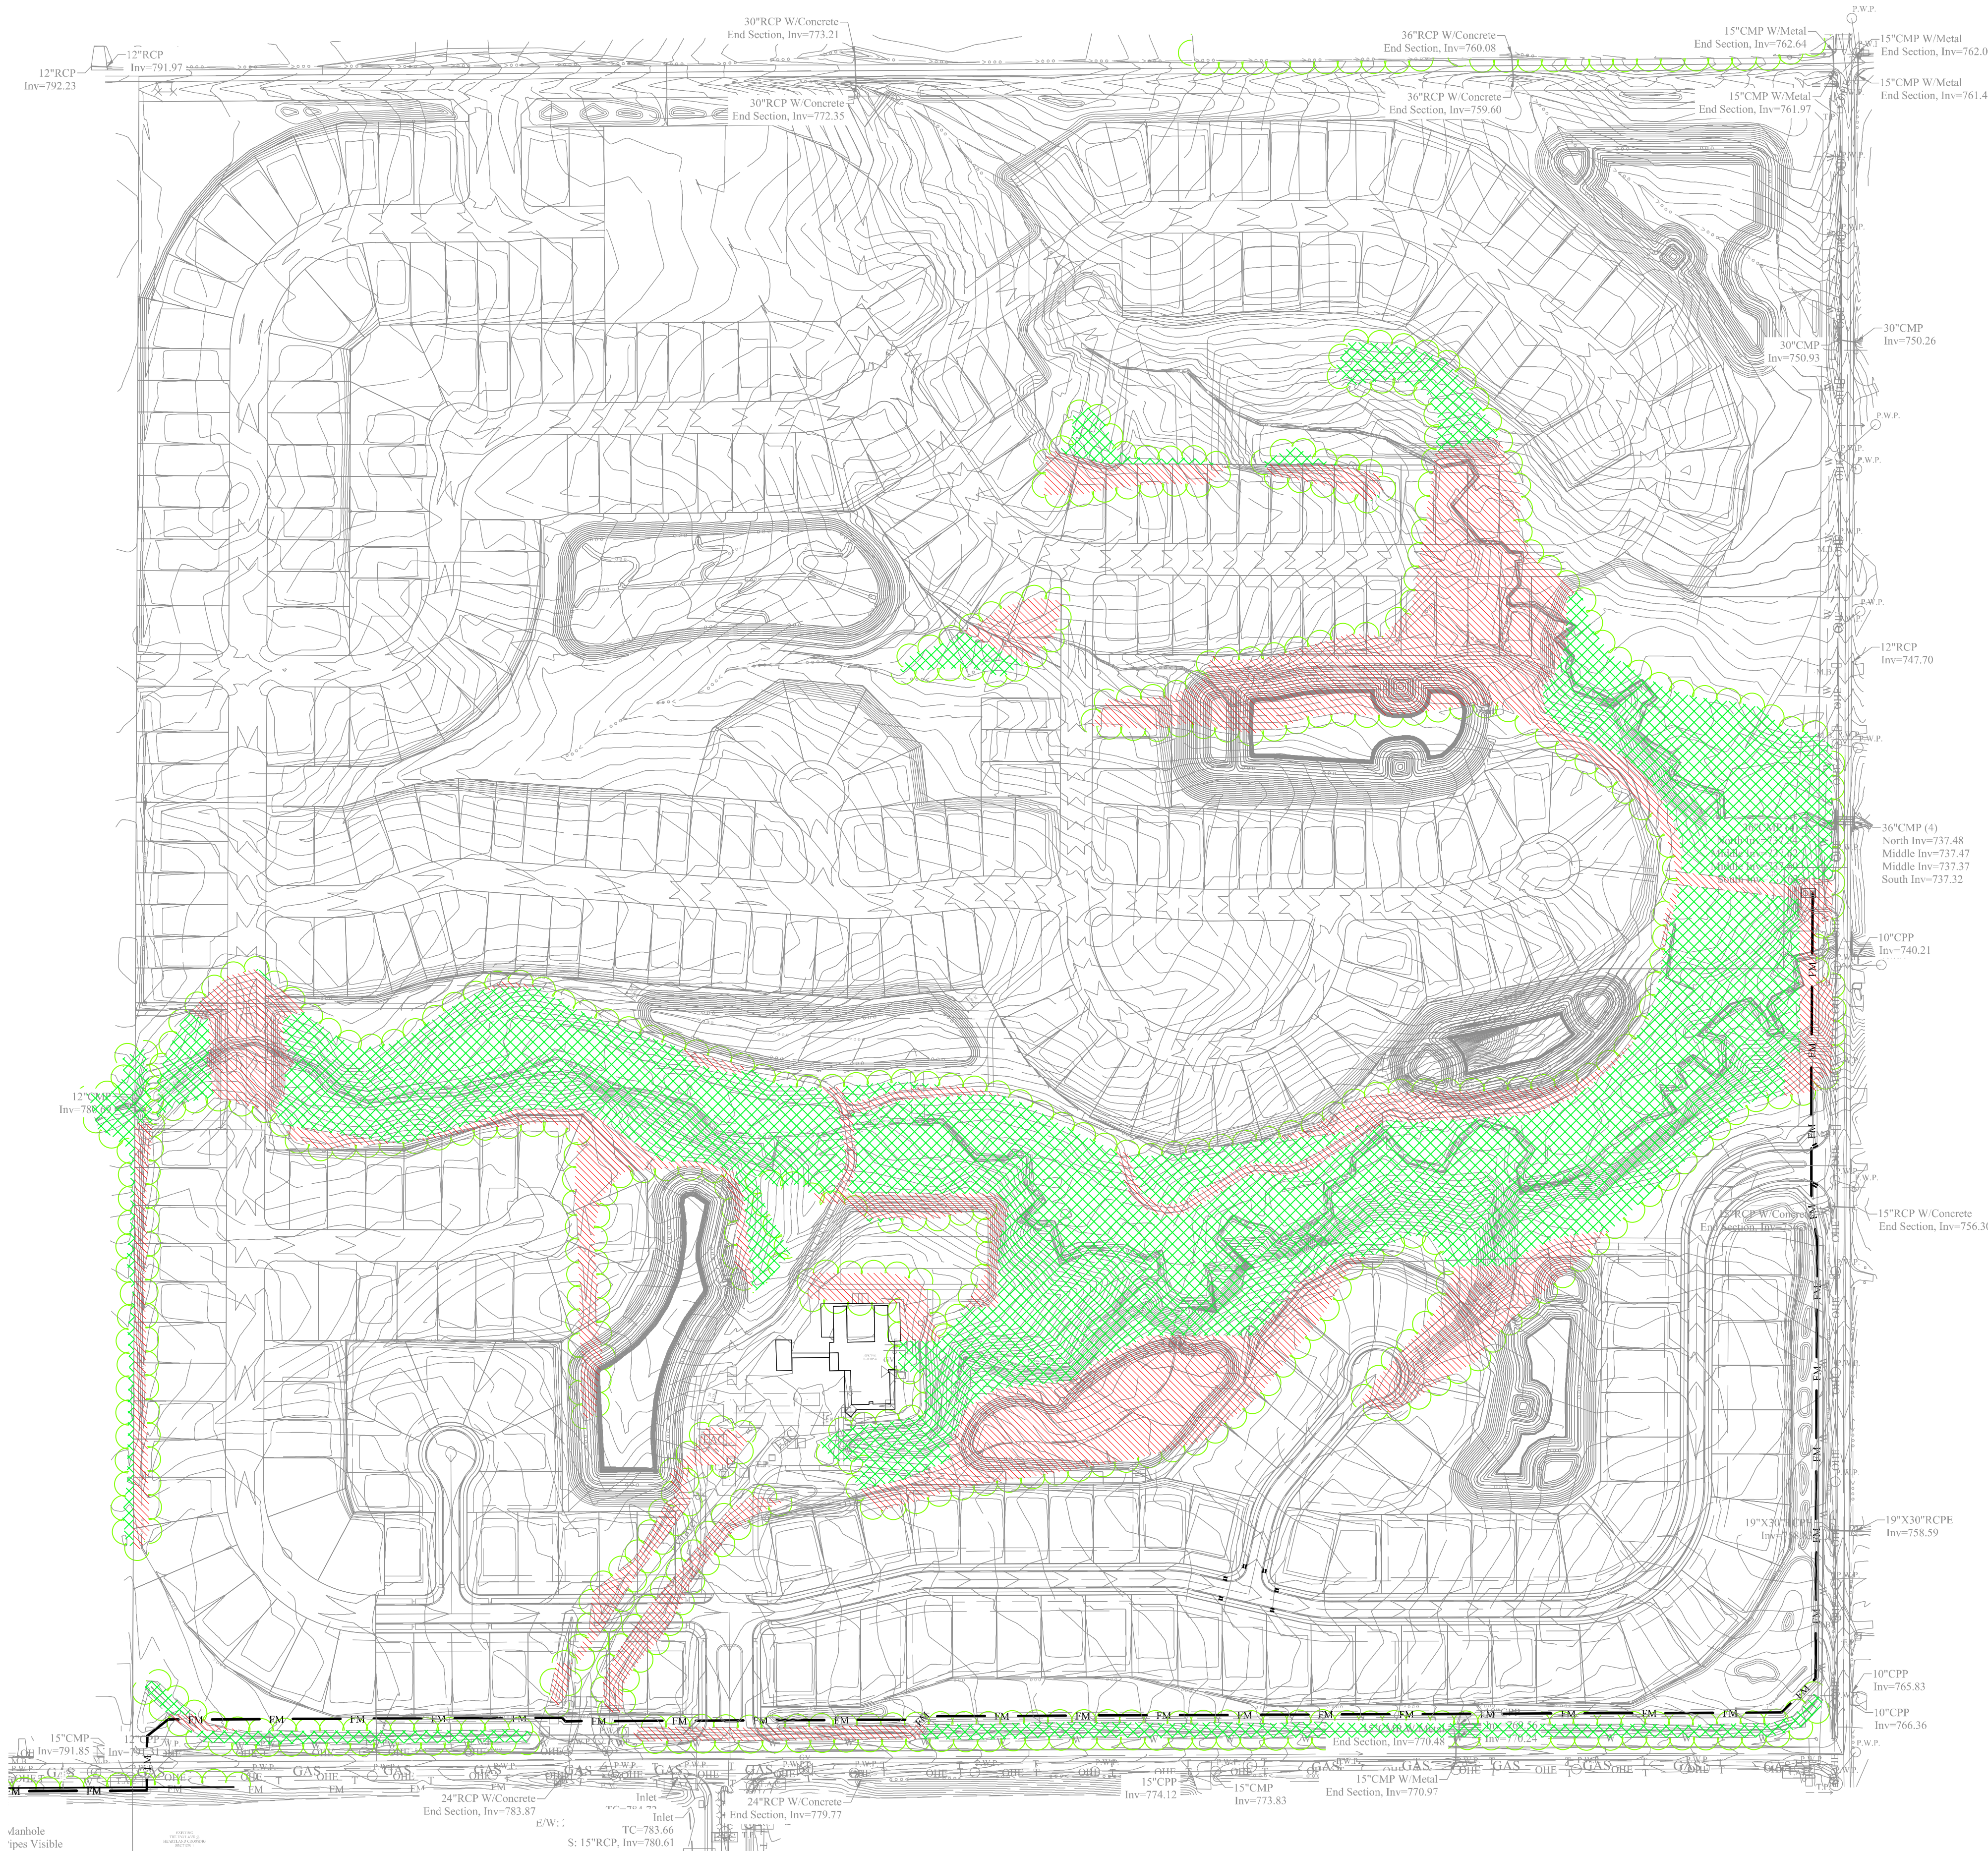
TREES TO BE REMOVED

TOTAL AREA OF TREES = 28.82 Ac±

AREA TO SAVE = 17.80 Ac±

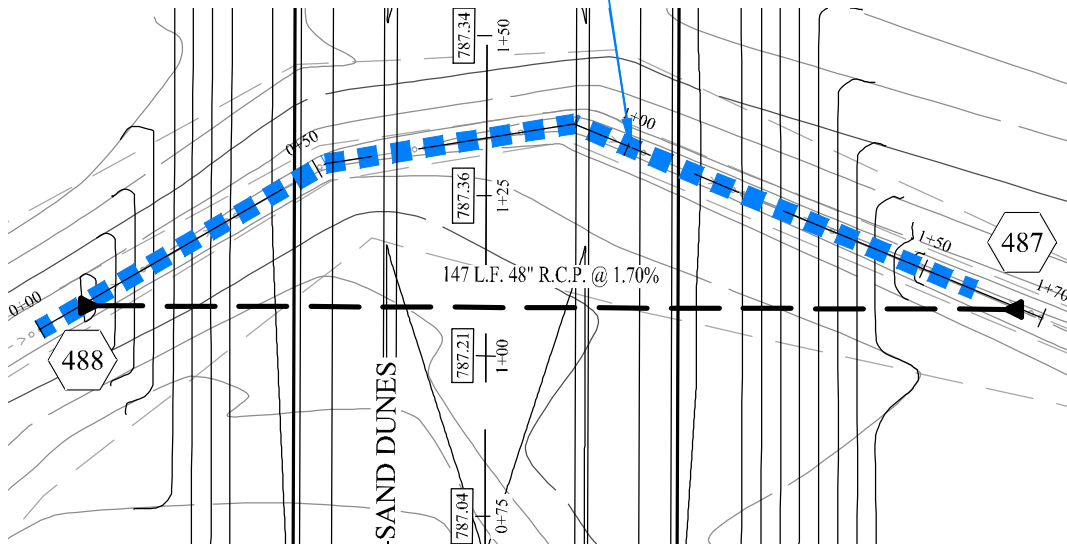
PARKS AT DECATUR STREAM AT SAND DUNES AVENUE

CHANNEL UNIT 1
 159 L.F.±

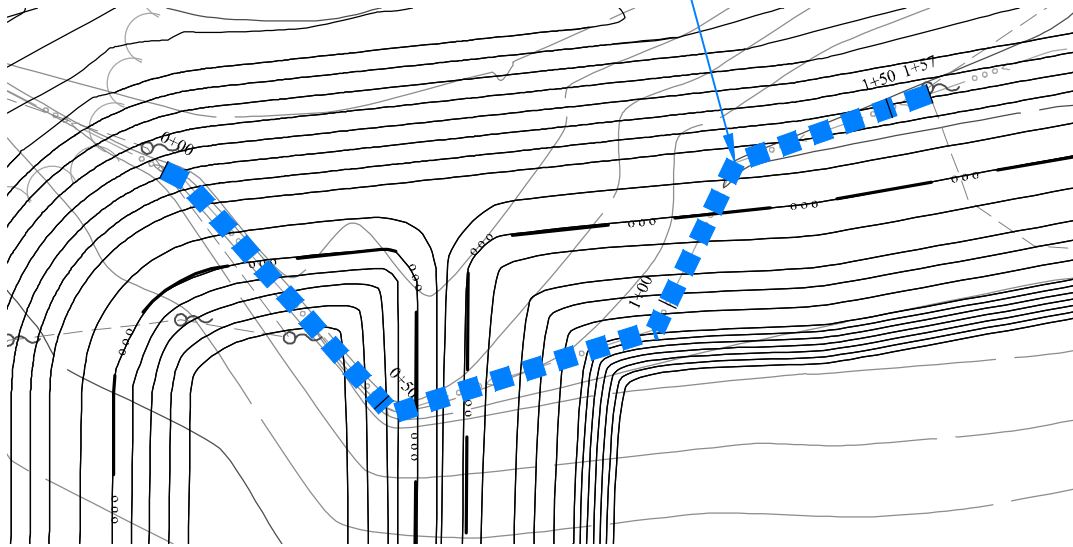
STREAM IMPACT AREA "B"

CHANNEL UNIT 5
 157 L.F.±

FILL 157 L.F.
 RELOCATION 157 L.F.
 ENCAPSULATED 0 L.F.

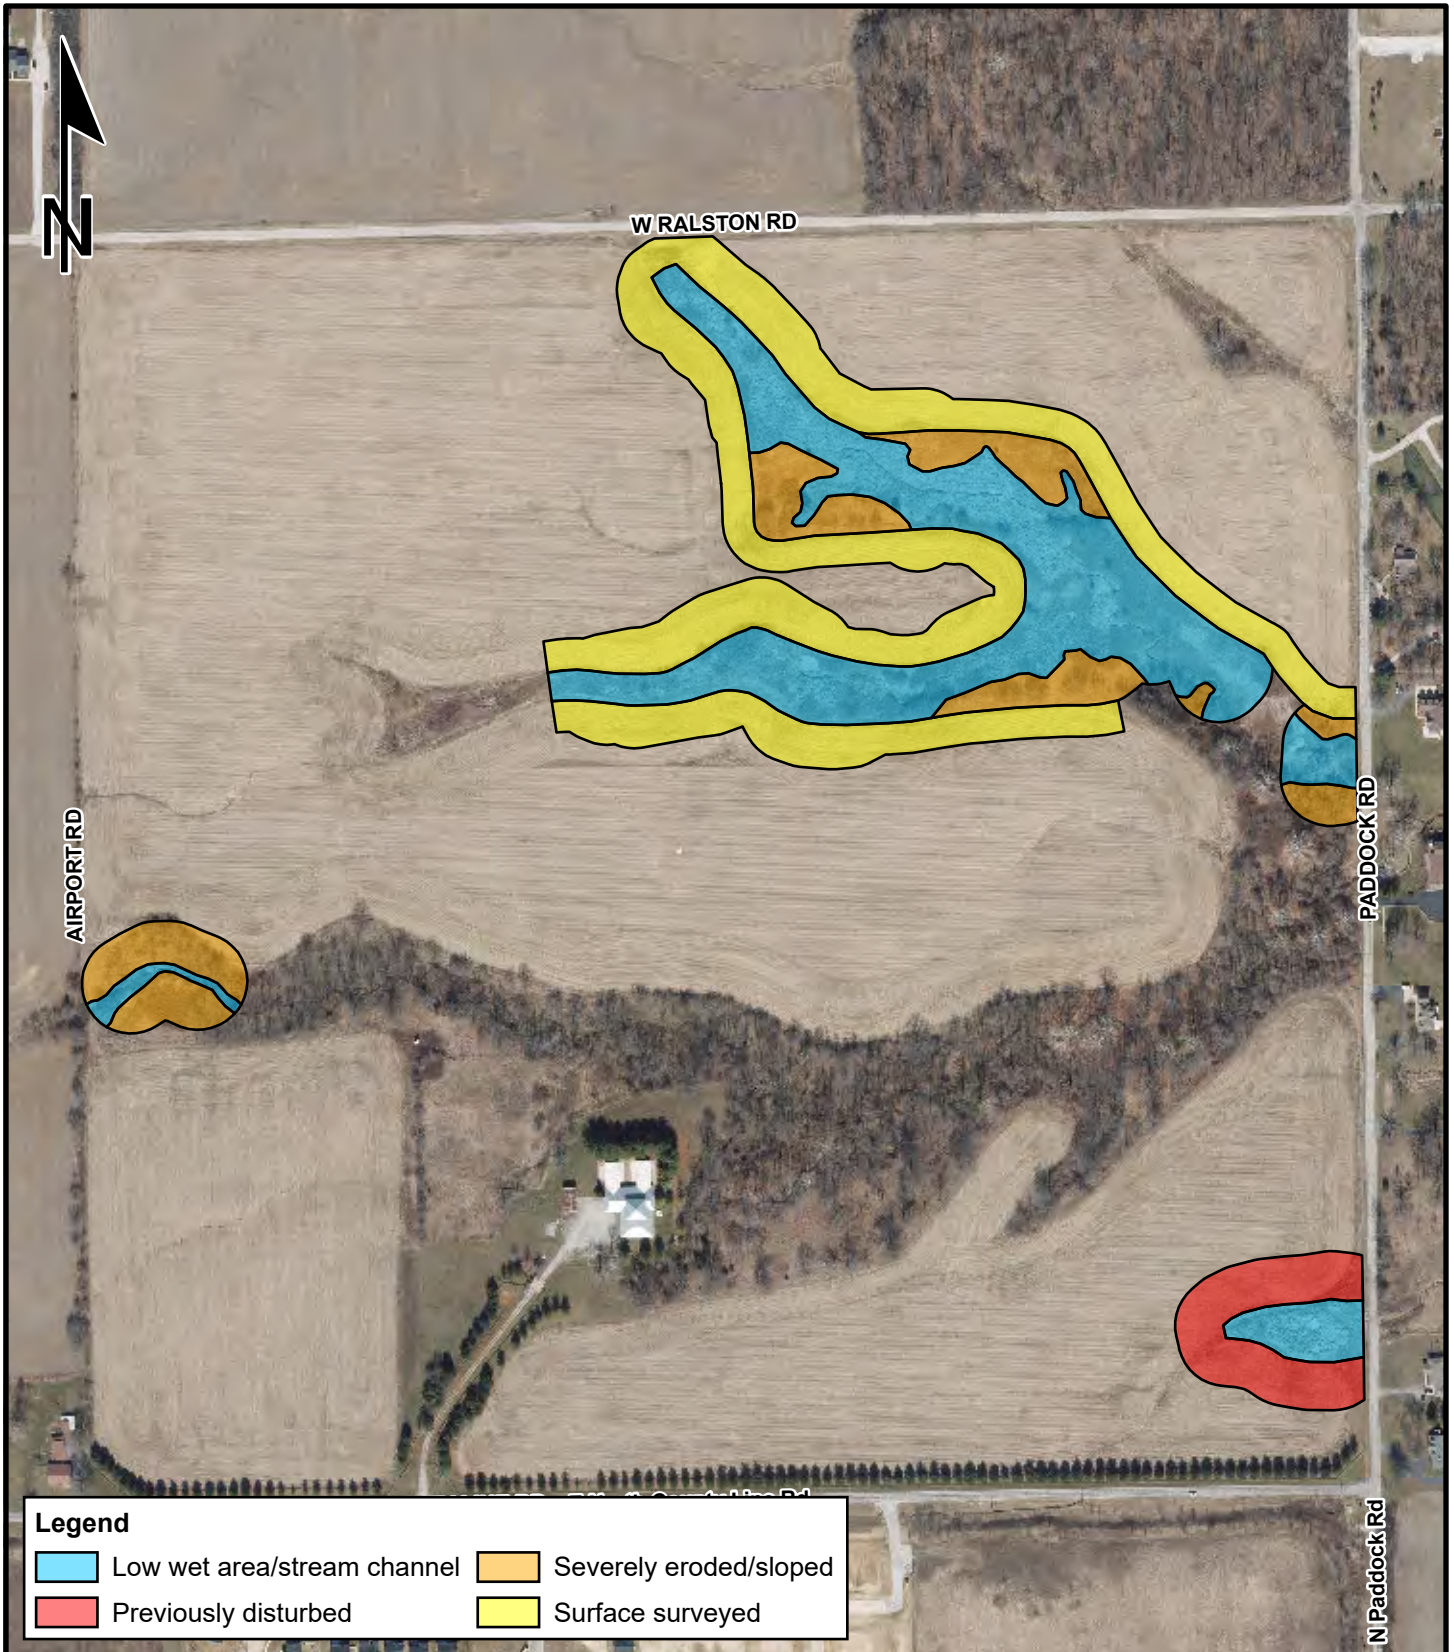
Legend			
■	Low wet area/stream channel	■	Severely eroded/sloped
■	Previously disturbed	■	Surface surveyed

As discussed above, the southeastern survey area was all found to be previously disturbed prior to this investigation. The southwestern survey area was entirely covered by woods and weeds and was also found to be disturbed; however, this time it was all natural disturbance caused by steep slope erosion and stream channel down-cutting.

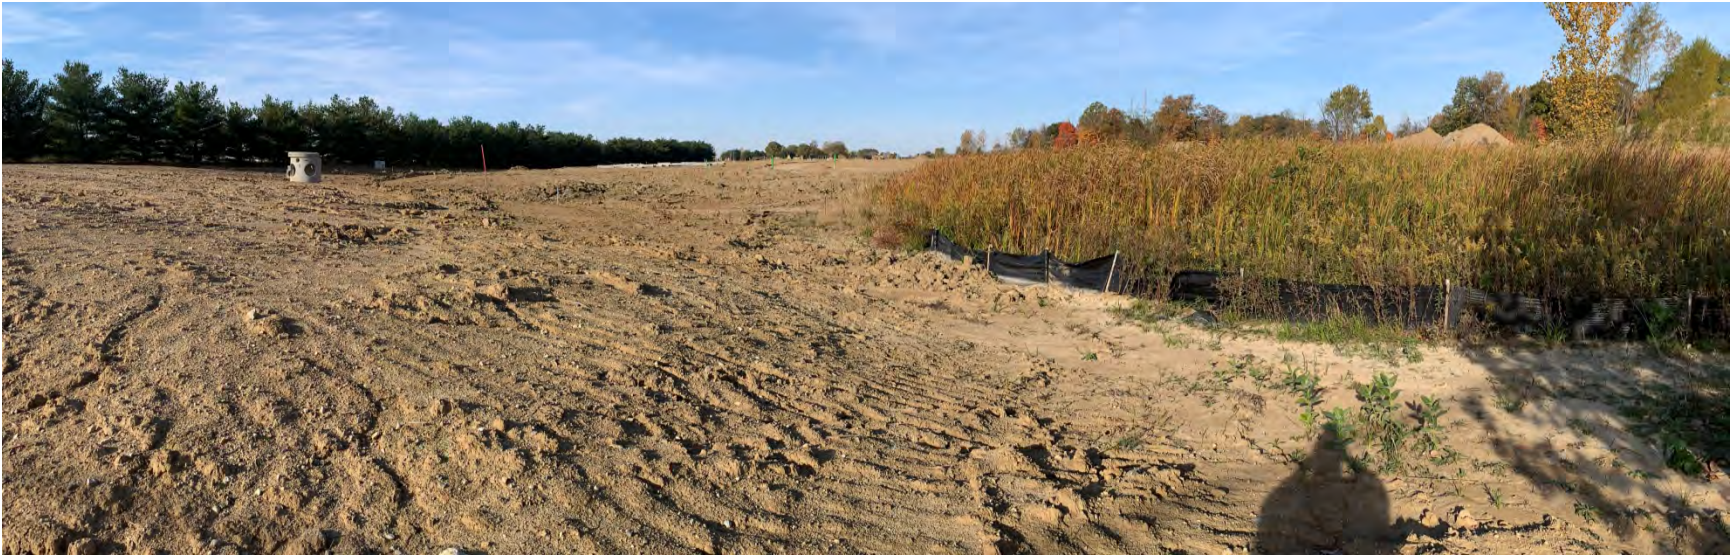
Photograph 1. Panoramic view of the south edge of the southeastern survey area showing previous disturbance, facing west.

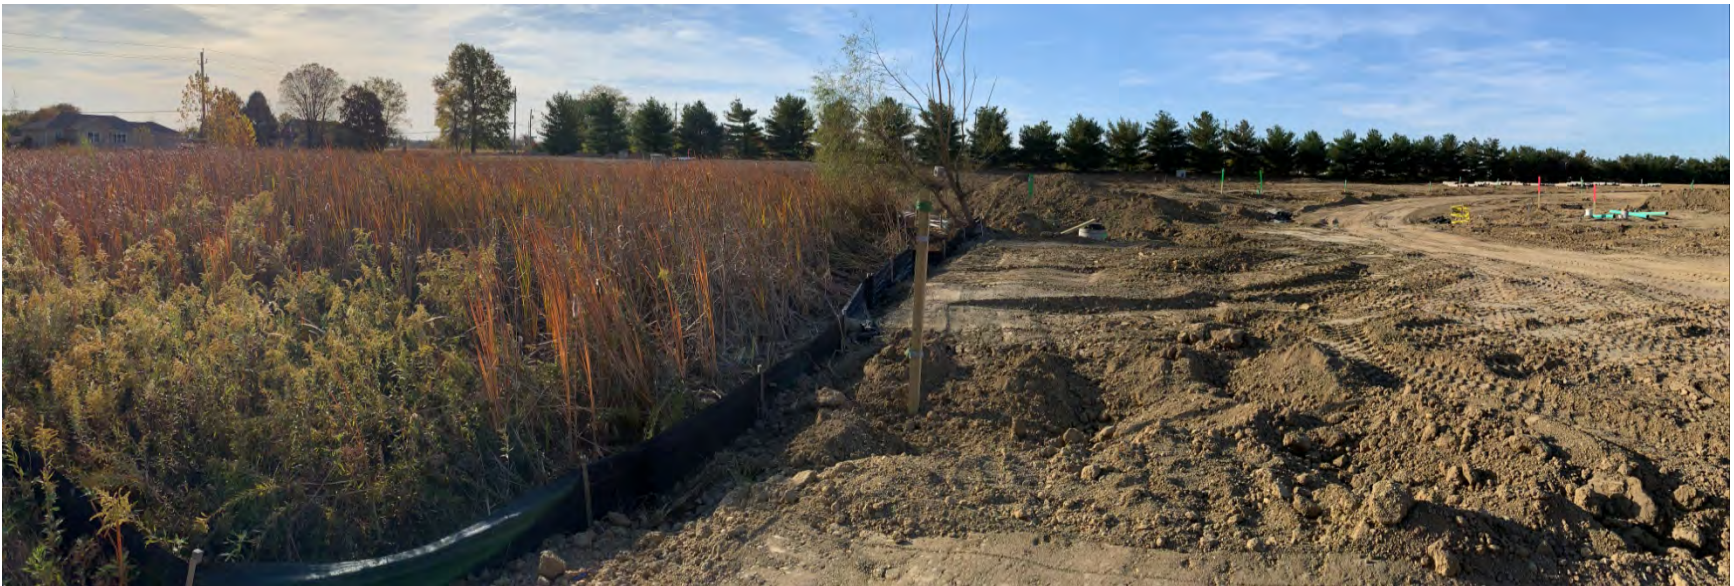
Photograph 2. Panoramic view of the west edge of the southeastern survey area showing previous disturbance, facing south.

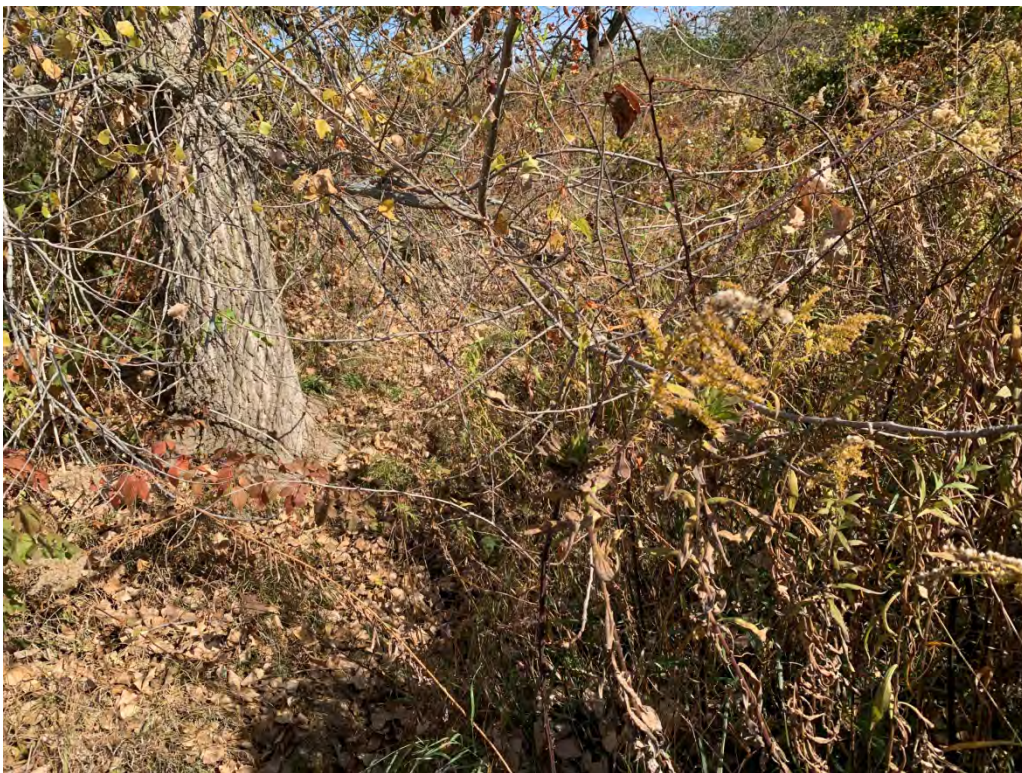
Photograph 4. View of down-cut channel in the southwest survey area, facing east.

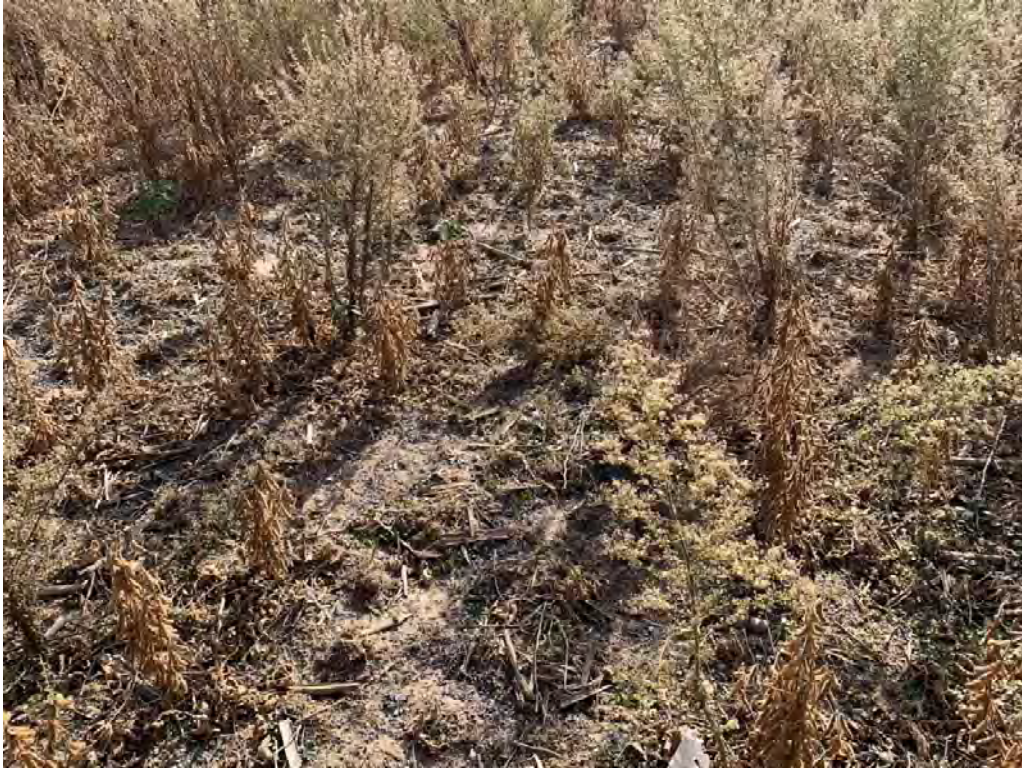
Photograph 9. Typical visibility in the soybean field northeast of the northern survey area.

Surface visibility 30-50%	Factors affecting visibility Visibility was affected by standing soy beans, leaf litter, and other vegetation.
Slope 0-12%	Environmental (weather) conditions during the survey Warm, breezy, dry and 70 degrees Fahrenheit

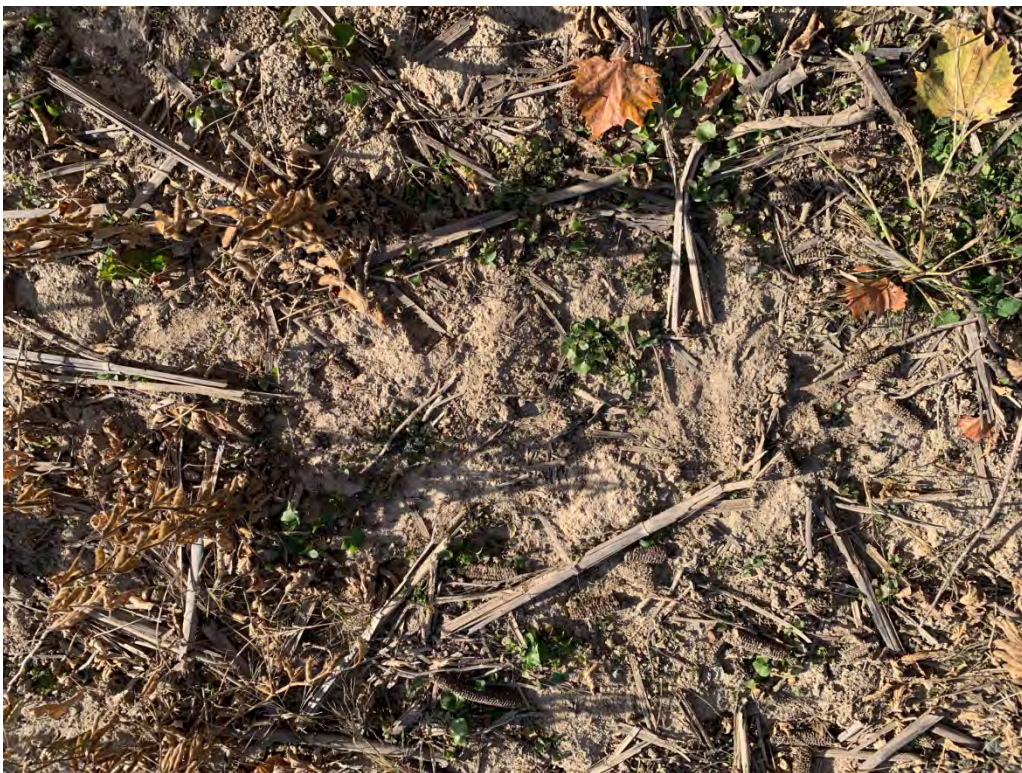
Photograph 10. Typical visibility in the soybean field south of the northern survey area.

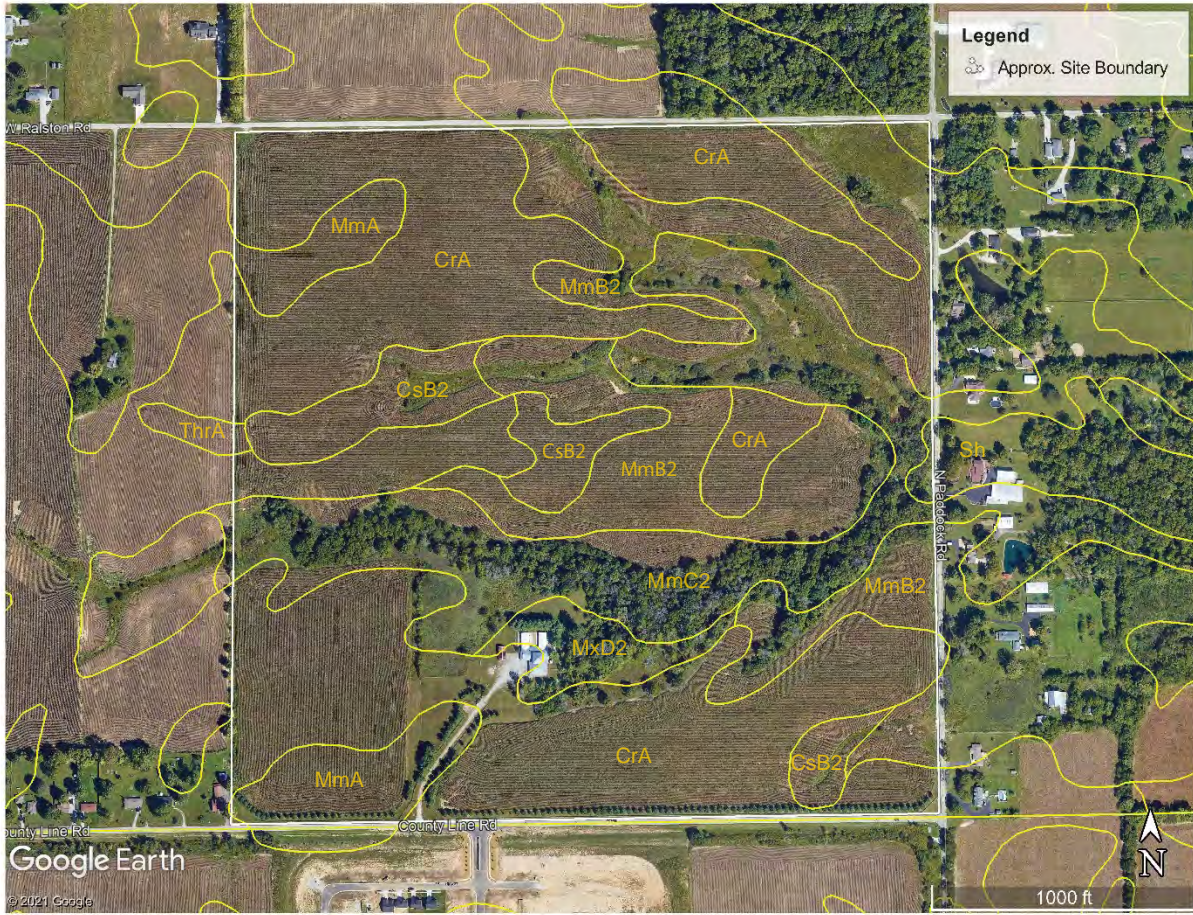
Figure 2. USDA NRCS Soil Survey.

Map Unit Symbol	Map Unit Name	Drainage	Hydric Soil Rating
ThrA	Treaty silty clay loam, 0 to 1 percent slopes	Poorly drained	Yes
Sh	Shoals silt loam, 0 to 2 percent slopes, frequently flooded, brief duration	Somewhat poorly drained	No
CrA	Crosby silt loam, fine-loamy subsoil, 0 to 2 percent slopes	Somewhat poorly drained	No
CsB2	Crosby-Miami silt loams, 2 to 4 percent slopes, eroded	Moderately well drained	No
MmA	Miami silt loam, 0 to 2 percent slopes, gravelly substratum	Moderately well drained	No
MmB2	Miami silt loam, 2 to 6 percent slopes, eroded	Moderately well drained	No
MmC2	Miami silt loam, 6 to 12 percent slopes, eroded	Moderately well drained	No
MxD2	Miami complex, 12 to 18 percent slopes, eroded	Moderately well drained	No

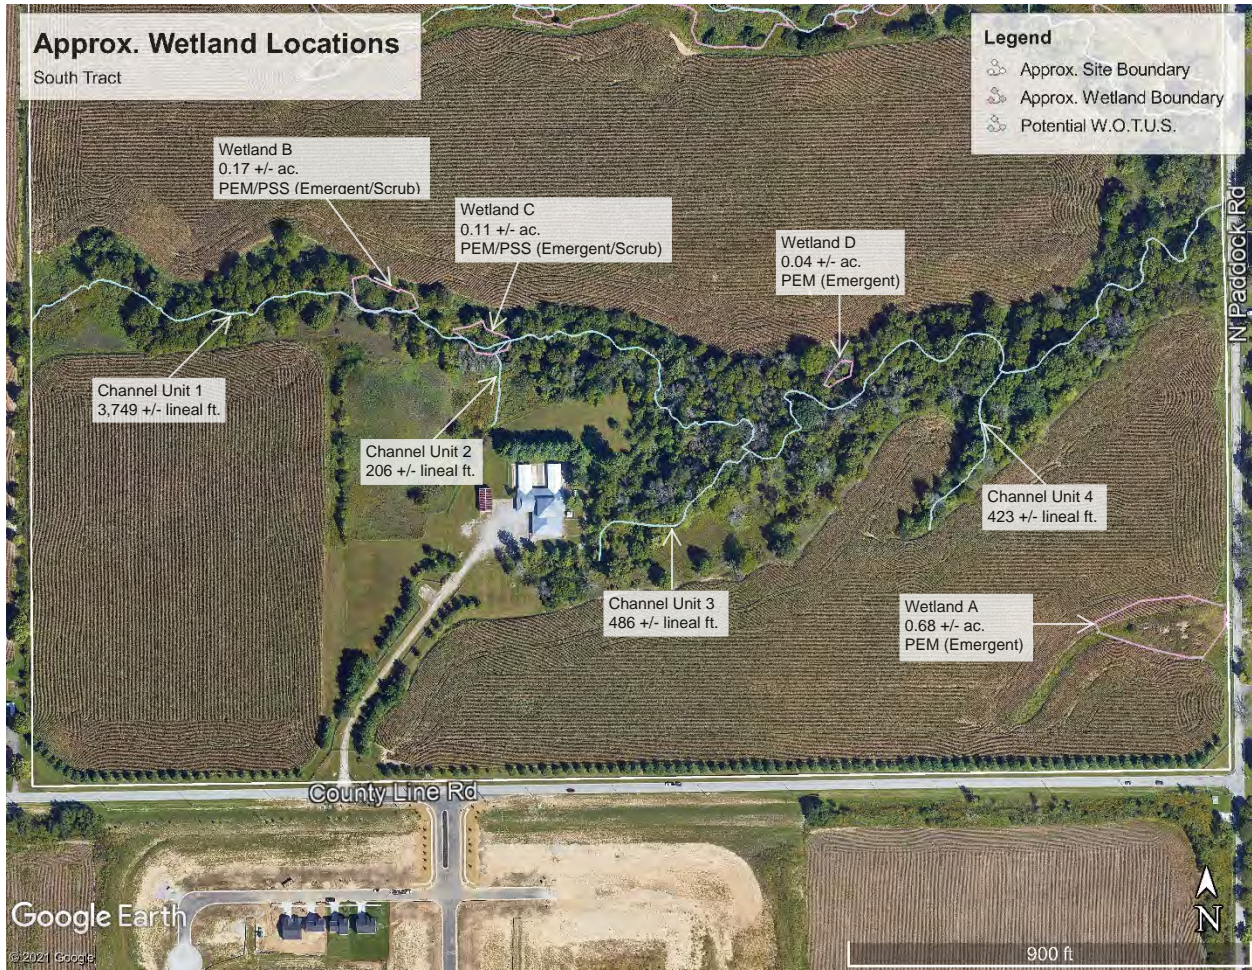
Figure 6. Approximate wetland and bed and bank channel locations – south tract.

Wetland	Size (acres +/-)	Type	Estimated JD Status
A	0.62	PEM (Emergent)	Jurisdictional
B	0.17	PEM (Emergent) / PSS (Scrub)	Jurisdictional
C	0.11	PEM (Emergent) / PSS (Scrub)	Jurisdictional
D	0.04	PEM (Emergent)	Jurisdictional
E	0.30	PEM (Emergent) / PSS (Scrub)	Jurisdictional
F	0.98	PEM (Emergent) / PSS (Scrub)	Jurisdictional
G	0.52	PEM (Emergent)	Jurisdictional
H	0.03	PEM (Emergent)	Jurisdictional
I	0.33	PEM (Emergent) / PSS (Scrub)	Jurisdictional
J	2.00	PEM (Emergent)	Jurisdictional
K	0.14	PEM (Emergent)	Jurisdictional

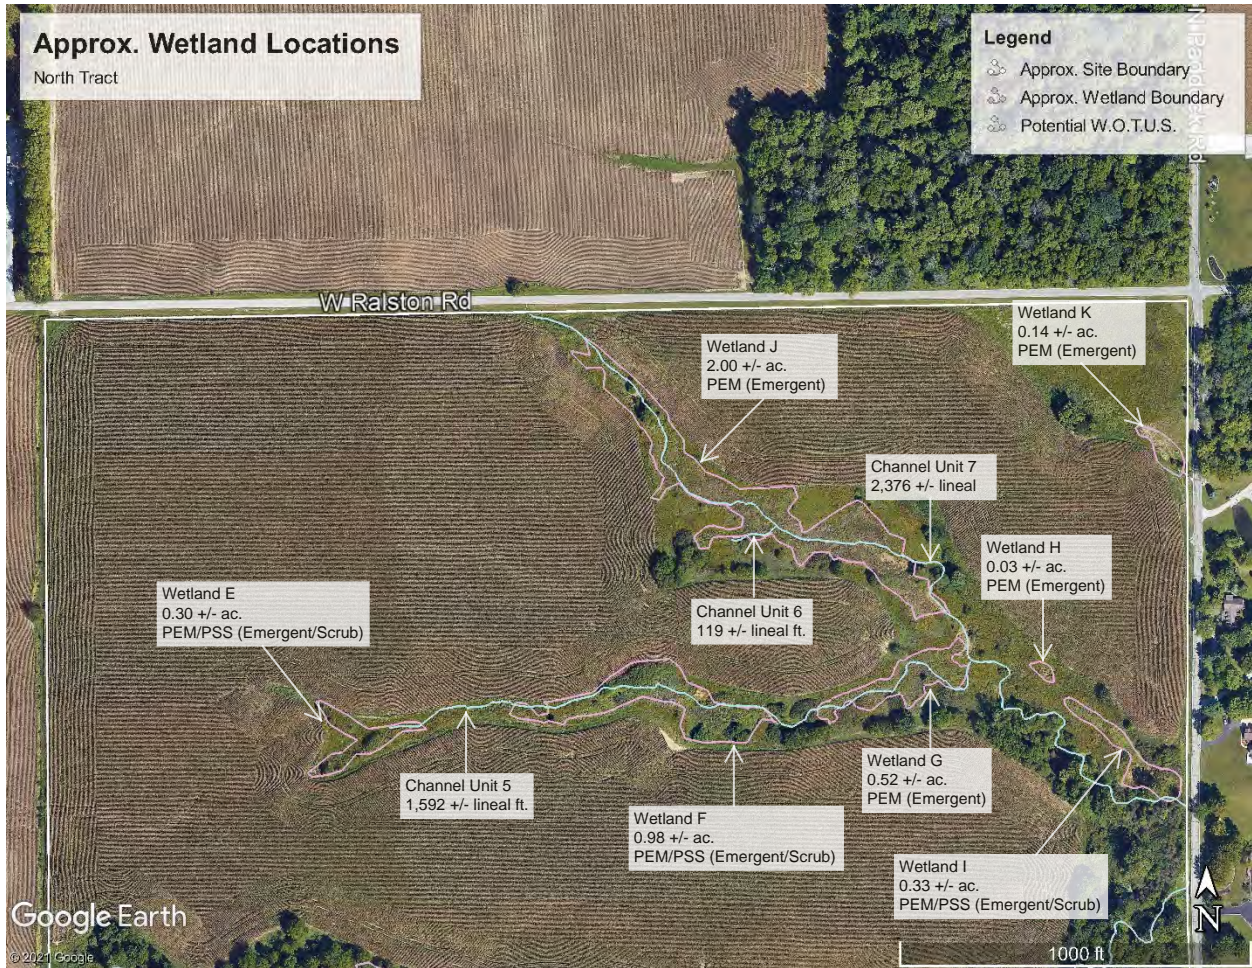
Figure 7. Approximate wetland and bed and bank channel locations – north tract.

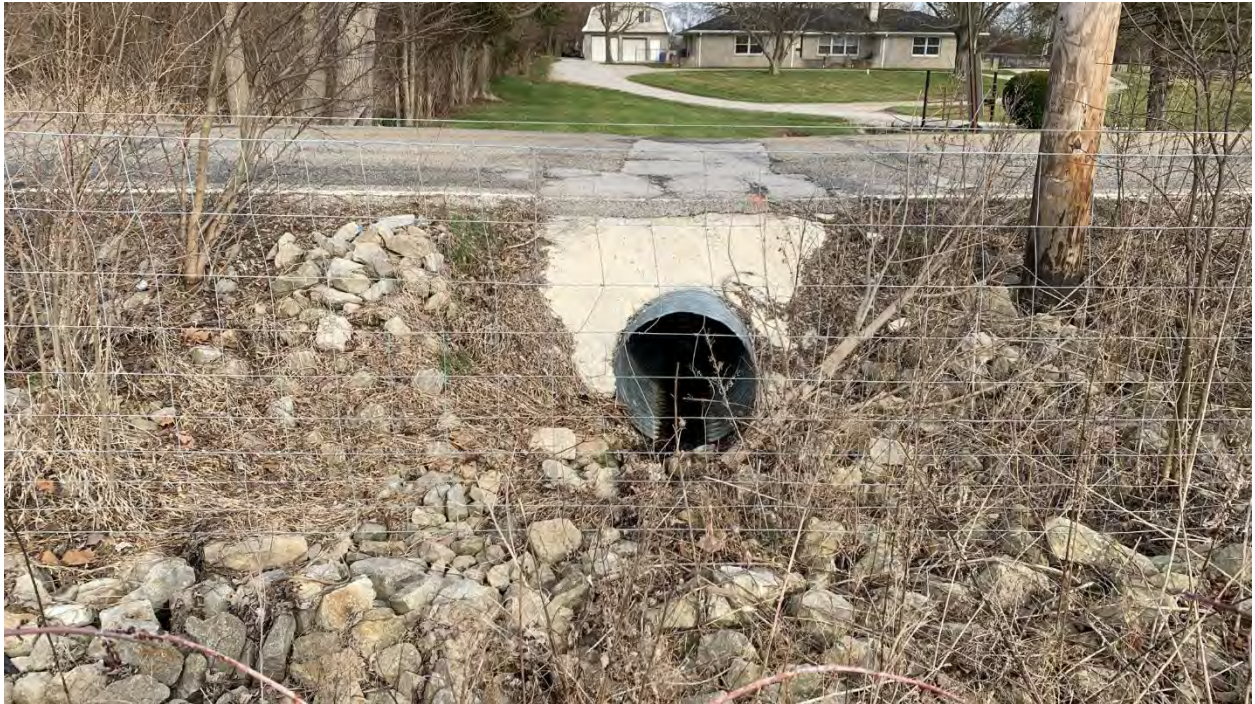
Phot 14. Looking east at the stormwater drainage outlet that Wetland K drains to.
