SECTION 401 WQC REGIONAL GENERAL PERMIT NOTIFICATION

Construction of a senior living facility on the site, including installation of one stormwater outfall and riprap apron along the south bank of Merry Branch. The outfall pipe will be 42 inches in diameter with an associated riprap apron and bank impact of 23 LF.

Regional General Permit (RGP) Notification
Harmony of Greenwood, S of Wheatcraft Way and E County Line Road
Johnson County, Indiana

Attachment 4: Engineering Design Plans

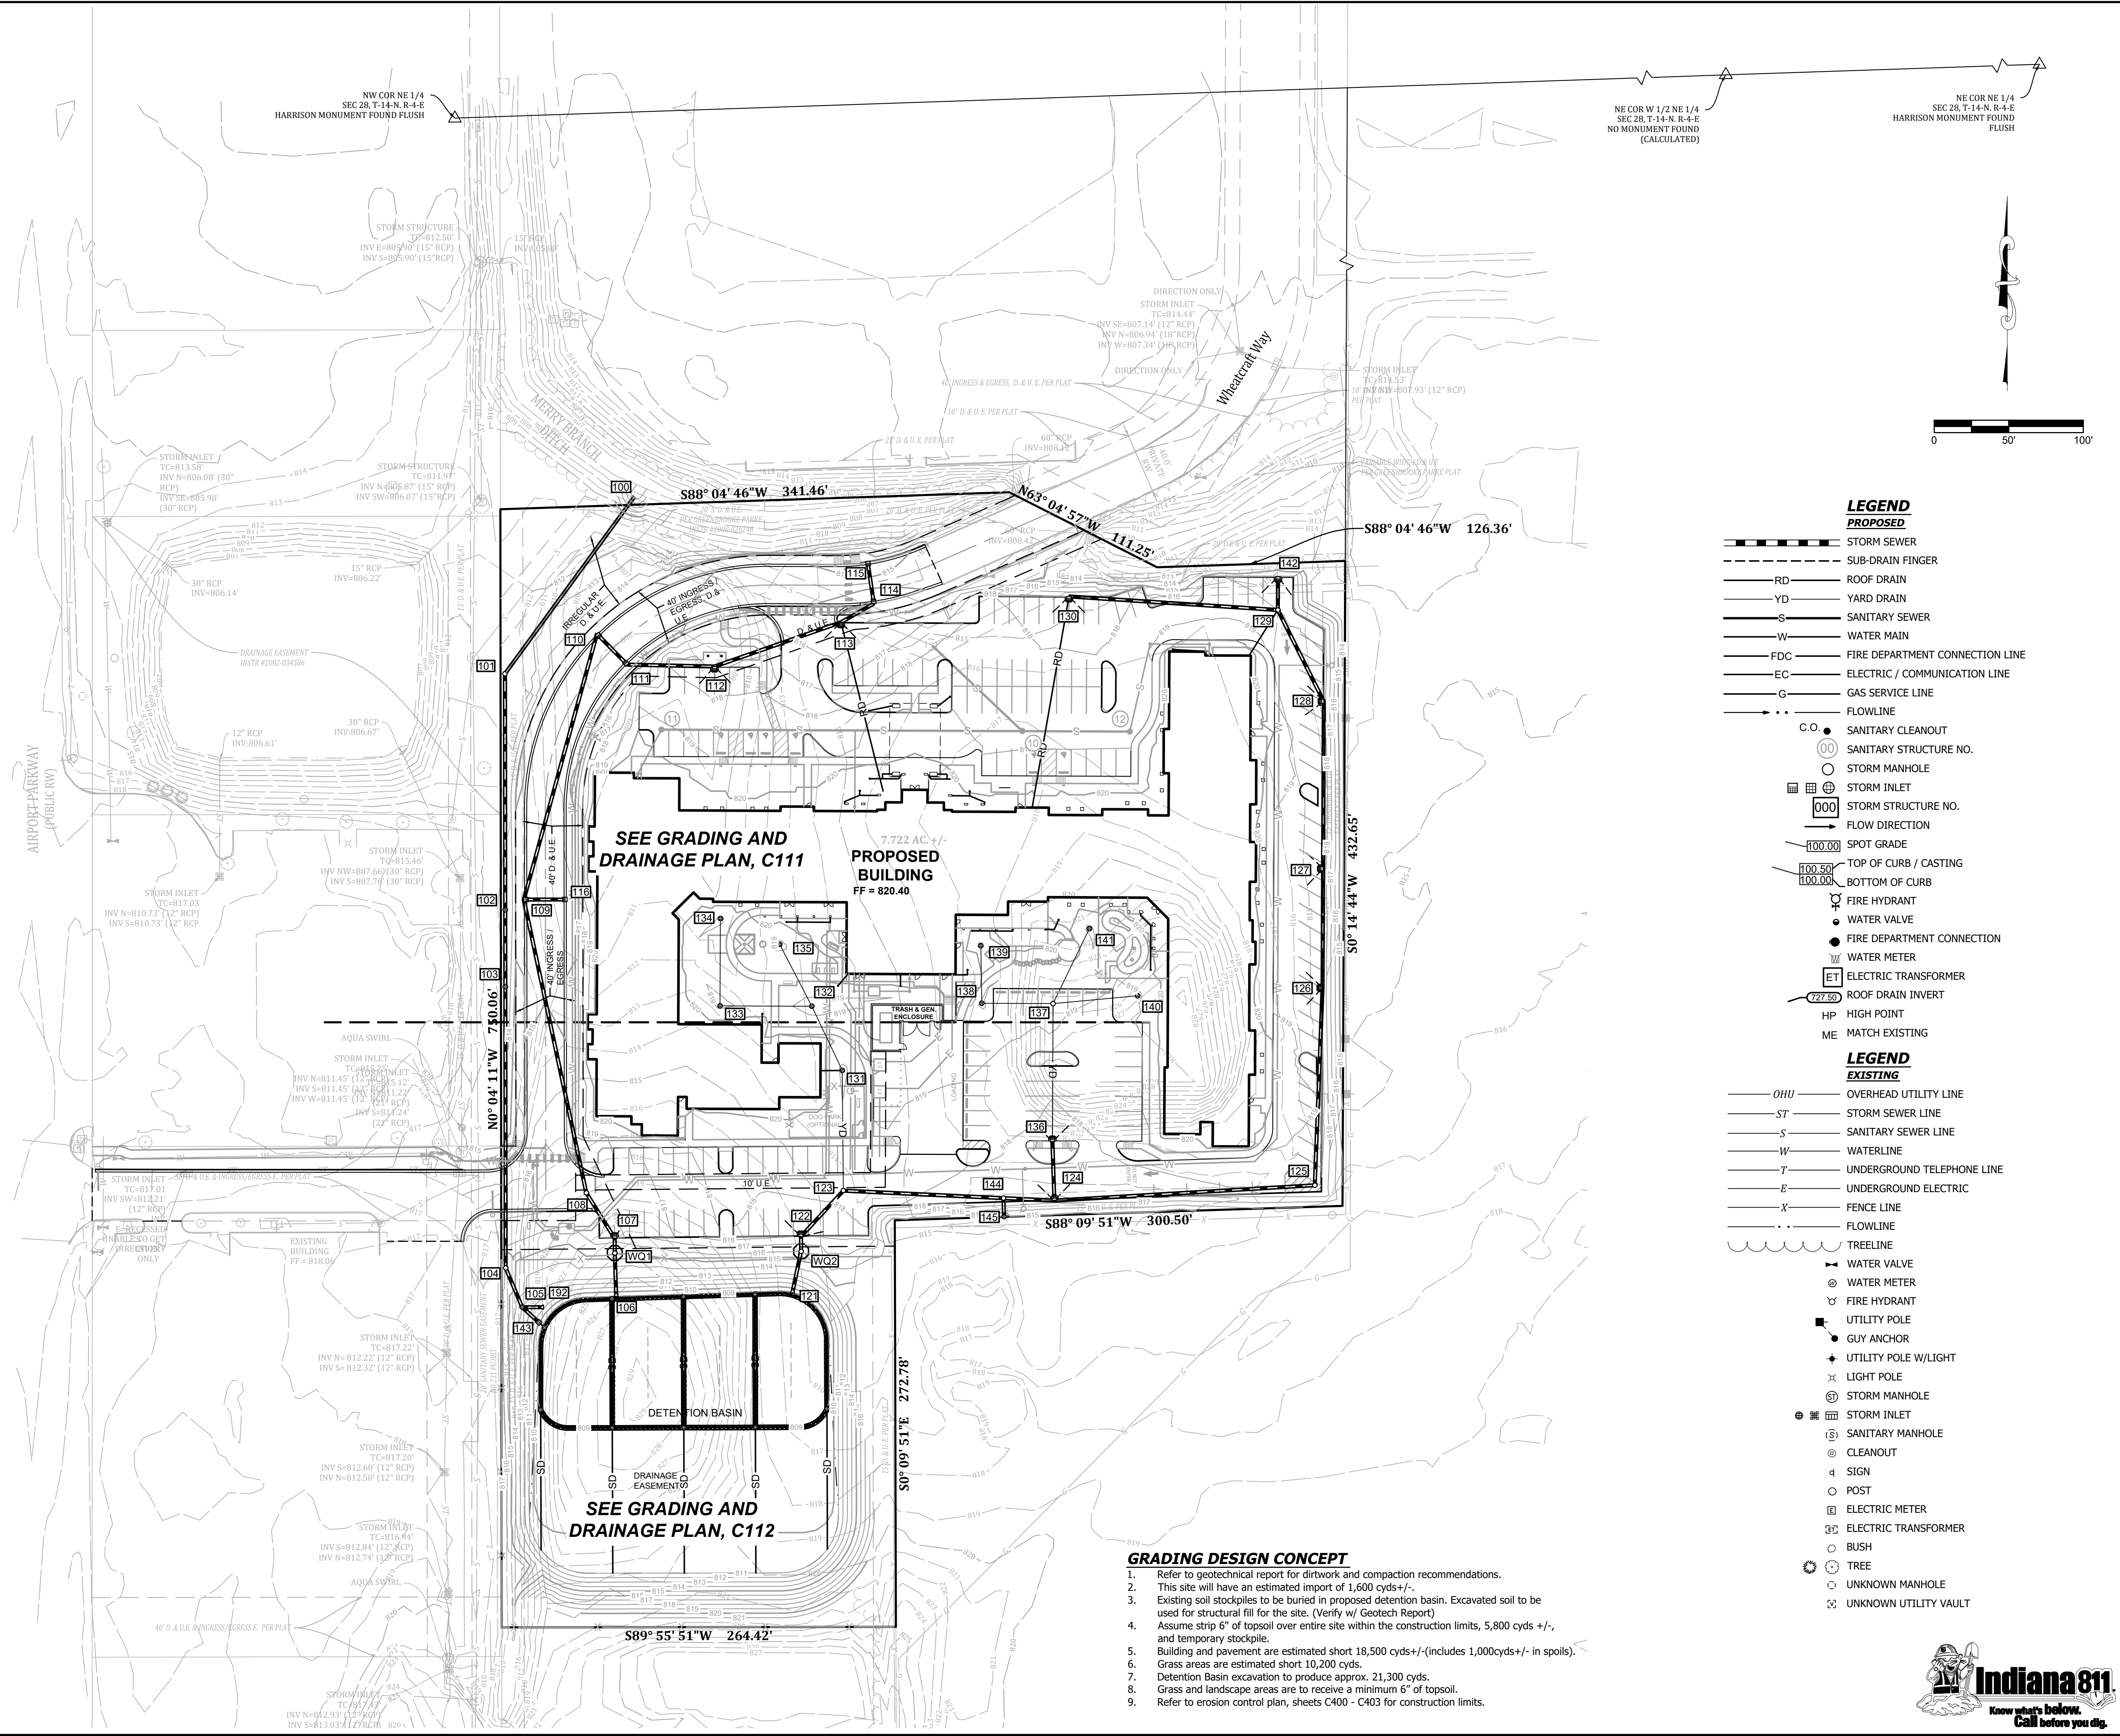
Project No: 21135
Sheet No: C110

- GRADING DESIGN CONCEPT**
- Refer to geotechnical report for dirtwork and compaction recommendations.
 - This site will have an estimated import of 1,600 cyds +/-.
 - Existing soil stockpiles to be buried in proposed detention basin. Excavated soil to be used for structural fill for the site. (Verify w/ Geotech Report)
 - Assume strip 6" of topsoil over entire site within the construction limits, 5,800 cyds +/-, and temporary stockpile.
 - Building and pavement are estimated short 18,500 cyds +/- (includes 1,000cyds +/- in spoils).
 - Grass areas are estimated short 10,200 cyds.
 - Detention Basin excavation to produce approx. 21,300 cyds.
 - Grass and landscape areas are to receive a minimum 6" of topsoil.
 - Refer to erosion control plan, sheets C400 - C403 for construction limits.

OVERALL GRADING PLAN
HARMONY OF GREENWOOD
JOHNSON COUNTY
GREENWOOD, INDIANA

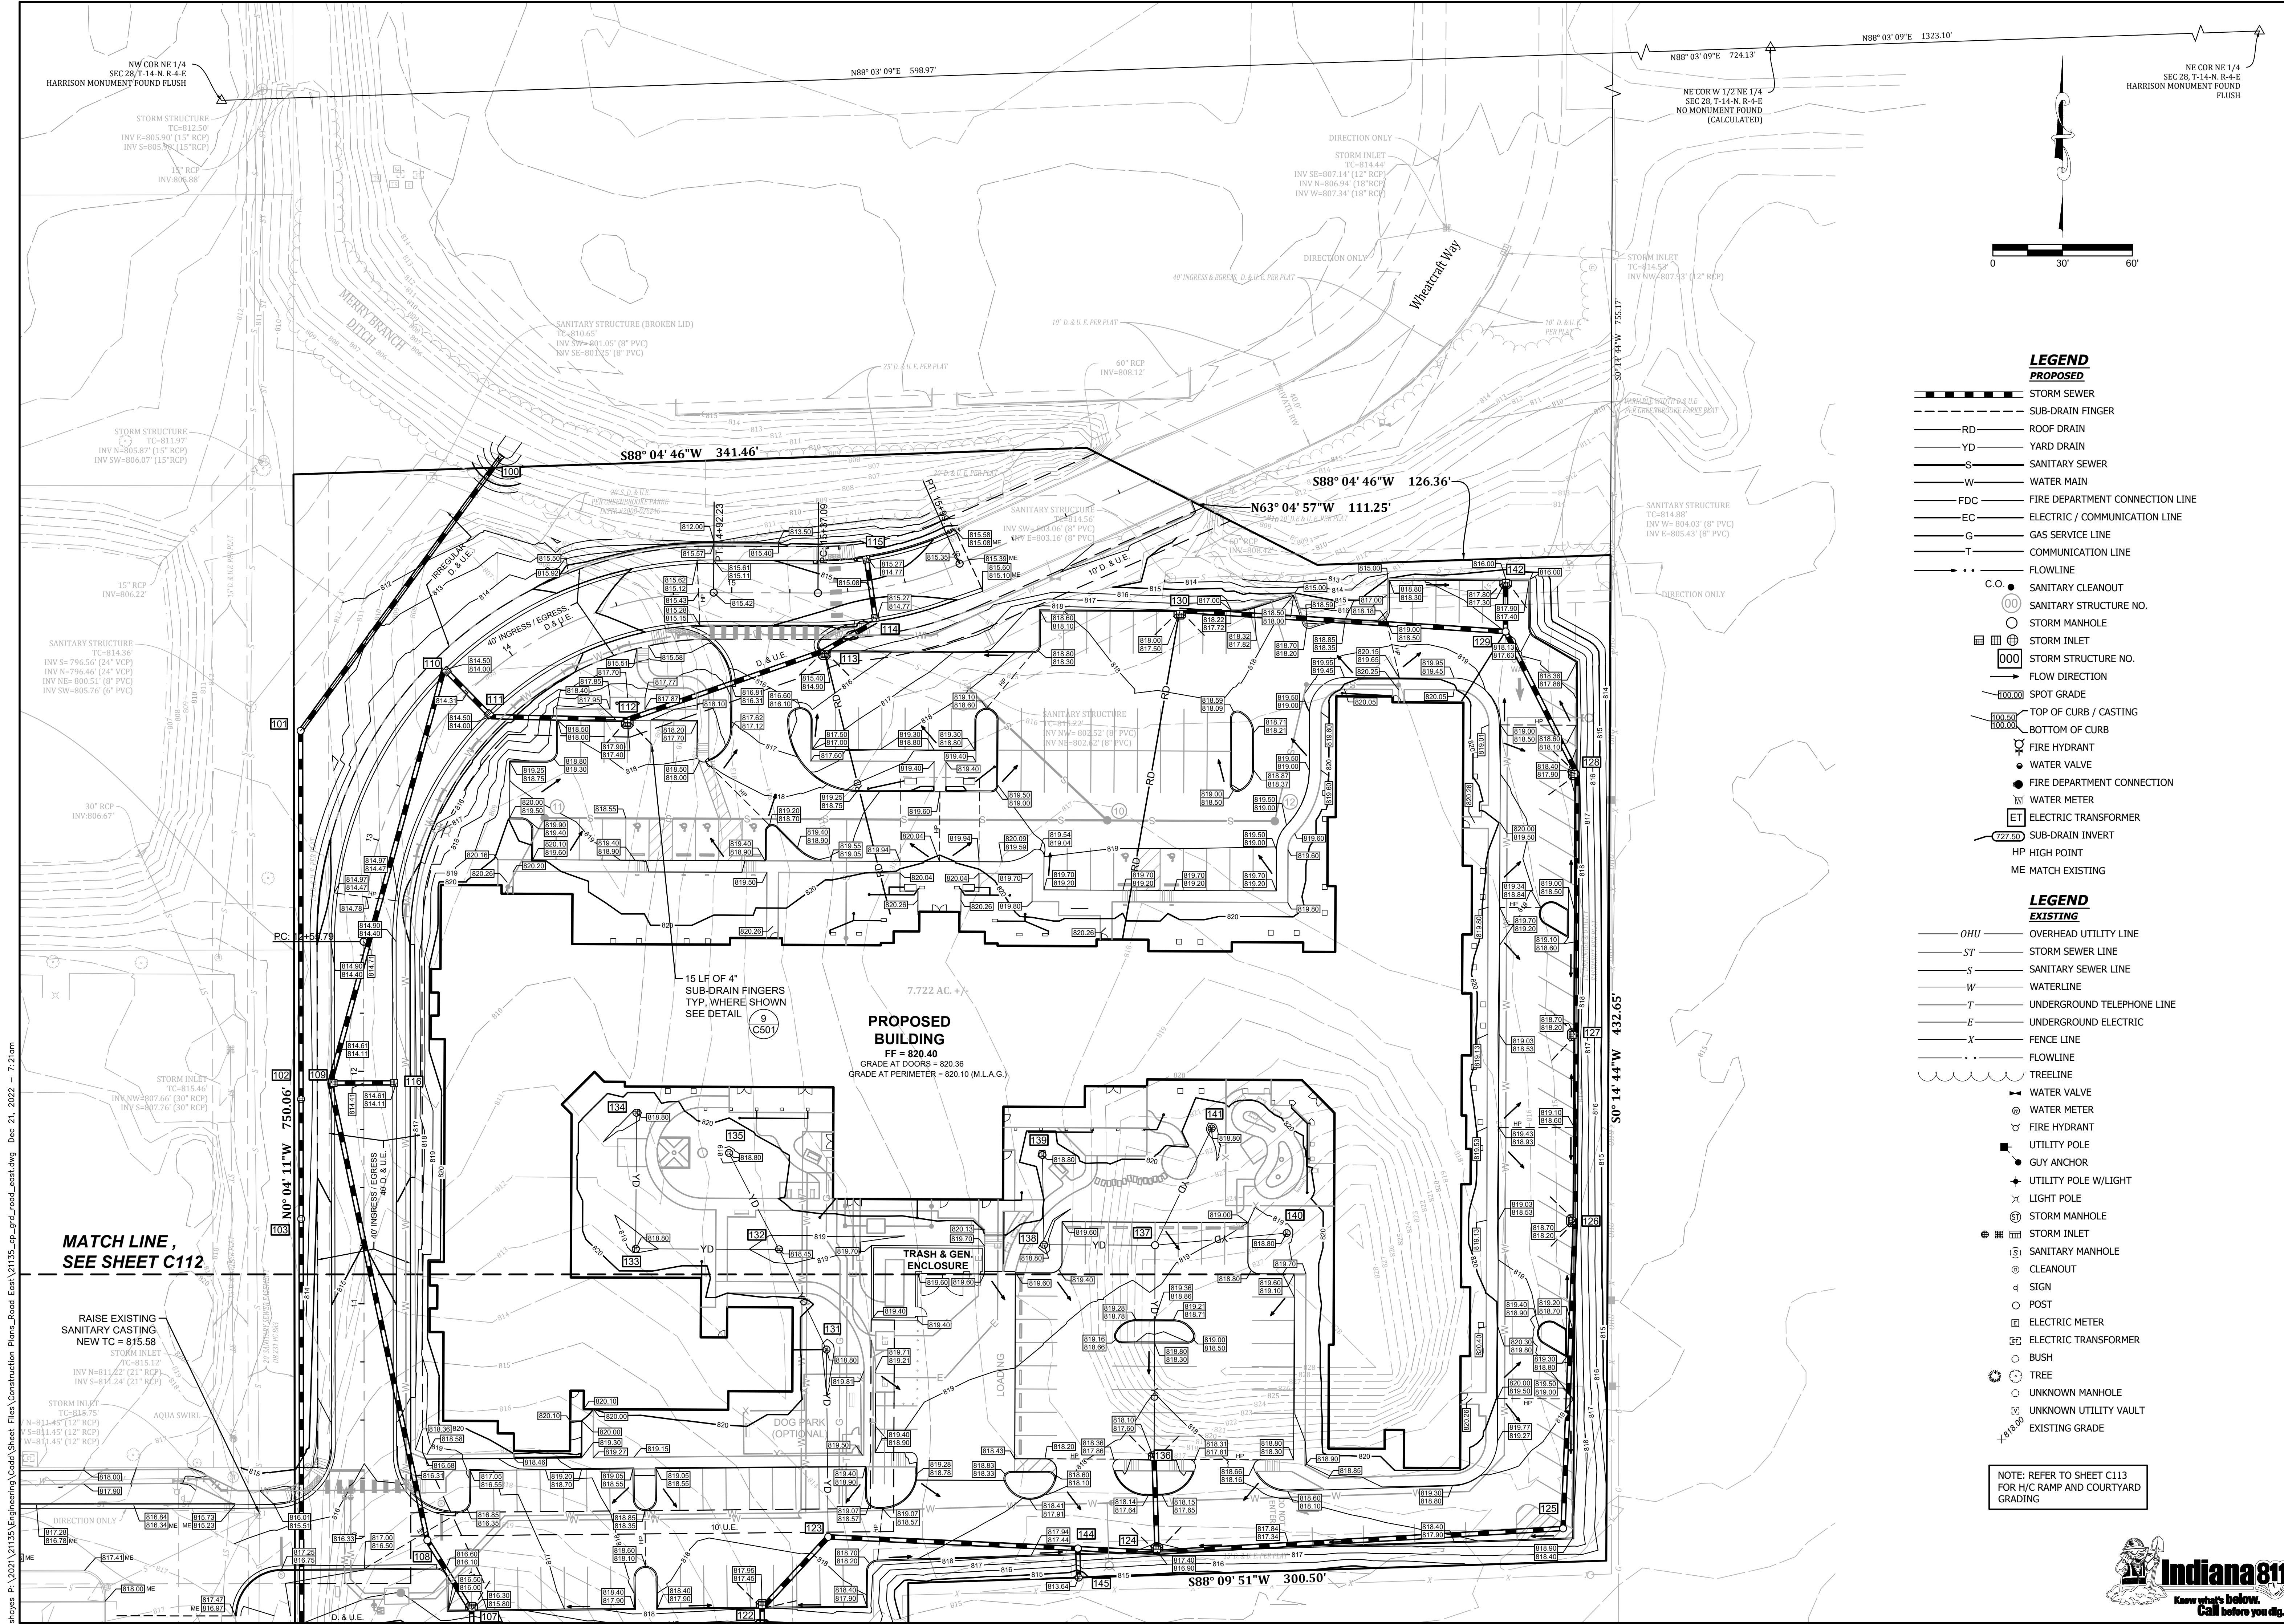
Project No: 21135
Sheet No: C111

GRADING AND DRAINAGE PLAN
HARMONY OF GREENWOOD
JOHNSON COUNTY
GREENWOOD, INDIANA

STORM INLET
TC=815.12
INV N=811.22' (21" RCP)
INV S=814.24' (21" RCP)

STORM INLET
TC=815.46
INV NW=807.66' (30" RCP)
INV S=807.76' (30" RCP)

STORM STRUCTURE
TC=814.36
INV S=796.56' (24" VCP)
INV N=796.46' (24" VCP)
INV NE=800.51' (8" PVC)
INV SW=805.76' (6" PVC)

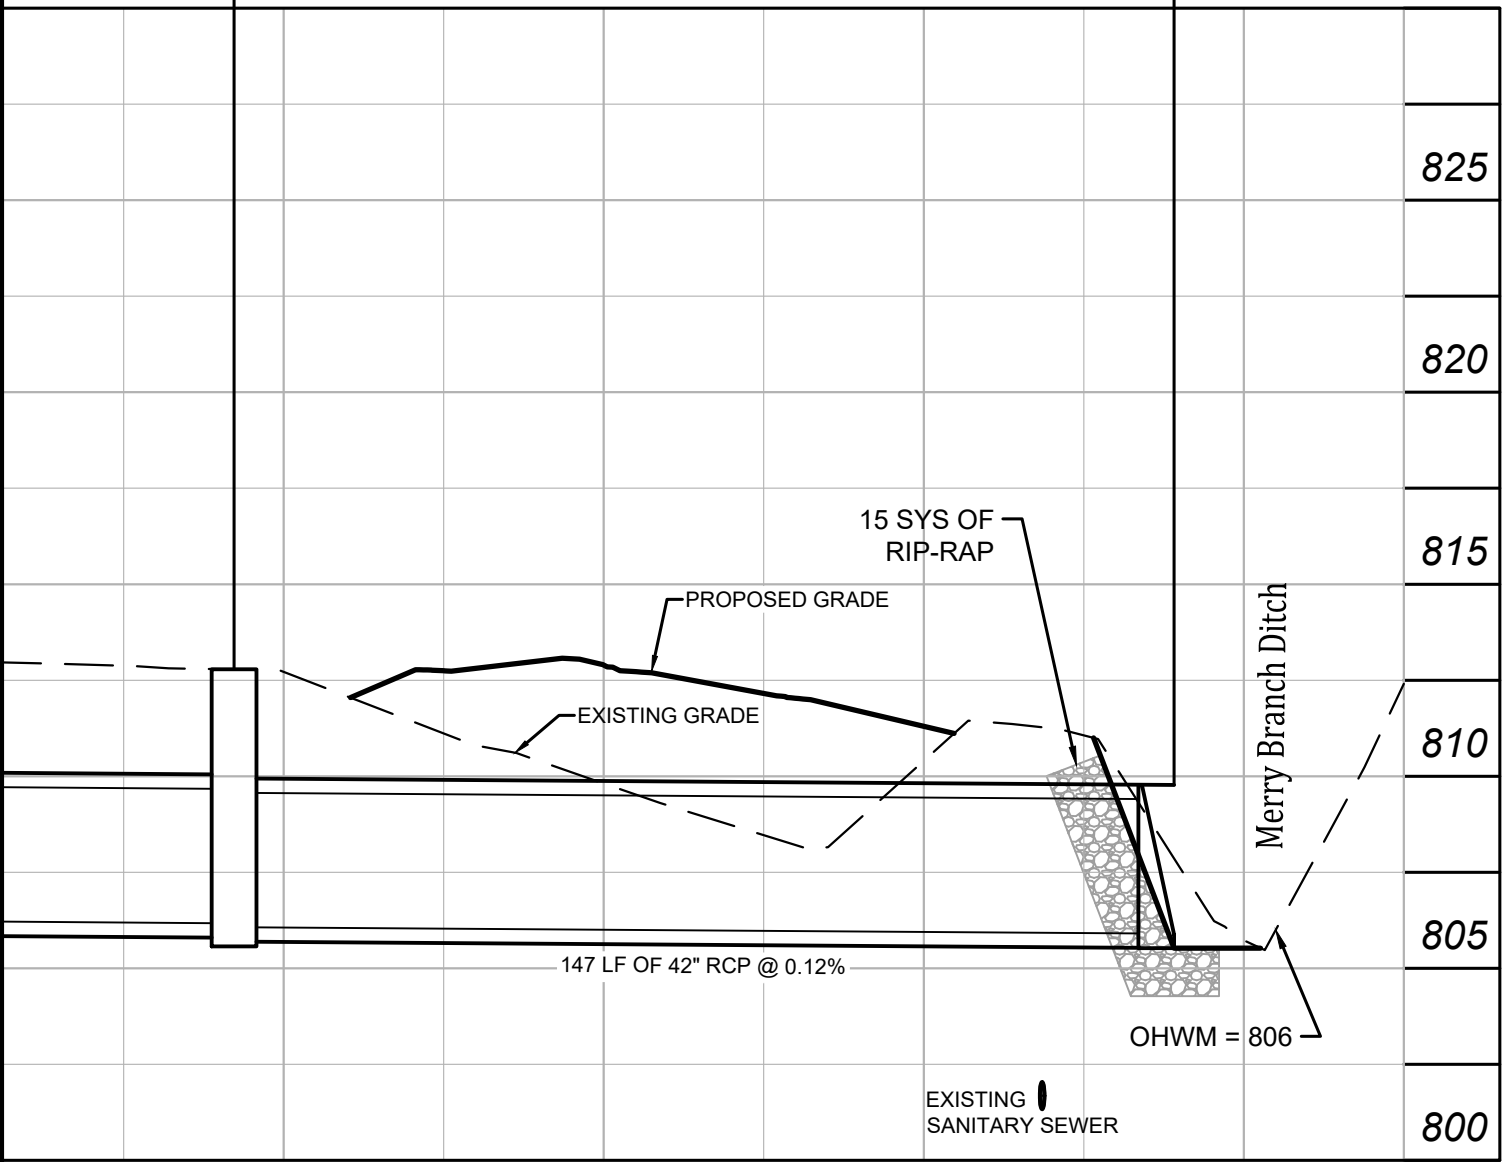
Because the proposed stream impacts do not exceed the threshold of 150 LF, no mitigation will be included as part of the scope of the proposed activities. Please see Attachment 4 for additional details regarding the location, dimensions, and cross-section of the proposed stormwater outfall and riprap apron.

SCALE:
 VERTICAL: 1" = 5'
 HORIZONTAL: 1" = 30'

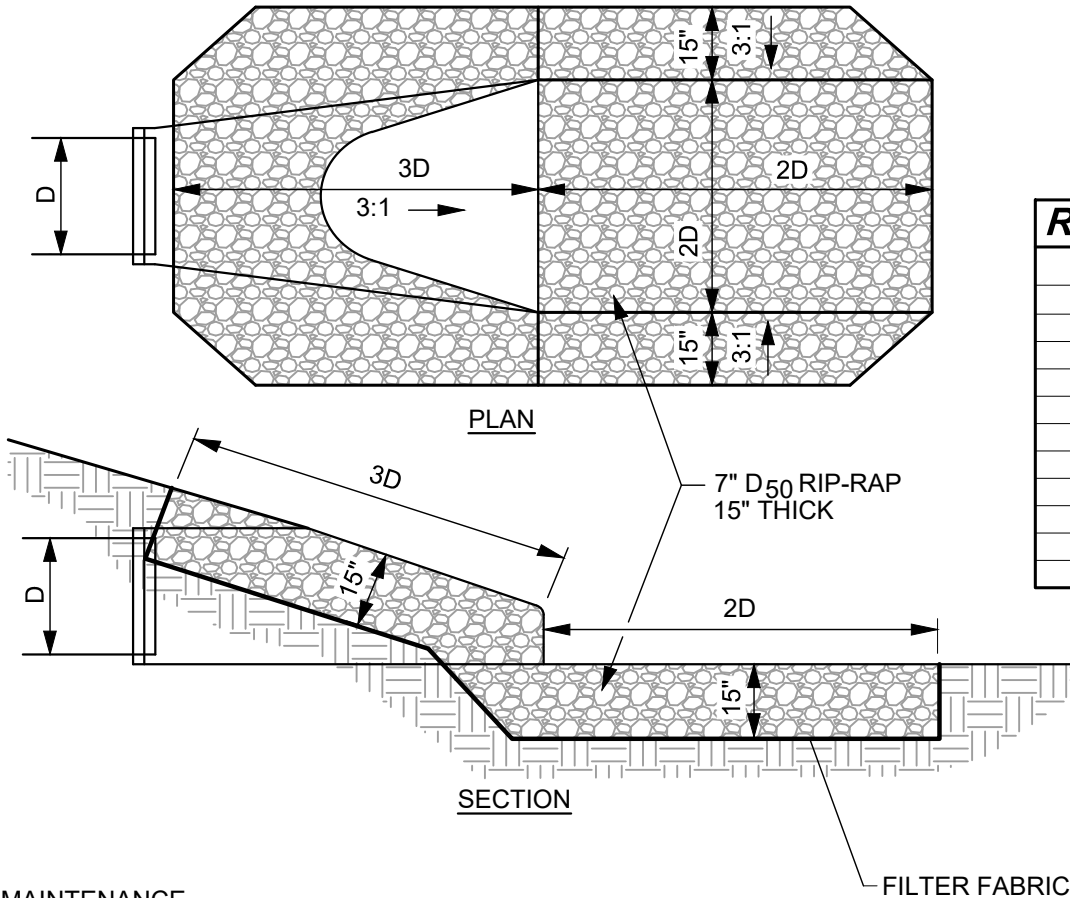
RIP-RAP SCHEDULE	
PIPE	SYS
12	2
15	3
18	4
21	5
24	6
27	7
30	8.5
33	10
36	11.5
42	15
48	19

MAINTENANCE

*Make needed repairs immediately; use appropriate size stone, do not place them above the finished grade.

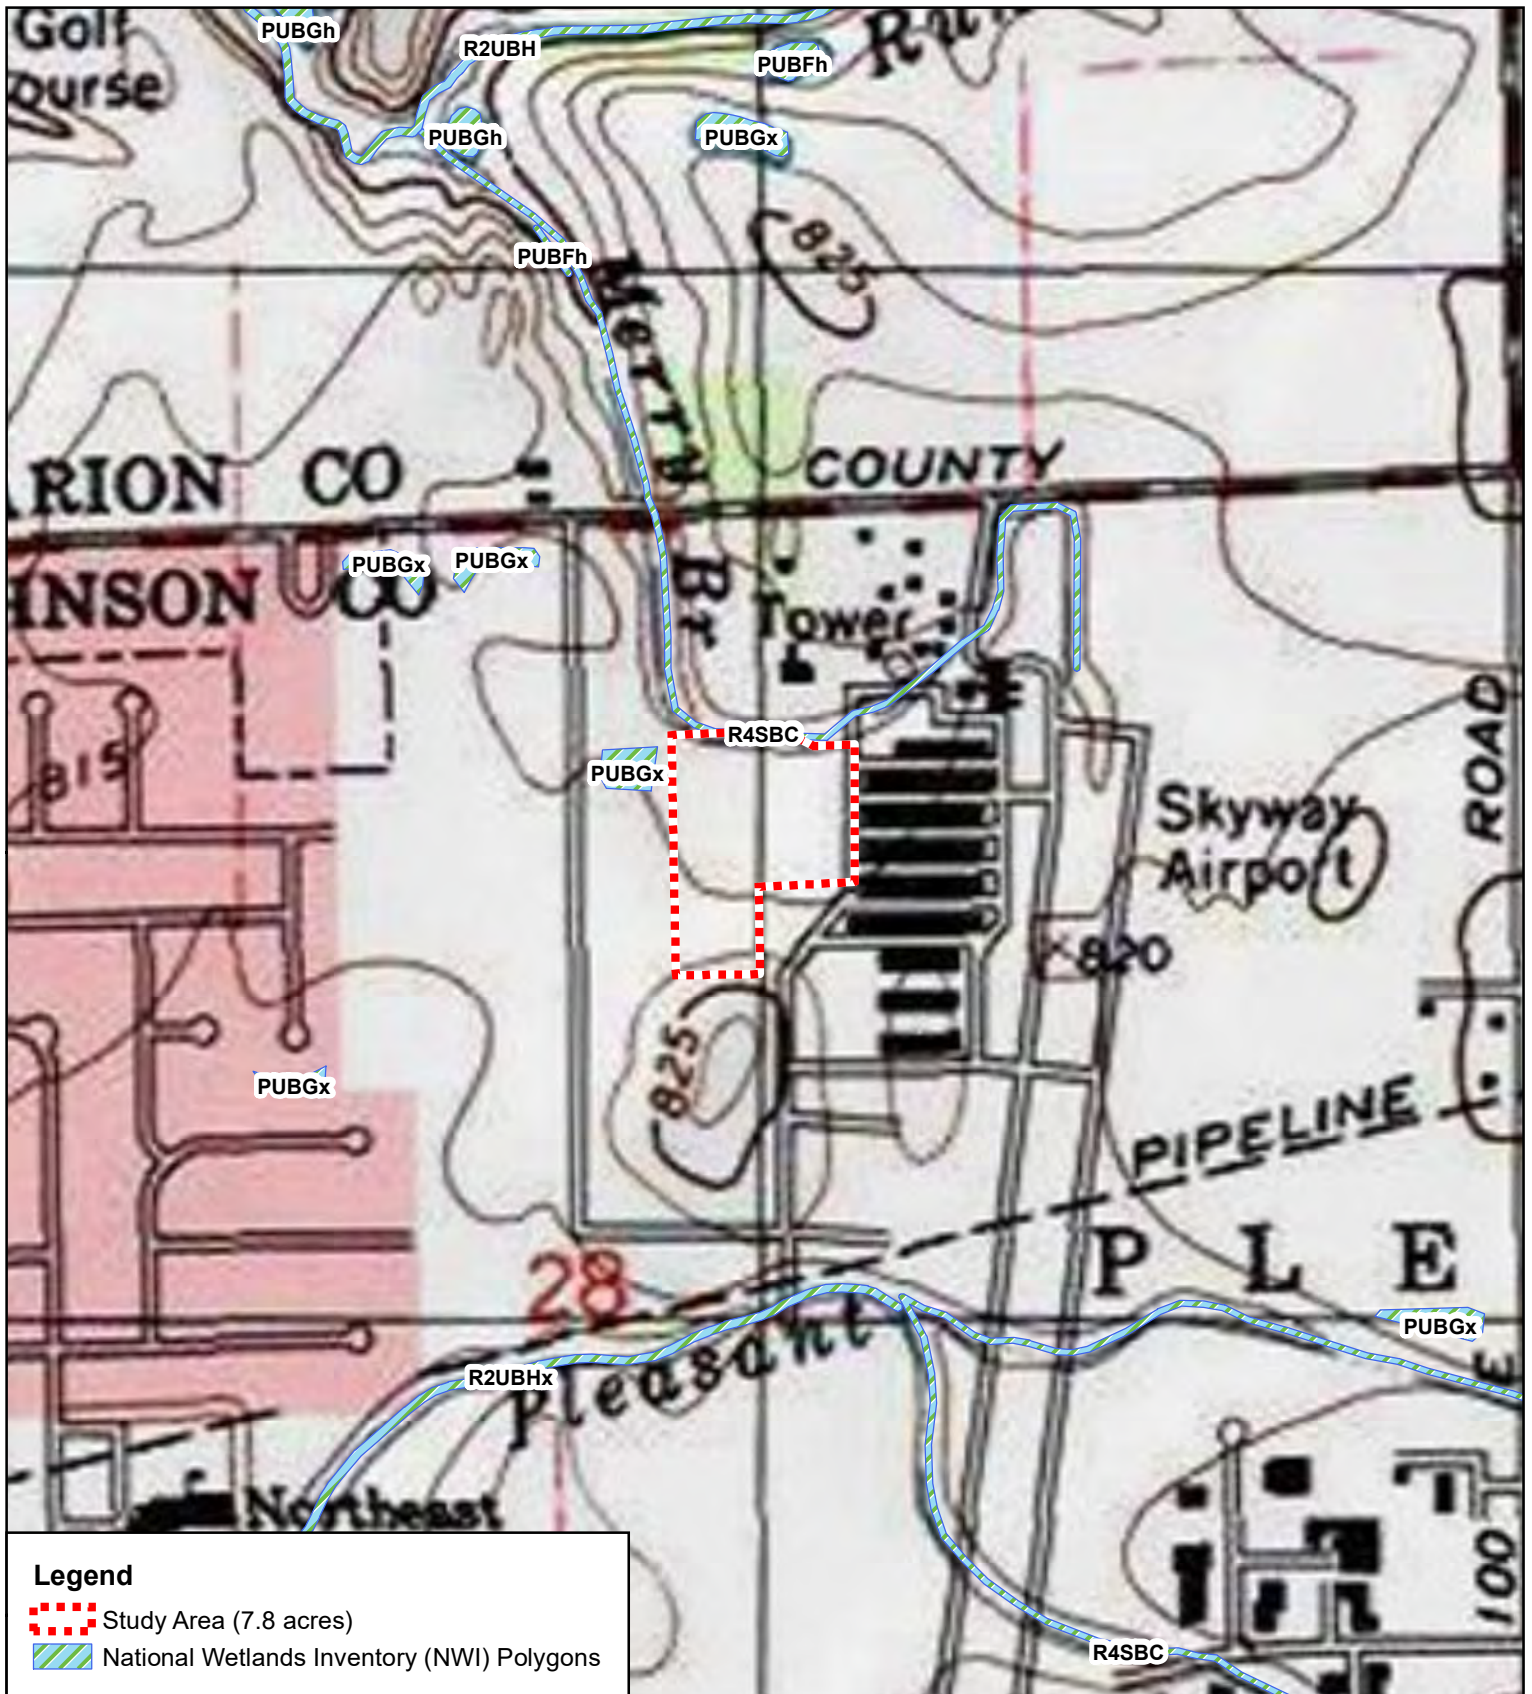
Appendix A, Figure 2:
Topographic and NWI Map

The U.S. Fish and Wildlife Service’s (USFWS) National Wetland Inventory (NWI) map was reviewed to determine the presence of any NWI polygons within or adjacent to the site. There was one (1) NWI wetland polygon observed within the Study Area boundaries (see Appendix A, Figure 2).

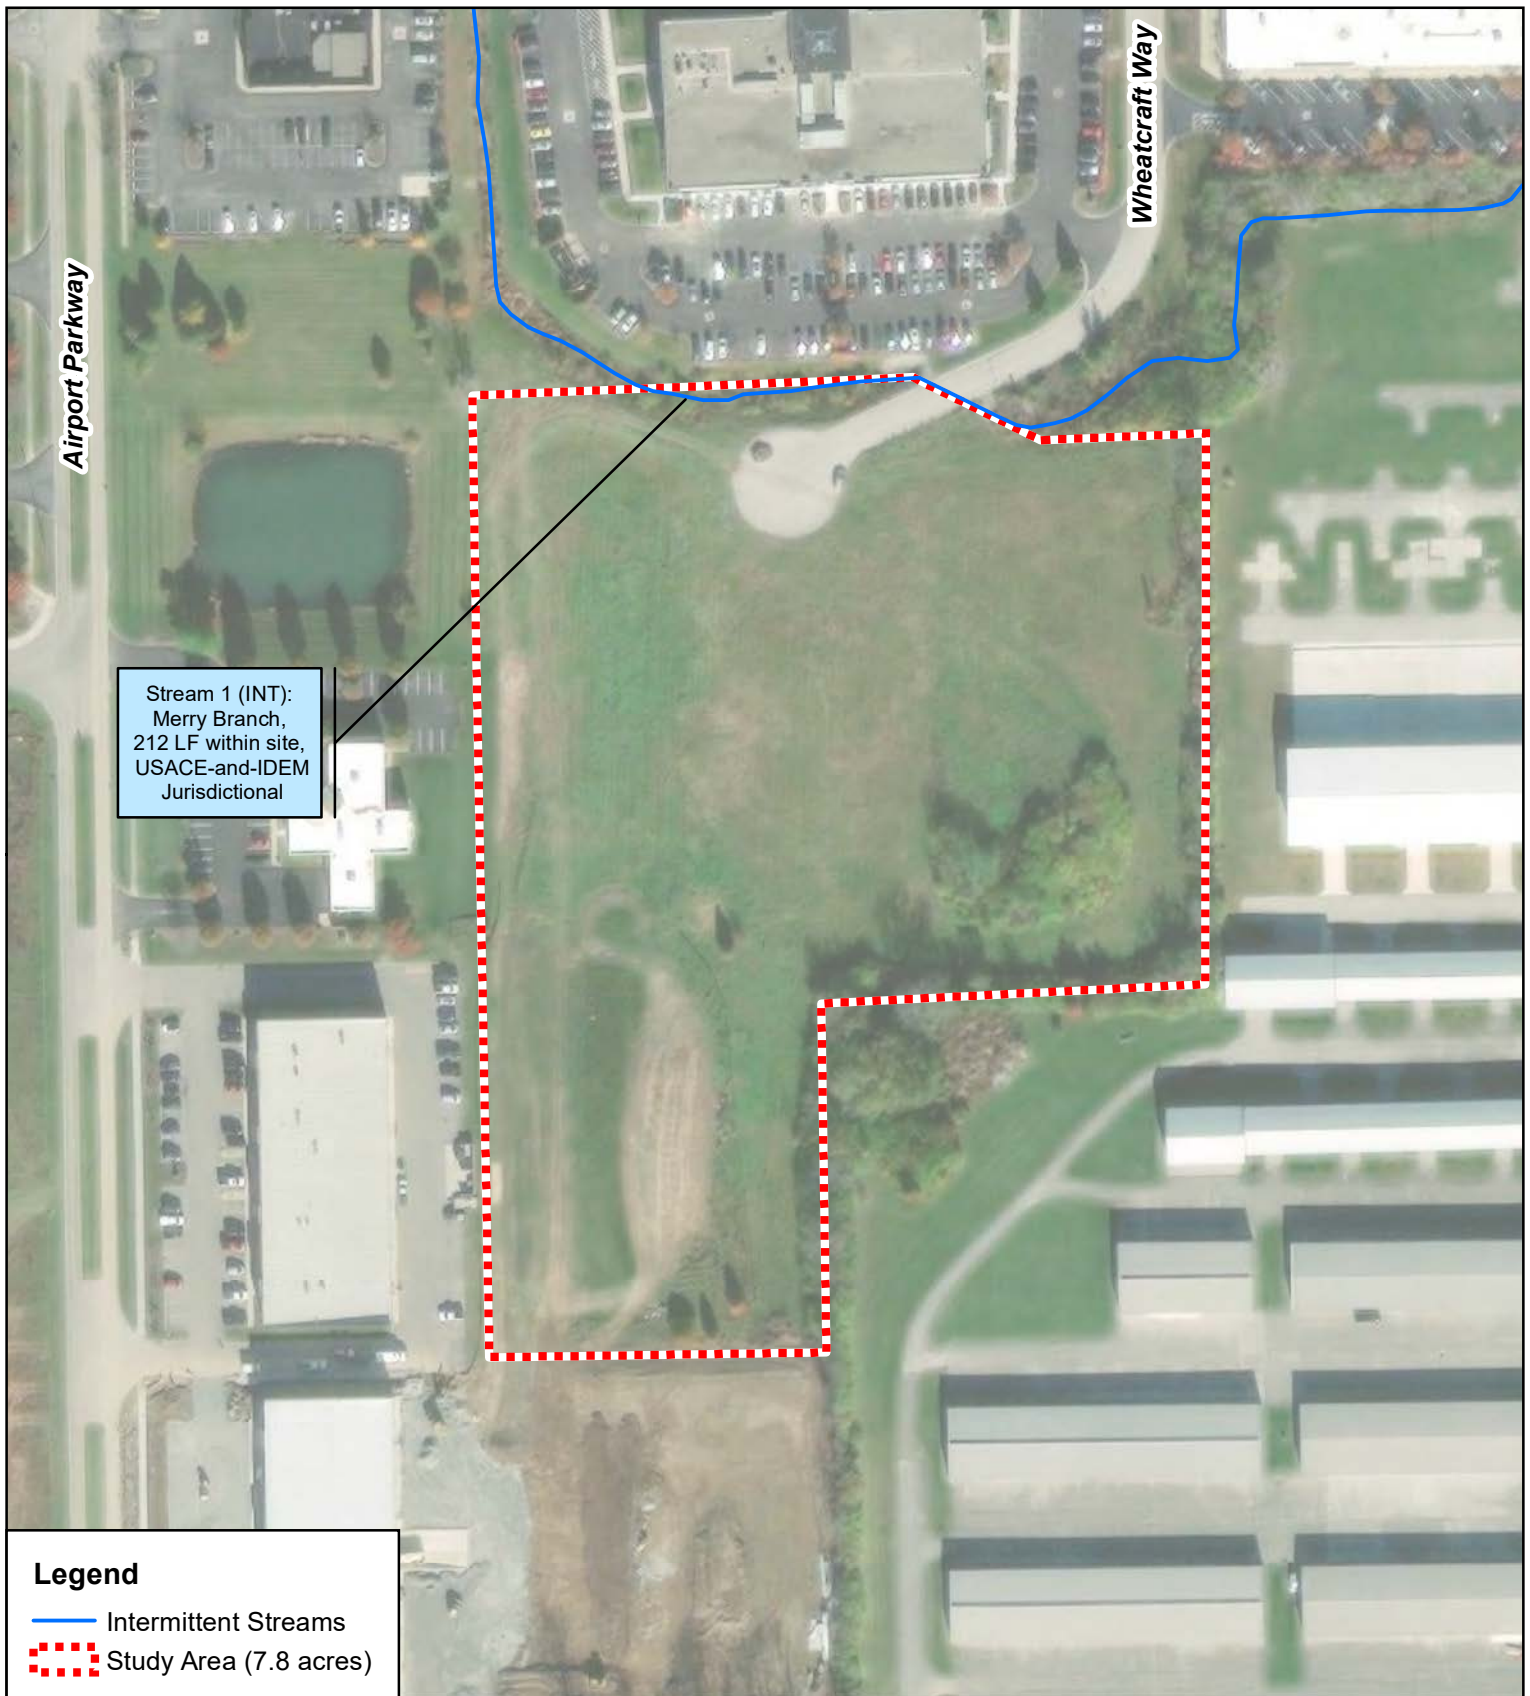
Appendix A, Figure 6:
Water Resources Delineation Map

Stream 1 (INT):
 Merry Branch,
 212 LF within site,
 USACE-and-IDEM
 Jurisdictional
