# INDIANA DEPARTMENT OF ENVIRONMENTAL MANAGEMENT

Re: **Summary Letter/Referral to Enforcement**  
EJ Dairies, Inc.  
FID 6176  
Francesville, Pulaski

**CFO**  
**INSPECTION REPORT**  
 INDIANA DEPARTMENT OF  
 ENVIRONMENTAL MANAGEMENT

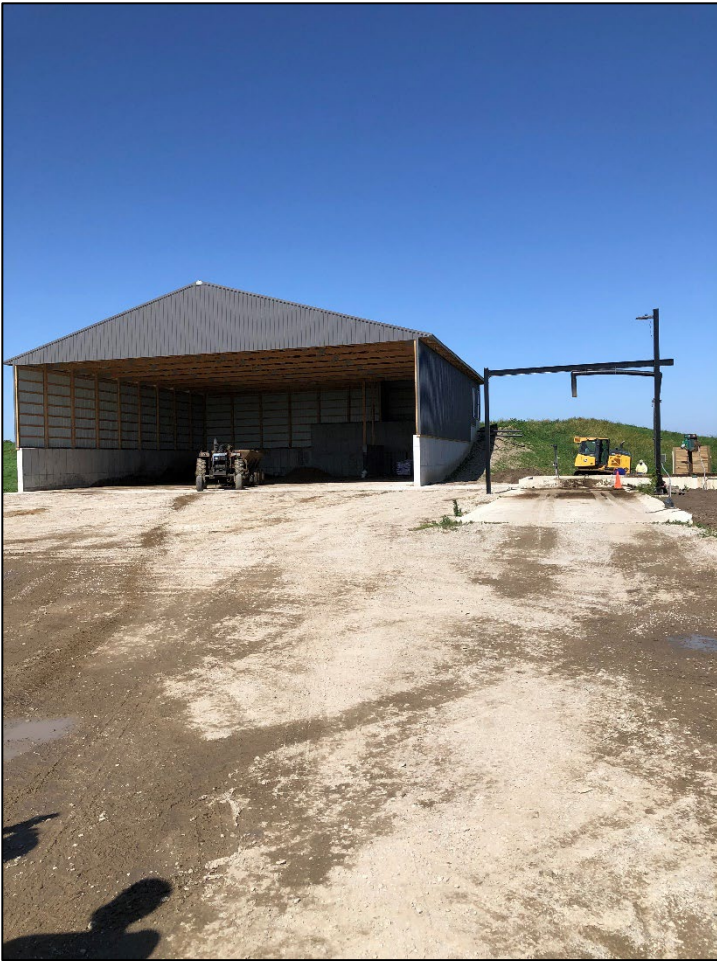
This photo shows the P2 stacking pad that was constructed into the East berm of P1, and the completed P3 reception pit.

The facility originally submitted a construction start notification and a completion affidavit for the lined storage impoundment P1 on 11/11/2020 and 4/1/2022 (**VFC# 83070326 and 83302706**). However, during construction of P2, a portion of the East berm of P1 was excavated and P2 was built into the East side of P1. This construction activity took place without prior approval and requires further investigation to determine the structural integrity of the lined storage impoundment.

**Violation Detail(s):** Multiple changes to structure P1, P2, and P3 have occurred without the appropriate facility changes being submitted since the original approval. The excavation of the P1 East berm for the construction of P2 required additional plans and notice to be submitted prior to construction.

**Required Action:** The facility must immediately contact IDEM's CFO Permitting section and submit the appropriate documentation regarding the changes made to P1, P2, and P3.

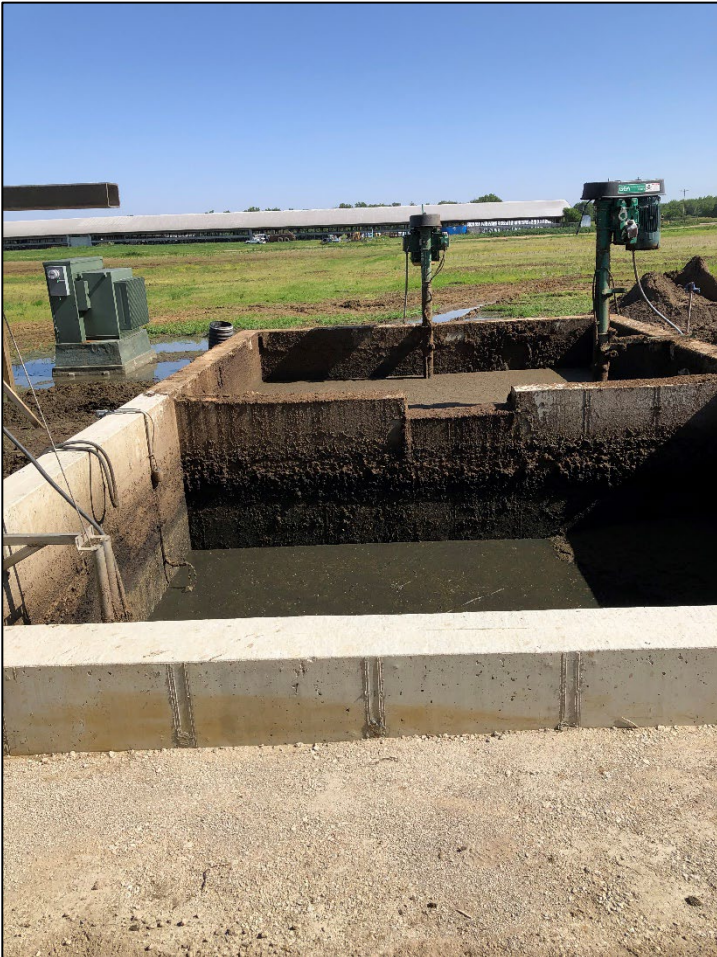
While observing P3 it was noted there was some manure outside of the structure, and visible signs that the pit had been at max capacity. Mr. Hein informed inspectors that there was air in the system, and that it purged while the pit was full. This allowed some manure to splash outside of the structure. The facility was in the process of scraping and cleaning the surrounding area during the inspection. **(See attached photo)**

This photo shows the completed and operational P3 reception pit, as well as the manure that splashed outside of the pit.

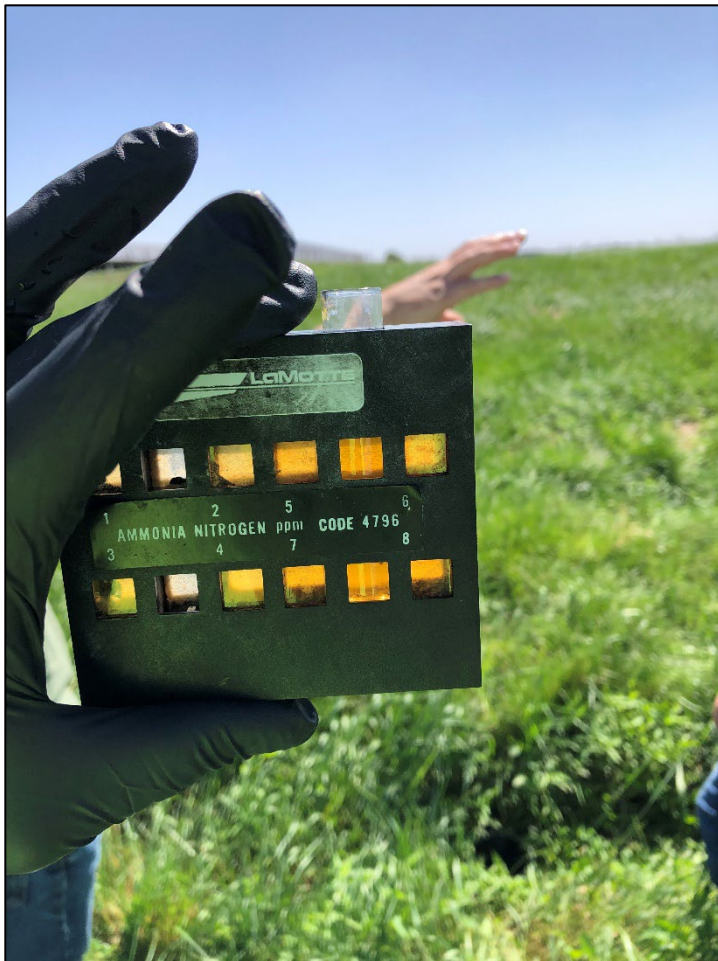
A visual inspection of the lined storage impoundment P1 was found that there was adequate freeboard, and a visible freeboard marker. Vegetation around the impoundment was established and well maintained where required. The perimeter tile for P1 does not have an observation point as shown in the facility's permit. Sampling could only occur at a tile inlet junction, that is located Northwest of P1 into the facility's on-site stormwater drainage. The tile inlet junction was unable to be sampled due to lack of water, however, another tile that was believed to be connected to the junction was located West of the drainage berm. This tile was sampled for ammonia/nitrogen, and the test result was 8ppm. **(See attached photo)**

This photo shows the ammonia/nitrogen test result of 8ppm, that was taken from the storm water tile outfall.

The facility was instructed to block off the tile and pump any contents from the tile back into P1 until the facility could determine the source of the contaminants. The facility was also instructed to ensure that the perimeter tile for P1 was constructed per the facility's permit, with no other tiles connected to the perimeter tile, or the outfall. Any changes to the approved plans for the permitted structures will require a facility change to be submitted to IDEM's CFO Permitting section.

The facility was instructed to immediately cap the impacted tiles, and begin monthly perimeter tile monitoring as required in the special conditions of the permit.

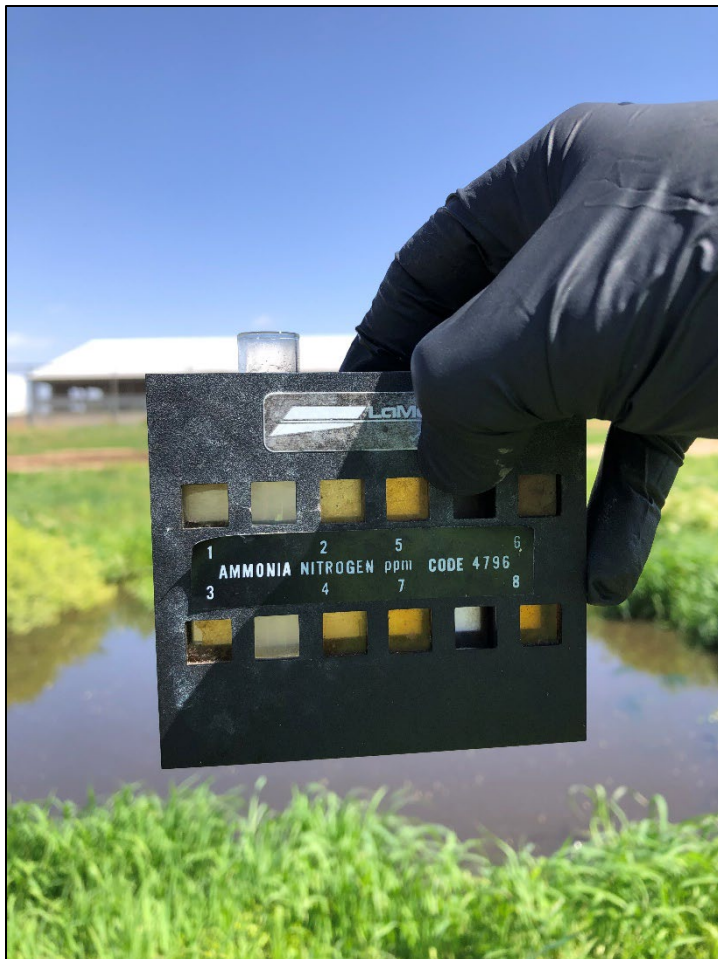
This photo shows the sample taken from the ponded water in the stormwater drainage area, prior to adding the reagents.

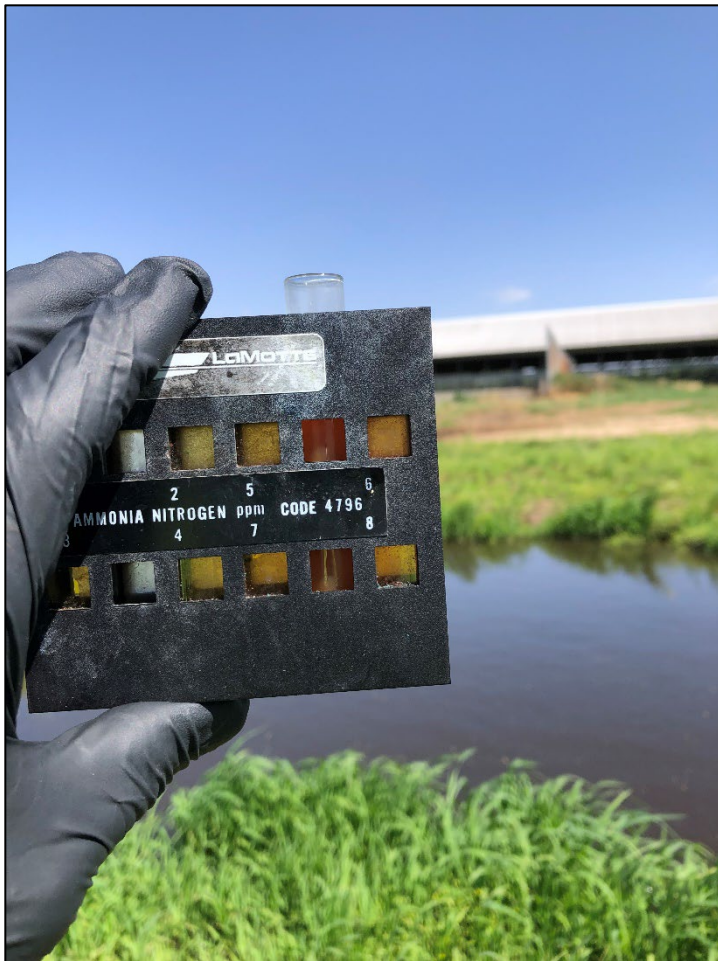
The stormwater drainage area between production building E1 and the lined storage impoundment P1 had rutting due to equipment passing through to access the field. Ponded stormwater was sampled and found to be 8+ppm ammonia/nitrogen.

**Violation Detail(s):** The drainage area between the production building and the field South of the facility contained manure impacted stormwater from equipment passing through the drainage area.

This photo shows the ammonia/nitrogen result of 8+ ppm taken from the ponded water in the stormwater drainage area

The facility was instructed to clean and scrape the contents for the stormwater ditch, and remove the manure appropriately. It is undetermined if this area was the cause of the elevated sample collected from the tile outfall.

**Required Action:** In the future equipment should utilize the designated roads on-site to reduce the potential of an unpermitted discharge. All necessary actions must be taken to prevent any unpermitted discharge from a CFO, which is considered a violation anytime manure (represented by ammonia) is detected in storm water run-off from the production site where manure is managed and threatens to enter, or has already entered, waters of the state.

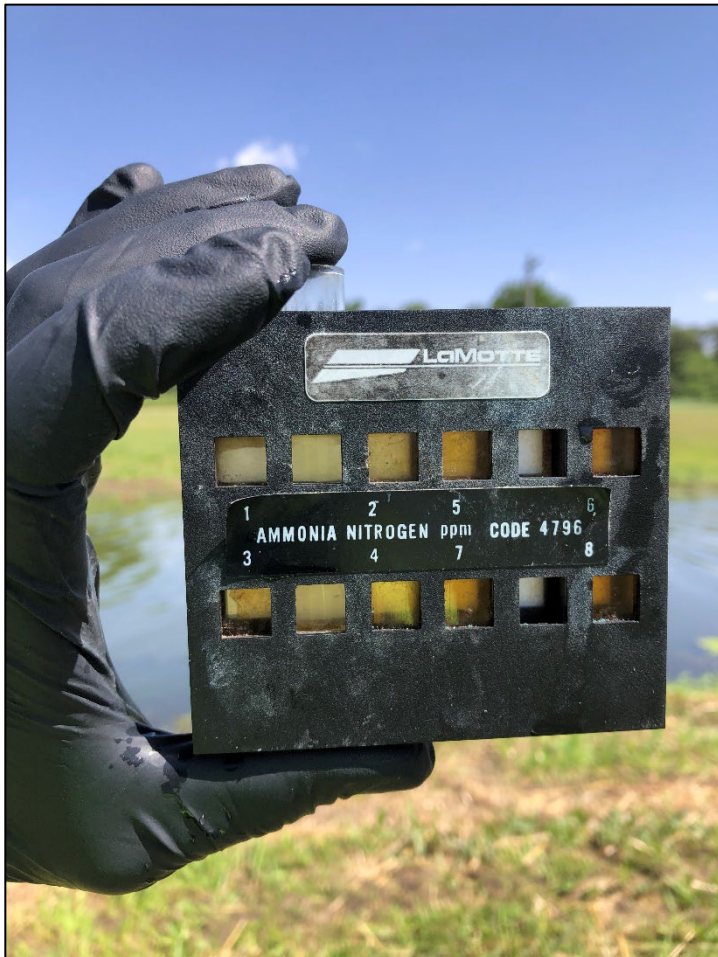
This photo shows the ammonia/nitrogen test result of non-detect taken from the NW stormwater pond.

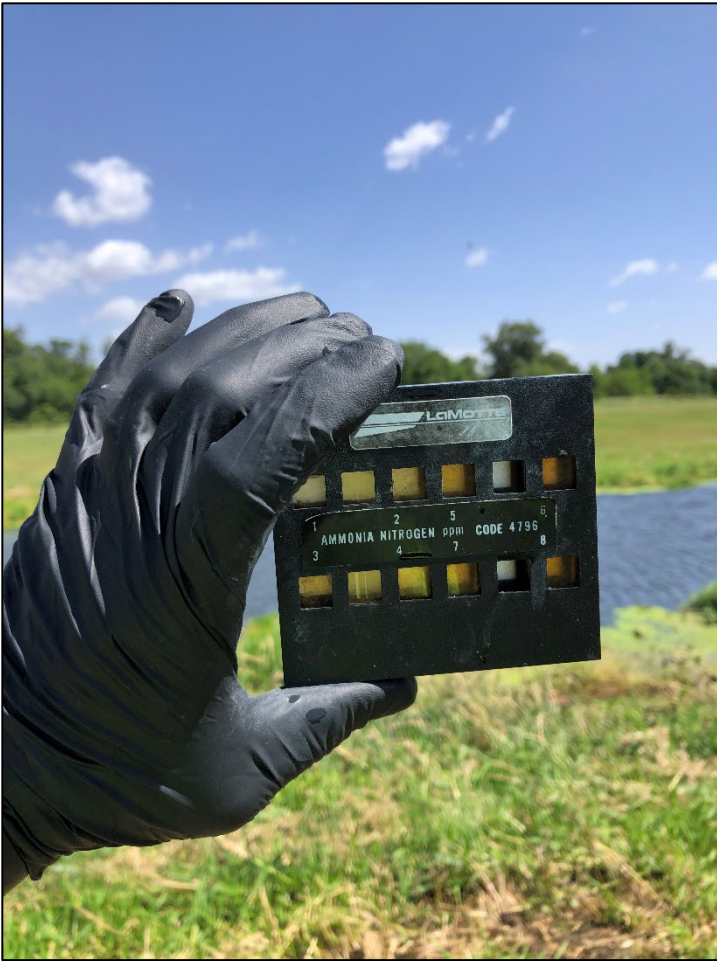
This photo shows the ammonia/nitrogen test result of non-detect taken from the NE stormwater pond.

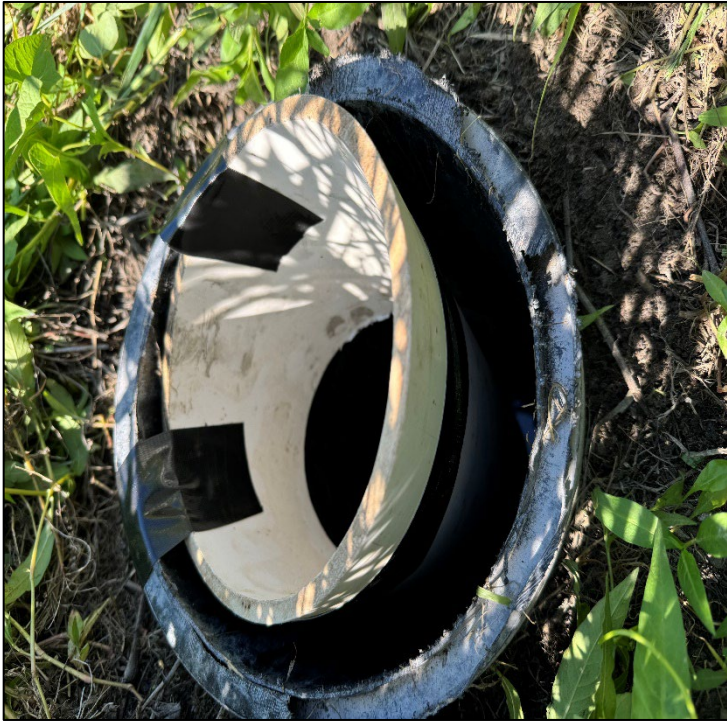
This photo shows the blocked off stormwater drainage tile outfall SW of E3

After IDEM inspectors left the facility, Mr. Hein sent this inspector photos showing the plugged tiles (**See attached photos**). **It should be noted that the methods used for plugging the tiles are only temporary, and that the facility must use a permanent method for plugging the tiles.**

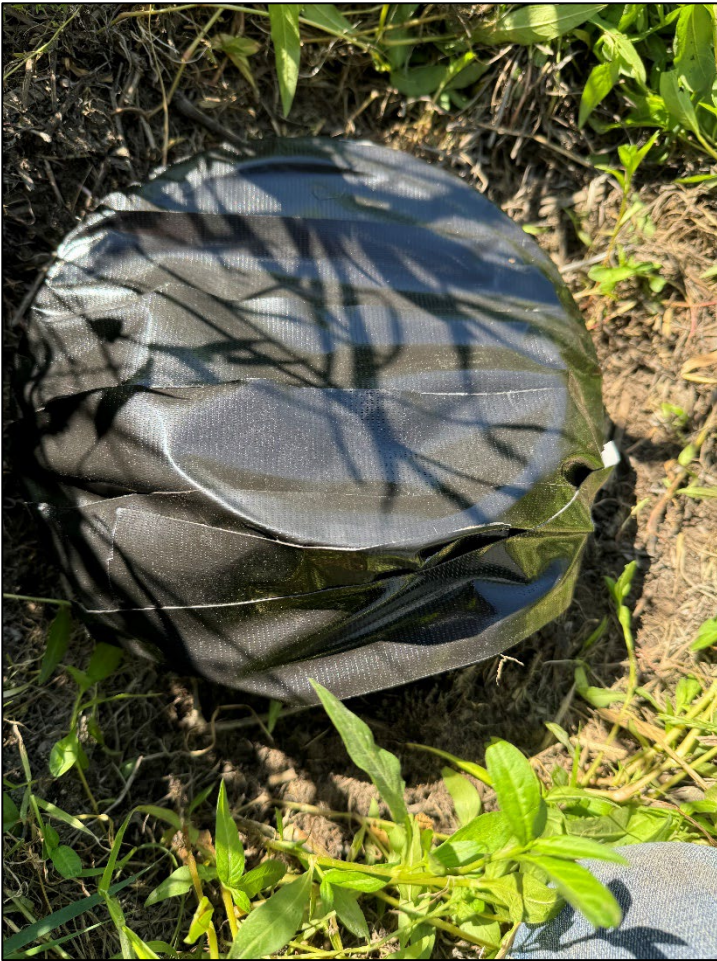
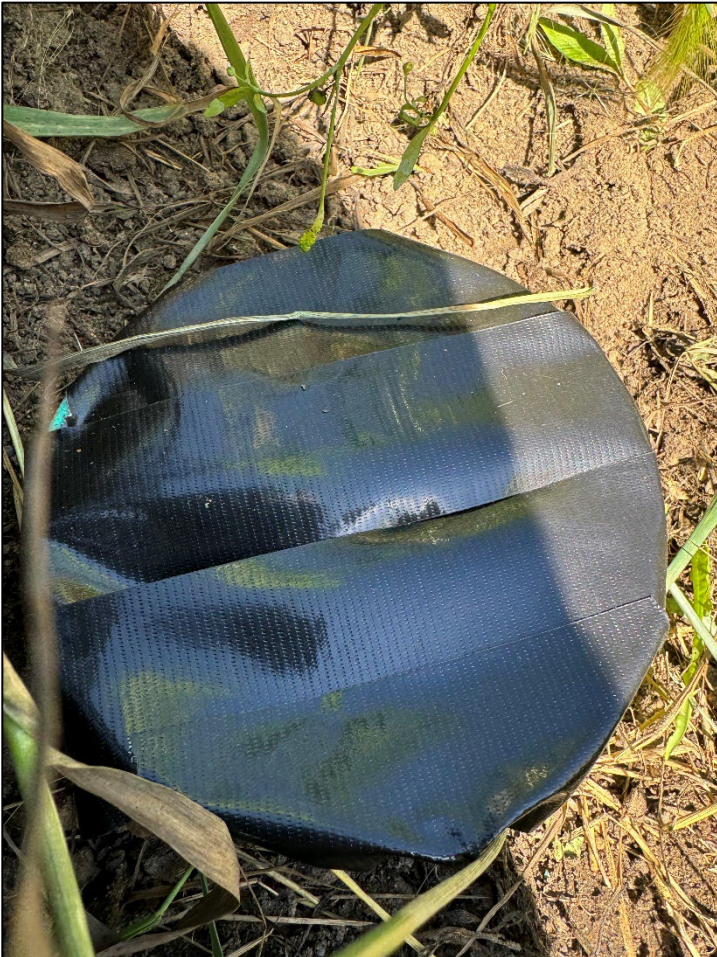
This photo shows the capped stormwater drainage tile inlet and P1 perimeter tile outfall locate SW of E3.
