Officer Narrative

Case Number: 2405EPA0000716 Entered On: 6/6/2024 7:37:00 AM
Subject: 05WATERWAY: CREEK, PONDS, WETLAND, RIVERS, ETC. Entered By: Wise, Keith

Ohio Environmental Protection Agency Emergency Response Unit
 District Office Investigation Report - Photograph Log
 Incident Number: 2405EPA0716

STREAM POLLUTION/ FISH KILL SUPPLEMENT

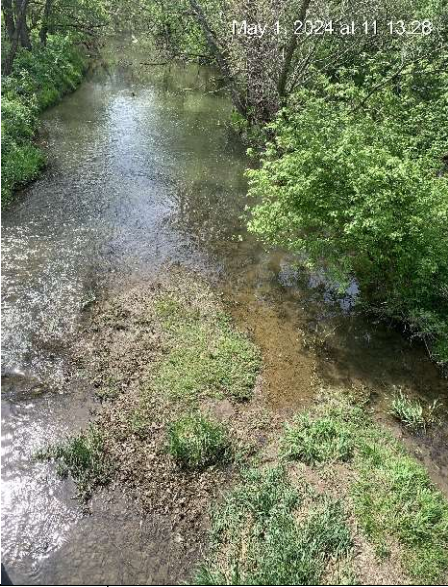
Name:	24-0716 (01)	Name:	24-0716 (02)

Taken By:	OSC WISE	Taken By:	OSC WISE
Date:	5/1/2024	Date:	5/1/2024
Description	Middle Fork East Fork Whitewater River at Hill Rd. IN.	Description	Ammonia reading at Hill Rd.
Name:	24-0716 (03)	Name:	24-0716 (04)

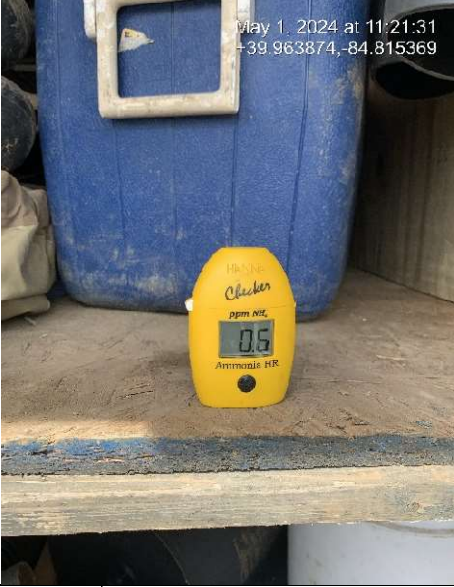
1110hr- OSC Wise arrived at Hill Rd. bridge and observed an ammonia reading of 4ppm and dead fish within Middle Fork East Fork Whitewater River. The OSC met with Jared Coppess and Elizabeth Farver, DCSWCD and was informed fields located near 1737 Hollansburg-Richmond Rd. had manure runoff impacting culverts. The OSC relocated and observed ammonia reading of 58.2ppm at the culvert just south of 1737 Hollansburg-Richmond Rd, manure laden field runoff west side of Hollansburg-Richmond Rd, large pooling of manure laden waters on the east side of Hollansburg-Richmond Rd., and dead fish within Middle Fork East Fork Whitewater River correlating with the manure runoff. The OSC determined manure laden waters (pollutant) impacting Middle Fork East Fork Whitewater River had originated from Justin Meyers property.

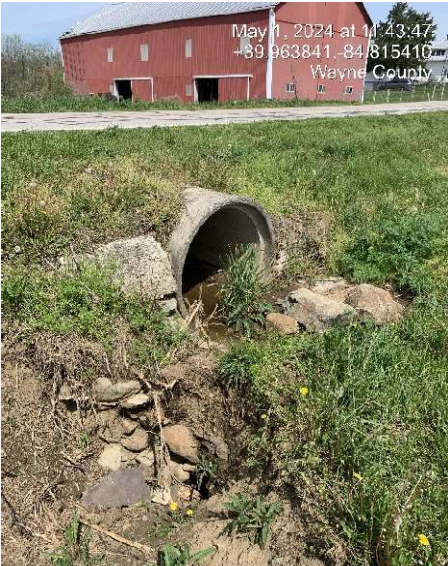
Taken by:	OSC WISE	Taken by:	OSC WISE
Date:	5/1/2024	Date:	5/1/2024
Description	Culvert pipe with manure laden water.	Description	Manure applied field with standing pools of manure laden water.

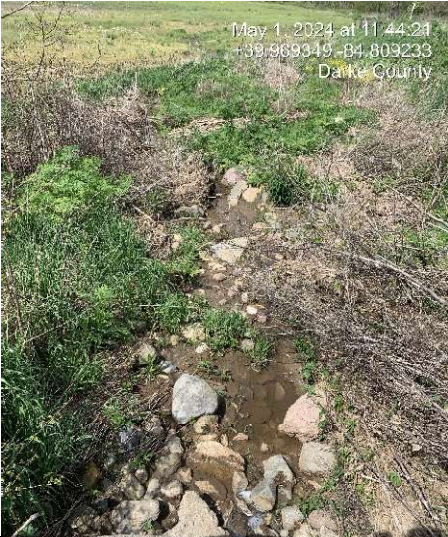
Name:	24-0716 (05)	Name:	24-0716 (06)

Taken By:	OSC WISE	Taken By:	OSC WISE
Date:	5/1/2024	Date:	5/1/2024
Description	Culvert pipe with manure laden water.	Description	Ammonia reading of manure laden water at culvert pipe.
Name:	24-0716 (07)	Name:	24-0716 (08)

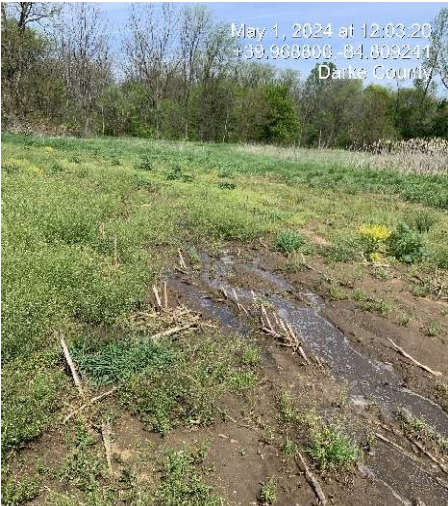
Taken By:	OSC WISE	Taken By:	OSC WISE
Date:	5/1/2024	Date:	5/1/2024
Description	Standing pool of manure laden water in field located west of Hollansburg-Richmond Rd.	Description	Large standing pool of manure laden water in field located west of Hollansburg-Richmond Rd.

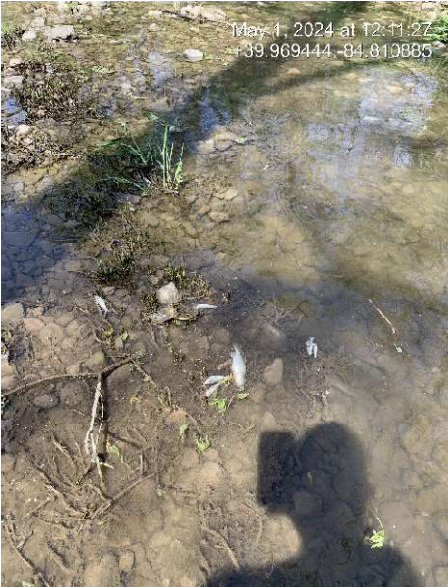
Name:	24-0716 (09)	Name:	24-0716 (10)

Taken By:	OSC WISE	Taken By:	OSC WISE
Date:	5/1/2024	Date:	5/1/2024
Description	Dead fish within Middle Fork East Fork Whitewater River.	Description	Ammonia reading of Middle Fork East Fork Whitewater River.
Name:	24-0716 (11)	Name:	24-0716 (12)
