Re: **Inspection Summary Letter**
Colton T. Moulder
FID# 6877
Kempton, Tipton County

CFO
INSPECTION REPORT
 INDIANA DEPARTMENT OF
 ENVIRONMENTAL MANAGEMENT

Inspection Type: CFO Follow-Up

FID# 6877 – Colton T. Moulder

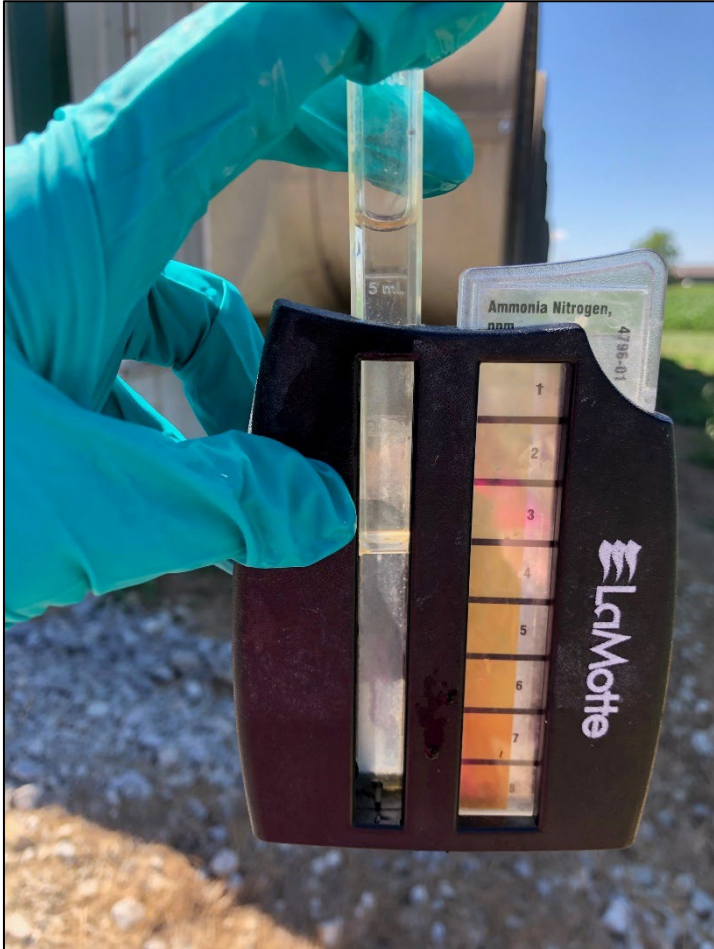
On June 24, 2024, a follow-up inspection was conducted to re-sample the perimeter drain tile riser located at 1E for ammonia nitrogen. During the routine compliance inspection conducted on 6/10/2024, the sample collected from this perimeter drain tile riser tested >6ppm for ammonia nitrogen.

The sample collected today was non-detect. See attached photo.

This photo shows the ammonia nitrogen test result of non-detect from the perimeter tile riser located at permitted structure 1E.

No further action is necessary.
