AGRICULTURE AND SOLID WASTE COMPLIANCE

State Form 47272 (R3/12-08)
INDIANA DEPARTMENT OF ENVIRONMENTAL MANAGEMENT

Table with inspection details: File, County (Vigo), Type of Report (Construction), Name of Inspector (Mike Sonnefeld), Date of Inspection (June 27, 2024), Time In (9:30 am), Time Out (10:45 am), Name of Facility (Sycamore Ridge LF), Permit (84-06), Mailing Address (Indianapolis, IN 46202), Location (5621 East Cottom Drive, Pimento, IN 47866)

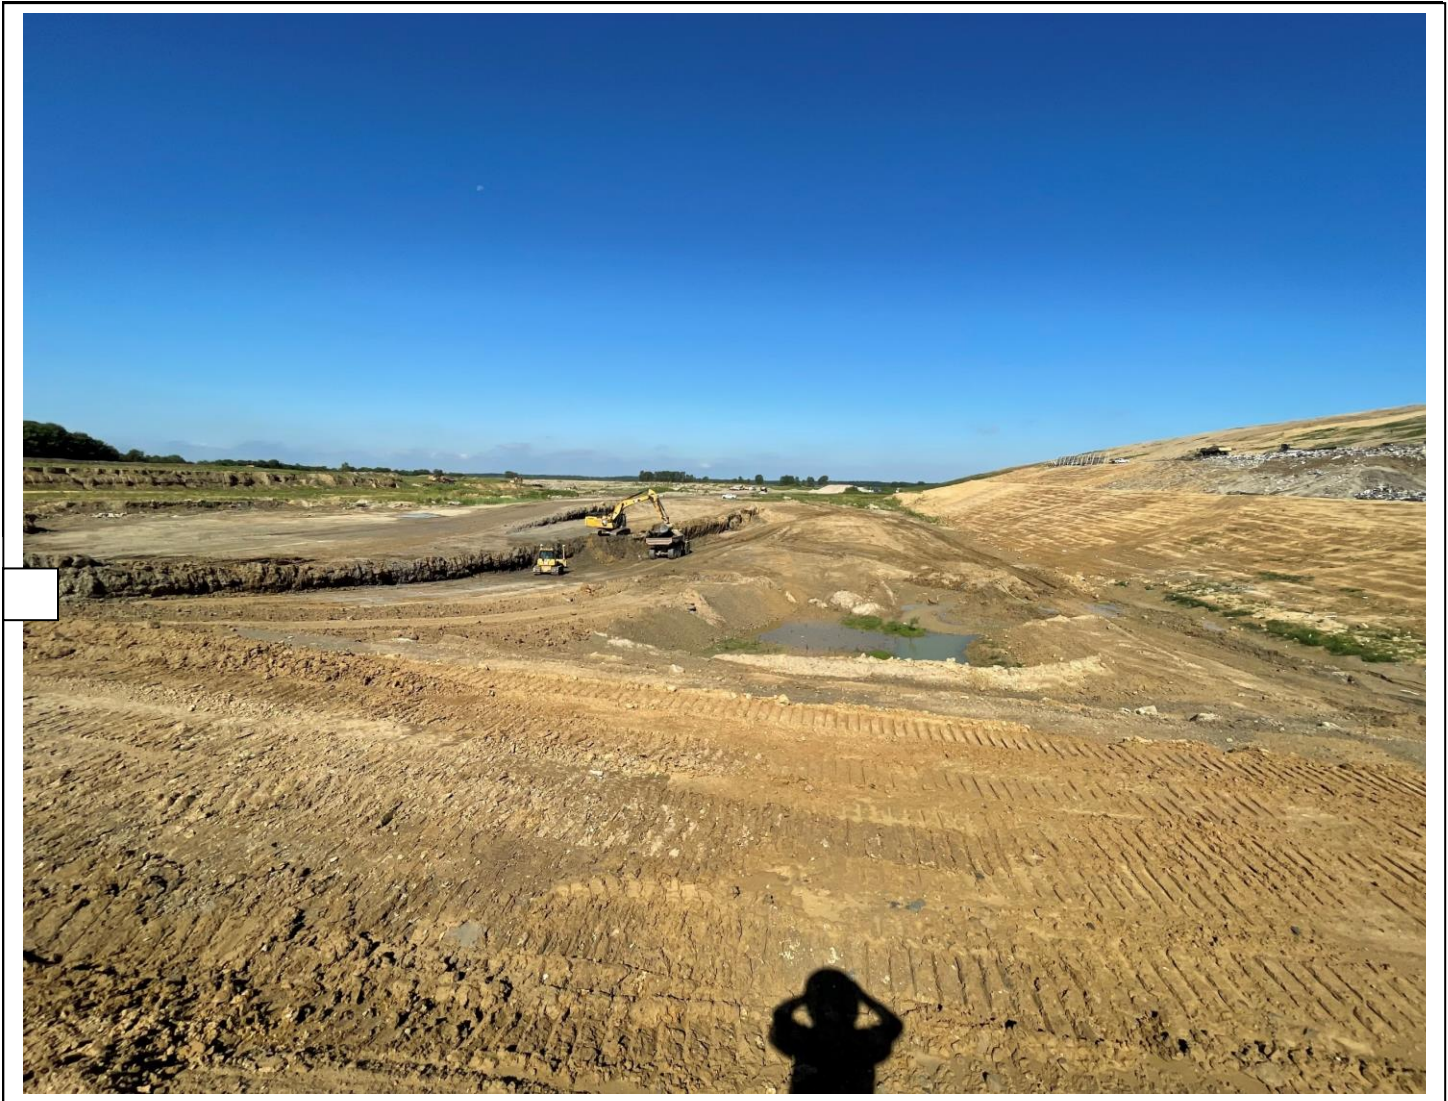
The Cell M contractor has completed mobilization and is mass excavating to remove overburden soil within the cell footprint down to top of foundation/bottom of soil liner contours. Excavated soil is hauled out of the construction area, south to a stockpile.

Number	1
		Description	Standing at the top of Cell M's east side slope looking west at the cell excavation.
		Photographer	Mike Sonnefeld
		Facility Name	Sycamore Ridge Cell M
		Photo Date	June 27, 2024
		Others

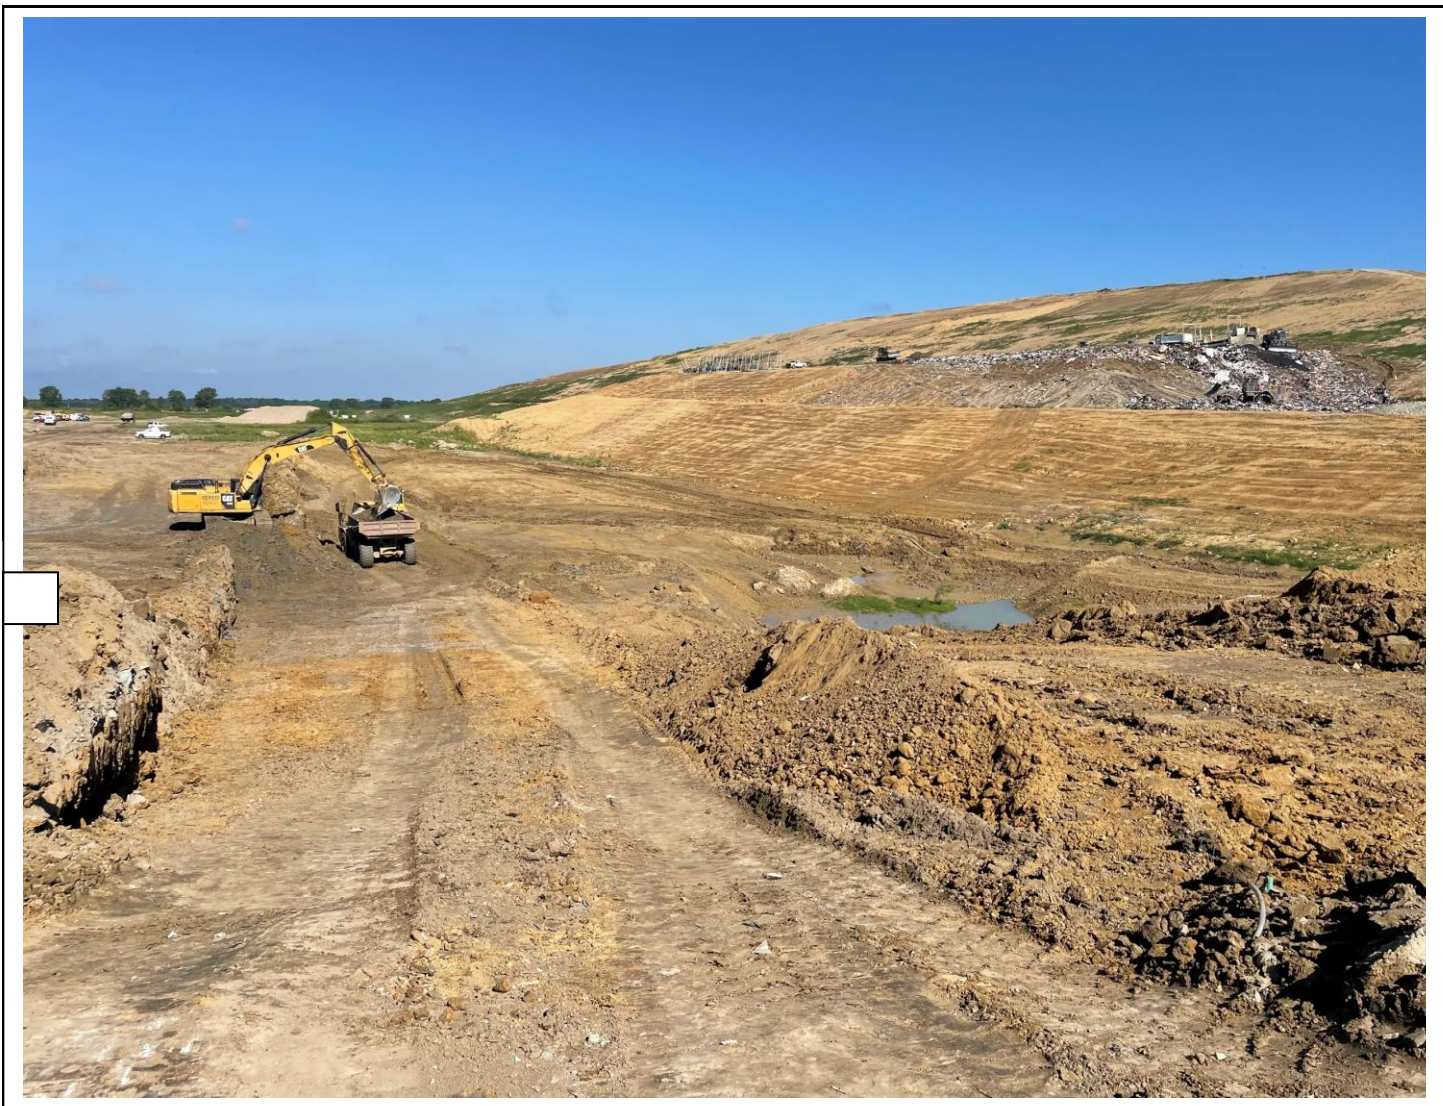
Some mucking will be necessary at the south east corner of the cell where water drains and collects.

Number	2
	Description	Standing at the top of Cell M's south east corner slope looking west at the cell excavation. Excavator moving south removing over burden from the south end of cell.
	Photographer	Mike Sonnefeld
	Facility Name	Sycamore Ridge Cell M
	Photo Date	June 27, 2024
	Others

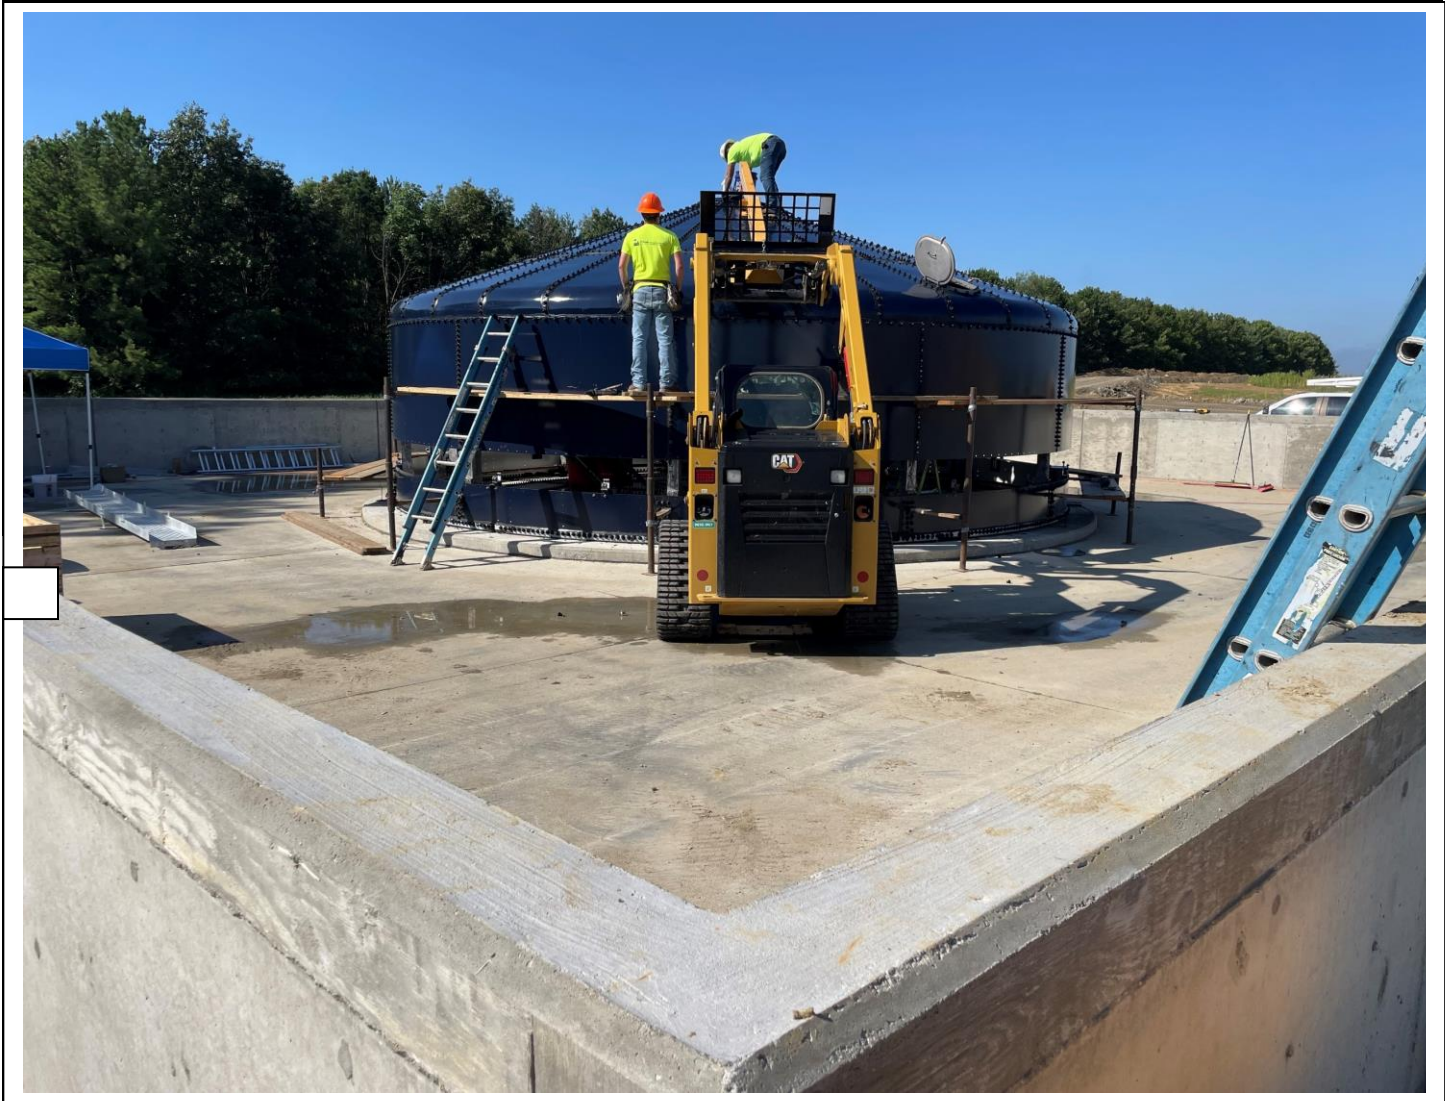
A second contractor is on-site installing the 150,000 gallon, steel/glass lined leachate storage tank.

Number	3
	Description	Standing at the northeast corner of the 150,000 gallon leachate tank secondary containment wall. Tank upper ring and top being assembled at ground level.
	Photographer	Mike Sonnefeld
	Facility Name	Sycamore Ridge Cell M
	Photo Date	June 27, 2024
	Others

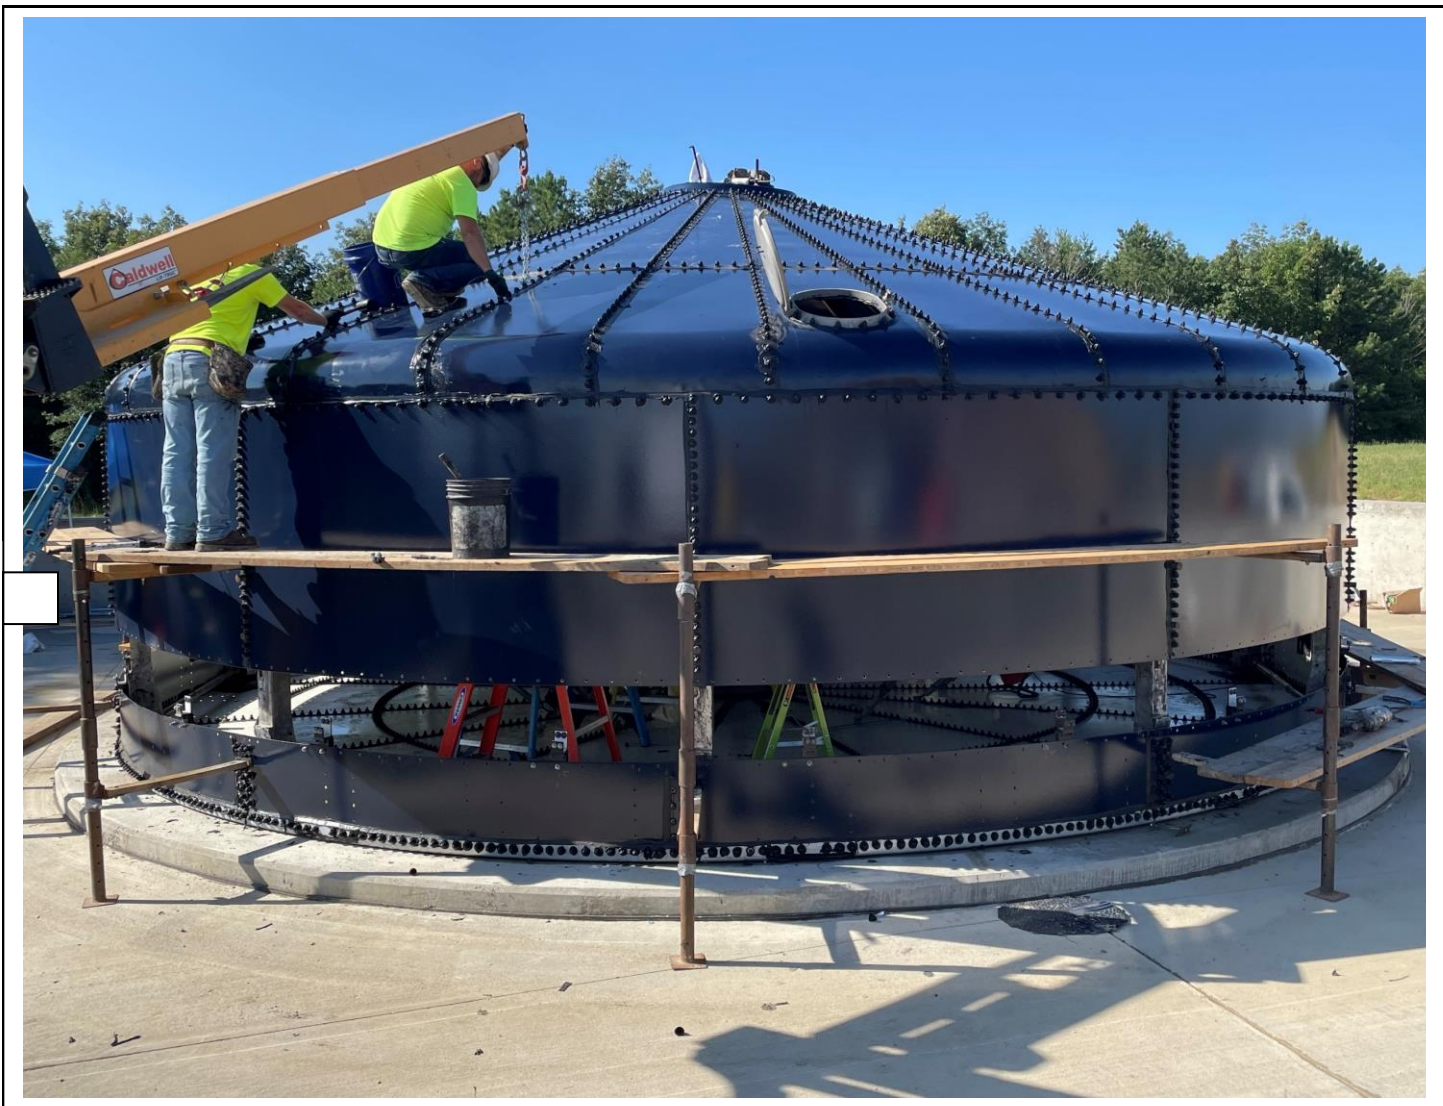
- The tank bottom is installed within the steel anchor ring that protrudes from the top of the concrete secondary containment slab.
Assembly of the tank's top circular steel ring and conical steel top is being completed now from the concrete slab. Once complete, the top ring/conical top will be lifted by screw jacks allowing installation/assembly of the subsequent rings from ground level (top of concrete slab) for safety.

Number	4
	Description	Tank assembly. Joints and bolts holes caulked with sealant. Work done at ground level. Tank secured to screw jacks for lifting to allow assembly of subsequent rings from ground level.
	Photographer	Mike Sonnefeld
	Facility Name	Sycamore Ridge Cell M
	Photo Date	June 27, 2024
	Others

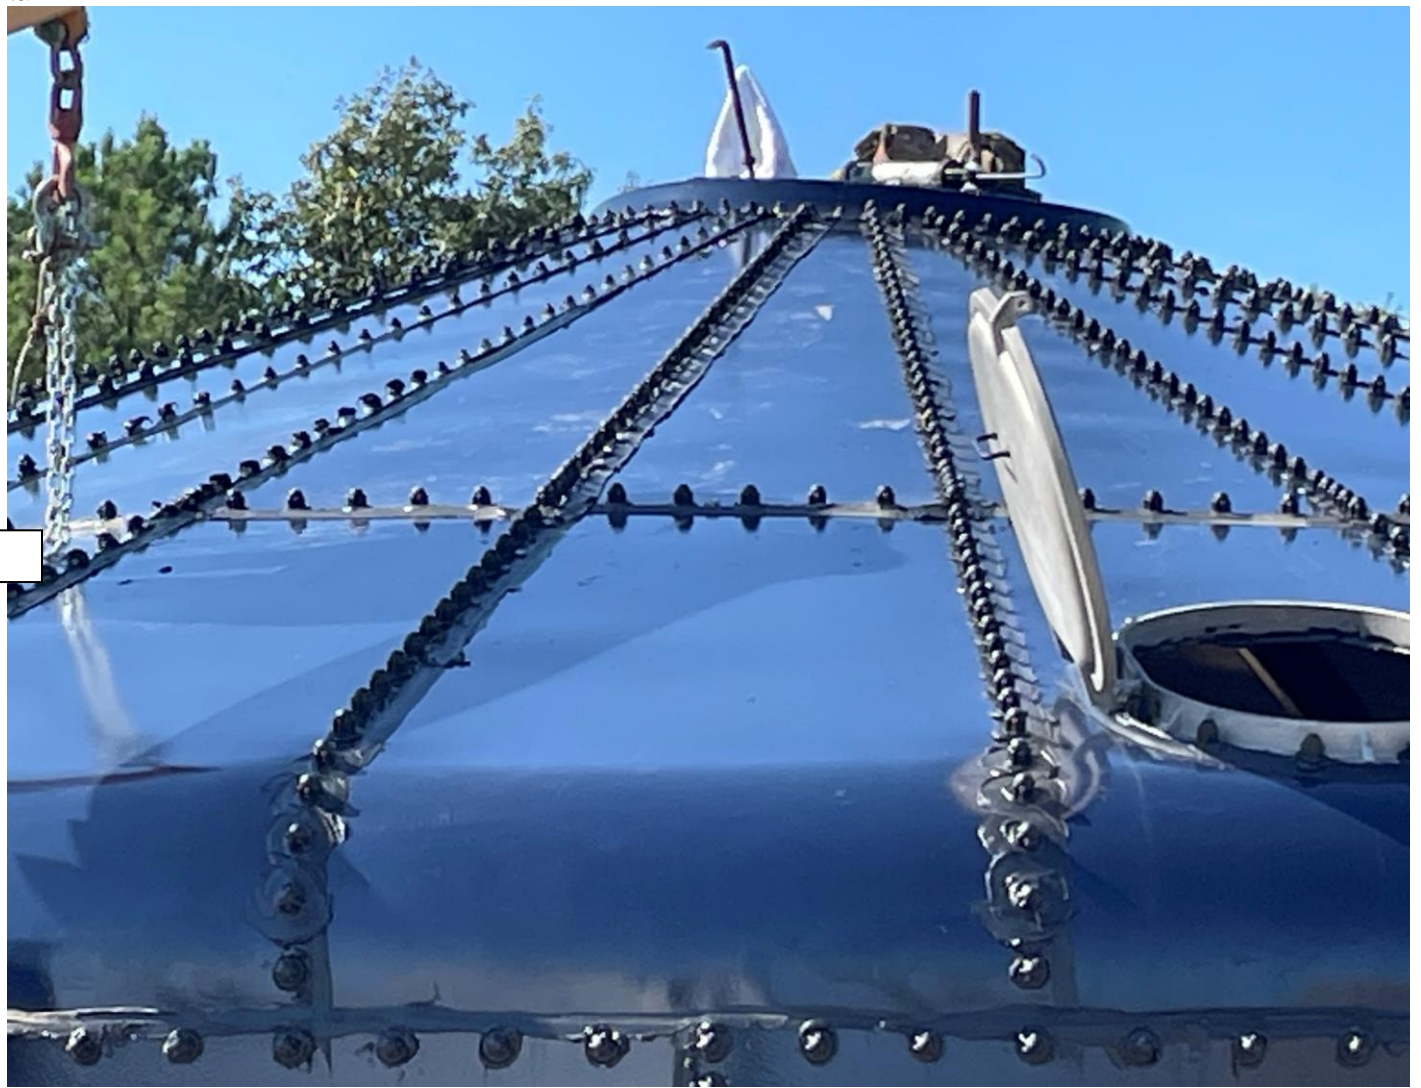
Number	5
	Description	Tank's conical top with man access port. Sealant applied to joints and bolt holes.
	Photographer	
	Facility Name	Sycamore Ridge Cell M
	Photo Date	June 27, 2024
	Others

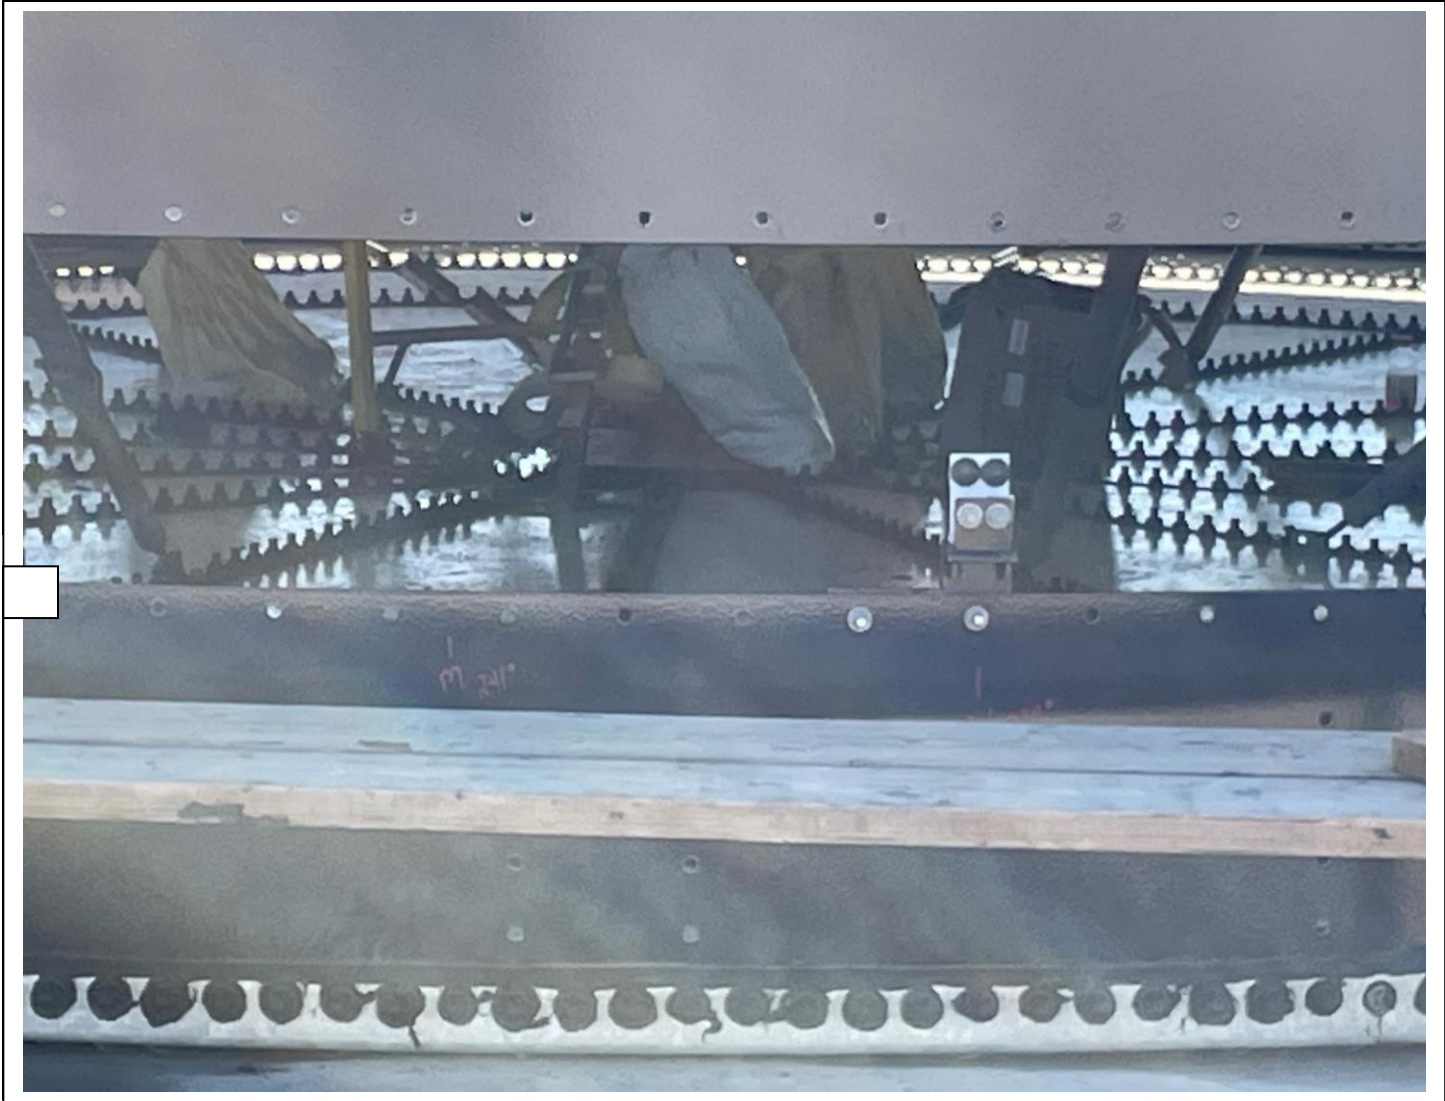
Number	6
	Description	Tank's circular glass lined steel bottom installed on concrete slab.
	Photographer	Mike Sonnefeld
	Facility Name	Sycamore Ridge Cell M
	Photo Date	June 27, 2024
	Others

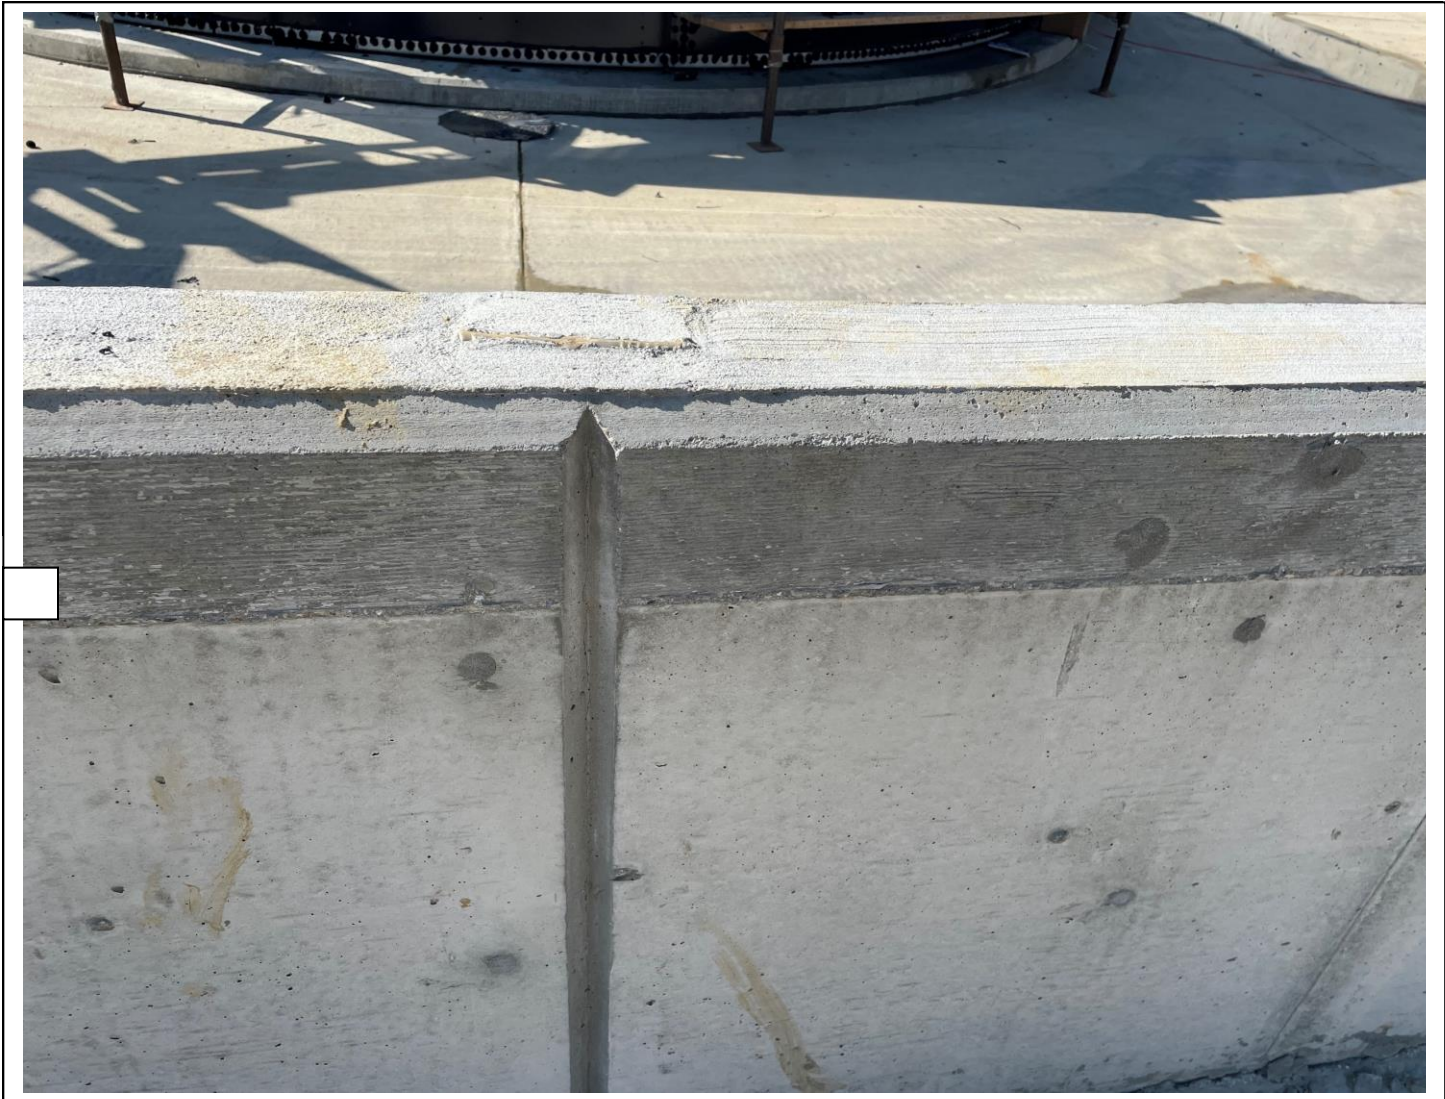
Number	7
	Description	Secondary containment concrete wall with vertical control joint w/waterstop.
	Photographer	Mike Sonnefeld
	Facility Name	Sycamore Ridge Cell M
	Photo Date	June 27, 2024
	Others

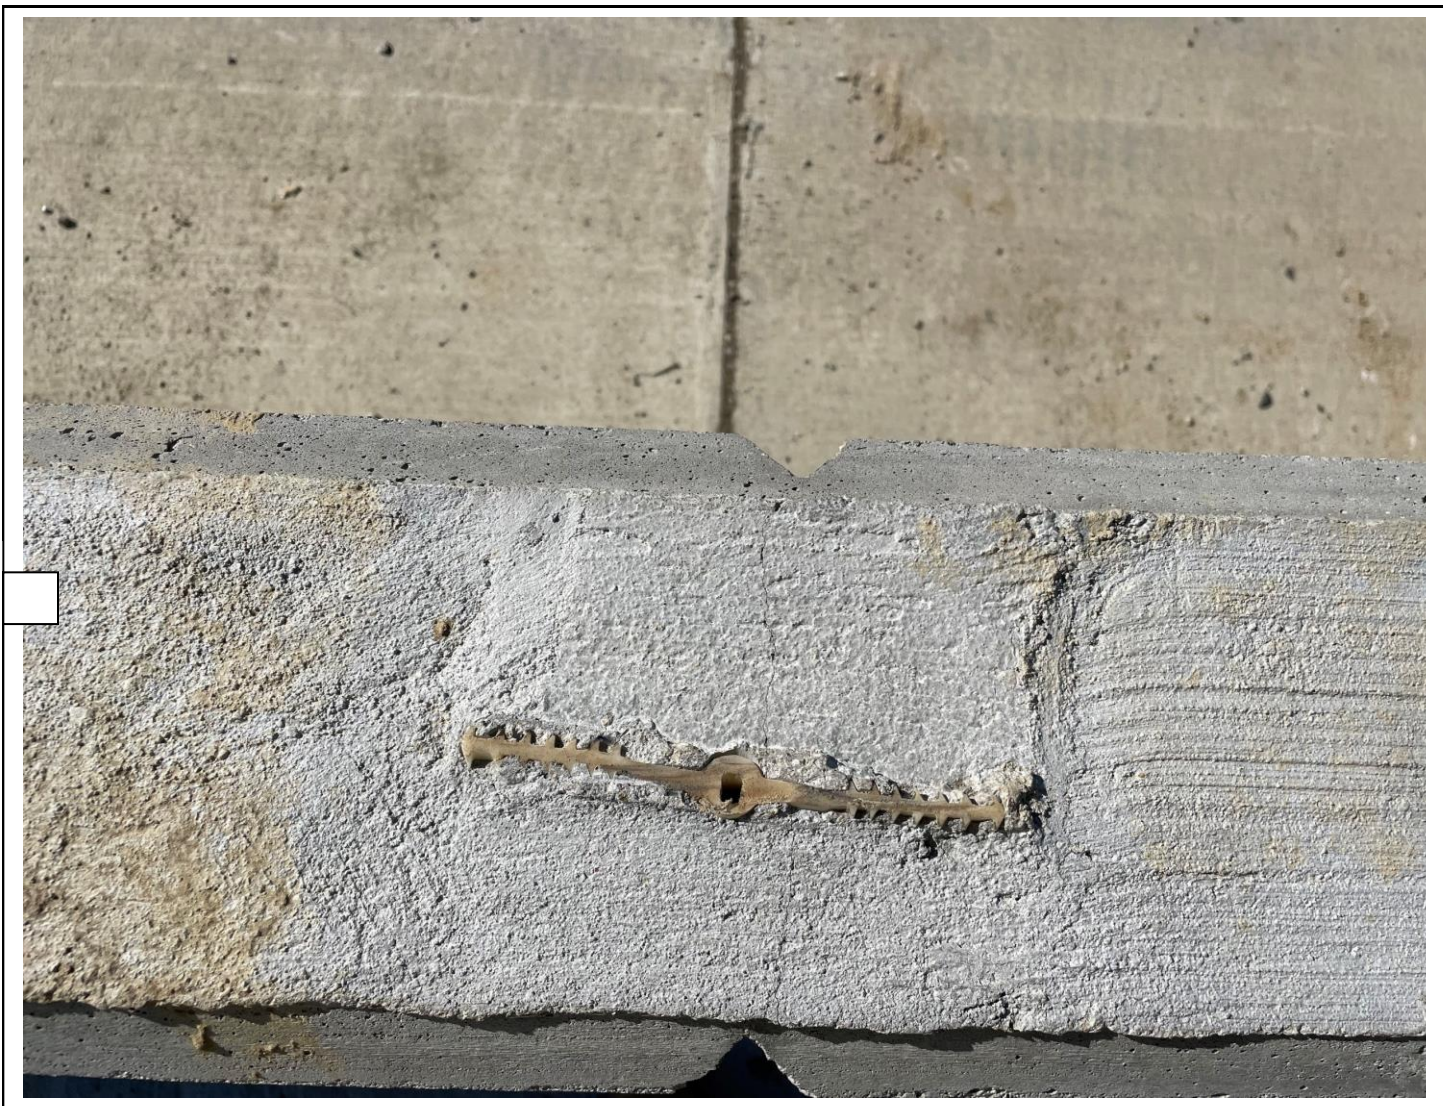
Number	8
	Description	Waterstop.
	Photographer	Mike Sonnefeld
	Facility Name	Sycamore Ridge Cell M
	Photo Date	June 27, 2024
	Others
