Re: Violation Letter

OTECH Corporation IND016604159

Rolling Prairie, La Porte County

HAZARDOUS WASTE INSPECTION REPORT

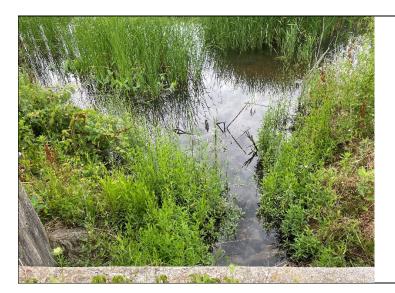
Number	5	
Description	Photo of the detention pond	
Photographer	Cathy Csatari	
Facility Name	OTECH Corporation	
Photo Date	6/26/2024	
Others	Mr. Jack Shrader- OTECH Corporation

The exterior of the facility was observed from other doorways and overhead doors. No other outside areas were observed to have signs of routine discharges of dust or powder. The detention pond was observed and did not appear to be impacted by the routine discharges of dust, powder, or dirty mop water. Stormwater was observed in one truck bay. There was no powder or dust observed in the stormwater. Mr. Shrader did state that they do use compressed air within the facility to clean equipment and under equipment but that the clean-up waste is not directed to outside the facility.

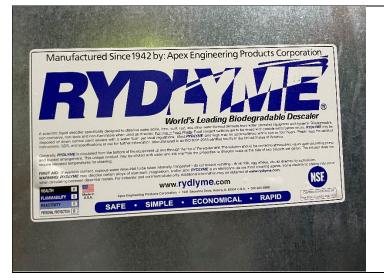
Number	1	
Description	Label for the Rydlyme descaler	
Photographer	Cathy Csatari	
Facility Name	OTECH Corporation	
Photo Date	6/26/2024	
Others	Mr. Jack Shrader- OTECH Corporation
